## MINERALS PROGRAM INSPECTION REPORT

<b>MINE NAME:</b> Hansen Uranium Project	<b>MINE/PROSPECTING ID#:</b> P-2009-025	<b>MINERAL:</b> Uranium	<b>COUNTY:</b> Fremont
<b>INSPECTION TYPE:</b> Surety Release Inspection	<b>INSPECTOR(S):</b> Timothy Cazier, P.E.	<b>INSP. DATE:</b> October 15, 2021	<b>INSP. TIME:</b> 10:00
<b>OPERATOR:</b> Black Range Minerals Colorado, LLC	<b>OPERATOR REPRESENTATIVE:</b> Mike Rutter	<b>TYPE OF OPERATION:</b> MP - Mineral Prospecting	
<b>REASON FOR INSPECTION:</b> Surety Release Requested	<b>BOND CALCULATION TYPE:</b> None	<b>BOND AMOUNT:</b> \$154,936.58	
<b>DATE OF COMPLAINT:</b> NA	<b>POST INSP. CONTACTS:</b> U.S.BLM	<b>JOINT INSP. AGENCY:</b> U.S.BLM	
<b>WEATHER:</b> Clear	<b>INSPECTOR'S SIGNATURE:</b>

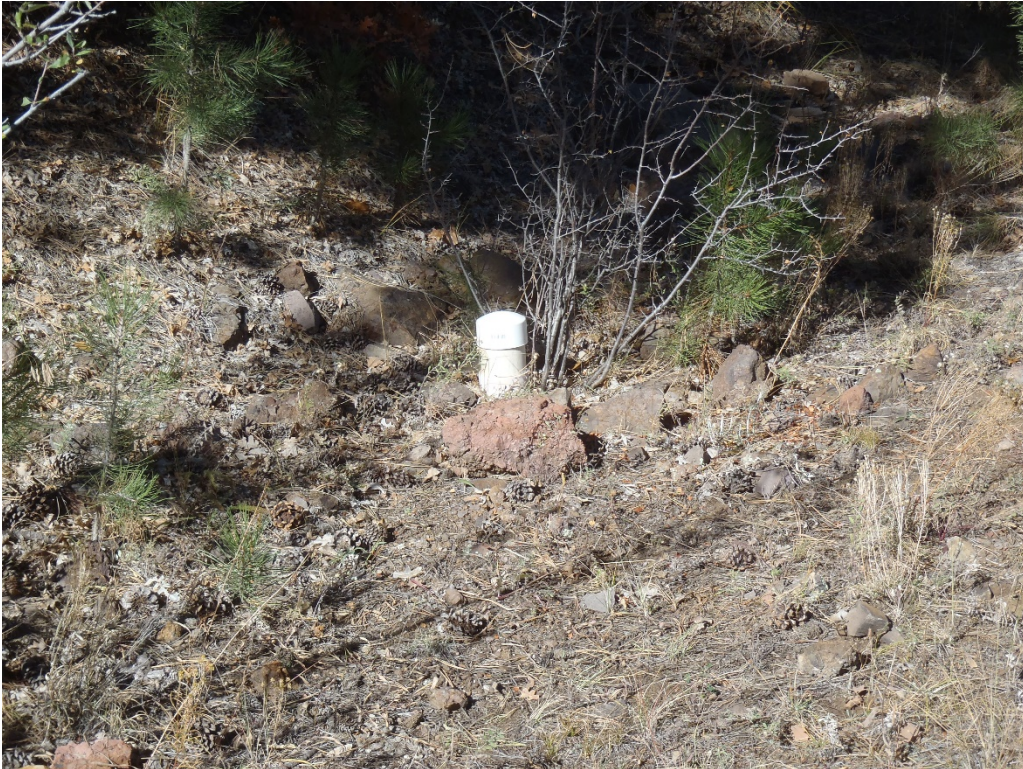
Photo 1. Capped PVC casing observed approximately 160 north of HNDD0009.

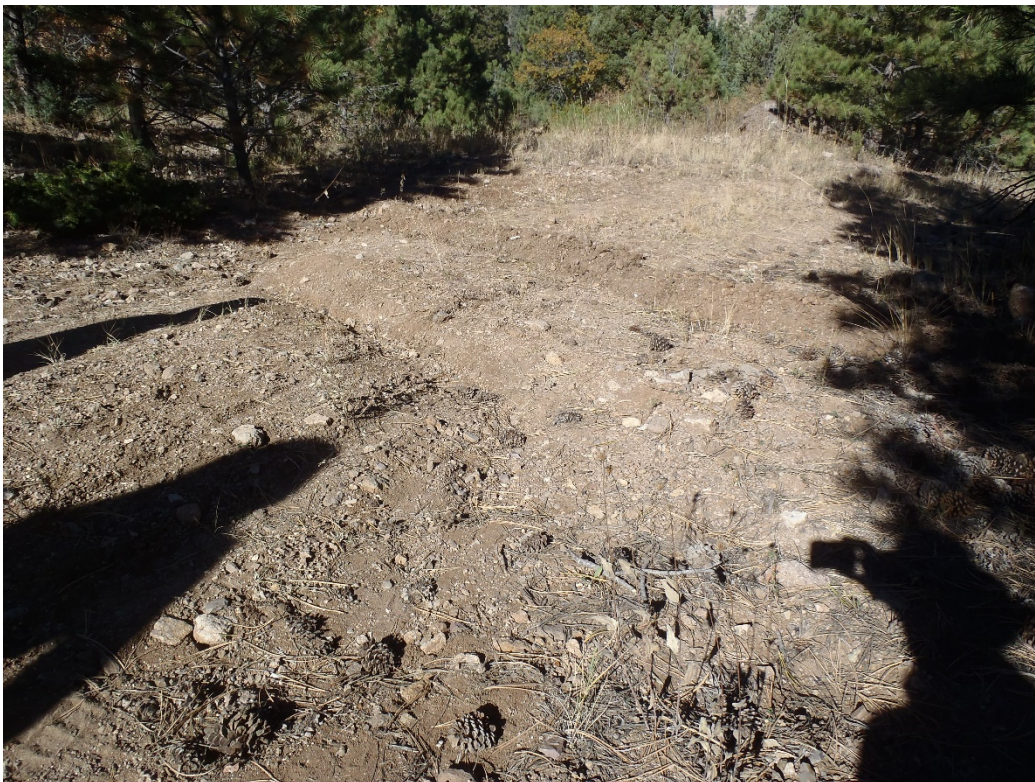
**Roads:** The water bar recommended during the previous inspection (where the drill road to HNDD0010 crests) had been constructed (see **Photo 2**). All other drill roads appeared adequately reclaimed (see **Photo 3**).

1. The aforementioned water bar was constructed on the HNDD0010 drill road (see **Photo 2**),
2. No Canada thistle was observed near the HNDD0010 drill site,
3. Straw wattles and rebar stakes previously observed near HNDD0006 have been removed (see **Photo 4**).

Photo 2. Water bars constructed in road to HNDD0010 (looking north).

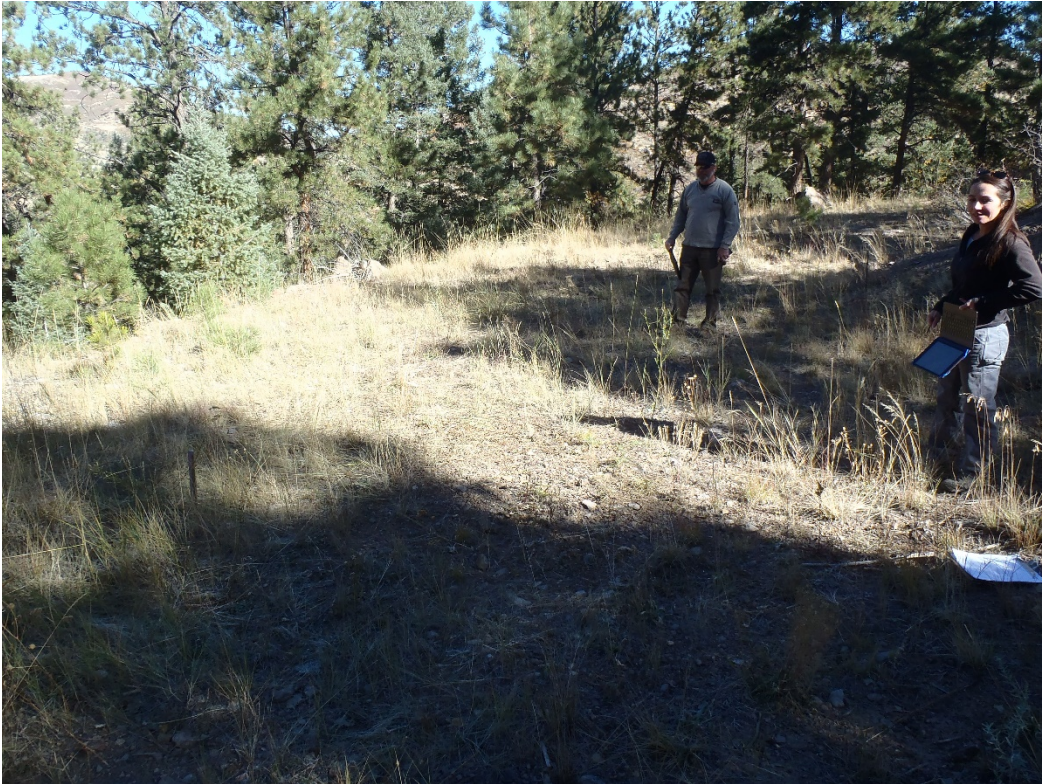
Photo 3. Reclaimed drill site and road – HNDD0010 (looking NE).

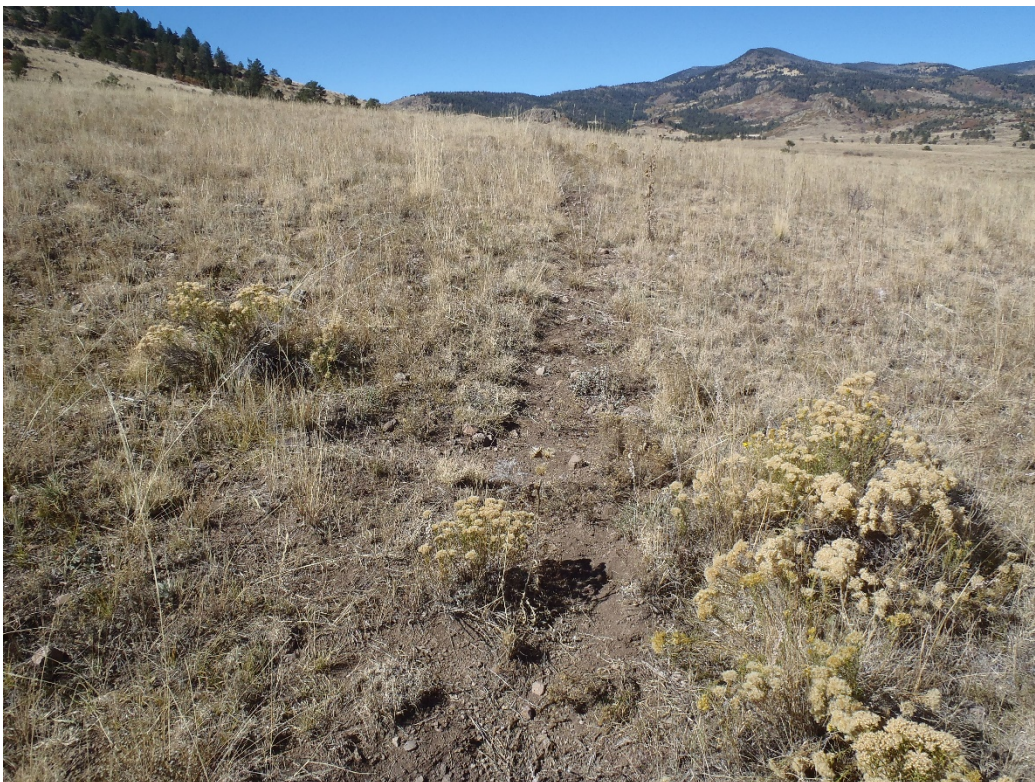
Photo 4. Straw wattles removed at HNDD0006 (looking NW).

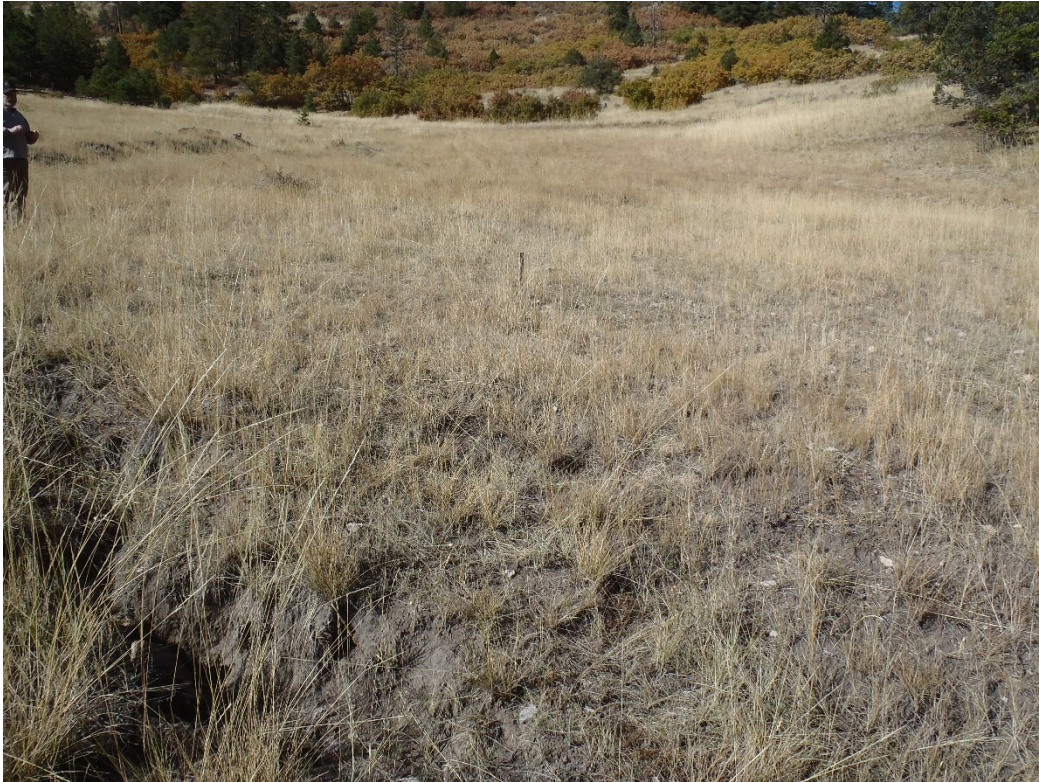
**Revegetation:** Vegetation appears to be diverse and well established at all drill sites (see **Photos 5 and 6**).

Photo 5. Revegetation at HNDD0011.

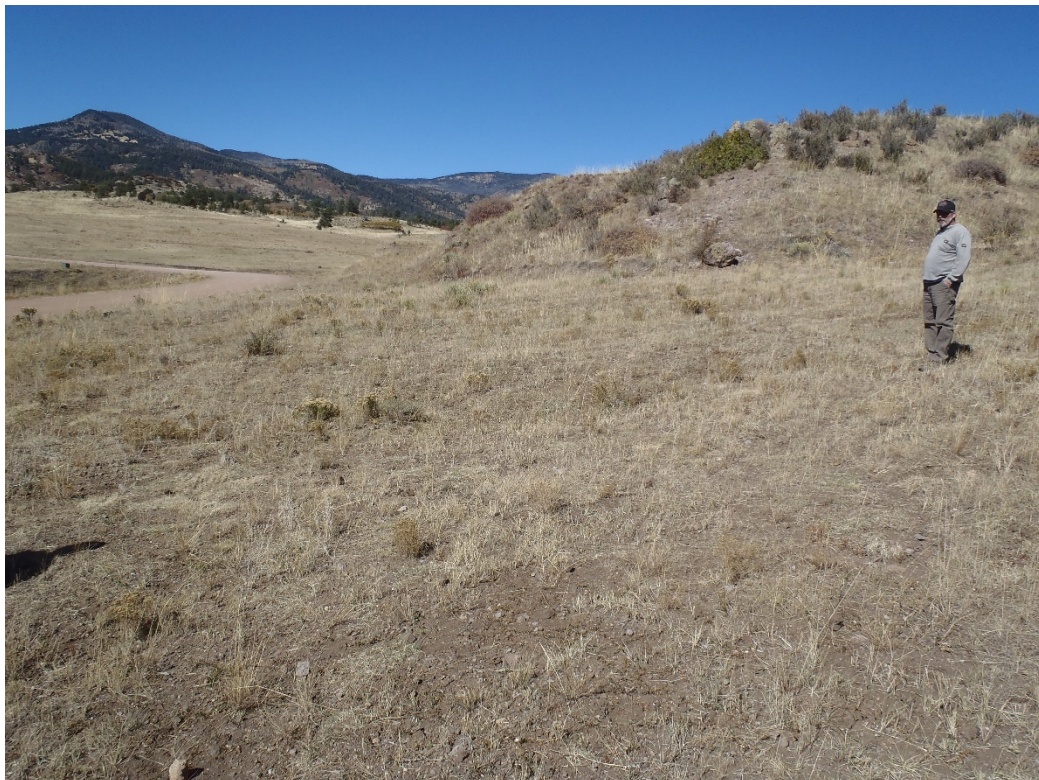
Photo 6. Revegetated HNDD0004 drill site (looking NW).
