MINERALS PROGRAM INSPECTION REPORT
PHONE: (303) 866-3567

MINE NAME: Pitch Project	MINE/PROSPECTING ID#: M-1977-004	MINERAL: Uranium and borrow construction	COUNTY: Saguache
INSPECTION TYPE: Monitoring	INSPECTOR(S): Dustin Czapla	INSP. DATE: October 13, 2021	INSP. TIME: 09:00
OPERATOR: Homestake Mining Company	OPERATOR REPRESENTATIVE: Dave Wykoff	TYPE OF OPERATION: 112d-3 - Designated Mining Operation	
REASON FOR INSPECTION: Normal I&E Program	BOND CALCULATION TYPE: None	BOND AMOUNT: \$24,451,940.00	
DATE OF COMPLAINT: NA	POST INSP. CONTACTS: None	JOINT INSP. AGENCY: None	
WEATHER: Clear	INSPECTOR'S SIGNATURE:

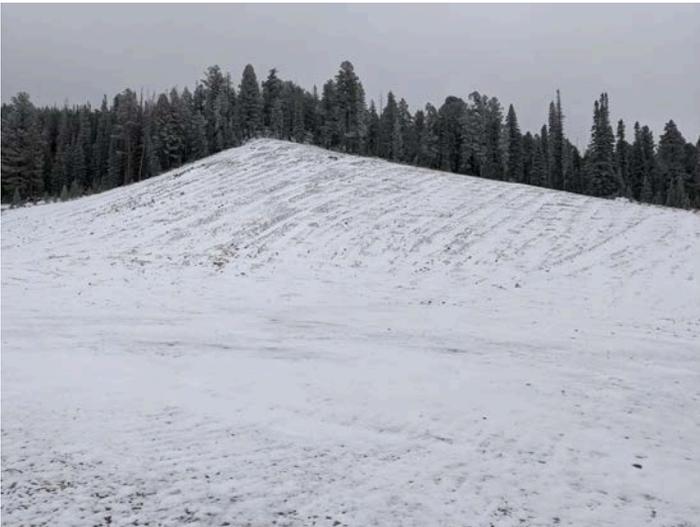
Limestone Quarry: Reclamation grading at the limestone quarry has been completed. The area was reseeded in the fall. The work observed appears to be in accordance with the approved reclamation plan. No problems were noted.

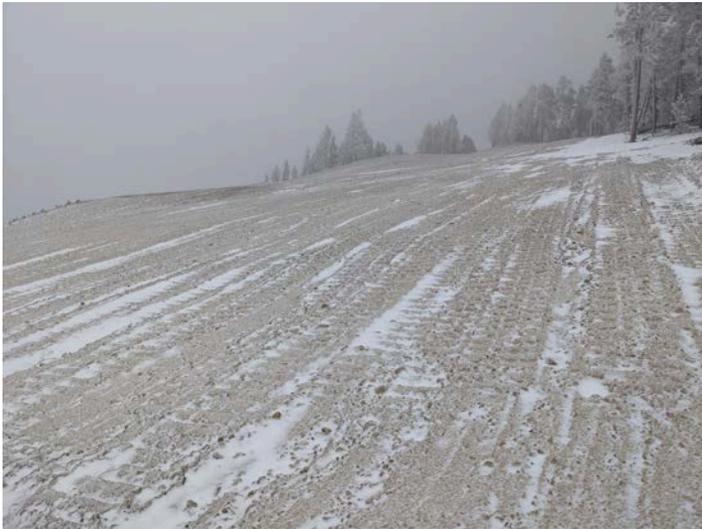
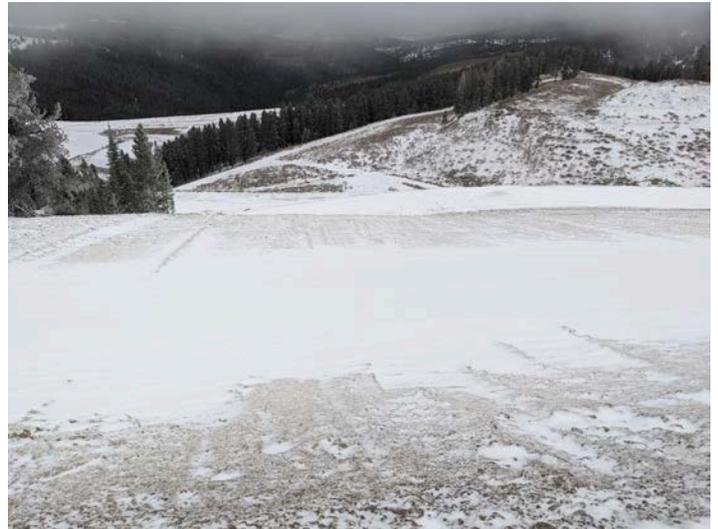
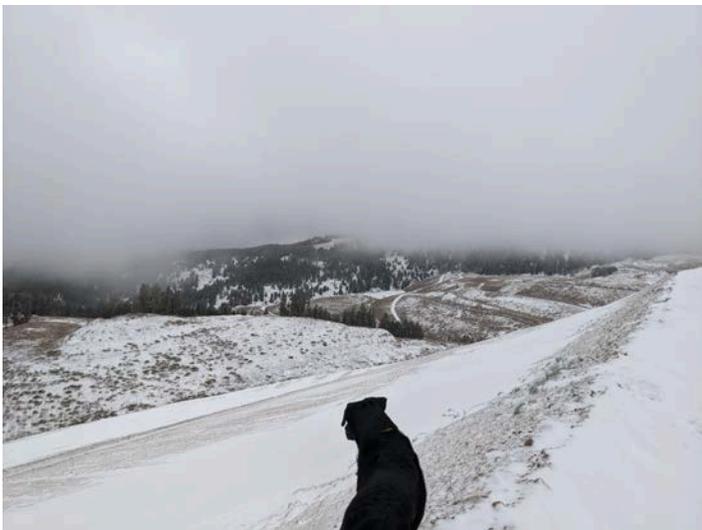
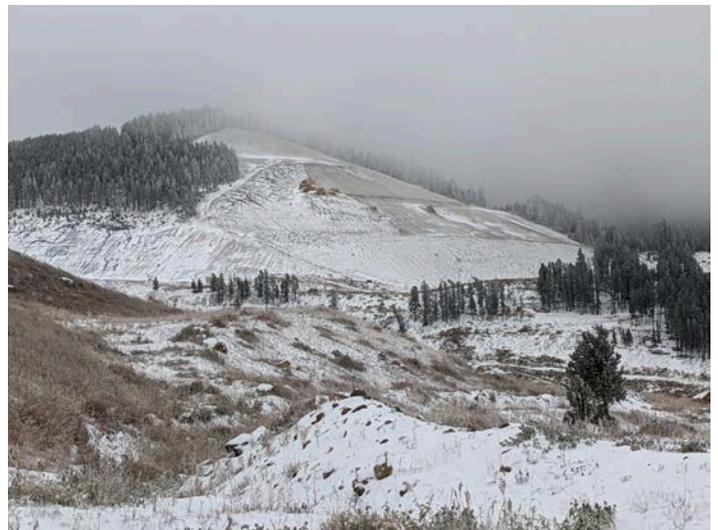
South Pit: Reclamation grading at the South Pit Landslide Crest Mitigation Area has been completed. The area was reseeded in the fall. The work observed appears to be in accordance with the approved reclamation plan. No problems were noted.

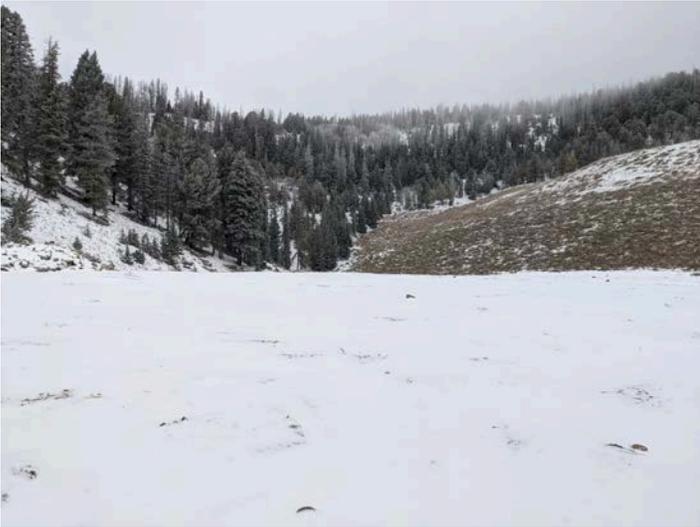
The laydown area above the Tie Camp Rock dump has been regraded and reseeded. The reclamation work looks good. No problems were noted.

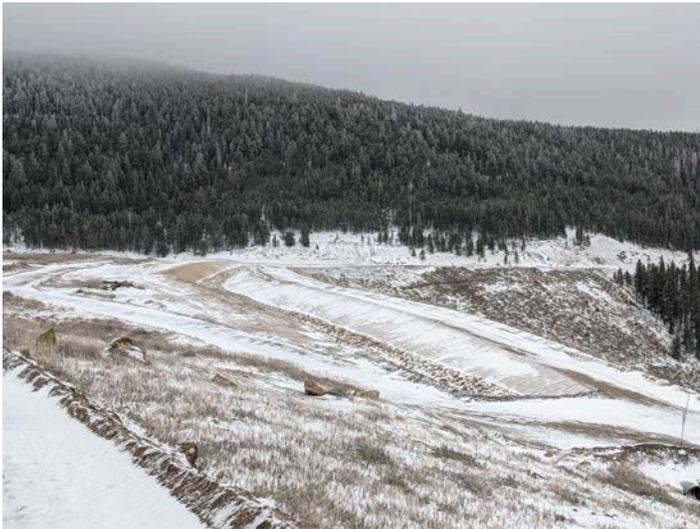
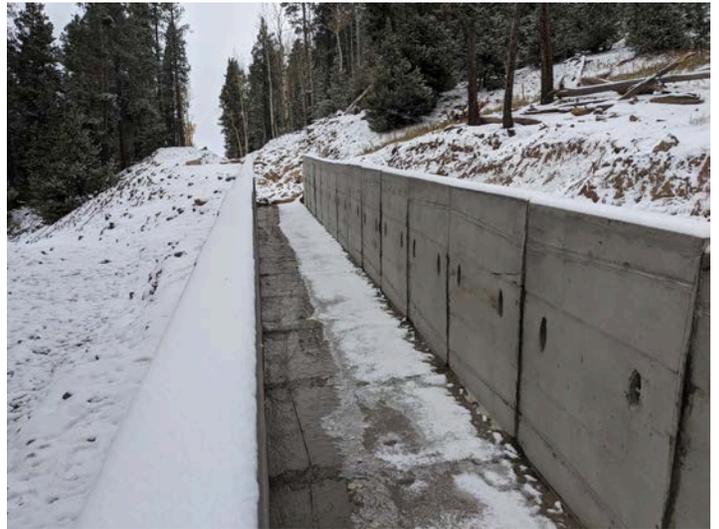
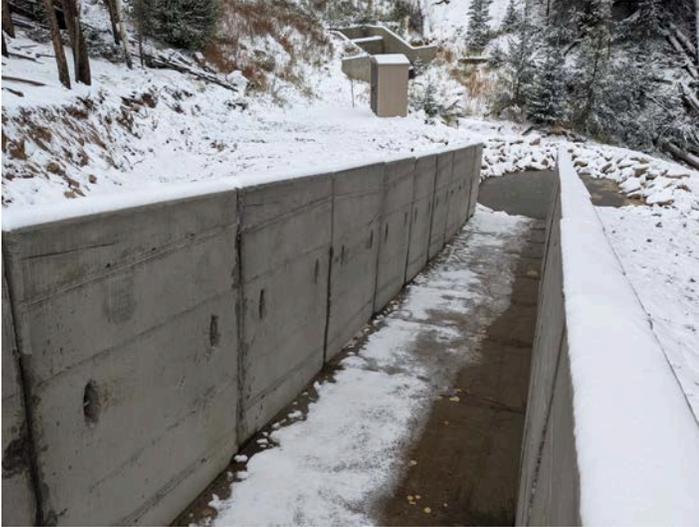
A significant amount of drainage work has been completed at the site. The channel above the north pit has been improved and constructed with rip-rap. A rip-rap drainage channel above the Tie-Camp rock dump has been constructed. 36" HDPE pipe has been installed along the road below the shop area and the channel has been improved down to the concrete structures above the sediment pond area.

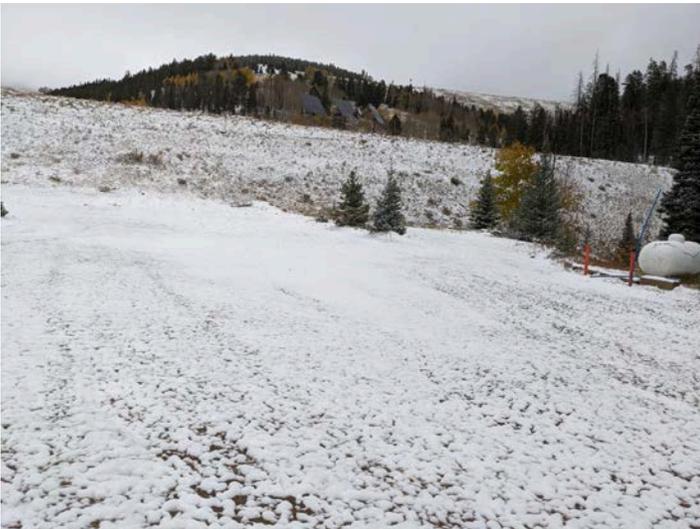
The cericite stockpile has been removed and the area regraded and reseeded.

The sand filter plant has been removed and the area regraded and reseeded.
