MINERALS PROGRAM INSPECTION REPORT

MINE NAME: Cresson Project	MINE/PROSPECTING ID#: M-1980-244	MINERAL: Gold	COUNTY: Teller
INSPECTION TYPE: Monitoring	INSPECTOR(S): Timothy Cazier, P.E.	INSP. DATE: September 28, 2021	INSP. TIME: 09:30
OPERATOR: Cripple Creek & Victor Gold Mining Compa	OPERATOR REPRESENTATIVE: Jeana Ratcliff	TYPE OF OPERATION: 112d-3 - Designated Mining Operation	
REASON FOR INSPECTION: Normal I&E Program	BOND CALCULATION TYPE: None	BOND AMOUNT: \$209,491,188.00	
DATE OF COMPLAINT: NA	POST INSP. CONTACTS: None	JOINT INSP. AGENCY: None	
WEATHER: Clear	INSPECTOR'S SIGNATURE:

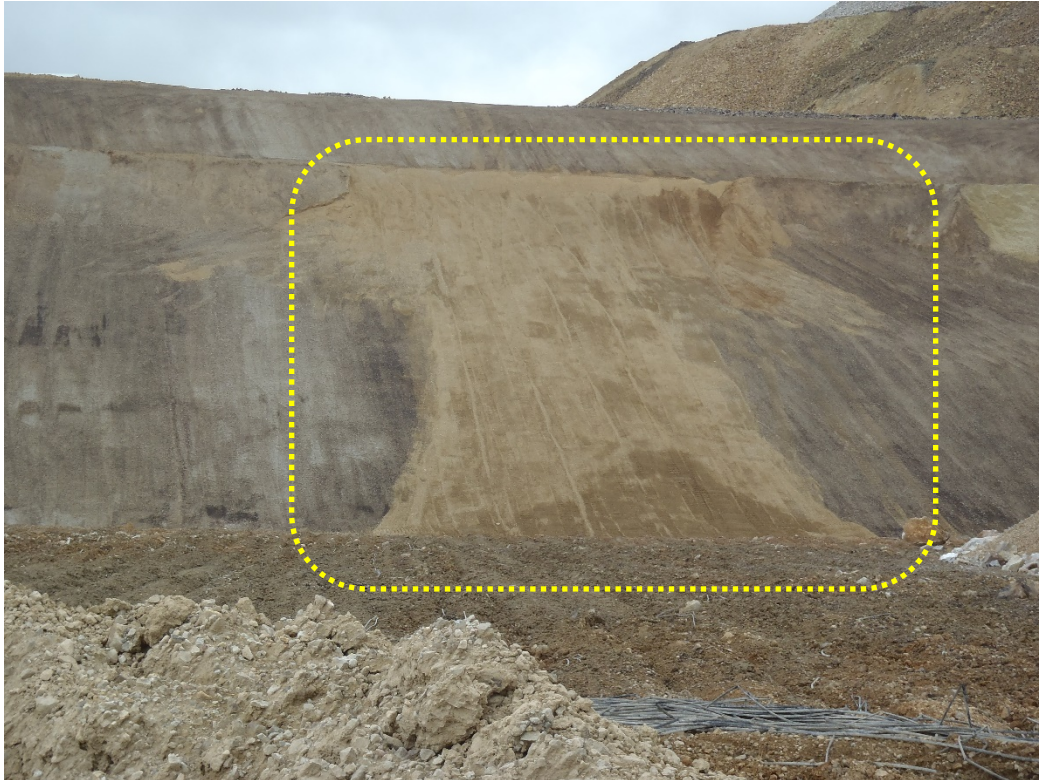
DCF damaged areas: Three areas where DCF was damaged or washed away by the recent heavy rains were visited. The area on the north side of VLF2 had been repaired with DCF having been replaced (see **Photo 1**). The toe berm (constructed using DCF) near the water tank between VLF 1 and VLF2 had been washed out in two places, sending stormwater down the low area between VLF1 and VLF2. The berm had been repaired (see **Photo 2**). The third area visited was the south side of VLF2 where DCF has been washed off the steep section just above the Low Volume Solution Collection System (LVSCS) building (see **Photo 3**). Repair had not begun in this area as the contractor selected for the repair around the header pipes did not have the necessary equipment available, but they were expected shortly after this inspection. Site representatives stated the liner in all areas had or would be recertified and reports would be provided to the DRMS.

Photo 1. Repaired area on the north side of VLF2 had been (looking north from VLF2 pad).

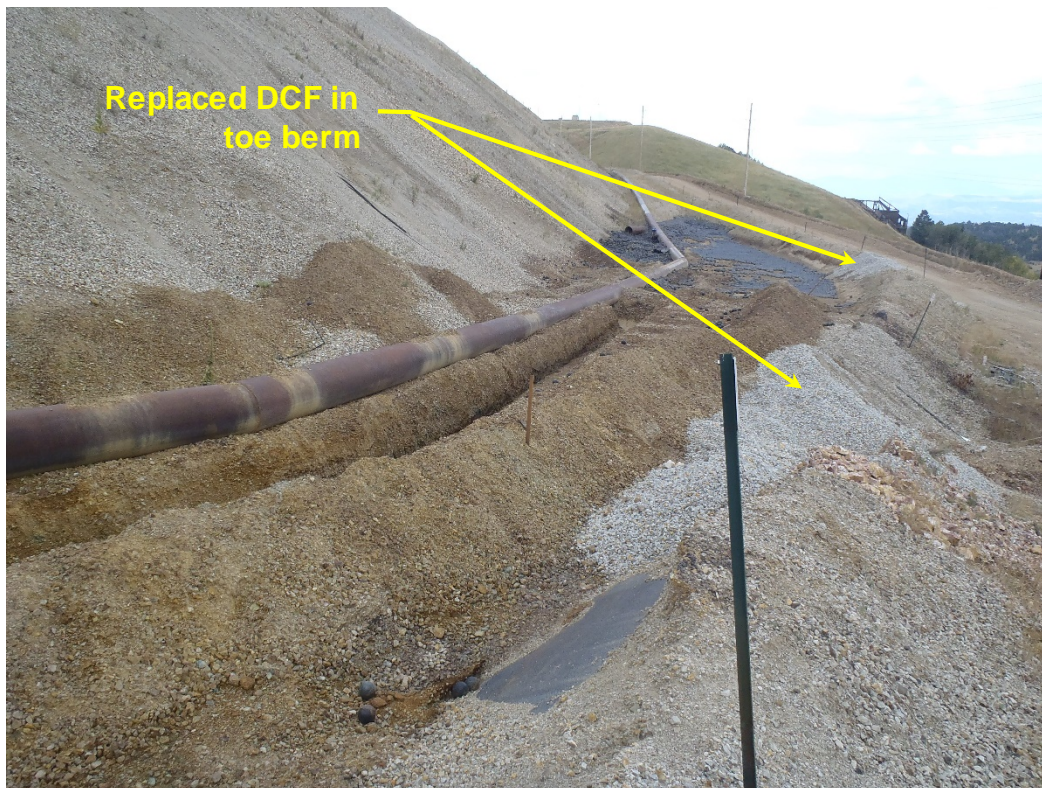
Photo 2. Repaired toe berm near the water tank between VLF 1 and VLF2 (looking west).

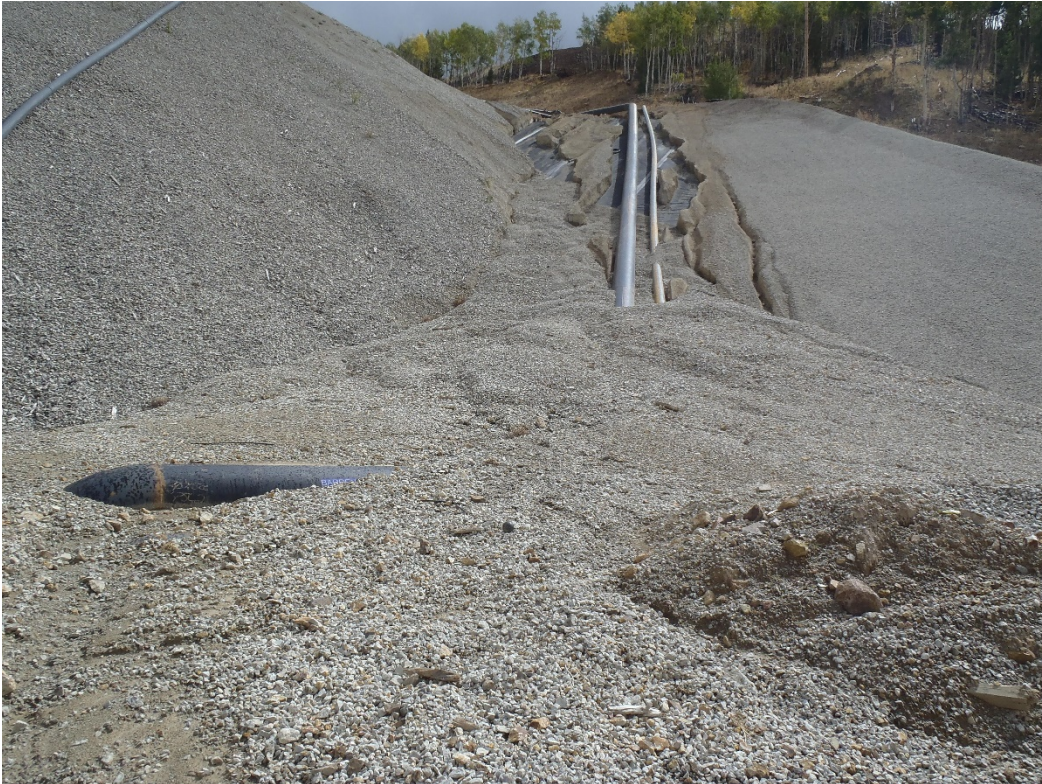
Photo 3. VLF 2: DCF washout above LVSCS building (looking east).

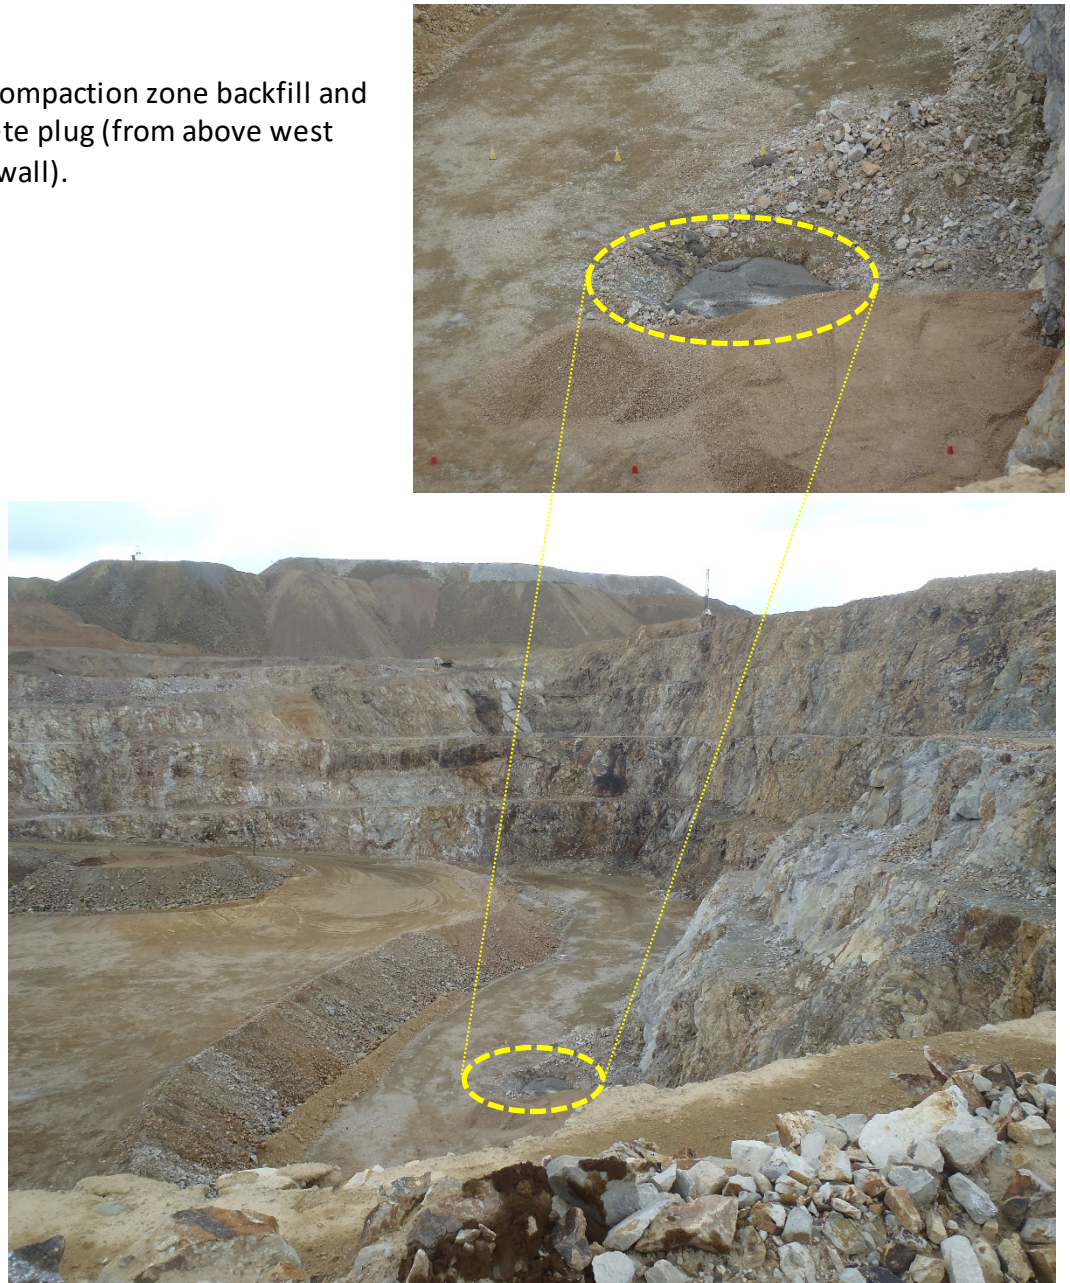
Schist Island backfill: Ms. Ratcliff and Messrs. Brandon Rising and Jeff Gaul accompanied the DRMS to an area above the west highwall to observe material placement in the Schist Island Pit low compaction zone. Mr. Gaul pointed out a concrete plug (see **Photo 4**) for a shaft remediation effort and that CC&V was keeping backfill away from it while the concrete cured. After a half hour with no haul trucks bringing backfill material, site representatives contacted site dispatch and we were informed that it would be at least an hour, if at all, before any haul trucks would bring backfill material to the Schist Island Pit. No low compaction zone fill placement was observed during this inspection.

Photo 4. Schist Island low compaction zone backfill and shaft remediation concrete plug (from above west highwall).

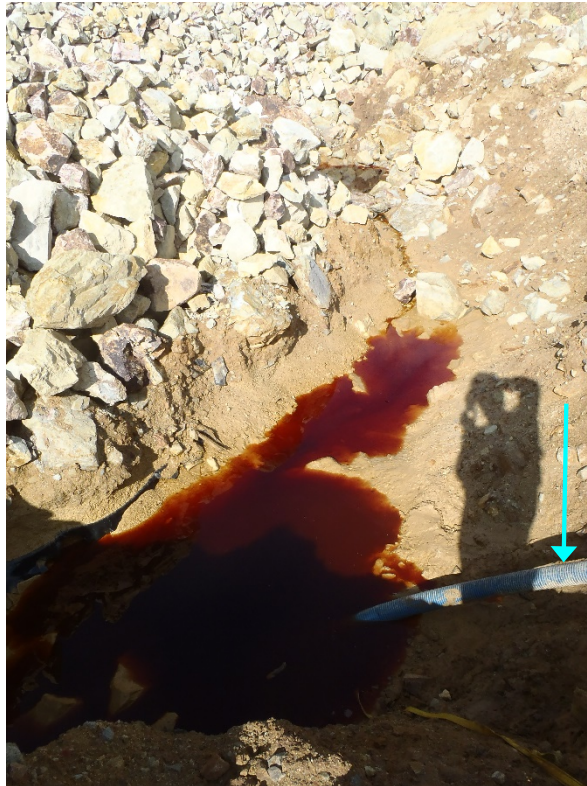
ECOSA Seeps: Ms. Ratcliff and Ms. Maria Bujenovic accompanied the DRMS to the ECOSA toe to observe the status of two seeps. The north ECOSA seep has two small collection ponds designated ECOSA Seep #2A (see **Photo 5**) and #2B (see **Photo 6**) by CC&V. Ms. Bujenovic stated they had observed about a 2-day lag between heavy rain and seepage expression in these two new seeps. She said based on field measurements the pH of the seepage water was 2.99. Site representatives pointed out a berm constructed on the east side of the ECOSA toe access road to control seepage (see **Photo 7**). The south ECOSA seep, now designated ECOSA Seep #1 was observed to have negligible inflow (see **Photo 8**). Both seeps are clearly a result of acid mine drainage (ARD) from the ECOSA. CC&V believes the placement of growth media on the ECOSA will reduce or eliminate the seeps. However, the current stormwater controls for the ECOSA as placed on the south end (see **Photo 9**) are inadequate as observed by the excessive erosion gully. [The DRMS strongly recommends CC&V recover eroded growth media at the toe of the south end of the ECOSA for future reclamation.](#) The sitewide stormwater management plan for reclamation committed to by CC&V with the approval of amendment 11 is overdue and should be prioritized given the ongoing concurrent reclamation effort.

Photo 5. ECOSA Seep #2A (at toe of ECOSA, inside toe berm, note blue pipe for pumping out seep water).

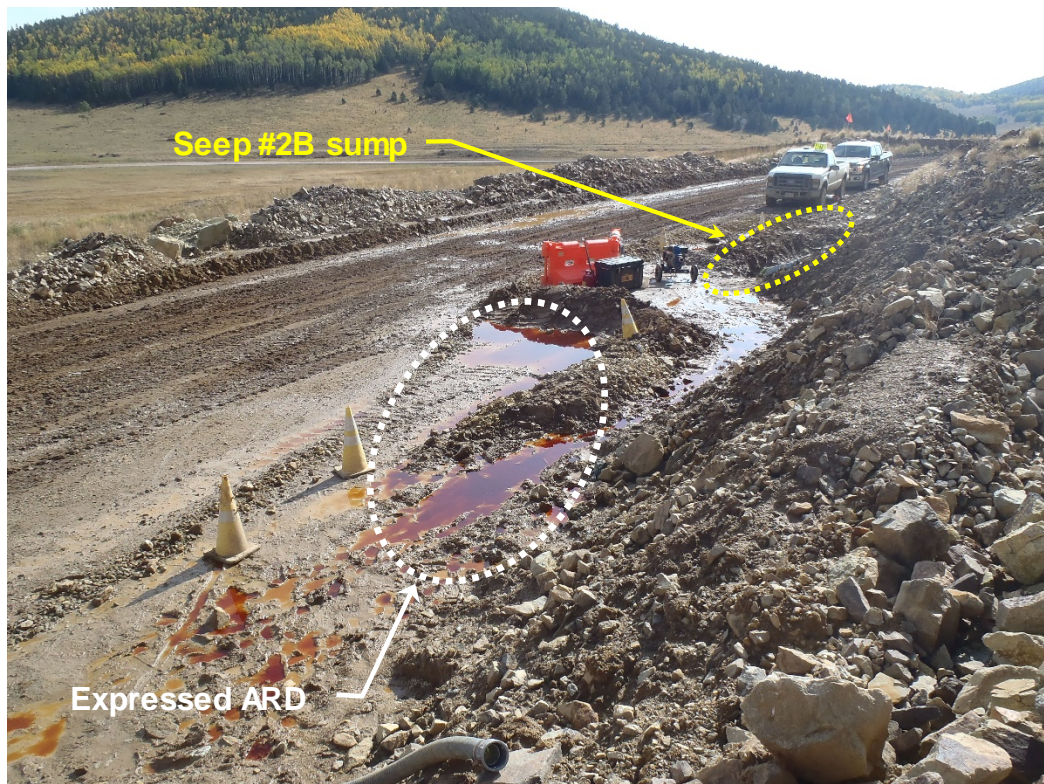
Photo 6. ECOSA Seep #2B (looking SE from ECOSA toe berm separating Seep 2A from 2B)

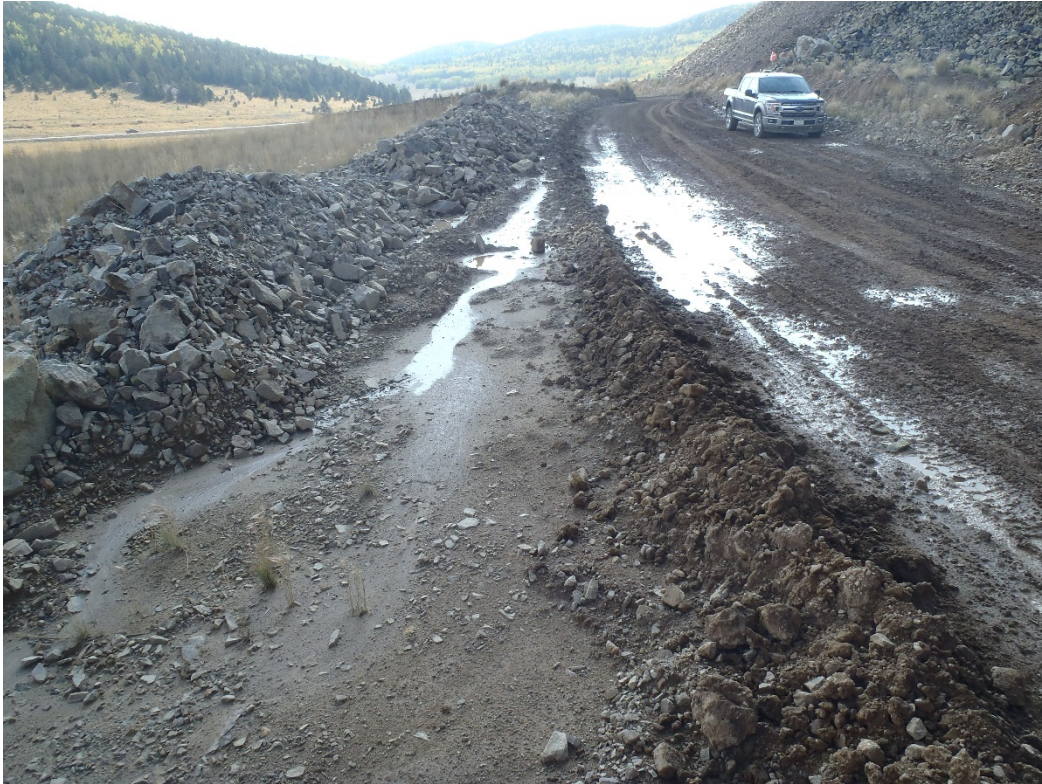
Photo 7. ECOSA access road constructed containment berm near ECOSA Seep #2 (looking SE).

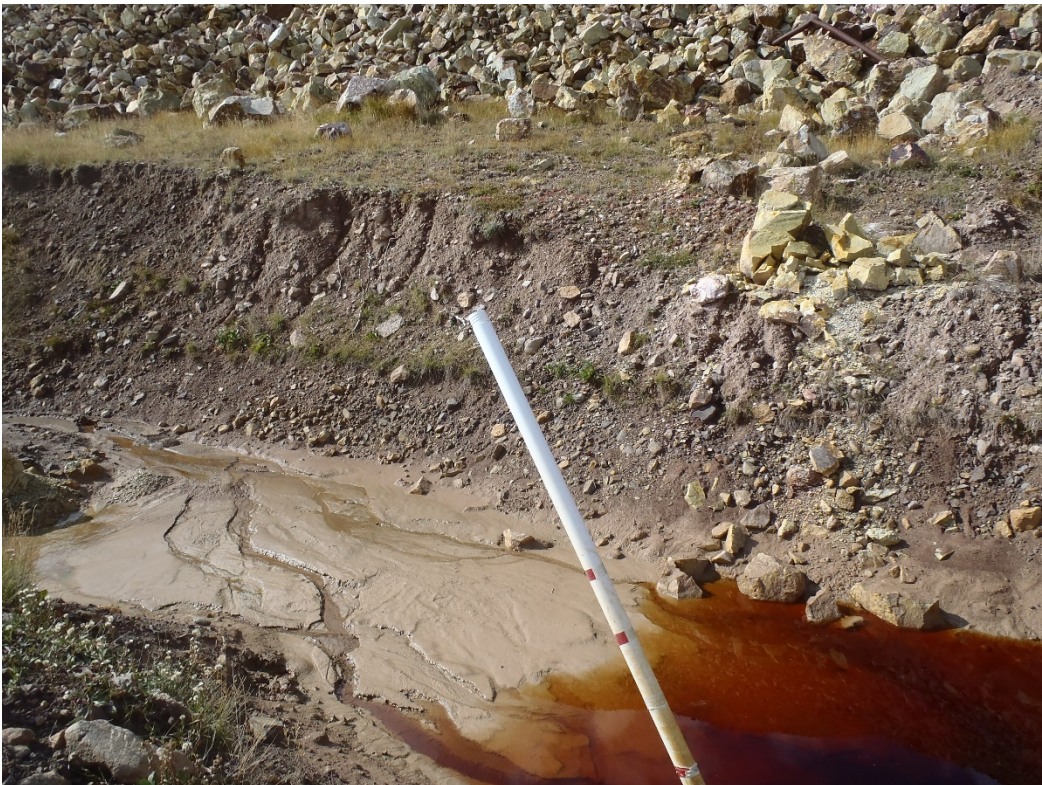
Photo 8. ECOSA Seep #1 (negligible inflow).

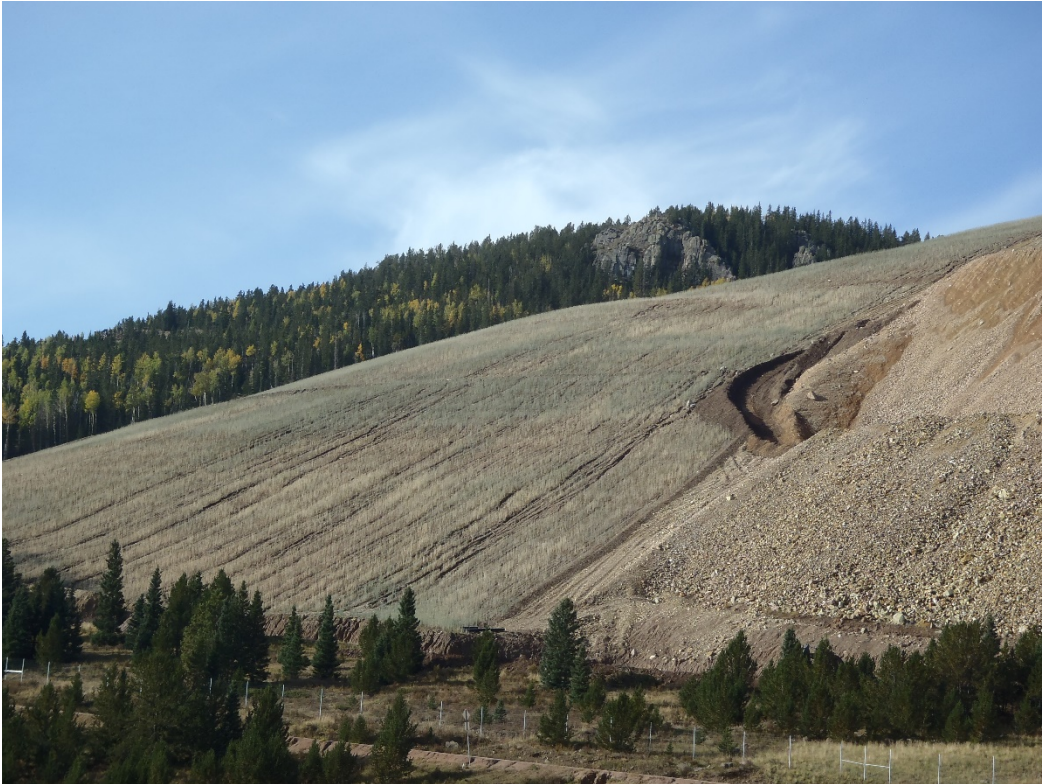
Photo 9. South ECOSA eroded reclamation (looking SW from CR 81).

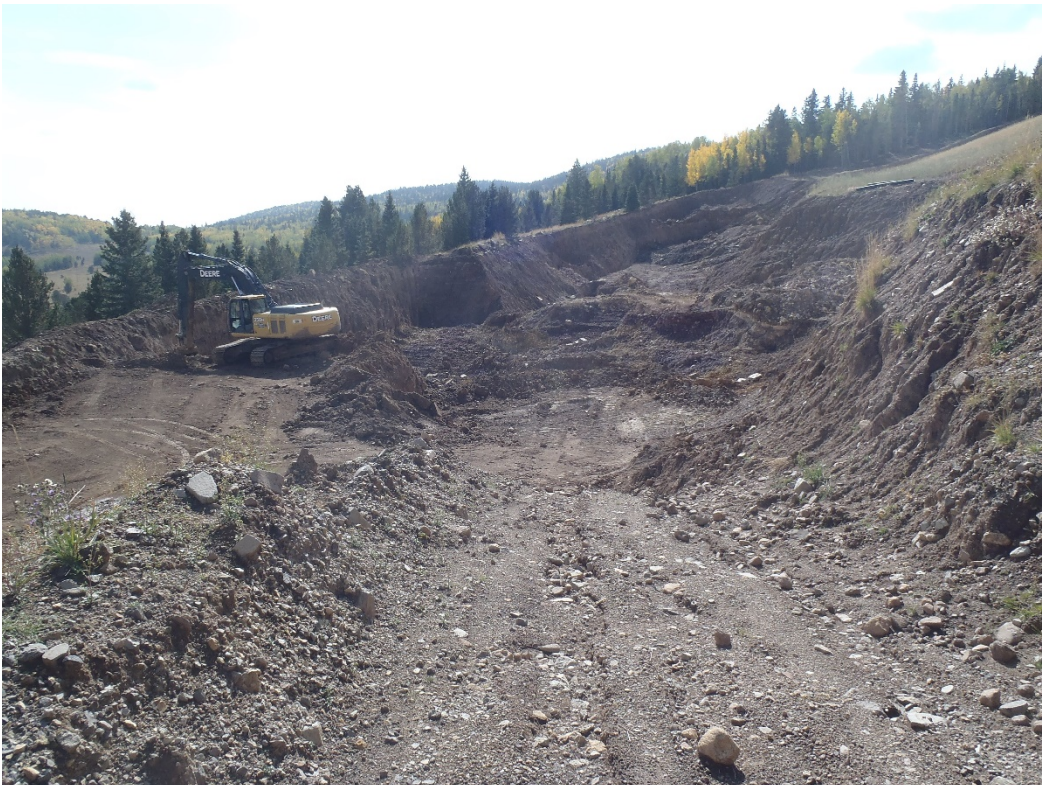
The clay borrow area at the south end of the ECOSA was observed (see **Photo 10**). Site representatives indicated

they were nearly finished extracting material for the borrow area. We discussed backfilling the borrow area to stabilize the slope above it. Ms. Ratcliff indicated the plan was to backfill the area with waste rock. The DRMS expressed concerns with this approach as the waste rock is what has been the cause of the ARD in the ECOSA seeps. Placing waste rock in the borrow area would also extend the footprint of the ECOSA, requiring a revision to the permit as it amounts to a change to both the approved mine and reclamation plans. I recommended using onsite inert material for backfill. However, [if inert material has to come from offsite, the DRMS will require a technical revision to approve the importation of inert fill in accordance with Rule 3.1.5\(9\).](#)

Photo 10. South ECOSA clay borrow pit (looking south).

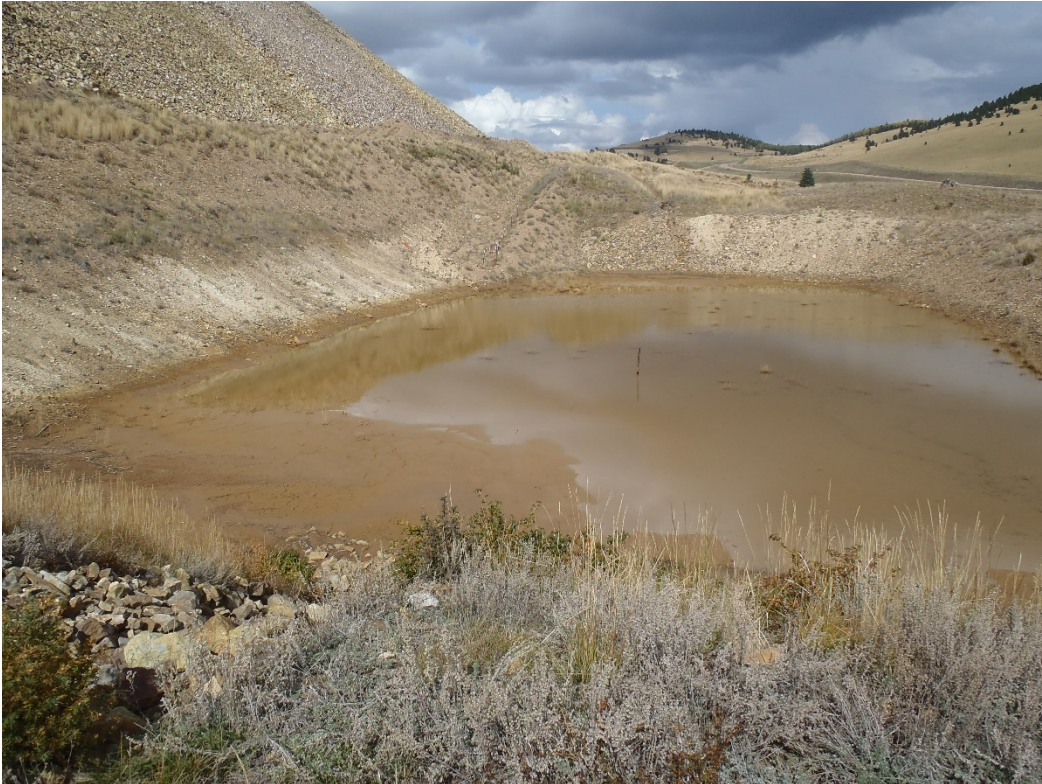
EMP 17 & 20: EMP 20 (see **Photo 11**) was observed and appeared to hold only stormwater with little to no ARD. EMP 17 appeared unimpacted.

Photo 11. EMP 20 pond – no evidence of ARD (looking NW).

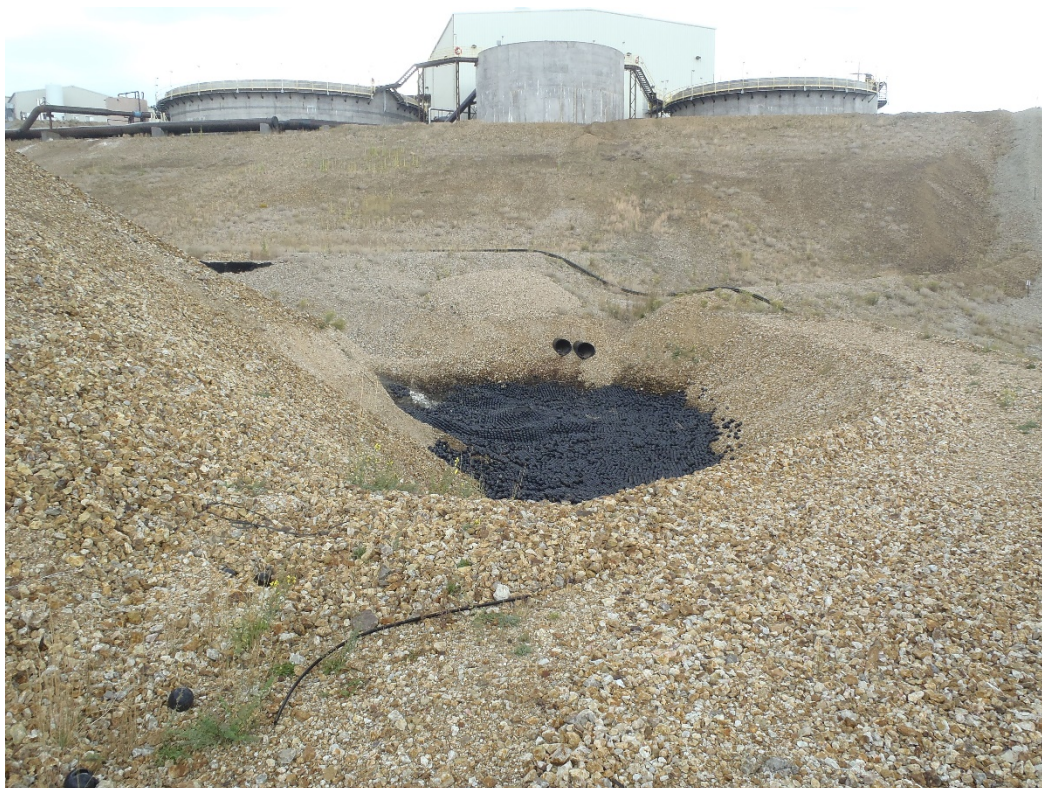
PSES stormwater pond: Ms. Ratcliff and Messrs. Rising and Dylan Noble accompanied the DRMS to the PSES bird-ball pond (see **Photo 12**) to inspect potential damage or overflow resulting from heavy rains in August. No significant high water mark or evidence of overtopping was observed.

Photo 12. PSES bird-ball pond (looking SE).
