MINERALS PROGRAM INSPECTION REPORT

MINE NAME: Monks Plant No 1	MINE/PROSPECTING ID#: M-1983-193	MINERAL: Sand	COUNTY: El Paso
INSPECTION TYPE: Monitoring	INSPECTOR(S): Timothy Cazier, P.E.	INSP. DATE: August 3, 2021	INSP. TIME: 09:30
OPERATOR: R E Monks Construction Co.	OPERATOR REPRESENTATIVE: Leroy Garcia	TYPE OF OPERATION: 112c - Construction Regular Operation

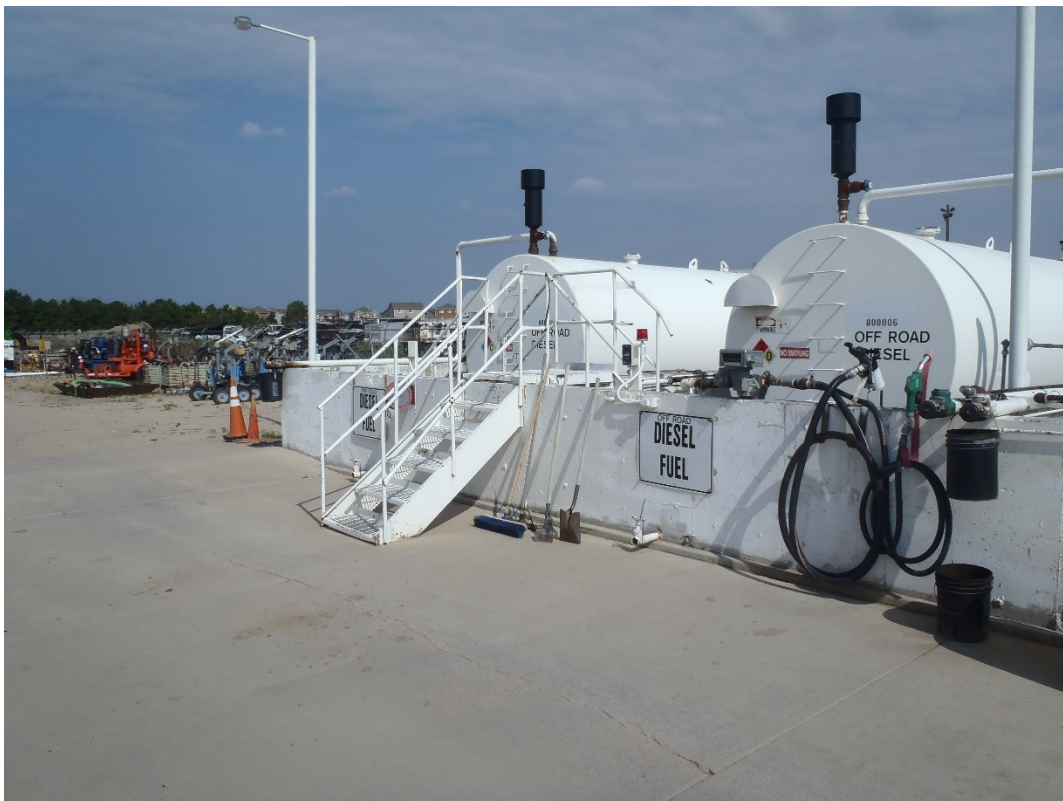
Acid And Toxic Materials: Diesel fuel is stored onsite and has adequate secondary containment (see **Photo 1**).

Photo 1. Diesel fuel storage tanks north of shop building (looking NW).

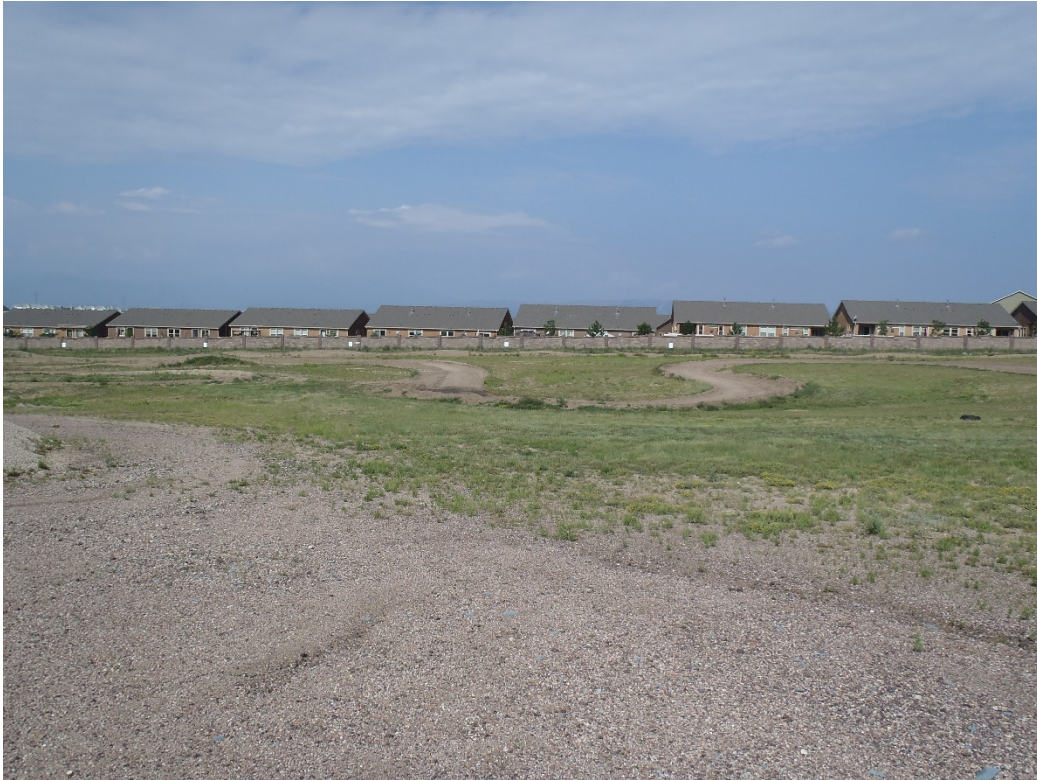
Backfilling and Grading: No active pit was observed. The former pit has been converted to a dirt bike track (see **Photo 2**). No backfill is necessary.

Photo 2. Former pit converted to a dirt bike track (looking SW).

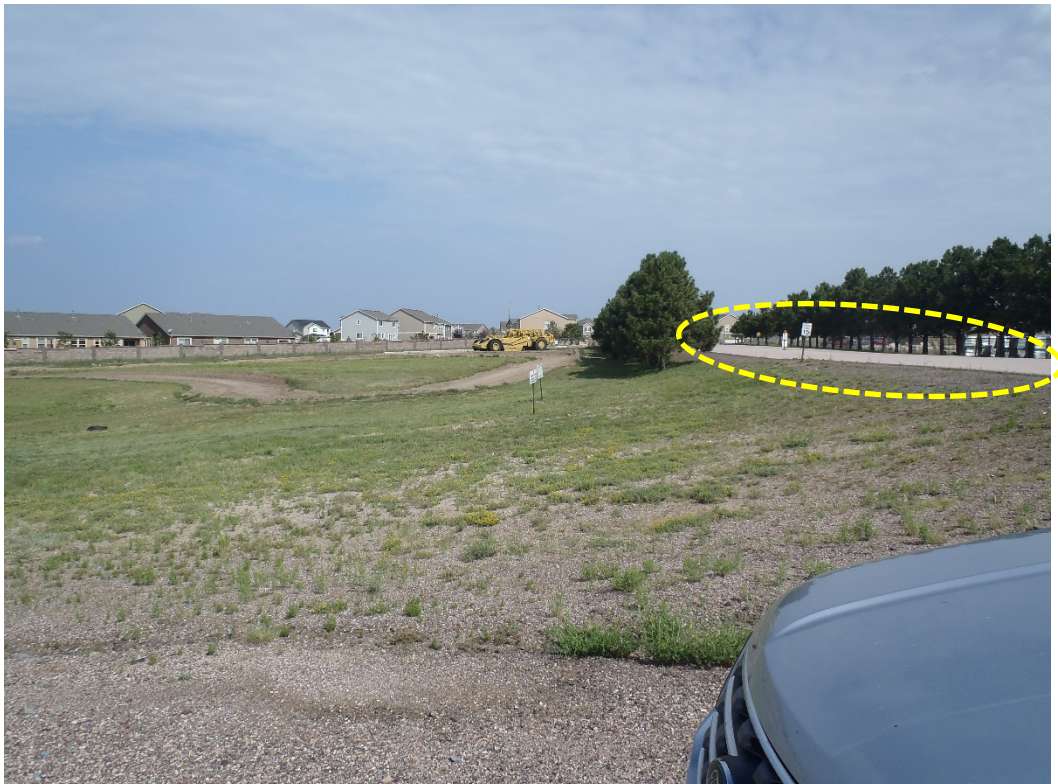
Roads: The main access road is paved (see **Photo 3**). With the exception of the dirt bike track area, the majority of the rest of the site is paved with concrete or graveled.

Photo 3. Paved main access road – north end of dirt bike track on left (north side, looking NW).

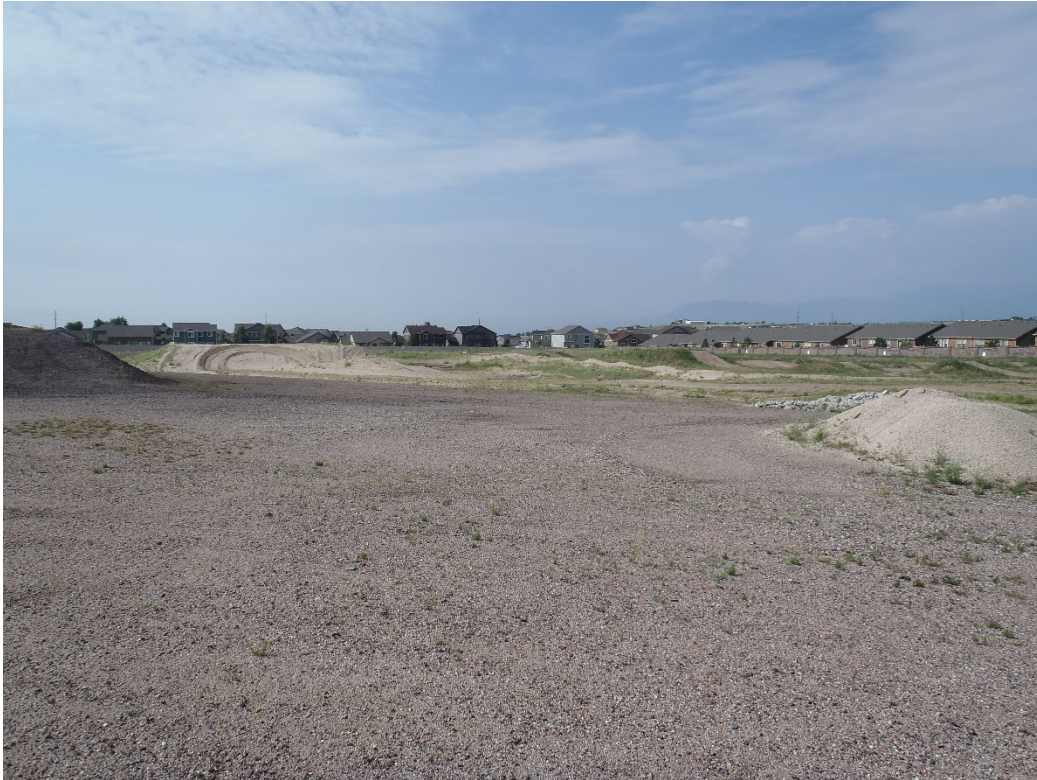
PROBLEM/POSSIBLE VIOLATION: Problem: Failure to initiate final reclamation in order to complete reclamation within five years pursuant to C.R.S. 34-32.5-116(4)(q)(I). The operator must follow the approved reclamation plan or provide sufficient information to describe or identify how the operator intends to complete reclamation.

Reclamation Success: The former pit is reclaimed except for the remaining dirt bike track. A pile of recycled asphalt and a small pile of crushed concrete (see **Photo 4**), both allowed for industrial use. As the initial 5-year period of TC expired on April 11, 2018, **the DRMS is citing a Problem on p. 1 of this report for not reclaiming within five years after the cessation of mining.**

Photo 4. RAP and crushed concrete piles on edge of former pit – dirt bike track beyond (looking SW).

CORRECTIVE ACTIONS: The operator shall submit a Technical Revision by the corrective action date, with the required \$216 revision fee, to update and clarify the current approved reclamation plan, including a schedule to complete reclamation and seek reclamation liability release before April 10, 2023.

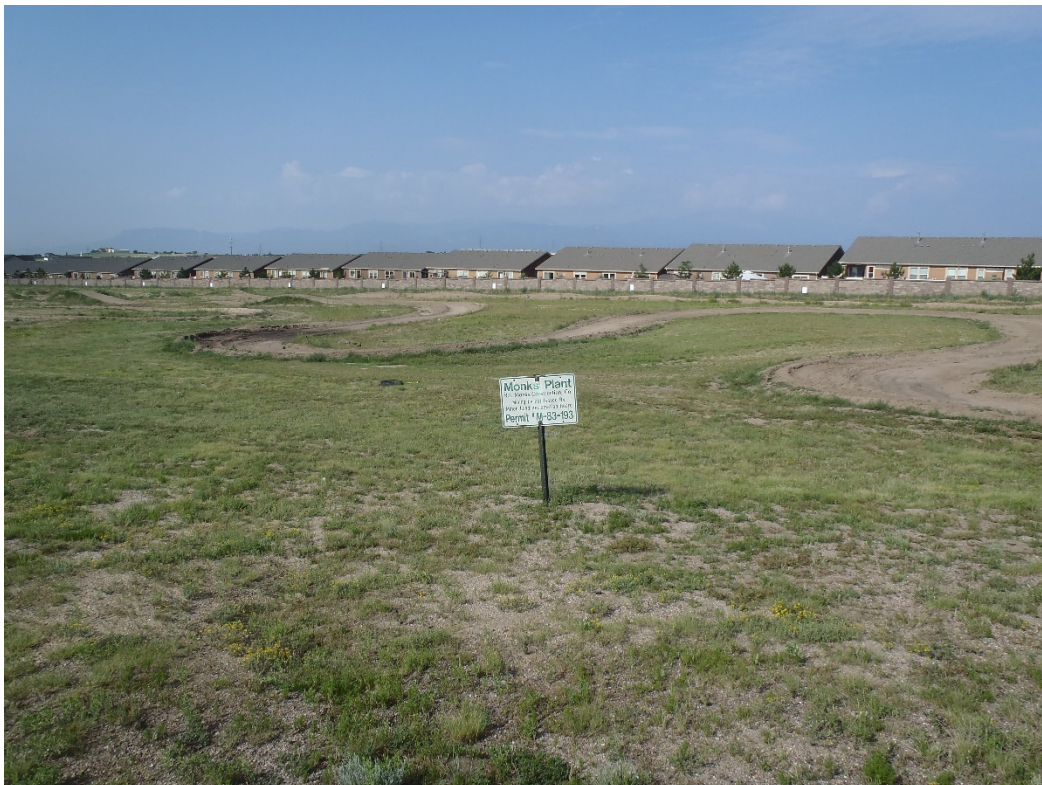
Signs and Markers: The permit sign was properly posted (see **Photo 5**) and the permit boundary is marked with a perimeter fence.

Photo 5. Permit sign – dirt bike track beyond (west side, looking SW).

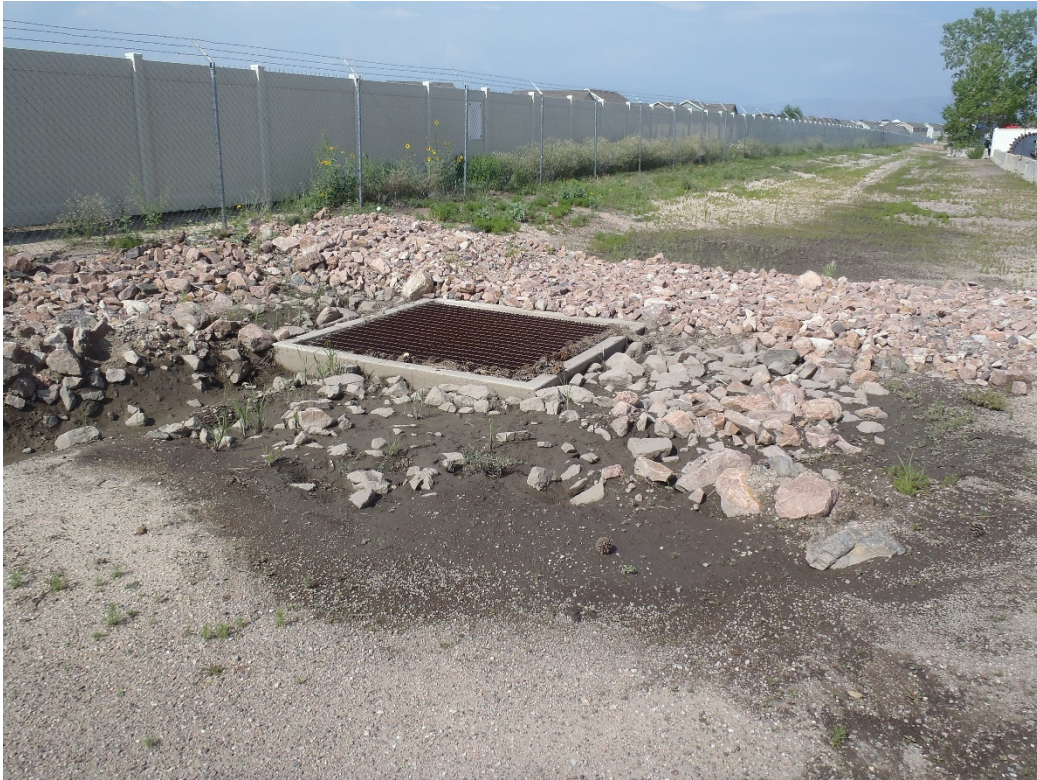
Storm Water MGT Plan: No oil or fuel spills observed. Representatives stated the stormwater management plan is kept in site office. Stormwater drains and other improvements (see **Photos 6 and 7**) have been installed, consistent with industrial/commercial use.

Photo 6. Grassed stormwater swale with grated drop inlet (south side, looking west).

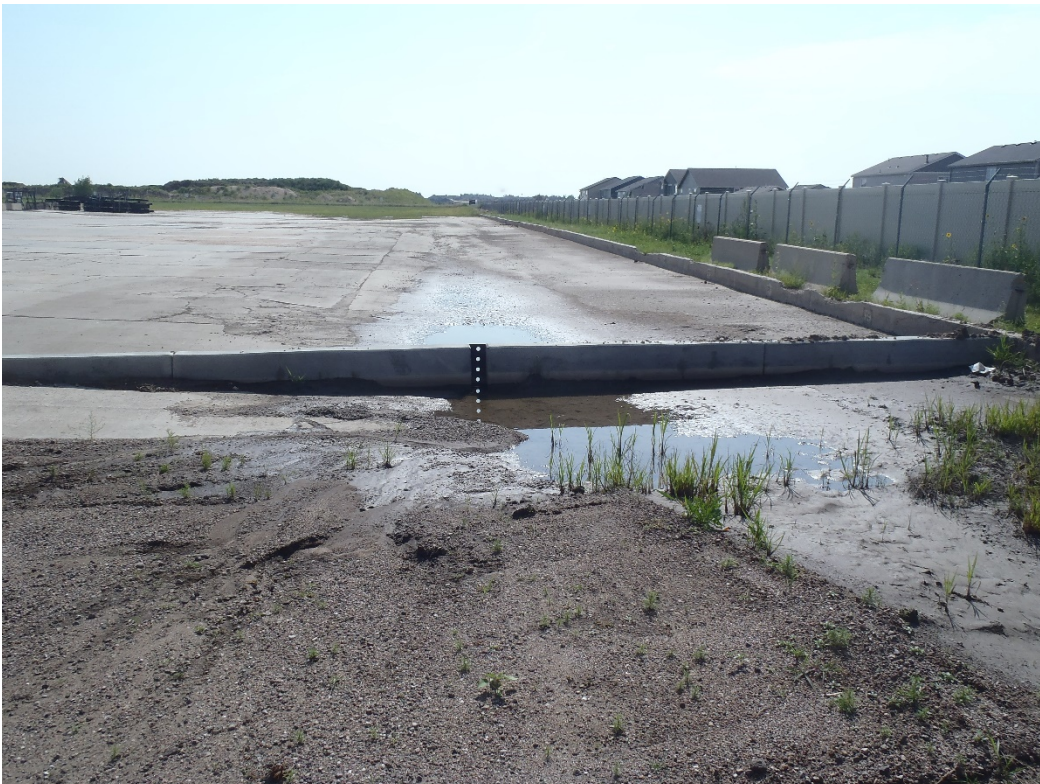
Photo 7. Paved stormwater swale with perforated discharge (south side, looking east).
