## MINERALS PROGRAM INSPECTION REPORT

<b>MINE NAME:</b> Jenkins Site	<b>MINE/PROSPECTING ID#:</b> M-1977-393	<b>MINERAL:</b> Sand and gravel	<b>COUNTY:</b> Boulder
<b>INSPECTION TYPE:</b> Monitoring	<b>INSPECTOR(S):</b> Amy Eschberger	<b>INSP. DATE:</b> October 28, 2021	<b>INSP. TIME:</b> 13:30
<b>OPERATOR:</b> City of Boulder	<b>OPERATOR REPRESENTATIVE(S):</b> Chris Lawlor, Megan Bowes	<b>TYPE OF OPERATION:</b> 112c - Construction Regular Operation	
<b>REASON FOR INSPECTION:</b> Normal I&E Program	<b>BOND CALCULATION TYPE:</b> None	<b>BOND AMOUNT:</b> \$0.00	
<b>DATE OF COMPLAINT:</b> NA	<b>POST INSP. CONTACTS:</b> None	<b>JOINT INSP. AGENCY:</b> None	
<b>WEATHER:</b> Clear	<b>INSPECTOR'S SIGNATURE:</b>

# M-1977-393 / Jenkins Site / City of Boulder (112c)

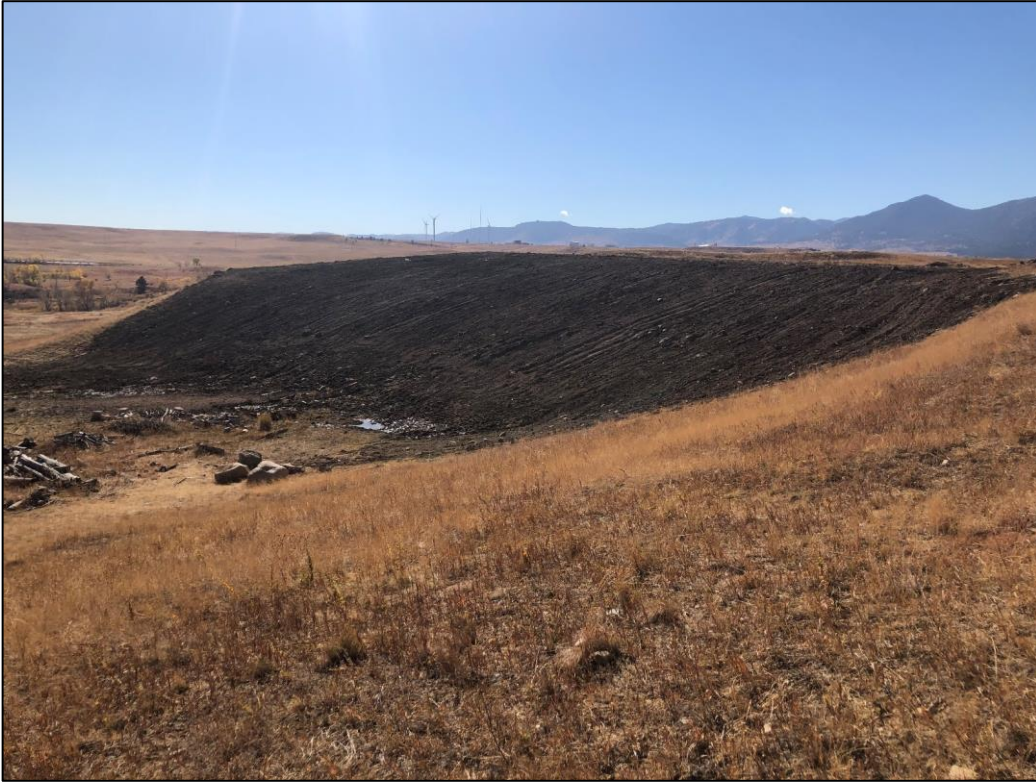
**Photo 1.** View looking southwest from access road at eastern side slope of lower backfill lift, graded to 3H:1V or flatter and scarified.

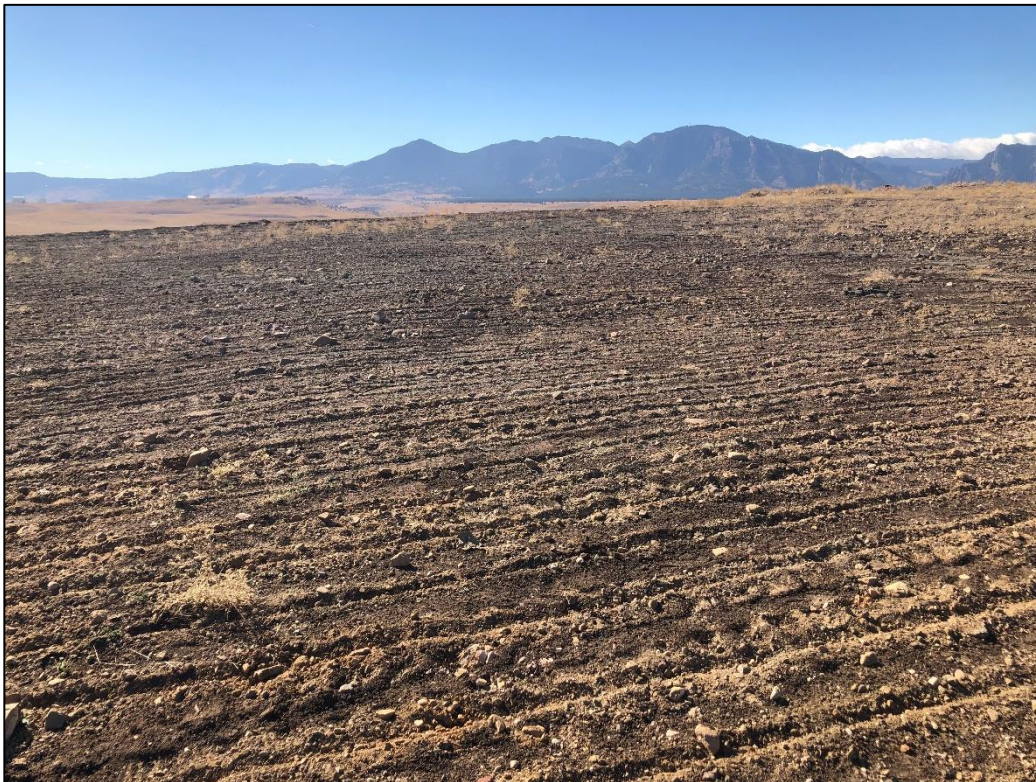
**Photo 2.** View looking southwest across top of upper backfill lift graded nearly flat and scarified.

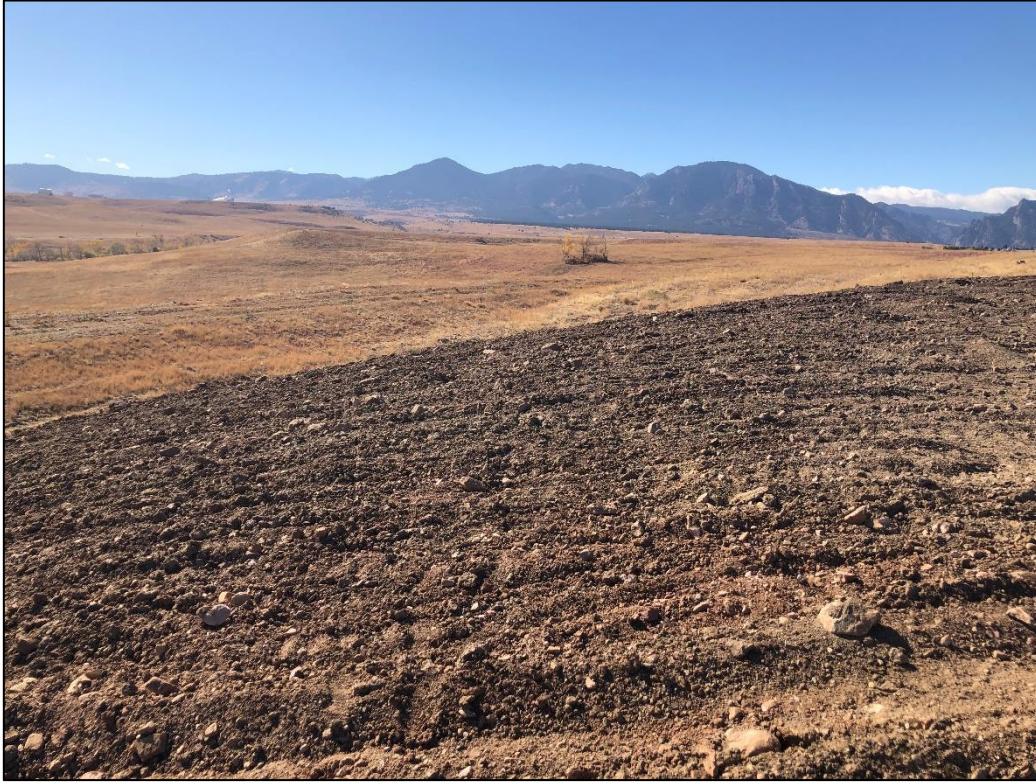
**Photo 3.** View looking west across southwestern side slope of upper backfill lift, graded to 3H:1V or flatter and scarified.

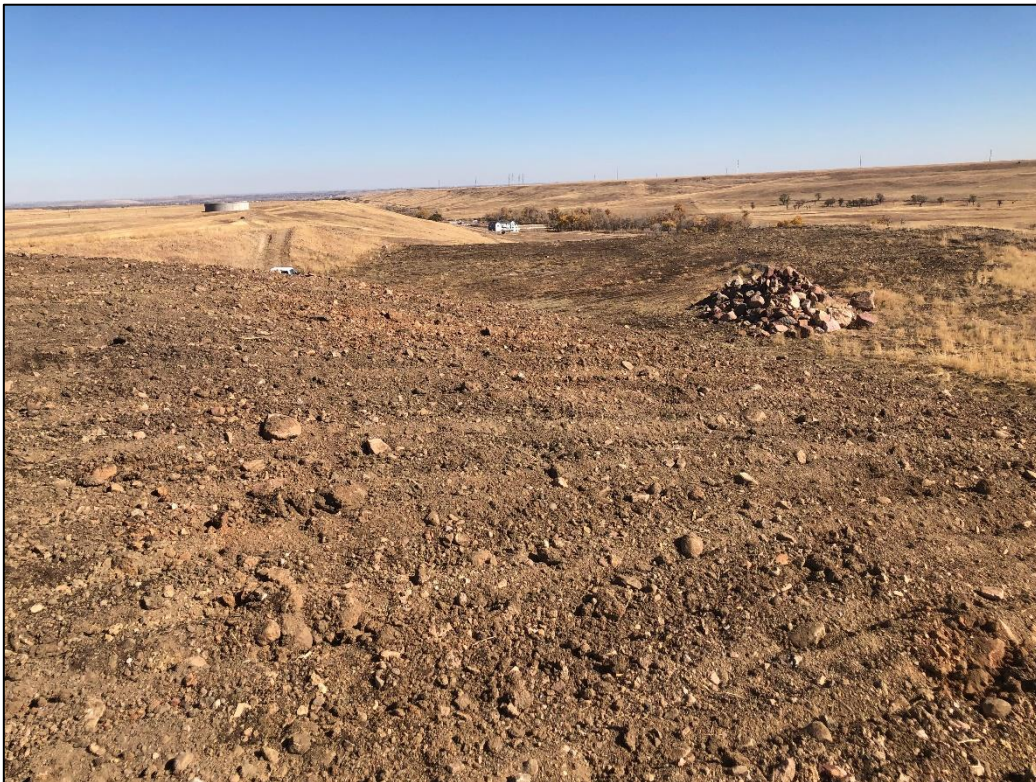
**Photo 4.** View looking east across southeastern side slope of upper backfill lift, graded to 3H:1V or flatter and scarified. Note small pile of boulders (on top of lower lift) to be removed from the site.

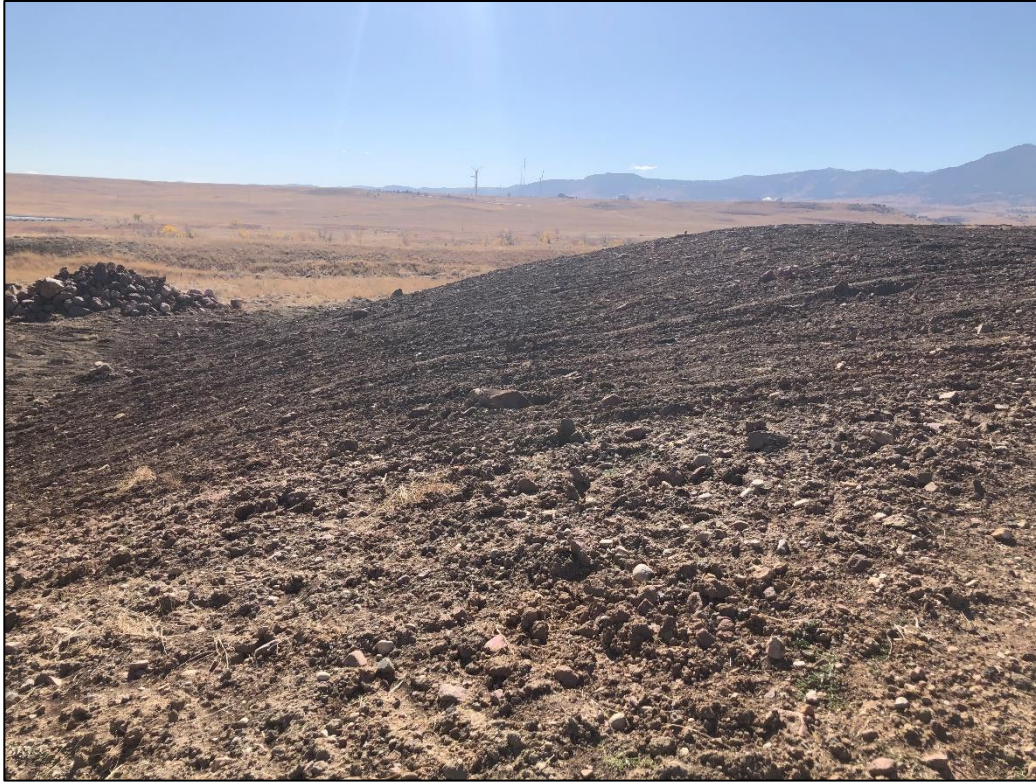
**Photo 5.** View looking south across eastern side slope of upper backfill lift, graded to 3H:1V or flatter and scarified.

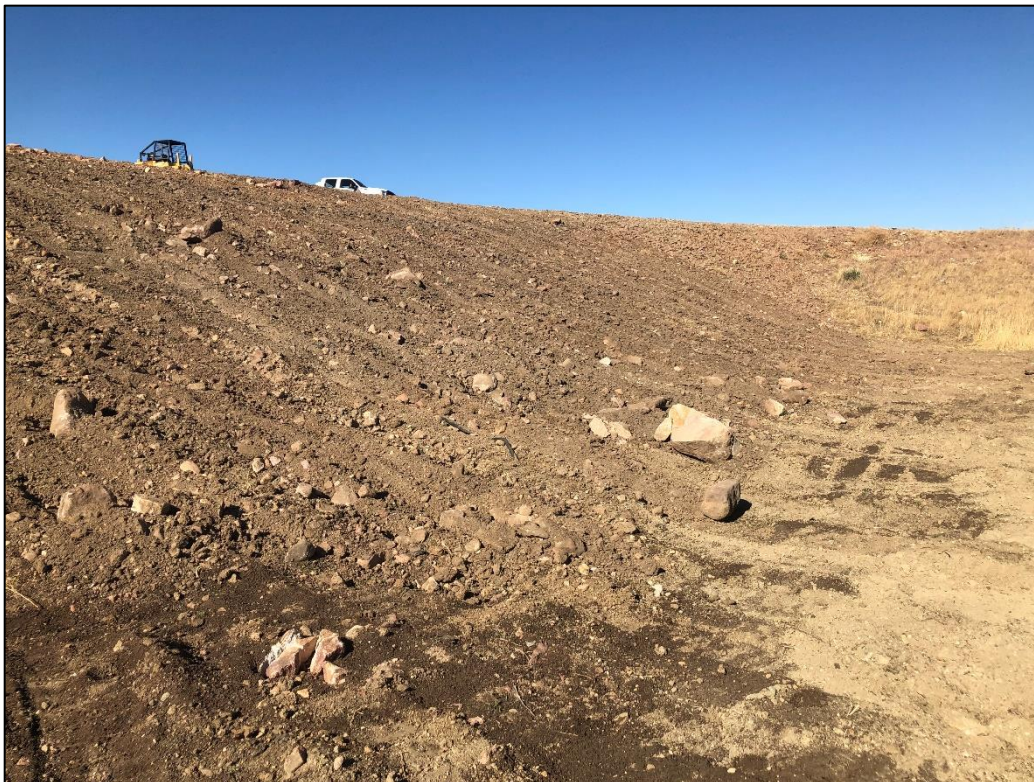
**Photo 6.** View looking north across eastern side slope of upper backfill lift, graded to 3H:1V or flatter and scarified.

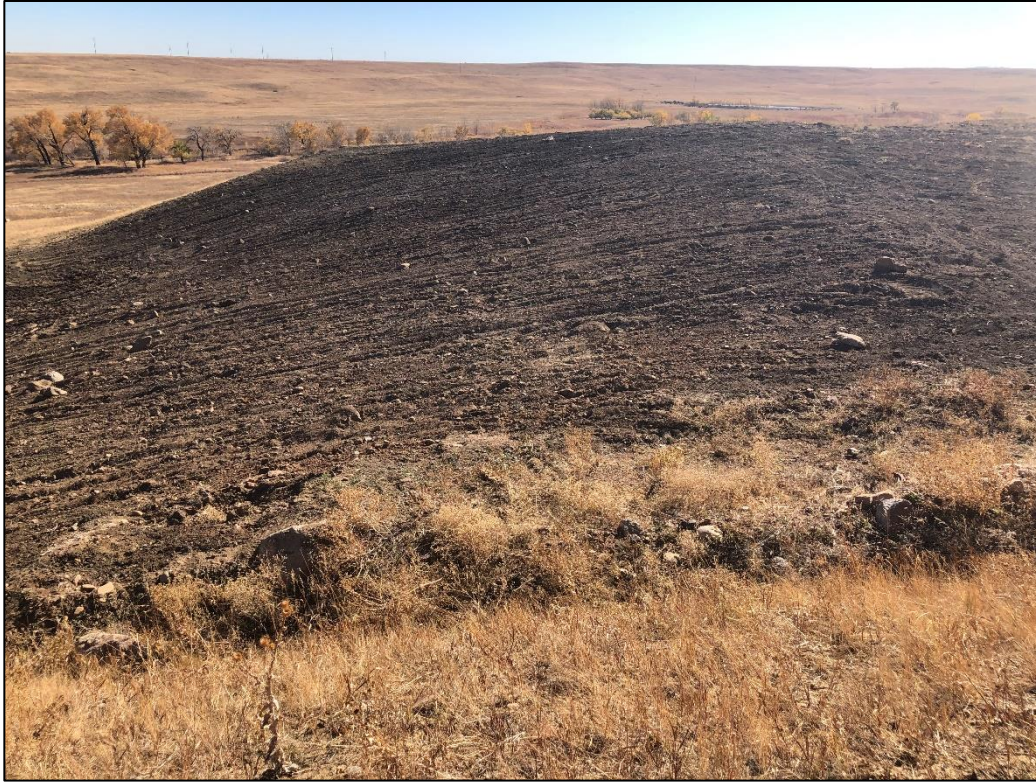
**Photo 7.** View looking south across eastern side slope of lower backfill lift, graded to 3H:1V or flatter and scarified.

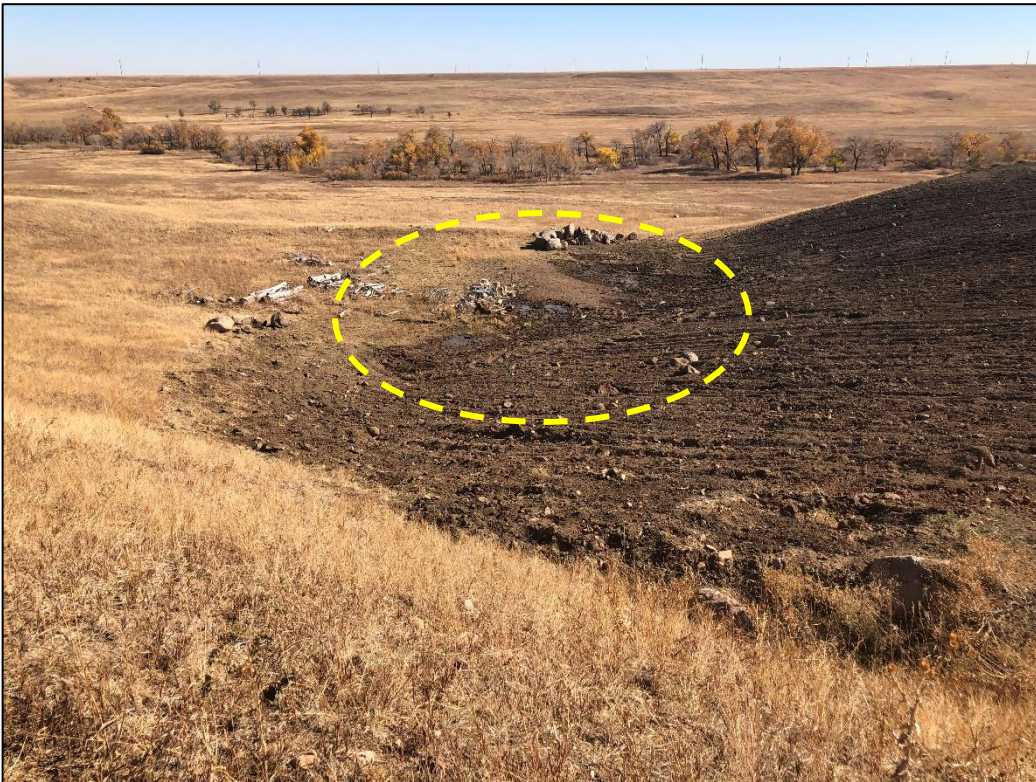
**Photo 8.** View looking southeast at eastern toe of lower backfill lift, showing small seepage area (circled) which may require additional backfill to mitigate.

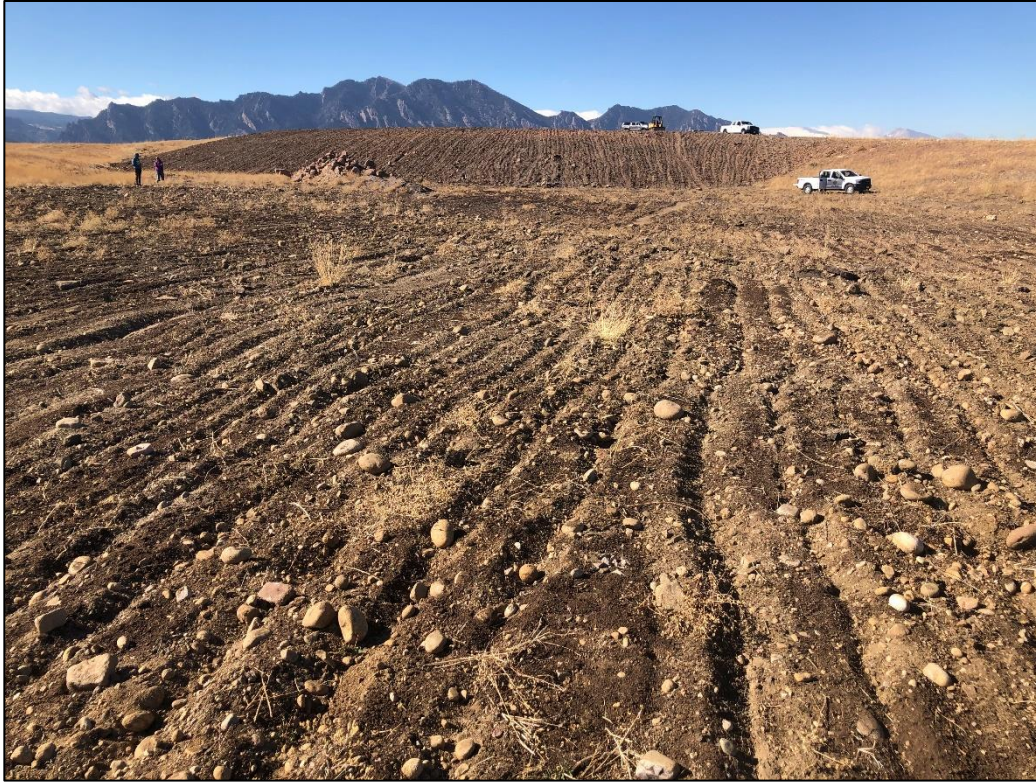
**Photo 9.** View looking west across top of lower backfill lift graded nearly flat and scarified. Eastern side slope of upper backfill lift visible in background.

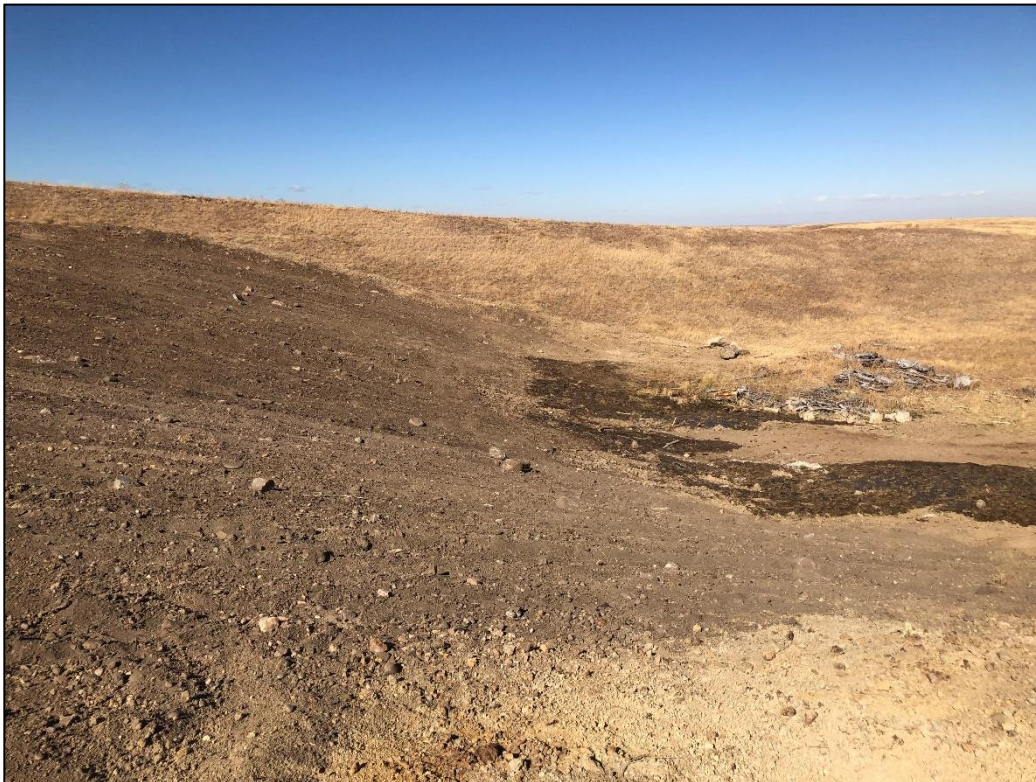
**Photo 10.** View looking north across eastern side slope of lower backfill lift, graded to 3H:1V or flatter and scarified. Note small seepage area at toe of lift (at left) which may require additional backfill to mitigate.

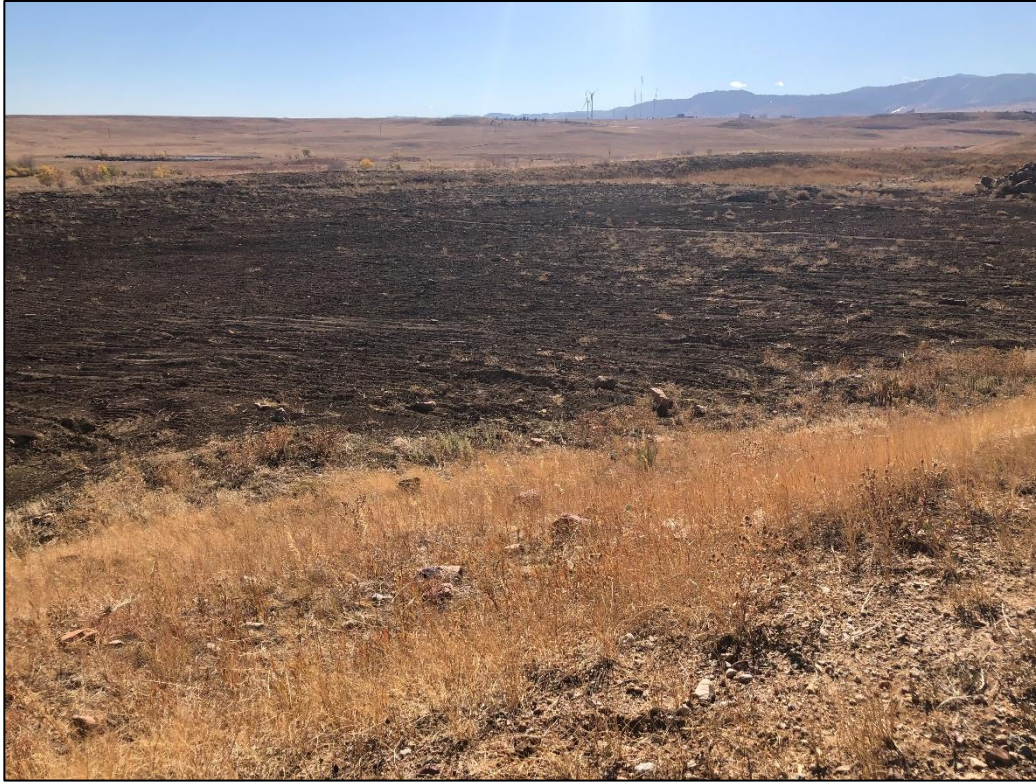
**Photo 11.** View looking southwest across top of lower backfill lift, graded nearly flat and scarified.

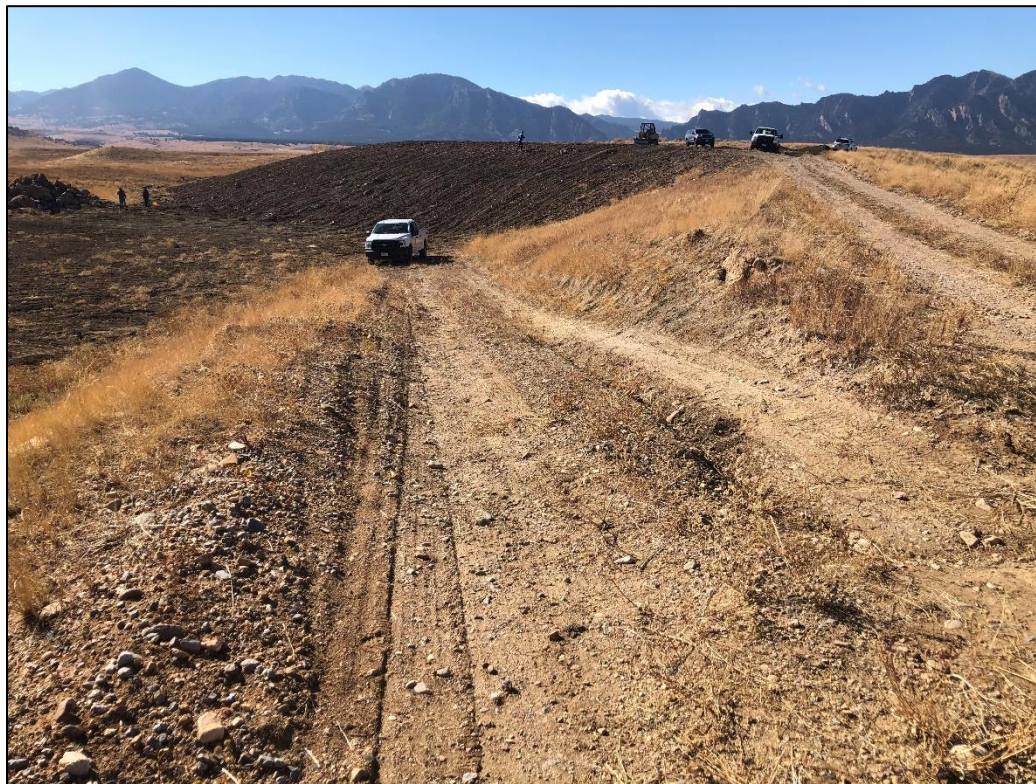
**Photo 12.** View looking west, showing access road to lower lift (left) and access road to upper lift (right) which will remain for reclamation.
