To: Jerald Schnabel From: Paul Kos
Continental Materials Corp. Denver, CO 80222
File: September 2021 Monitoring Summary Date: October 31, 2021

Reference: September 2021 Geotechnical Monitoring Summary Pikeview Quarry

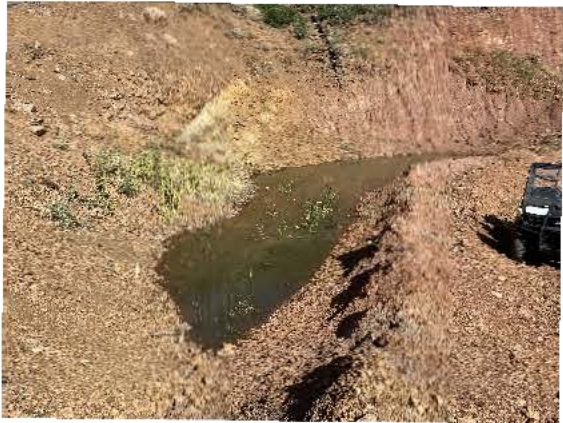
- The Pond below the Middle Peak remains partially filled and there are plans for a notch to be added to the pond's berm to keep the water level from exceeding a specific level (Photo 6).

6. POND NEAR TOP OF HAUL ROAD

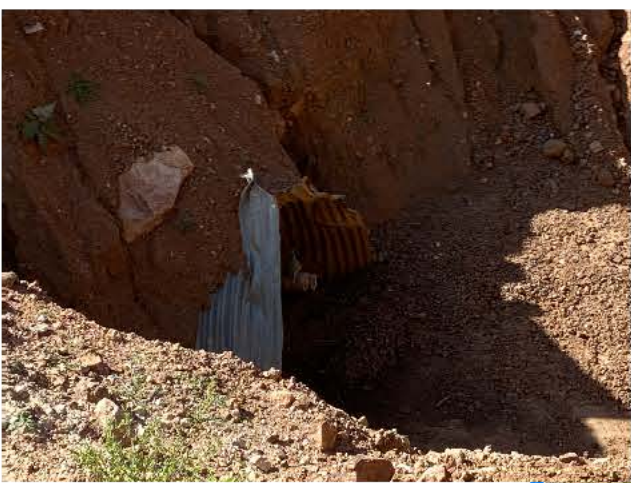
- The culvert remains cleared but mostly blocked inside. CMC has partially cleared the debris, but access limitations and supports within the culvert inhibit clearing all the debris. CMC has procured a pump and will begin pumping operations if any water collects behind the culvert. CMC inspects the culvert for ponded water following rain events, and should any water be observed, it will be removed using pumps. To date, no ponding has been observed (Photo 5).

5. CULVERT INLET WITH CULVERT JETTER INSIDE

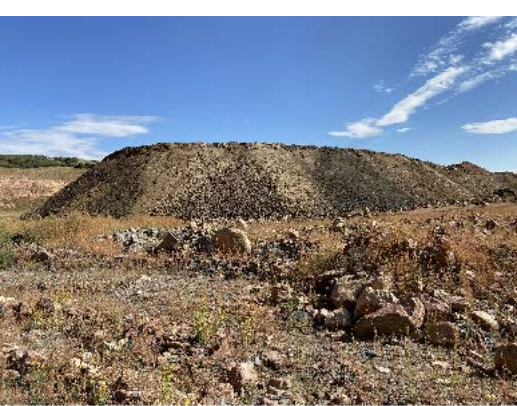
4. FILL PLACED AT PRODUCTION FLOOR

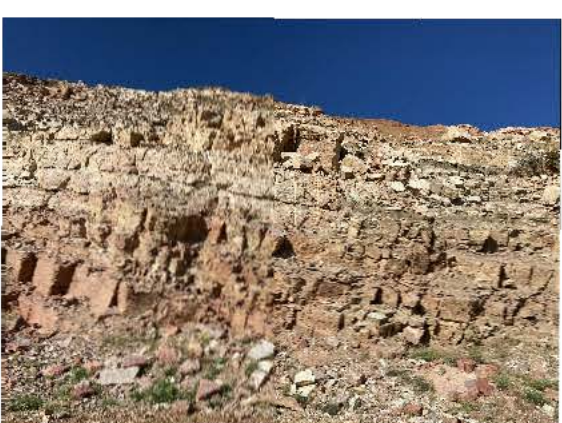
- Small boulders are occasionally breaking off from the rock face just above the production floor and rolling onto the ground. Prisms P63 and TOE3 monitor for slope movements in this area (Photo 3).

3. UNSTABLE ROCK FACE AT BASE OF SLIDE

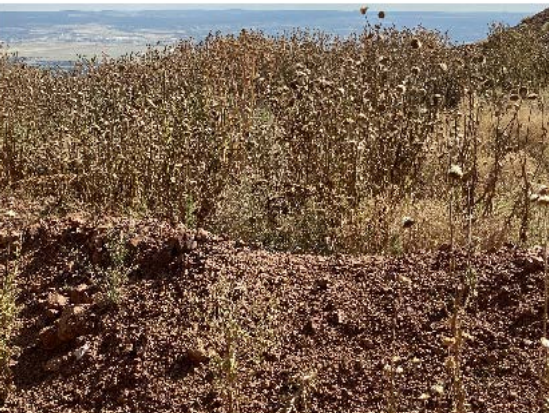
- Weed killer has been applied to all areas that had weed growth, overall, the spray appears effective at killing most of the weeds on site (Photo 7).
- Prisms: Several prisms were passed along the walking route and appeared to be in their original position and operating normally. Control points and most of the monitoring points are permanently cemented into the ground while some of the monitoring points are cemented into 5-gal buckets to be portable as needed.

7. WEED KILLER APPLIED ALONG HAUL ROAD

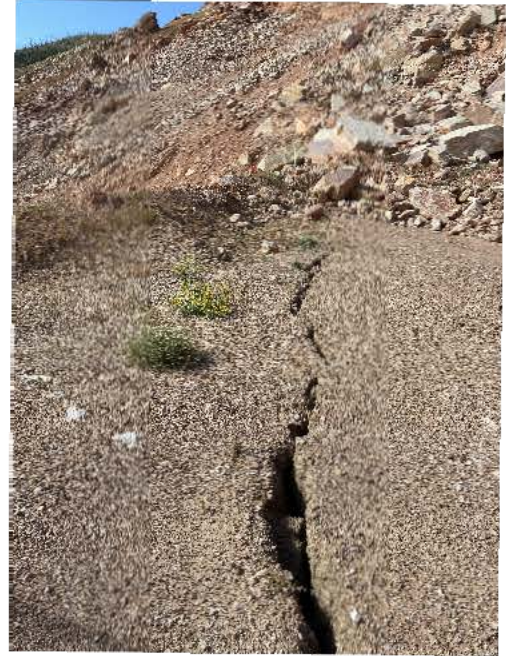
- Previously Observed Cracks: Previously observed tension cracks remain on the production floor and at the crest of fill slopes. These cracks were observed following the period of heavy rain. The cracks are not believed to be a problem, they are likely due to the recent heavy rain saturating the area (Photo 2).

2. CRACKING NEAR PRODUCTION FLOOR

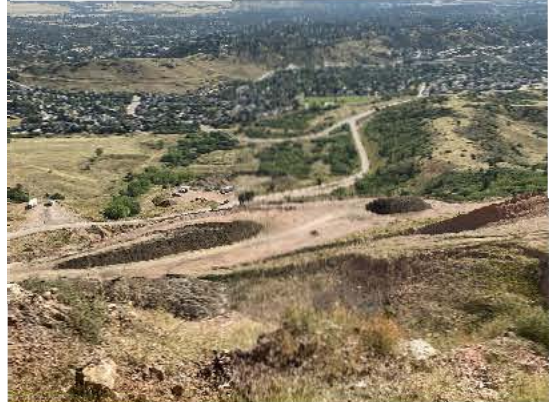
8. GROWTH MEDIUM AND MULCH PILES

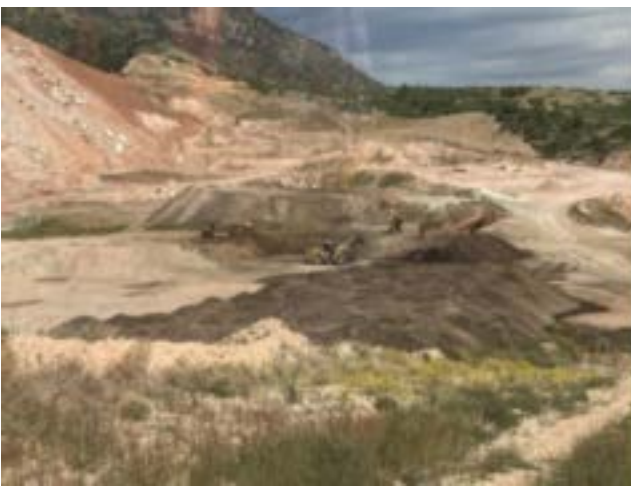
- Growth Medium: Mulch and soil are being processed on the production floor to produce growth medium (Photo 1).
- Healed Cracks: Older cracks and recent cracks are being monitored for changes. Currently the cracks are not growing in any of the areas of concern on the slopes of the site.

1. ACTIVITY ON THE PRODUCTION FLOOR

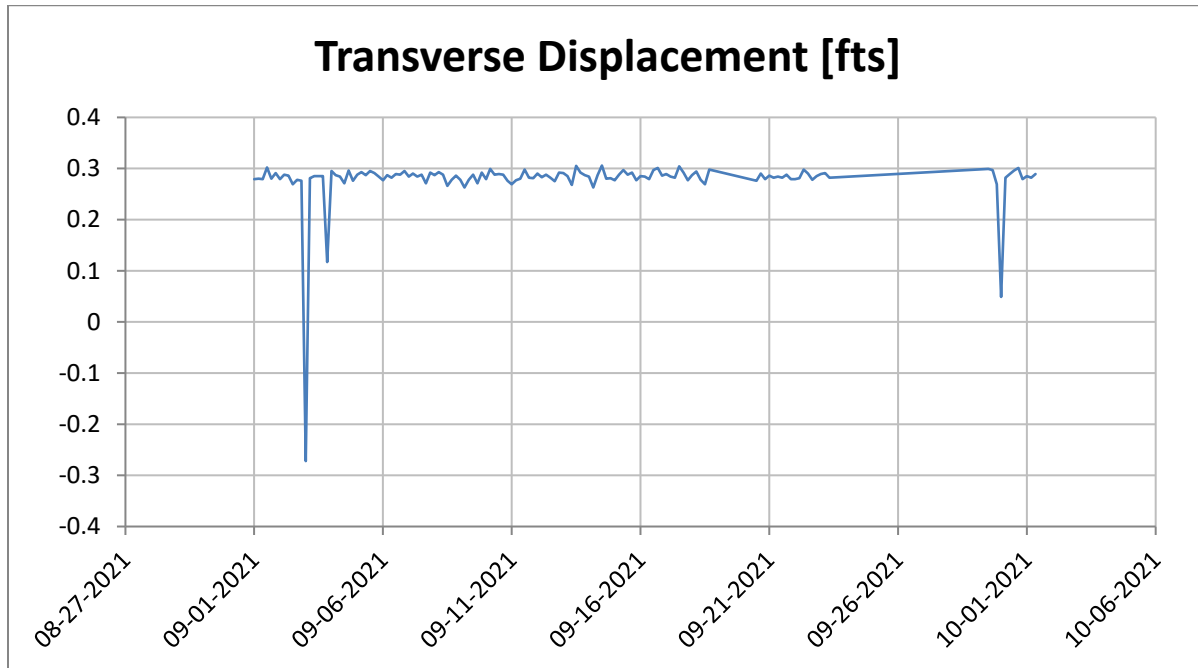
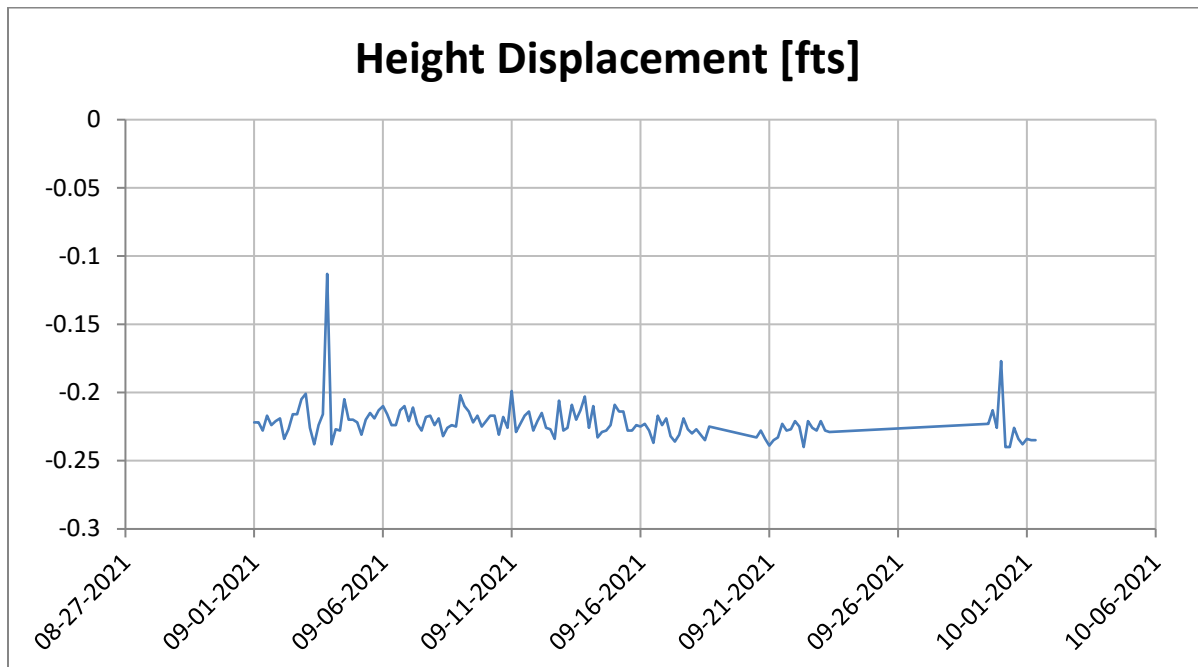
1. Survey accuracy is ± 0.016 feet.
2. Alarm threshold is ± 0.35 feet.
3. Transverse displacement is in the horizontal direction. Positive direction means closer to the robotic station.
4. Height displacement is in the vertical direction. Positive direction means higher in elevation.
5. From the 18th to the 20th Prism CP3 was vandalized and repaired.

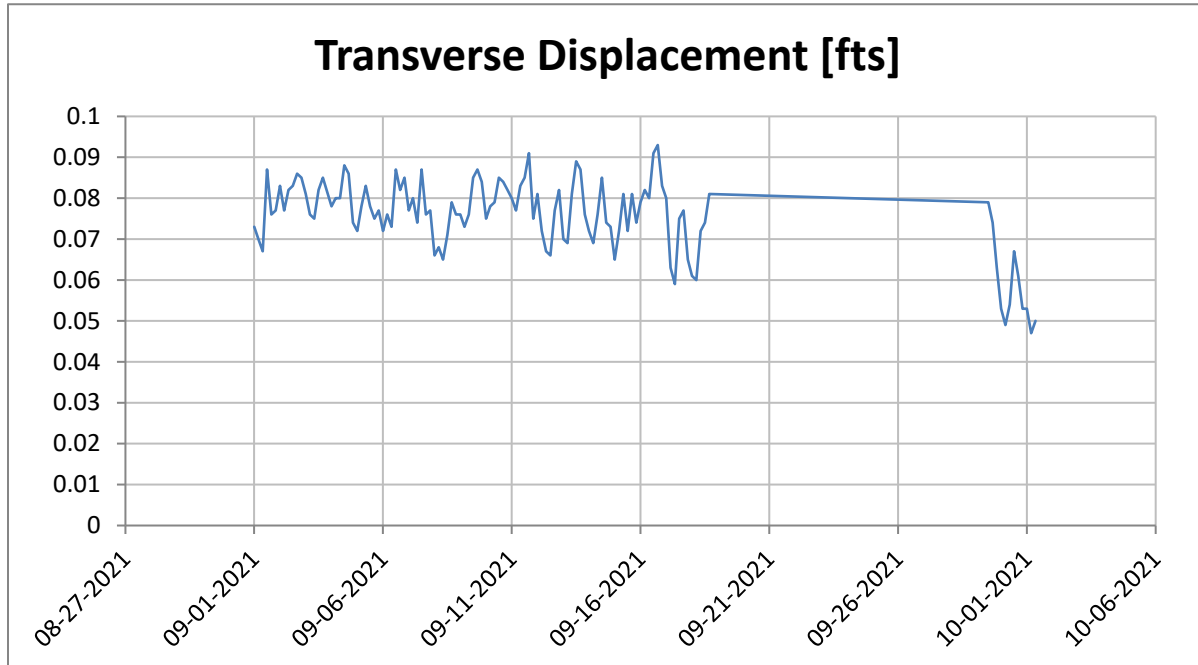
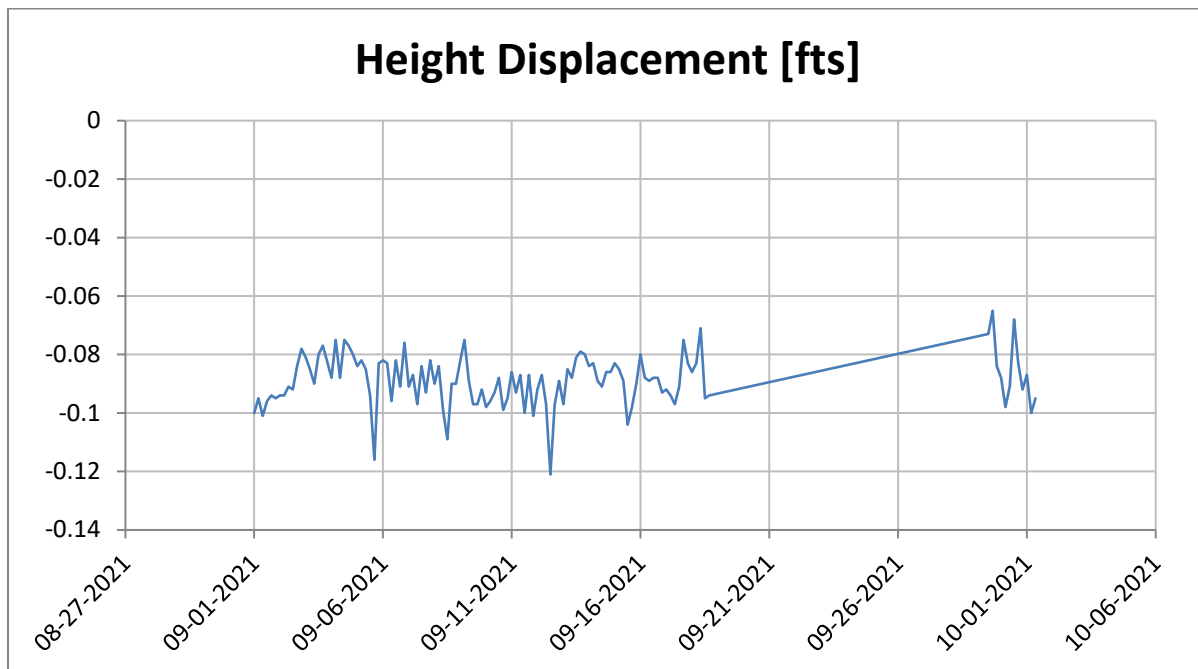
1. Survey accuracy is ± 0.016 feet.
2. Alarm threshold is ± 0.35 feet.
3. Transverse displacement is in the horizontal direction. Positive direction means closer to the robotic station.
4. Height displacement is in the vertical direction. Positive direction means higher in elevation.
5. From the 18th-23rd Prism NP2 was stolen and replaced in its original position.

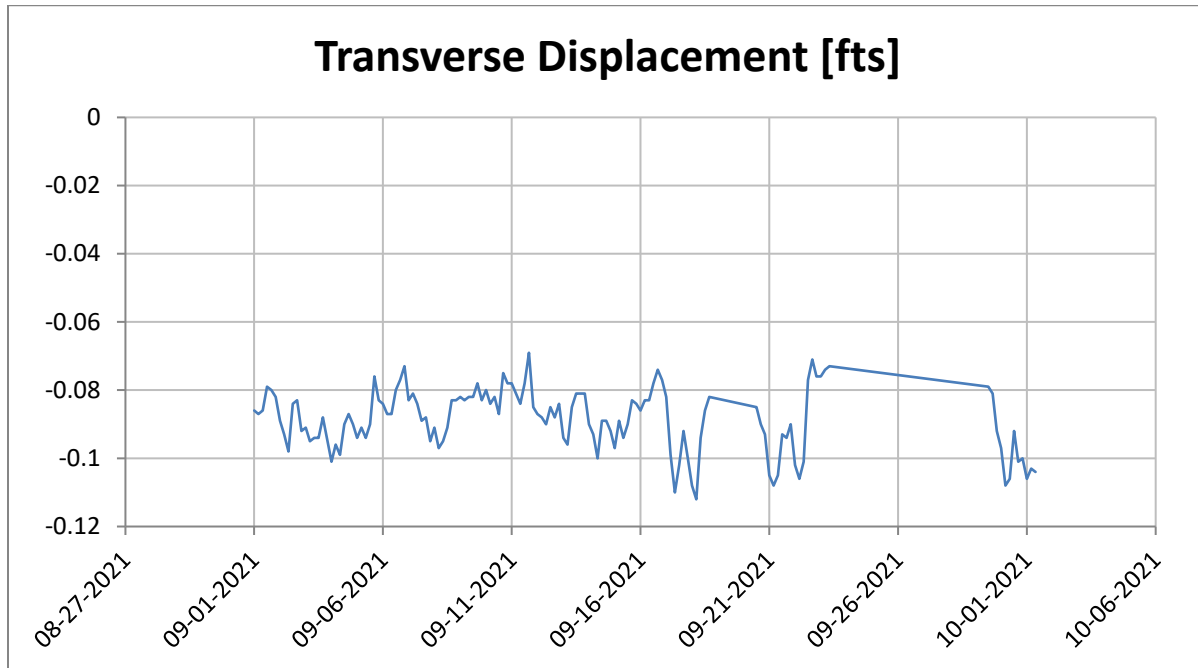
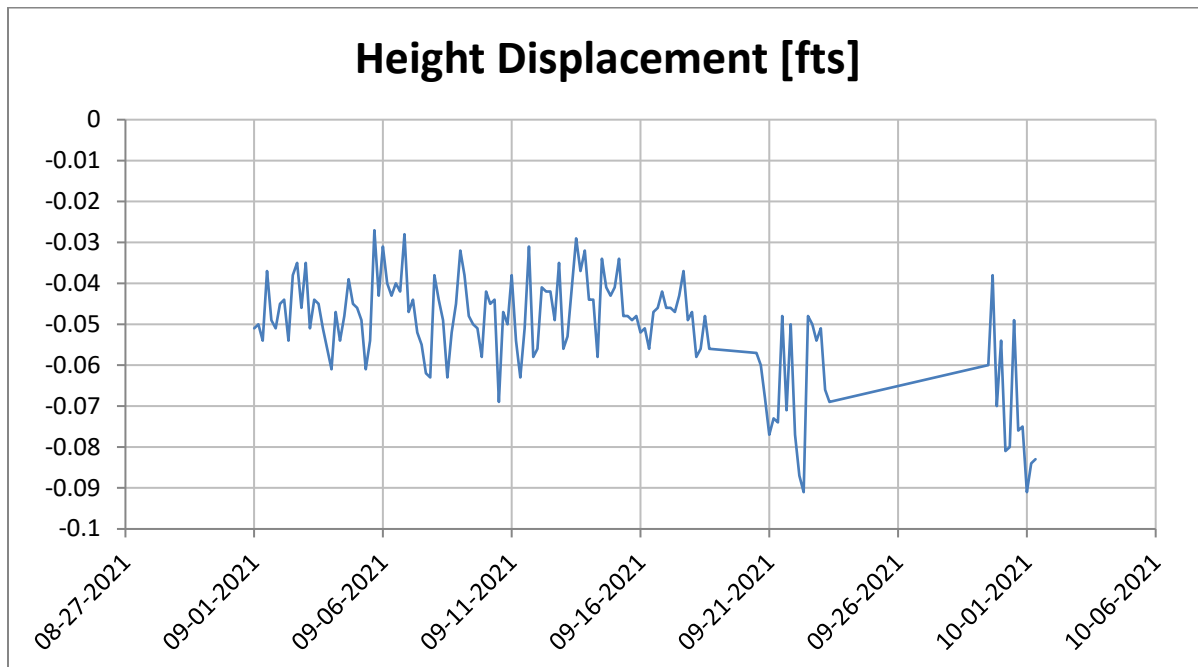
1. Survey accuracy is ± 0.016 feet.
2. Alarm threshold is ± 0.35 feet.
3. Transverse displacement is in the horizontal direction. Positive direction means closer to the robotic station.
4. Height displacement is in the vertical direction. Positive direction means higher in elevation.
5. From the 18th-20rd Prism P33 was stolen and replaced in its original position.

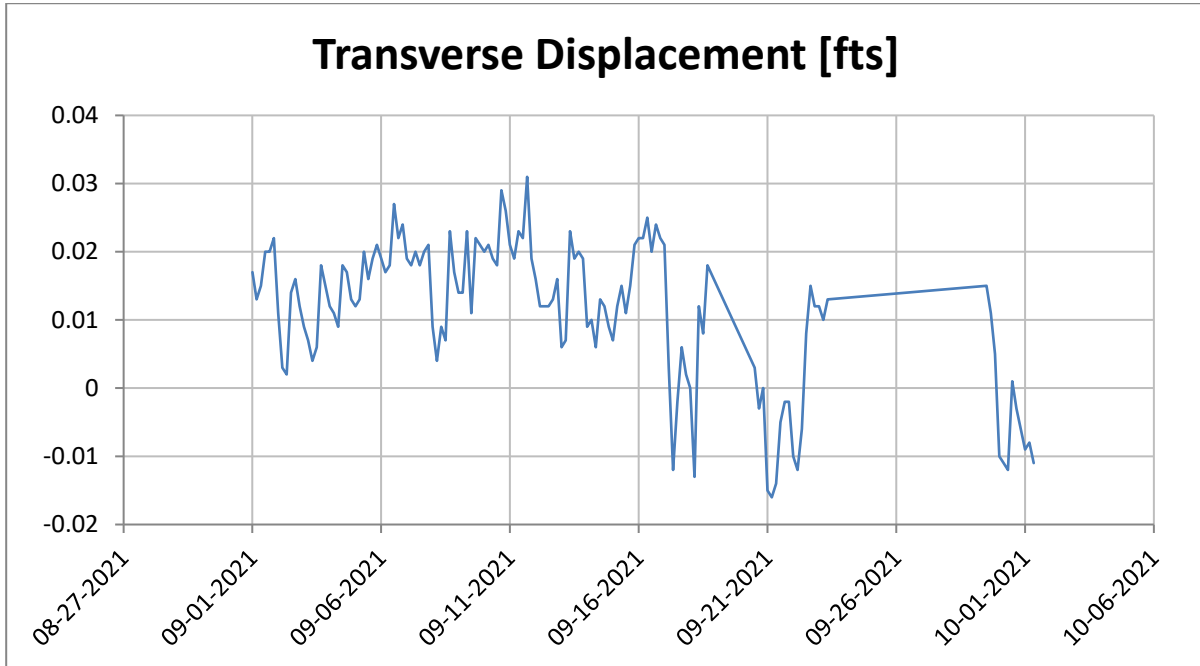
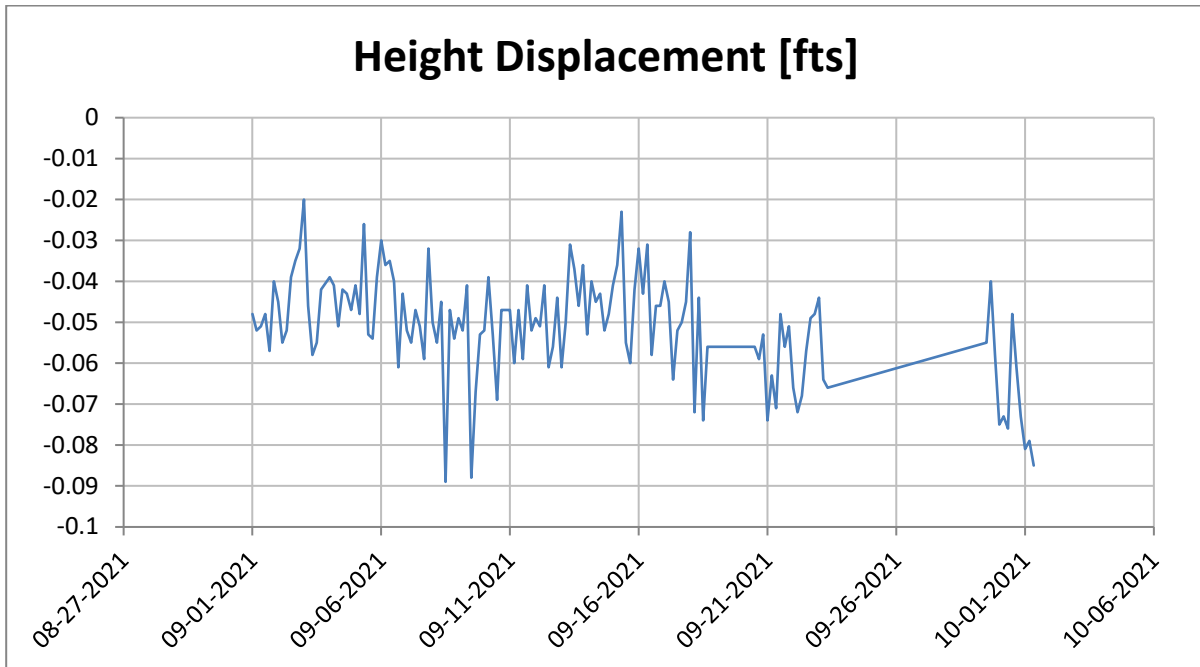
1. Survey accuracy is ± 0.016 feet.
2. Alarm threshold is ± 0.35 feet.
3. Transverse displacement is in the horizontal direction. Positive direction means closer to the robotic station.
4. Height displacement is in the vertical direction. Positive direction means higher in elevation.
5. From the 18th-20rd Prism P69 was stolen and replaced in its original position.

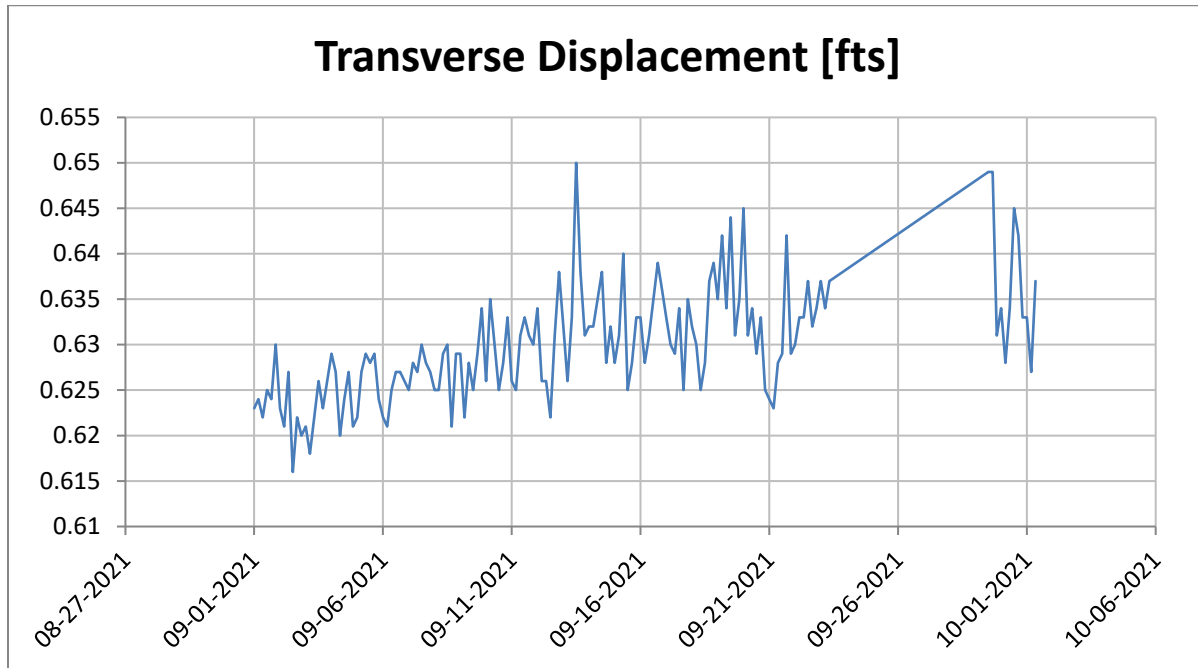
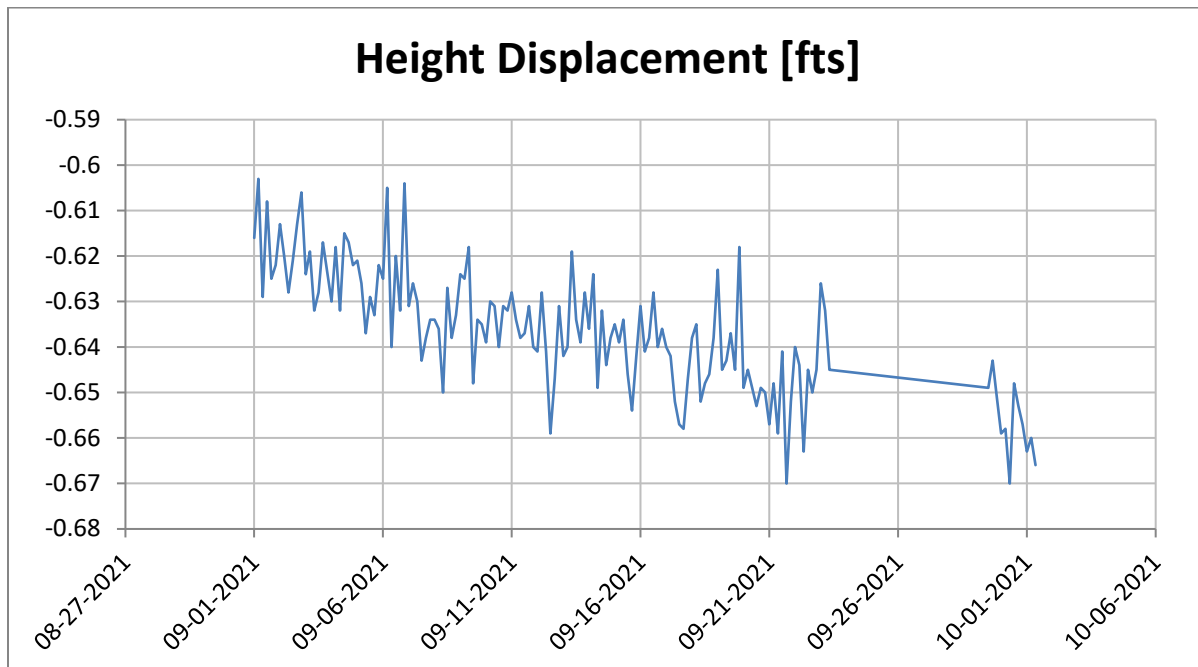
Prism TOE2

Prism ID	Cumulative Transverse Displacement (ft)	Cumulative Height Displacement (ft)	Monthly Delta (ft)	Cumulative Delta (ft)	Notes / Recommendations
CP1	-0.001	-0.037	0.0142	0.0379	
CP2	-0.067	-0.017	-0.0020	0.4178	
CP3	0.289	-0.235	0.0137	0.3756	Prism vandalized then repaired
NP1	0.300	-0.315	0.0390	0.4350	
NP2	0.050	-0.095	0.0069	0.1502	Prism was stolen and replaced
NP66	0.476	-0.625	0.0682	0.9270	Slope creep movements
P1	0.334	-0.089	-0.0161	0.3477	
P2	0.145	-0.054	-0.0181	0.2204	
P25	-0.025	0.012	-0.0002	0.1496	
P32	-0.085	-0.107	0.0199	0.2911	
P33	-0.104	-0.083	-0.0008	0.2104	Prism was stolen and replaced
P35	0.019	-0.206	-0.0073	0.4548	
P4	0.361	-0.153	-0.0139	0.4901	
P5	0.393	-0.163	-0.0184	0.6237	
P63	15.546	-6.376	0.0600	16.8030	Slope creep movements
P69	-0.011	-0.085	-0.0658	2.0368	Prism was stolen and replaced
P70	0.345	-0.332	-0.0040	0.6094	
TOE1	0.148	0.013	-0.0159	0.1630	
TOE2	0.637	-0.666	0.0382	0.9620	Slope creep movements

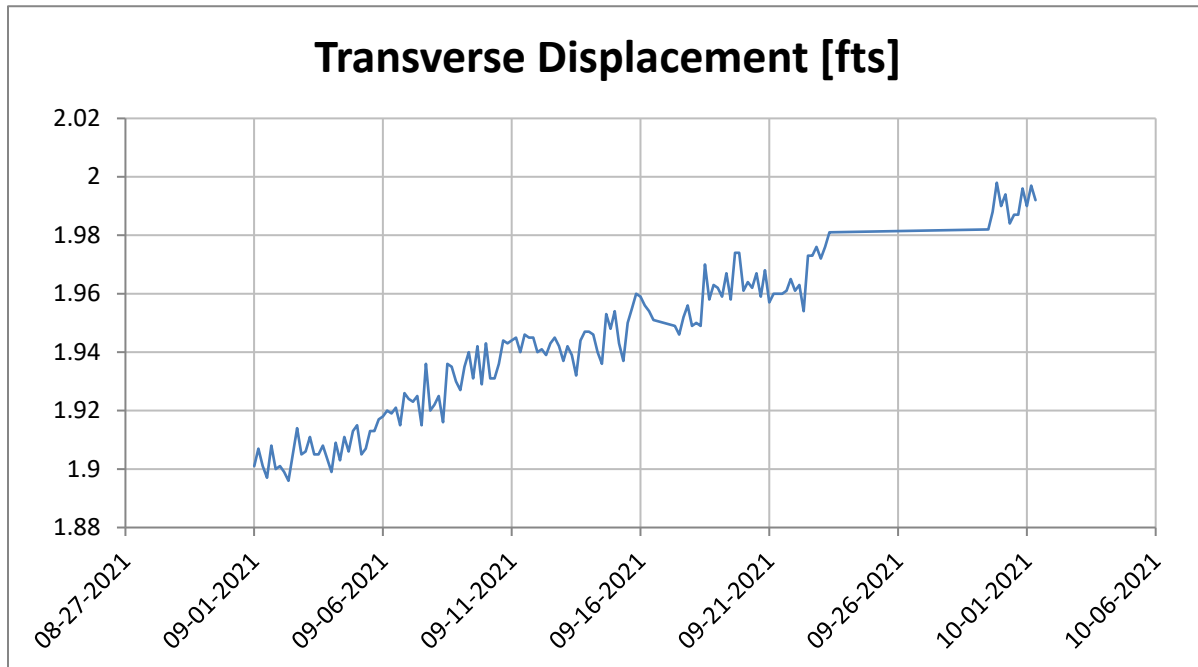
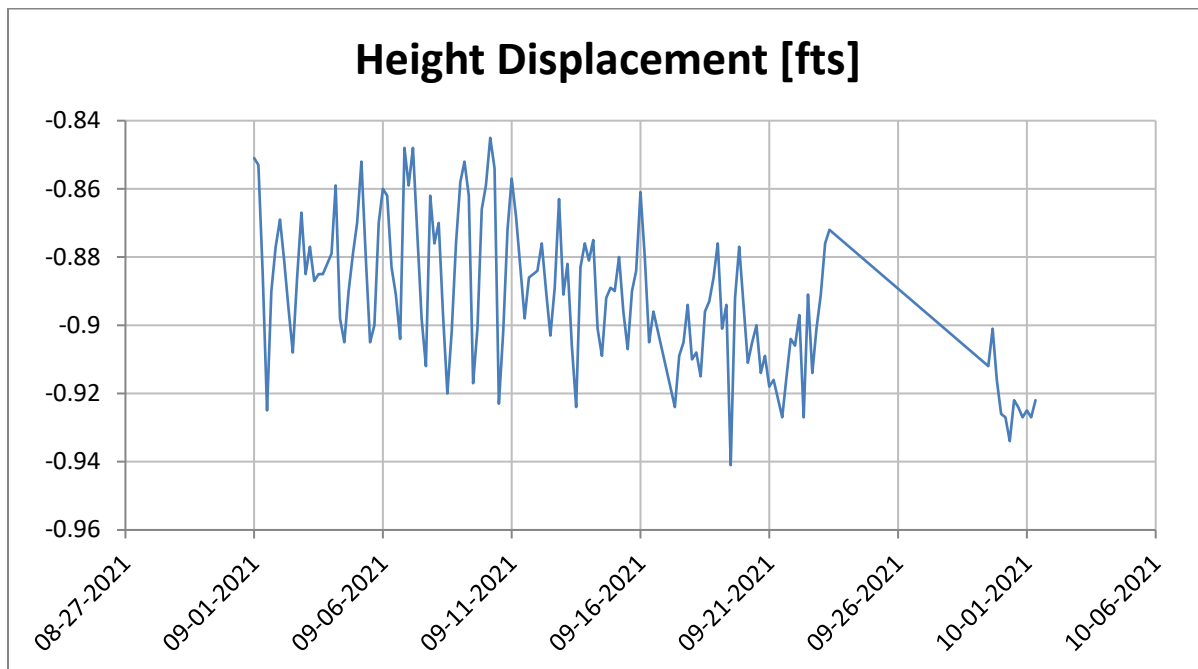
TOE3	1.992	-0.922	0.1092	2.3225	Slope creep movements

1. Survey accuracy is ± 0.016 feet.
2. Alarm threshold is ± 0.35 feet.
3. Transverse displacement is in the horizontal direction. Positive direction means closer to the robotic station.
4. Height displacement is in the vertical direction. Positive direction means higher in elevation.
5. On the 16th, Prism TOE3 was briefly blocked by equipment on site.

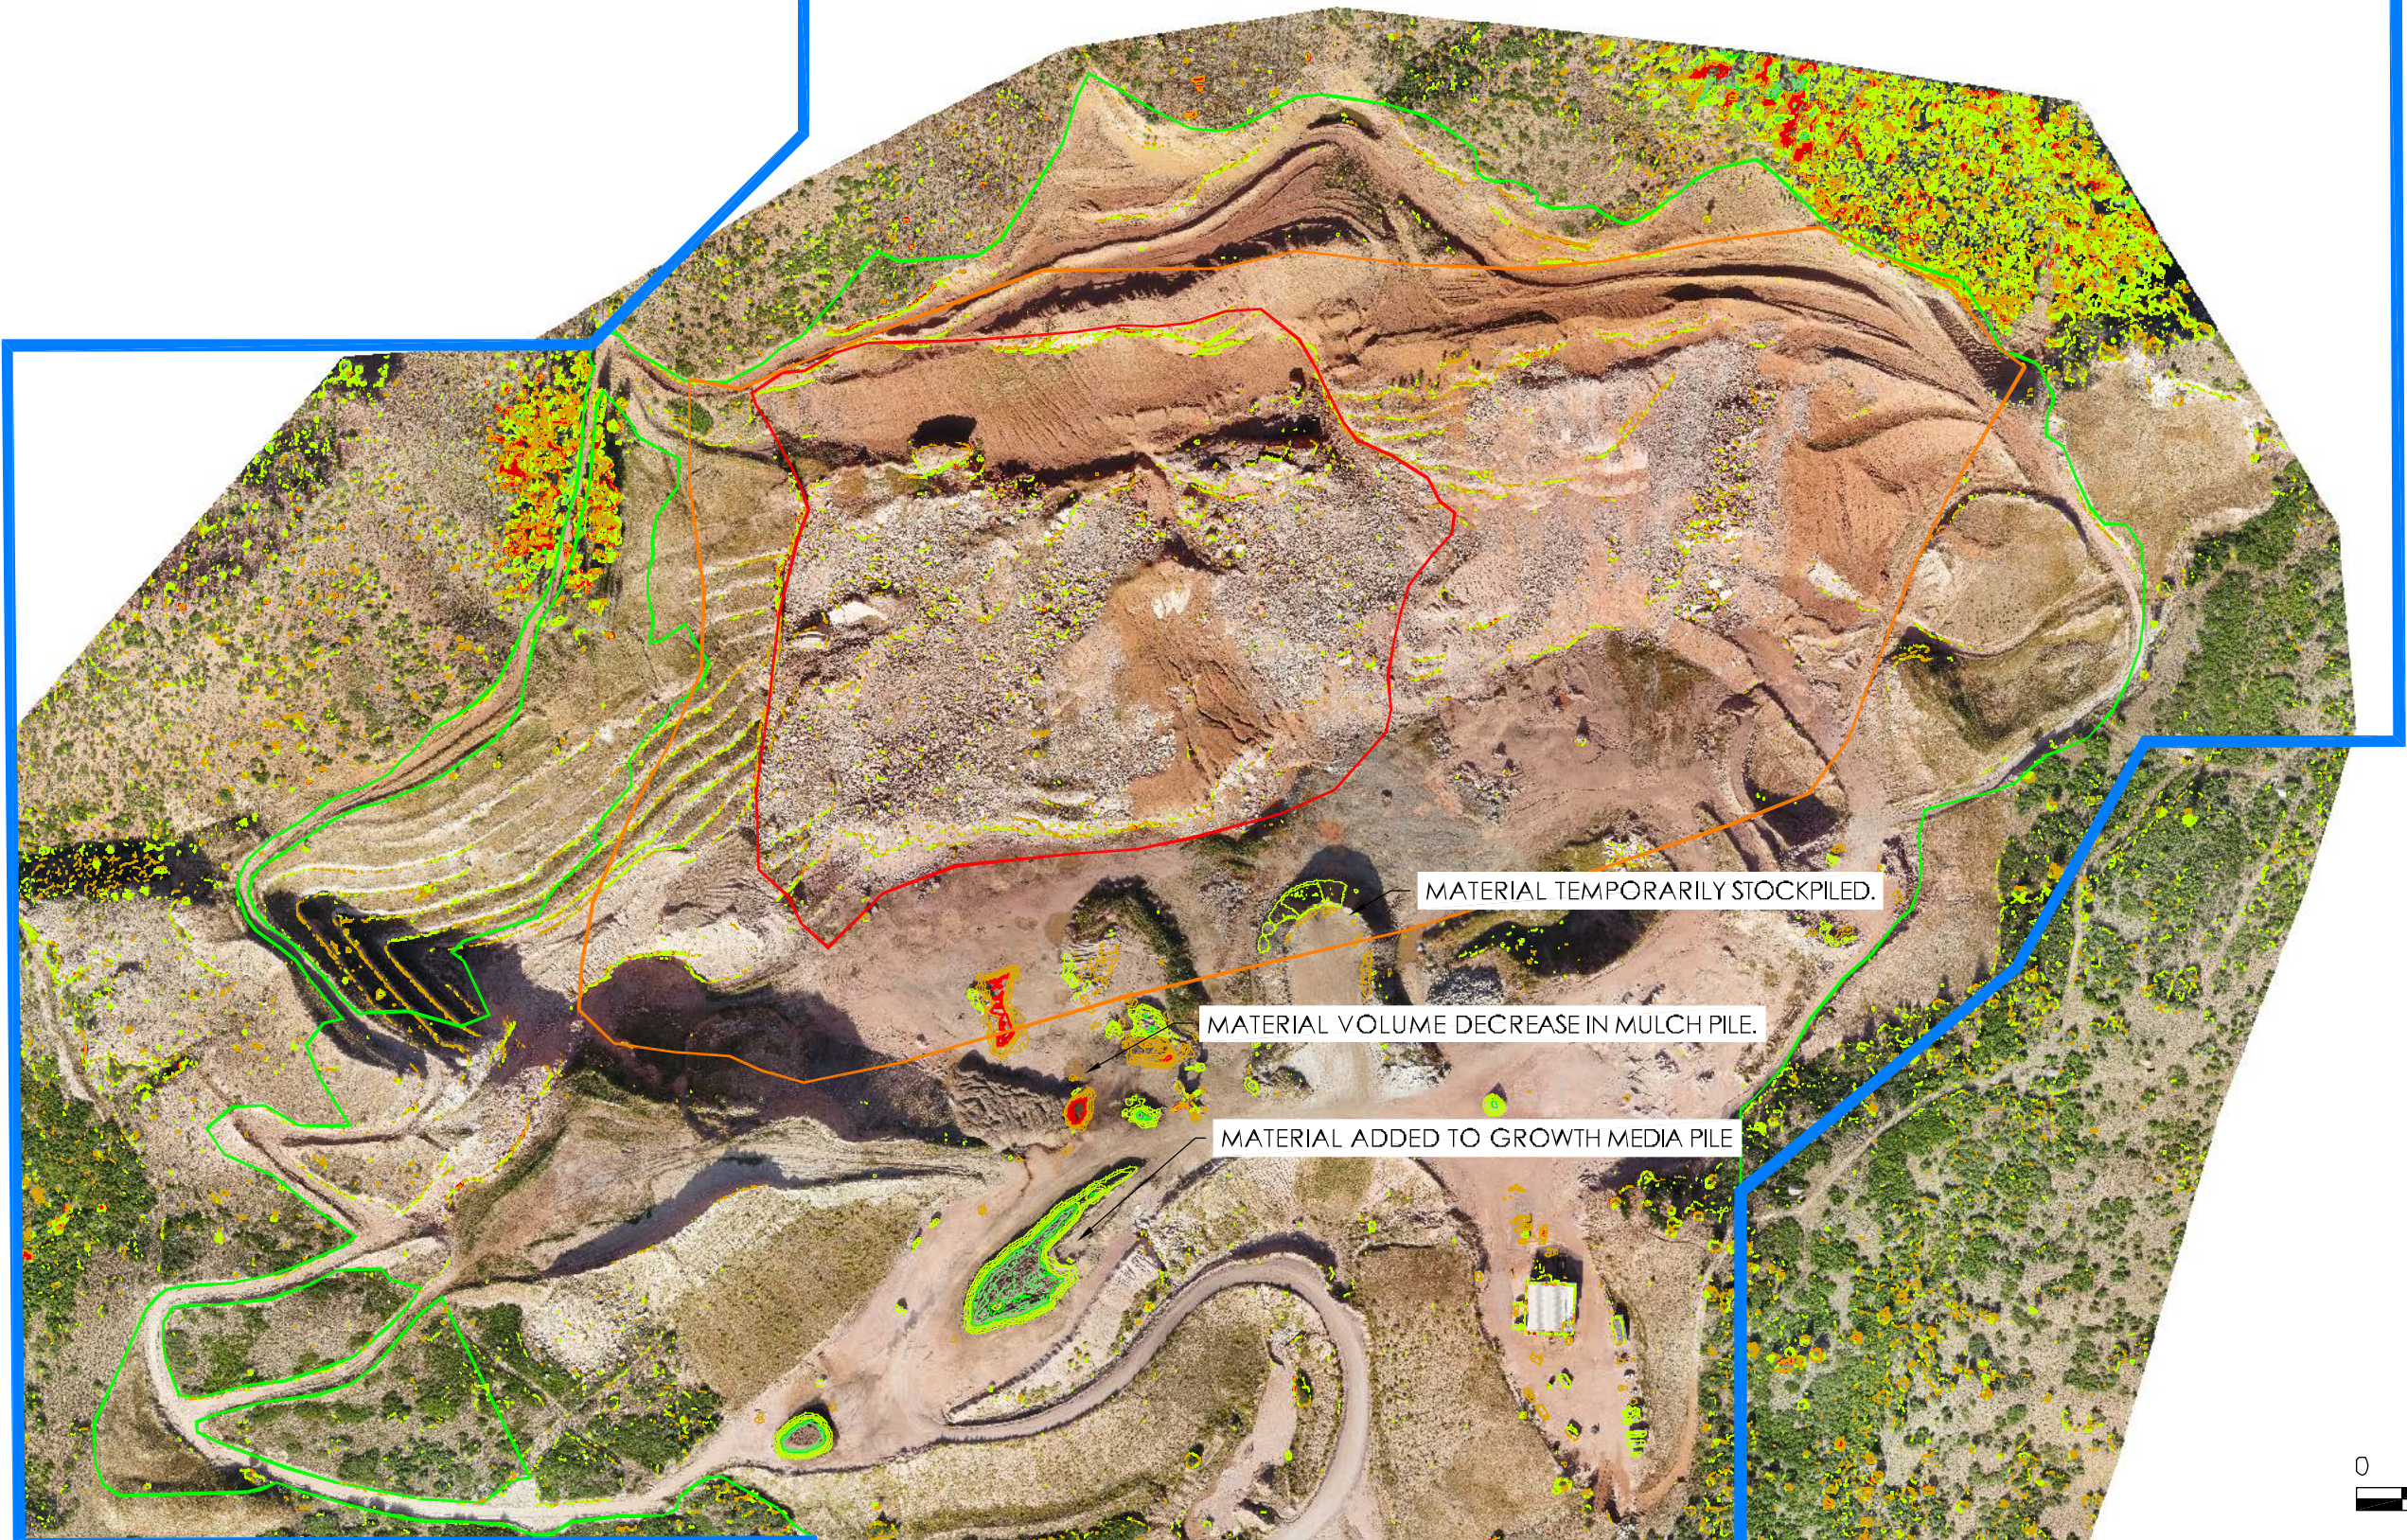
Figure No.
5

The August topography was also compared to the September topography to identify changes in the site topography. Comparison of the two surveys showed that approximately 9800 yd³ of fill had been imported and temporarily placed. Much of the imported fill was topsoil, and it was added to the growth media pile. No slope movements or other changes in topography were identified. The current imagery and topography are included in Figures 1 and 3, and the comparison surface is included as Figure 5 in Appendix C.

As previously reported in the September 2020 monitoring report, there are limitations with the method of comparing drone surveys from different months. The drone data indicate changes in the slopes along each of the reclamation benches, buildings, and areas with trees or shrubs. These areas are stable, and the changes are the result of survey limitations on or near vertical slopes.
