MINERALS PROGRAM INSPECTION REPORT
PHONE: (303) 866-3567

MINE NAME: Lamar Pit	MINE/PROSPECTING ID#: M-1987-079	MINERAL: Sand and gravel	COUNTY: Prowers
INSPECTION TYPE: Monitoring	INSPECTOR(S): Amy Eschberger	INSP. DATE: October 20, 2021	INSP. TIME: 14:45
OPERATOR: All-Rite Paving & Redi-Mix, Inc.	OPERATOR REPRESENTATIVE: Mario Ambrosio	TYPE OF OPERATION: 112c - Construction Regular Operation

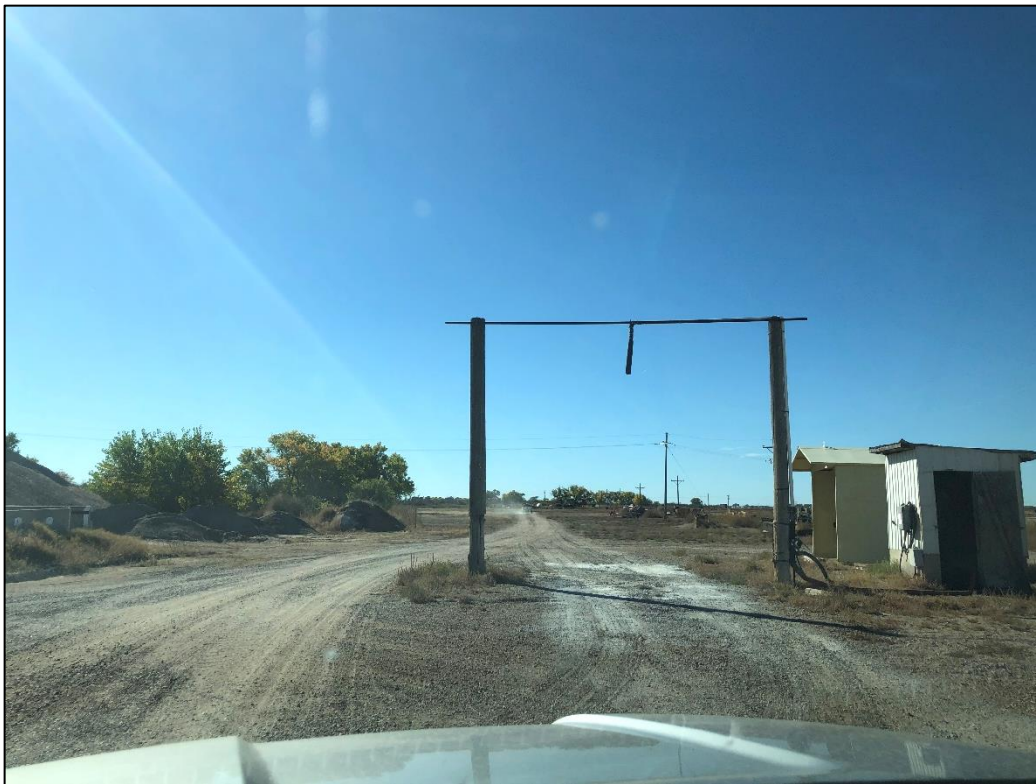
Photo 2. View looking west along northern edge of permit boundary, showing structures present on access road to Phase 2 mine area. Operator will need to specify on updated reclamation plan map if these structures (including road) will remain for reclamation.

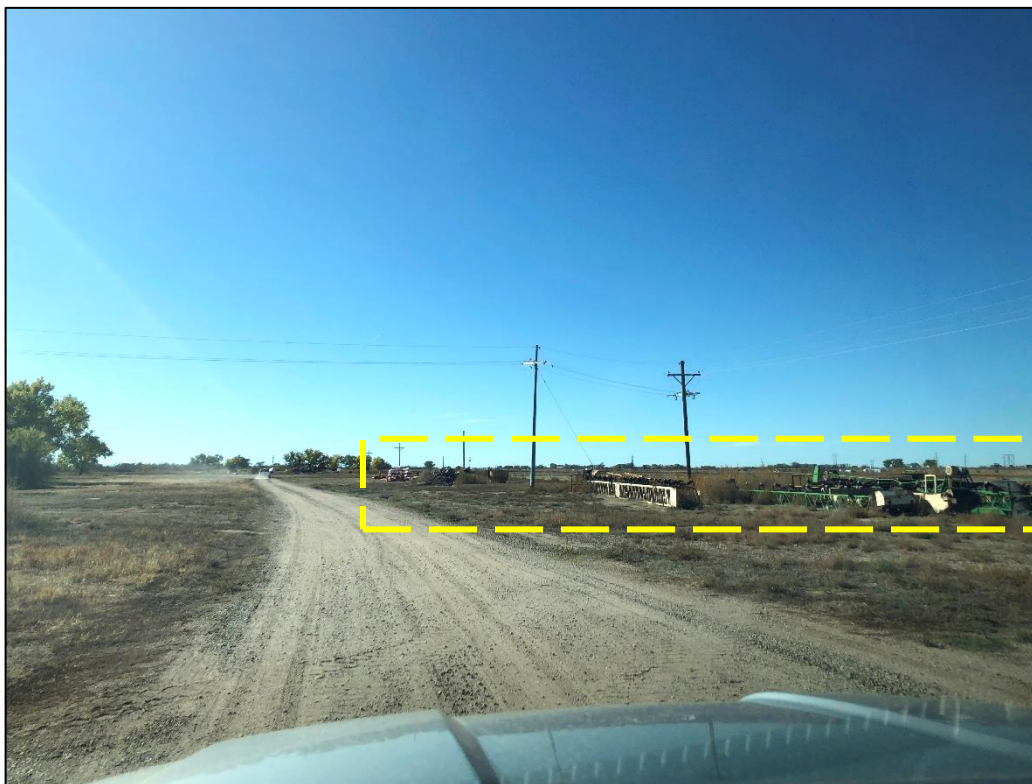
Photo 3. View looking west along northern edge of permit boundary (in Phase 2 mine area), showing area north of access road used for equipment storage (indicated). Operator will need to specify on updated reclamation plan map if this area will continue to be used for storage after reclamation.

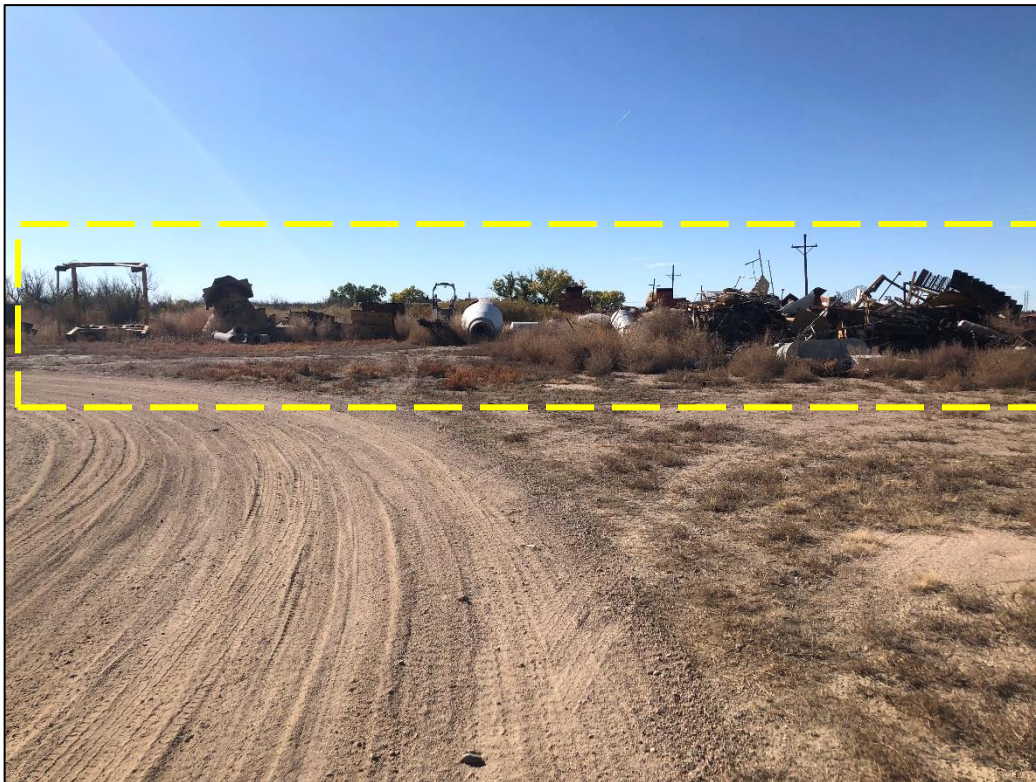
Photo 6. View looking west across northwestern corner of Phase 2 mine area, which is being used for trash/debris storage (indicated). Operator will need to remove any trash or debris from the site or include costs in the updated bond estimate for removing this material.

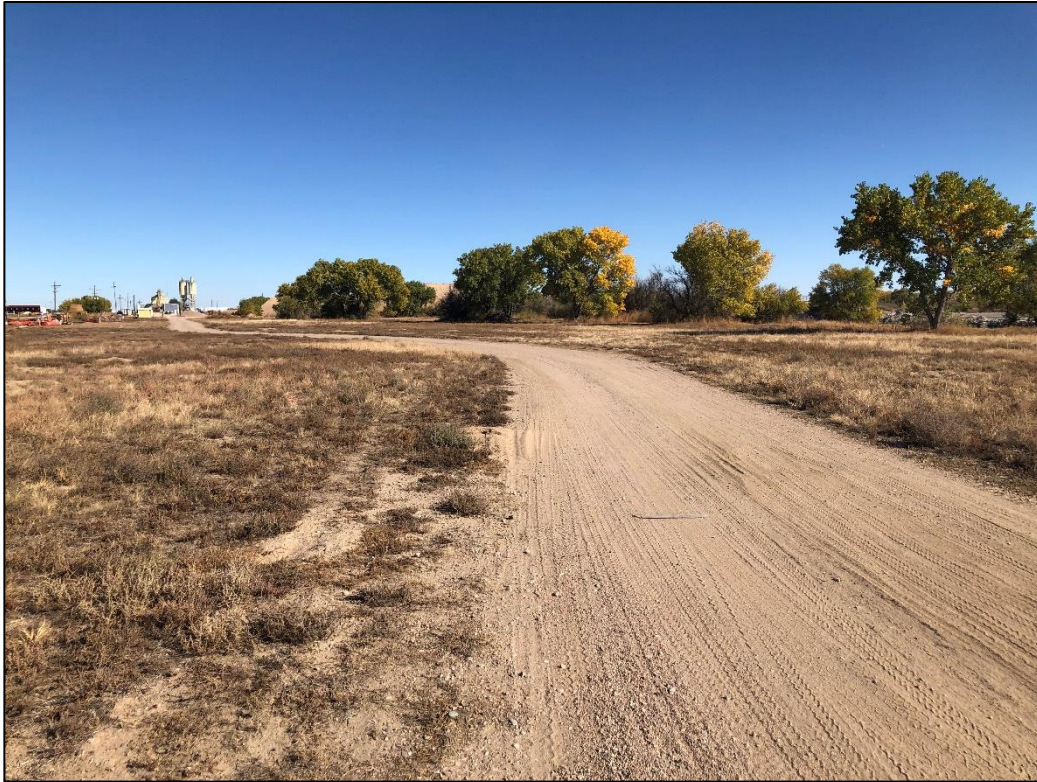
- 4) It is not clear whether the road present in the Phase 1 and 2 mine areas will remain for reclamation. The operator will need to specify any roads to remain.

Photo 7. View looking east across Phase 2 mine area, not mined by operation. Operator will need to specify on updated reclamation plan if the existing road in this area will remain for reclamation.

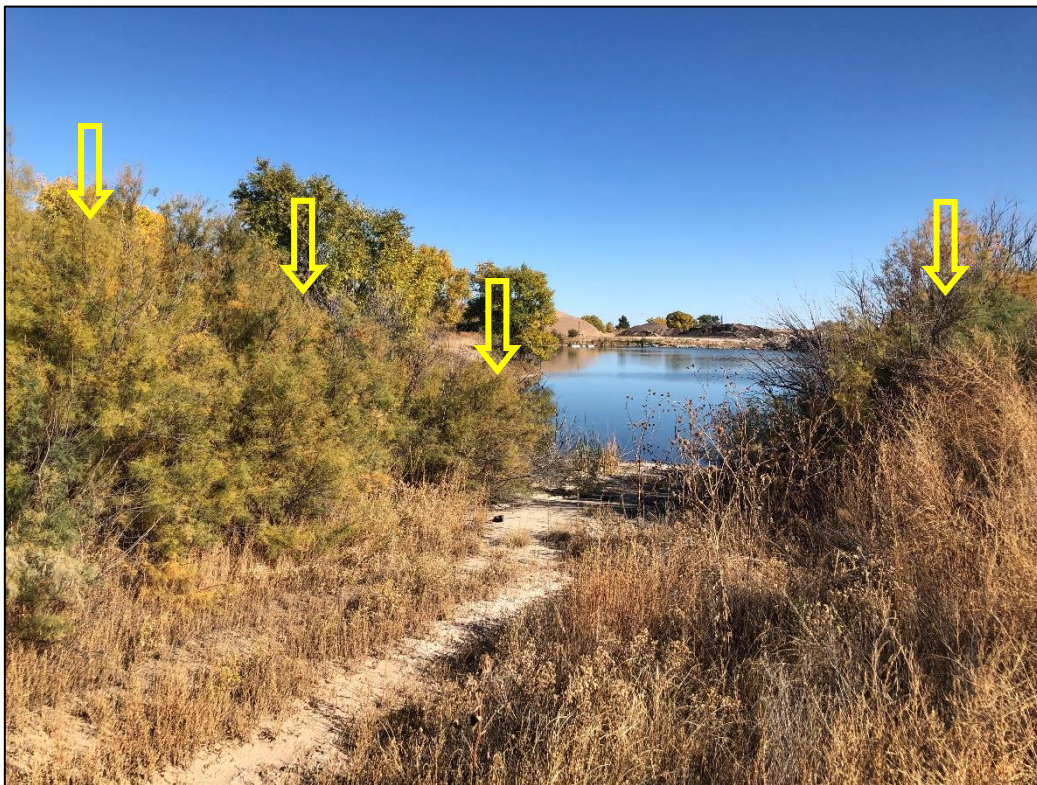
PROBLEM #1: Tamarisk (salt cedar) trees are present within or have volunteered into the permit area and are becoming established. This is a problem for failure to employ weed control methods for a state listed noxious weed species within the permitted area, and to reduce the spread of weeds to nearby areas as required by Rule 3.1.10(6).

Photo 8. View looking east at western edge of Phase 1 pond, showing Tamarisk (salt cedar) trees (indicated) present along pond edges. Operator will need to implement approved weed control plan for this noxious weed species or submit an updated plan in a Technical Revision.

CORRECTIVE ACTIONS: By the corrective action due date, the operator shall provide sufficient evidence the existing weed control plan has been implemented at the site, or submit a Technical Revision, with the required \$216 revision fee, with an updated weed control and management plan for the site. This updated plan should be developed in consultation with the county extension agency or weed control district office, and should include specific control measures to be applied, a schedule for when control measures will be applied, and a post-treatment monitoring plan.

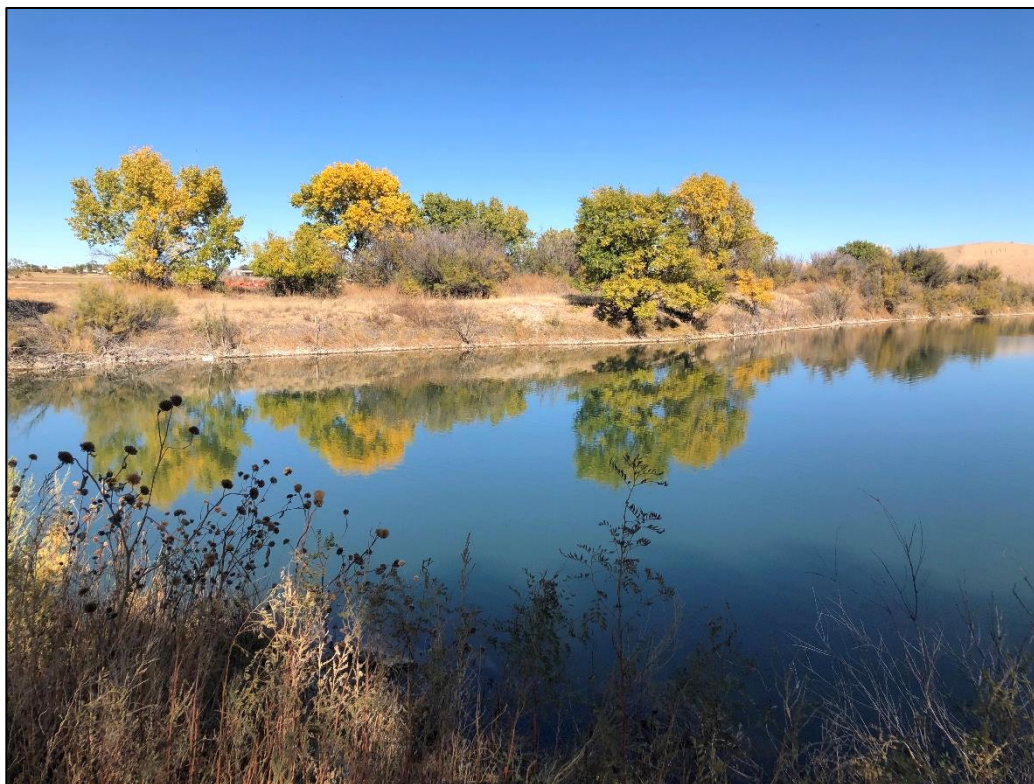
Photo 9. View looking northeast at northern shoreline of Phase 1 pond, with slopes at approximately 2H:1V. All pond slopes must be graded to 3H:1V or flatter for reclamation.

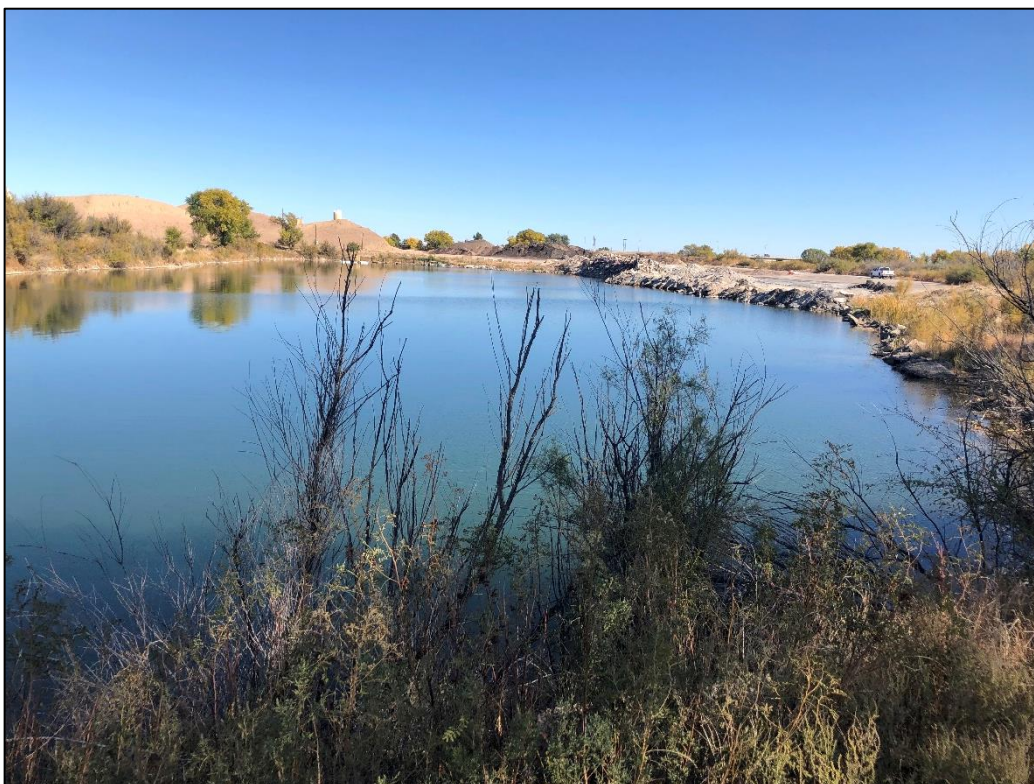
Photo 10. View looking southeast across Phase 1 pond. Note southern shoreline (at right) lined with concrete waste material to be backfilled into pond. Also note Tamarisk (salt cedar) trees present along edges of pond (in foreground).

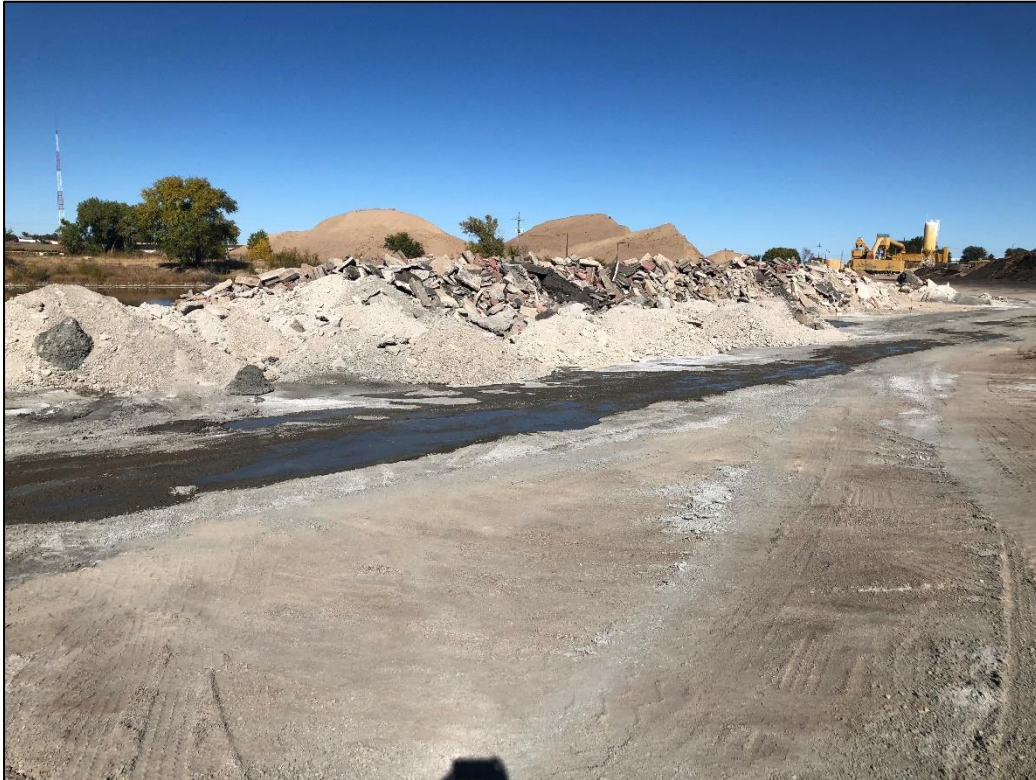
Photo 11. View looking northeast at concrete waste material piled along southern edge of Phase 1 pond to be backfilled into pond.

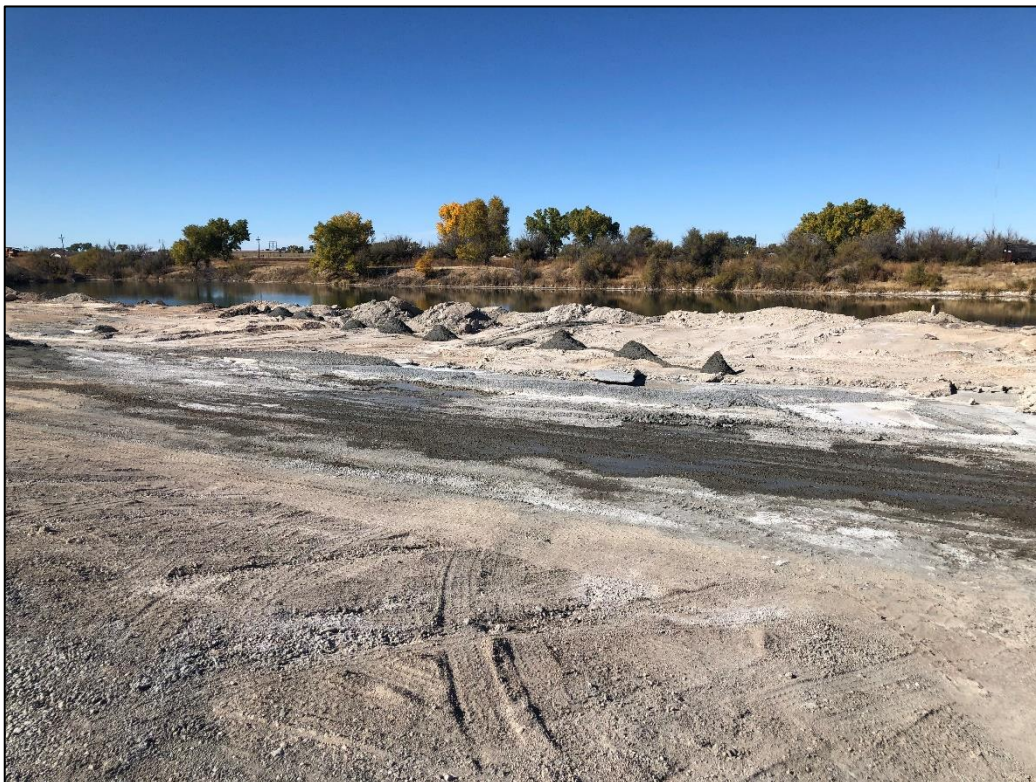
- 3) It is not clear which portions of the disturbed area have exposed concrete at the ground surface and how these areas will be reclaimed. The operator will need to specify which areas have exposed concrete and clarify how these areas will be reclaimed. Will the concrete be ripped up prior to retopsoiling and revegetating these areas? If not, is there sufficient topsoil available on site to place 2-3 feet of topsoil on these areas prior to revegetation?

Photo 12. View looking northwest at concrete waste material piled along southern edge of Phase 1 pond to be backfilled into pond. Operator will need to specify areas where exposed concrete is present at ground surface (from previous use as wash pond) and describe how these areas will be reclaimed.

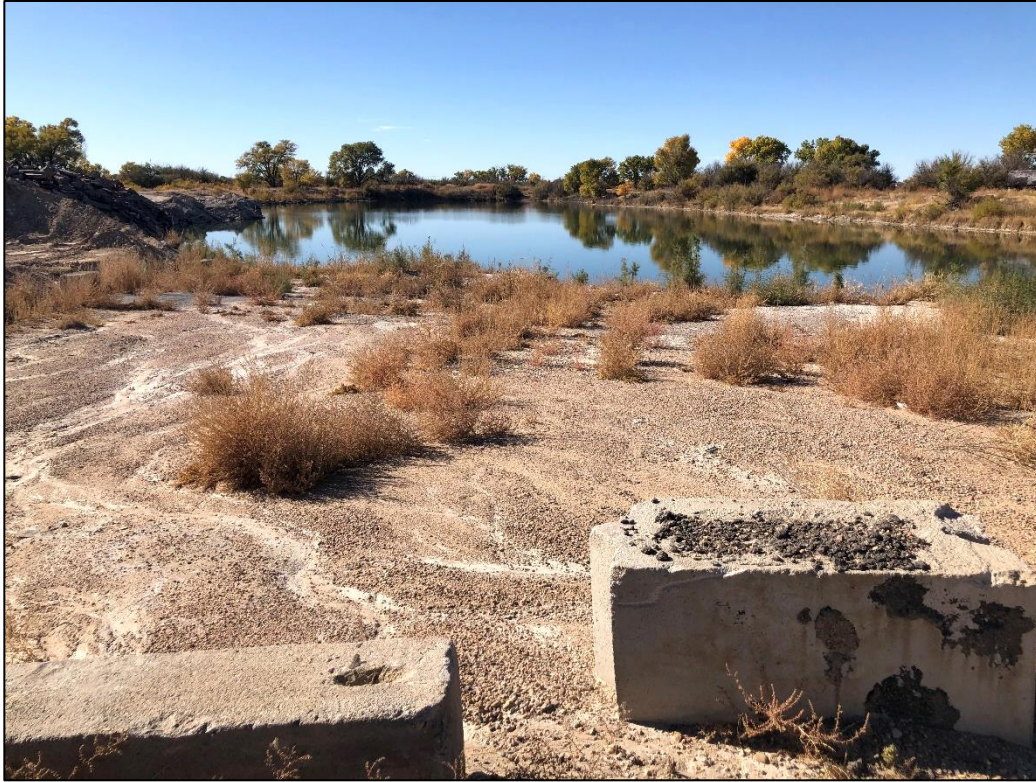
Photo 13. View looking west at eastern edge of pond which was slightly backfilled over the past several years. Current backfill activities appear to be focused along the southern pond shoreline.
