MINERALS PROGRAM INSPECTION REPORT
PHONE: (303) 866-3567

MINE NAME: RBK Pit No. 30	MINE/PROSPECTING ID#: M-1990-106	MINERAL: Gravel	COUNTY: Pueblo
INSPECTION TYPE: Monitoring	INSPECTOR(S): Patrick Lennberg	INSP. DATE: October 26, 2021	INSP. TIME: 11:00
OPERATOR: RBK Construction, Inc.	OPERATOR REPRESENTATIVE: Guy Baxter	TYPE OF OPERATION: 110c - Construction Limited Impact

INSPECTION TOPIC: Revegetation

INSPECTION TOPIC: Signs & Markers

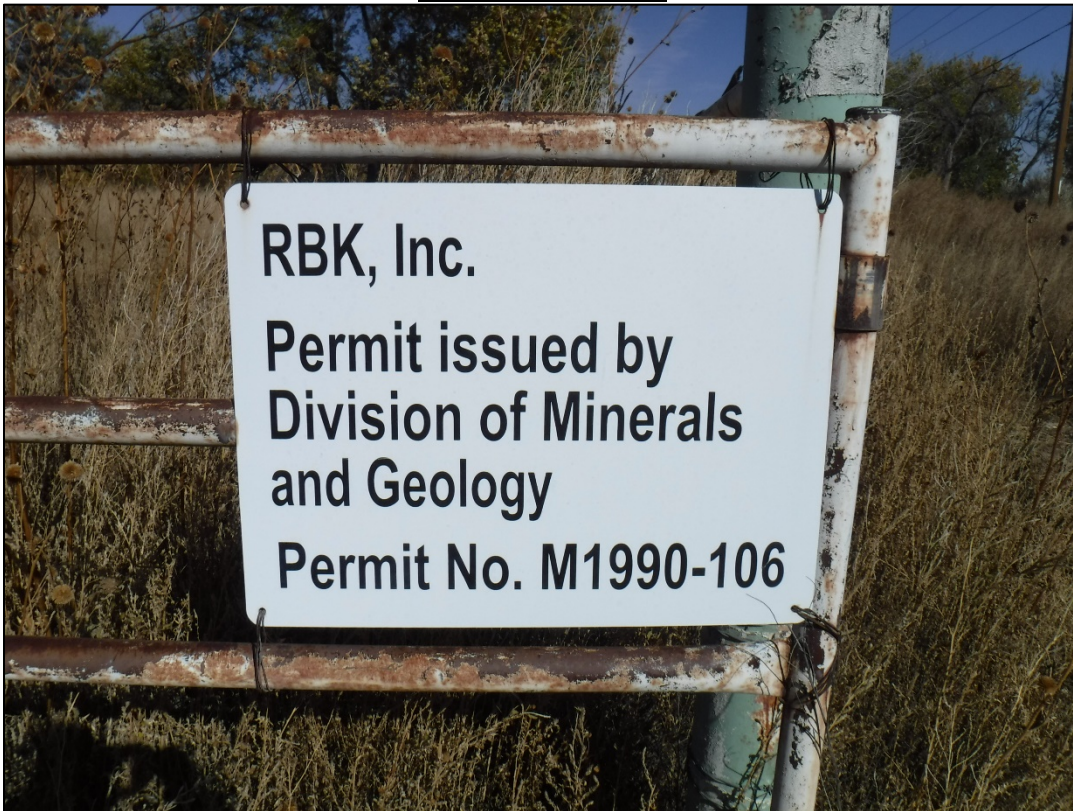
Photo 1: Mine sign at mine entrance location

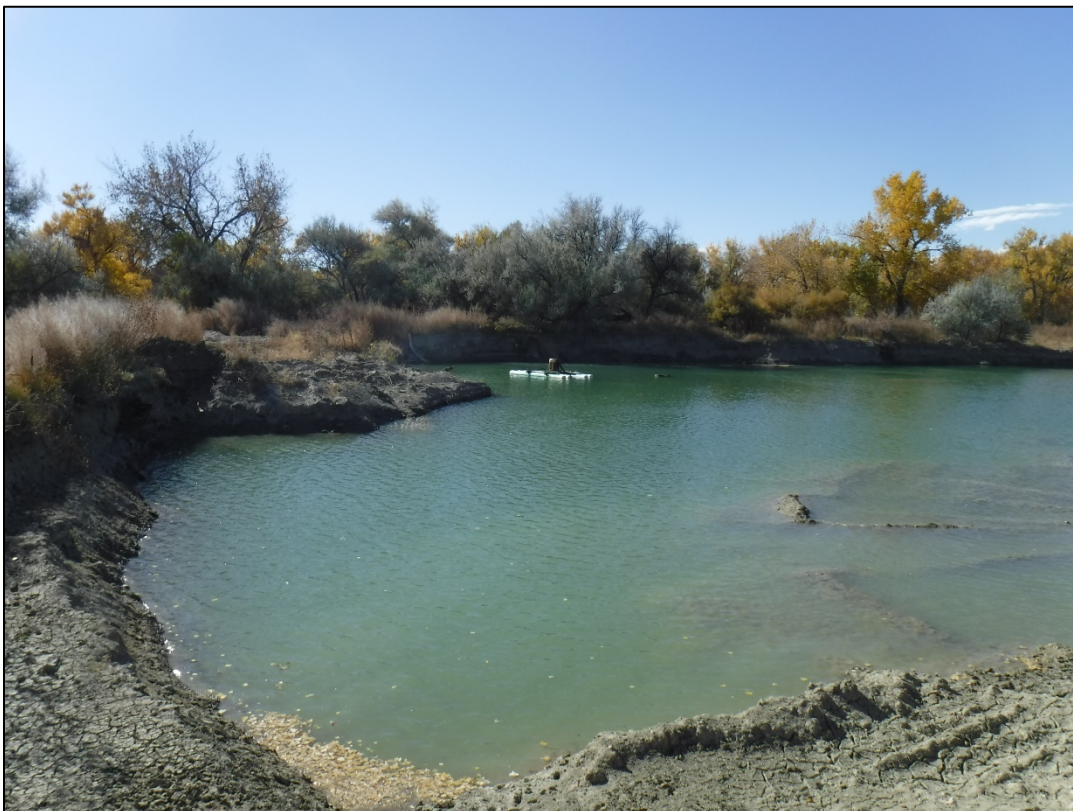
Photo 2: Pond in the southeastern portion of permit area

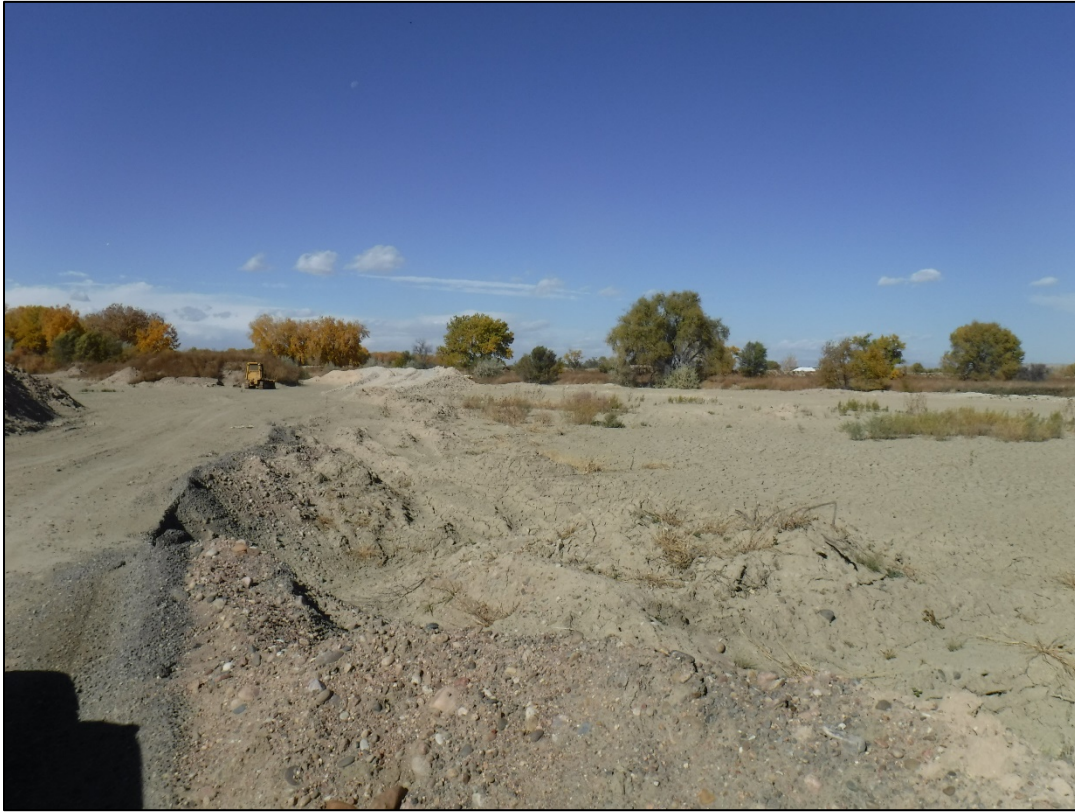
Photo 3: Looking from the main gate towards the northwestern corner of permit area

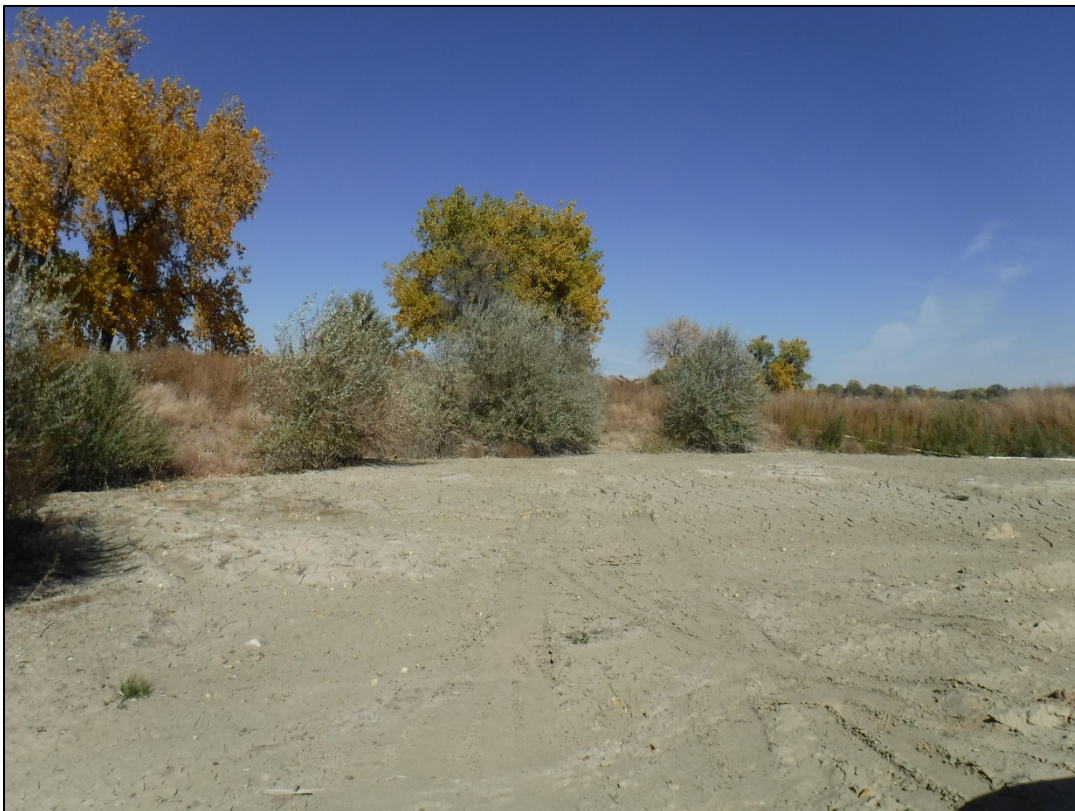
The pit area does have Saltcedar, or Tamarisk (*Tamarix* spp.), and a Russian-olive trees growing along and in the pit area, these were also noted in the previous two inspection reports. Saltcedar and Russian olive trees are List B Noxious Weeds in Colorado. Having state-listed noxious weeds growing at the site is being cited as a problem in this report. The Operator must begin mitigation efforts to control these in order to assist in future reclamation efforts.

Photo 4: Russian olive trees along the northwestern corner of permit area

CORRECTIVE ACTIONS: The operator shall either implement the existing weed control plan, develop a weed control and management plan in accordance with Section 3.1.10 (6) of the Rule, or remove the weeds from the site. This plan should be developed in consultation with the county extension agency, or weed control district office and should include specific control measures to be applied, a schedule for when control measures will be applied and a post-treatment monitoring plan. This weed control plan shall be submitted to the Division as a Technical Revision to the approved plan with the appropriate Technical Revision fee of \$216.00 by the corrective action date. Photographic documentation of the removal of the weeds will also suffice.

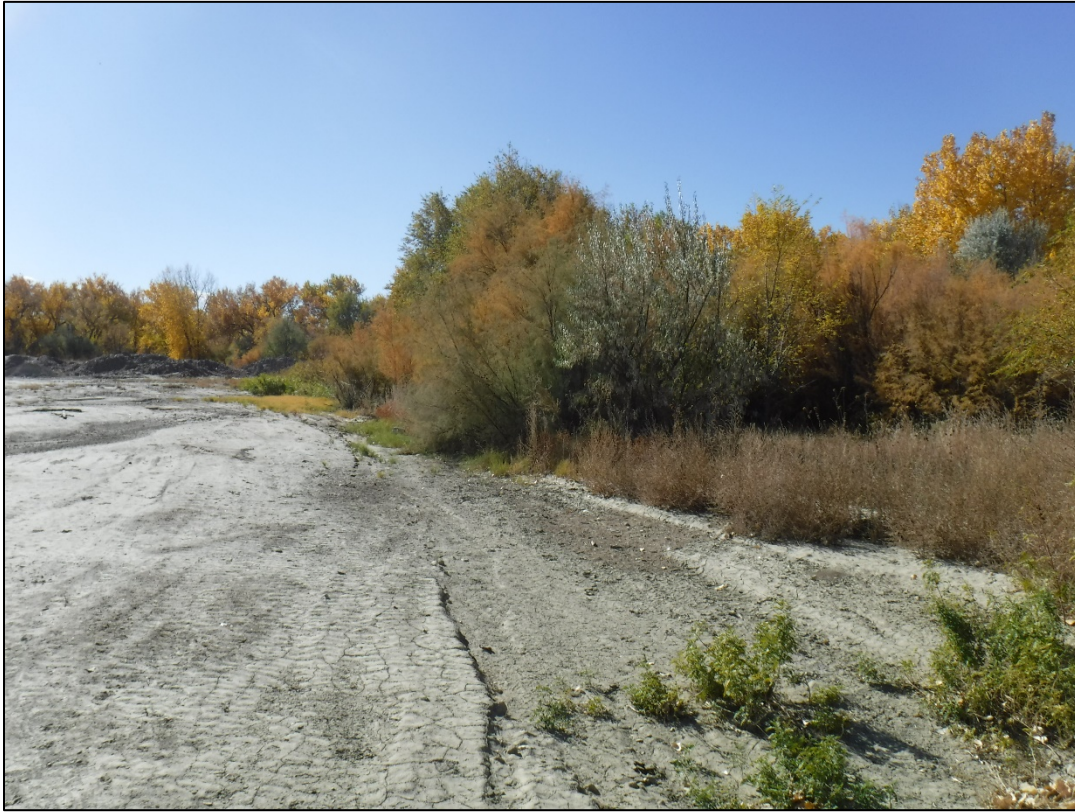
PROBLEM: Tamarisk (salt cedar) trees are present within or have volunteered into the permit area and are becoming established. This is a problem for failure to employ weed control methods for a state listed noxious weed species within the permitted area, and to reduce the spread of weeds to nearby areas as required by Section 3.1.10 (6) of the rule.

Photo 5: Saltcedar and Russian olive trees along western border of permit area

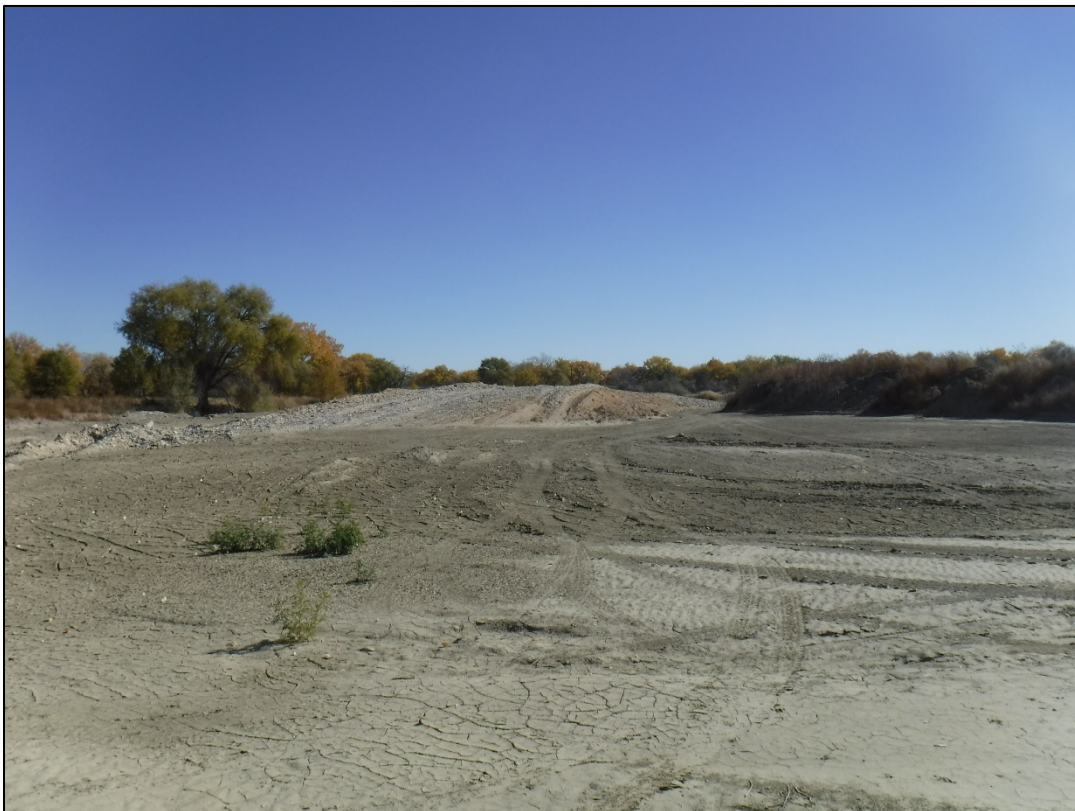
There appears to sufficient topsoil stockpiled at the site to complete reclamation. Additionally there is a stockpile of shale material mixed with reject material. It is unclear where this material came from but it is believed to have come from the bottom of the pit area.

Photo 6: Overburden stockpile, center of picture, topsoil stockpile to the right

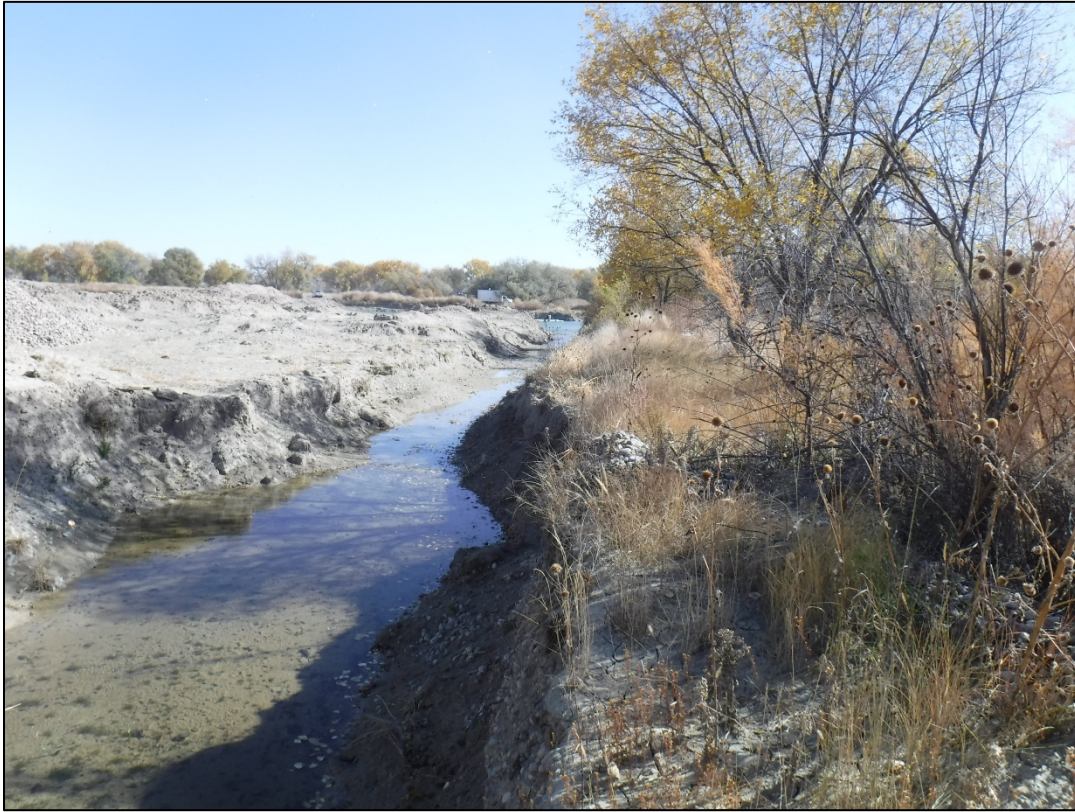
Photo 7: Looking east from the southwestern corner area along the southern permit boundary

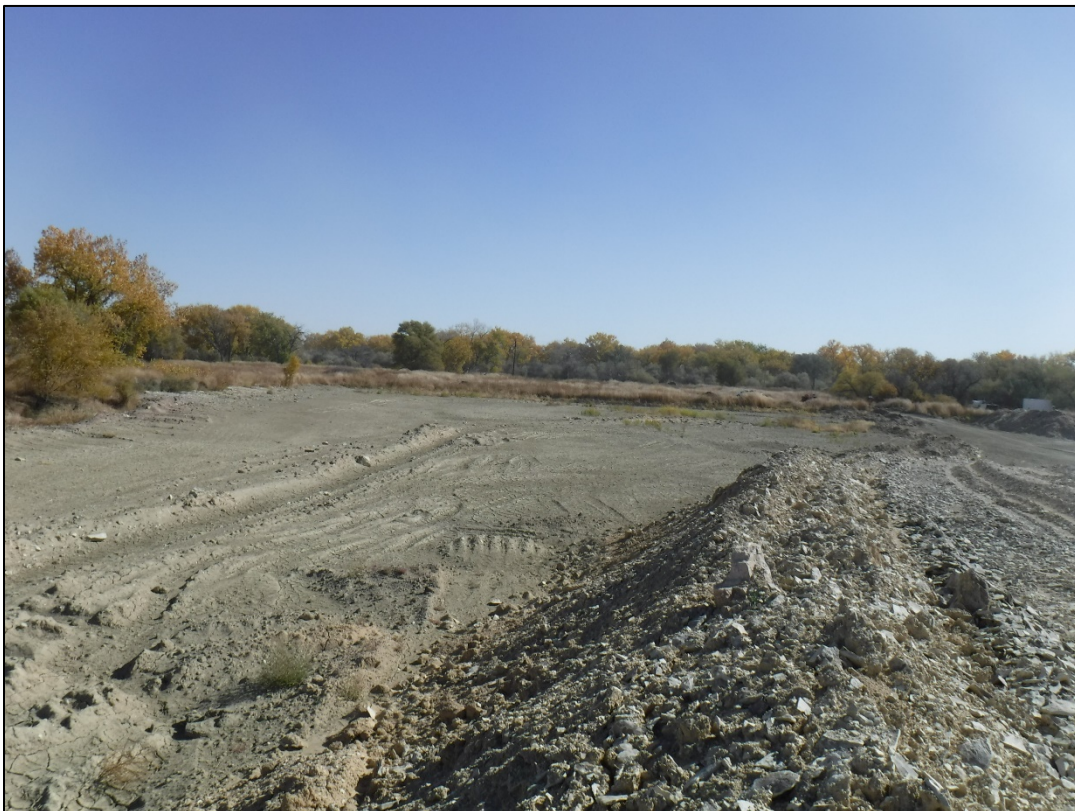
Photo 8: Looking east from the top of the overburden stockpile

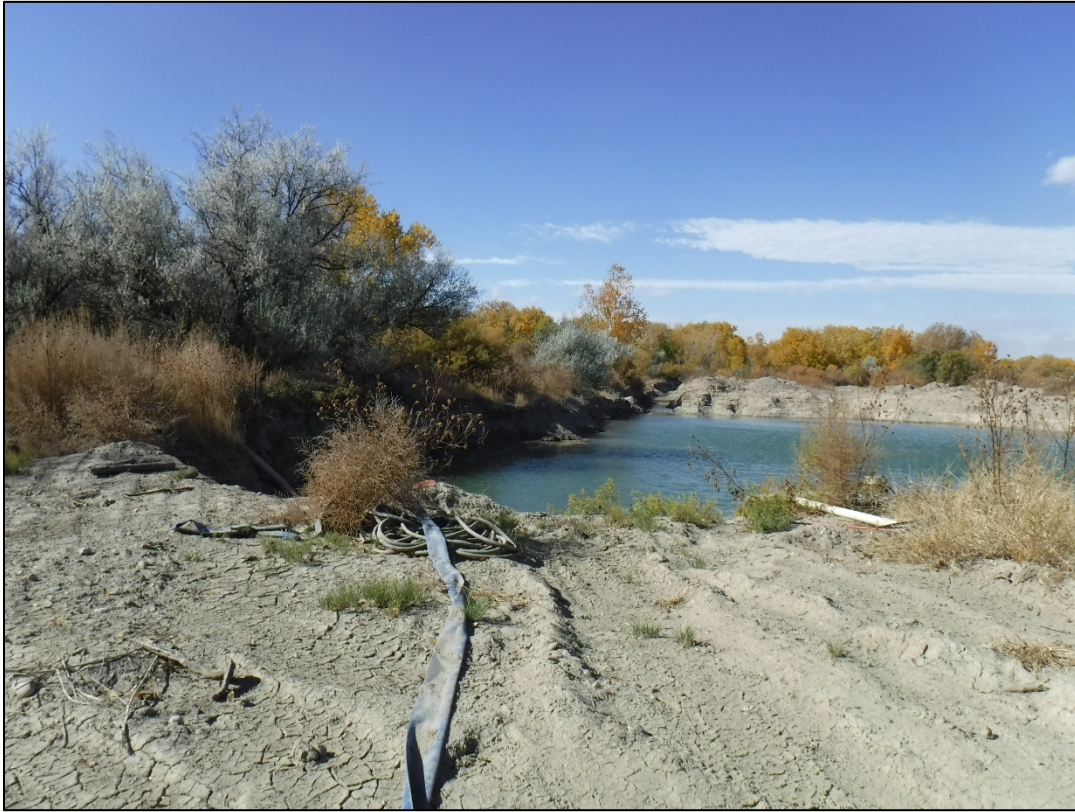
Photo 9: Looking west along the southern boundary of the permit

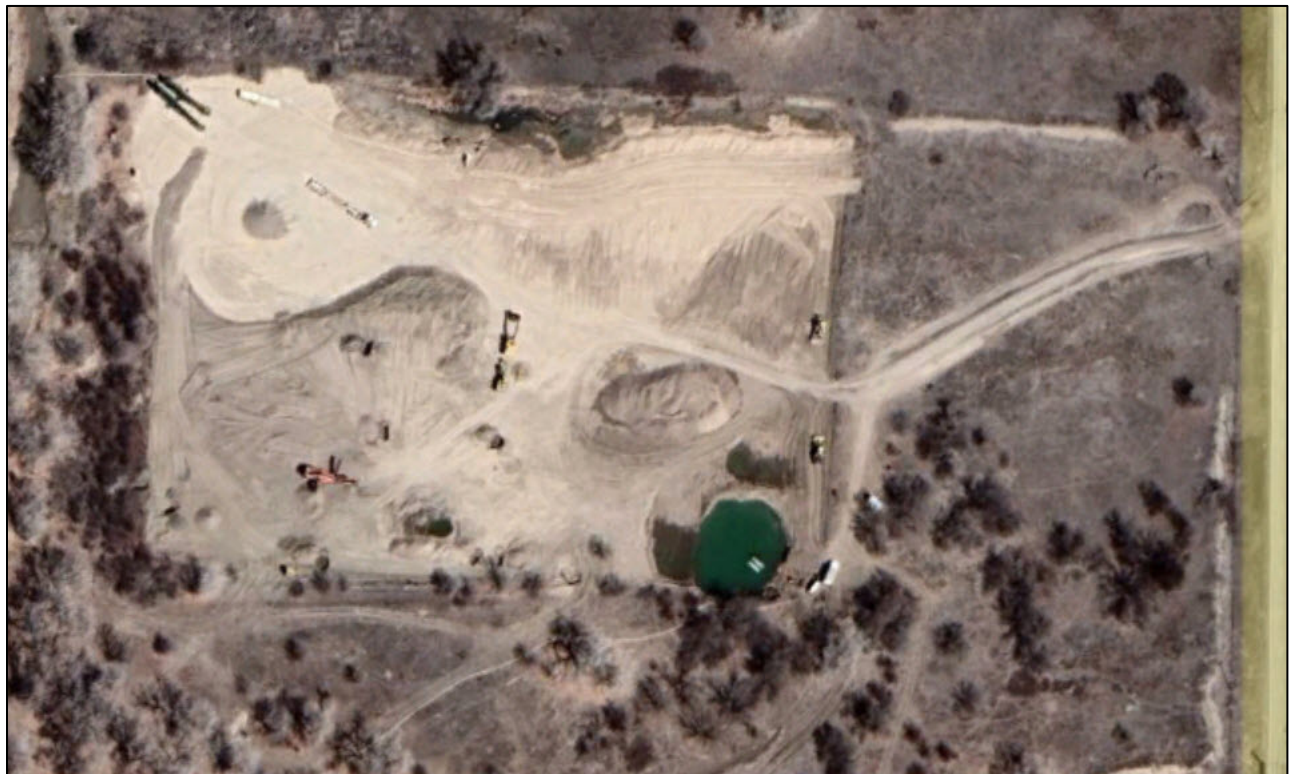
Photo 10: Google Earth Image dated from March 2021
