**MINERALS PROGRAM INSPECTION REPORT**  
**PHONE: (303) 866-3567**

<b>MINE NAME:</b> Benton Dawson Gravel	<b>MINE/PROSPECTING ID#:</b> M-1983-209	<b>MINERAL:</b> Sand and gravel	<b>COUNTY:</b> Delta
<b>INSPECTION TYPE:</b> Monitoring	<b>INSPECTOR(S):</b> Robert Zuber, P.E.	<b>INSP. DATE:</b> October 21, 2021	<b>INSP. TIME:</b> 11:40
<b>OPERATOR:</b> Frank Gilmore	<b>OPERATOR REPRESENTATIVE:</b> Frank Gilmore	<b>TYPE OF OPERATION:</b> 110c - Construction Limited Impact

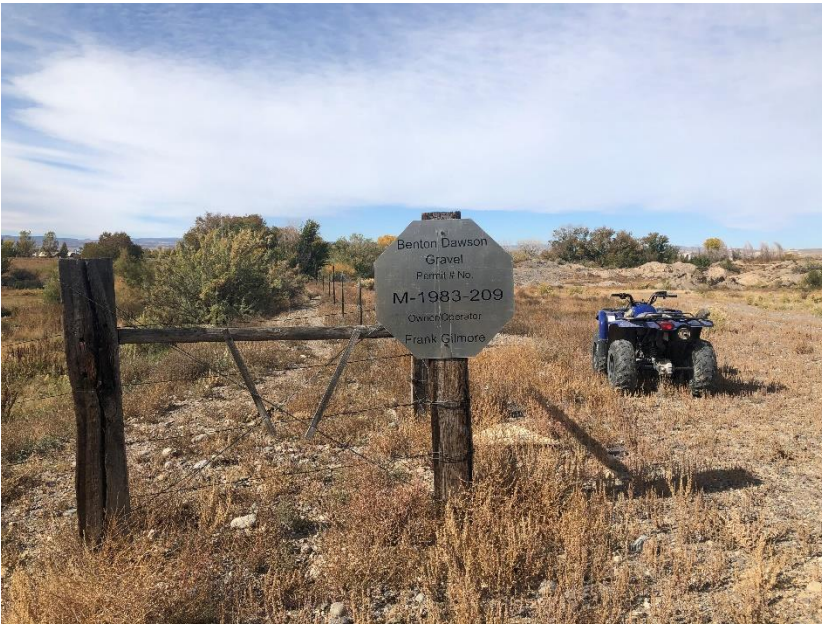
The entrance sign and boundary markers (fence) were in place and in compliance.

**Entrance sign at southeast corner – contains sufficient information**

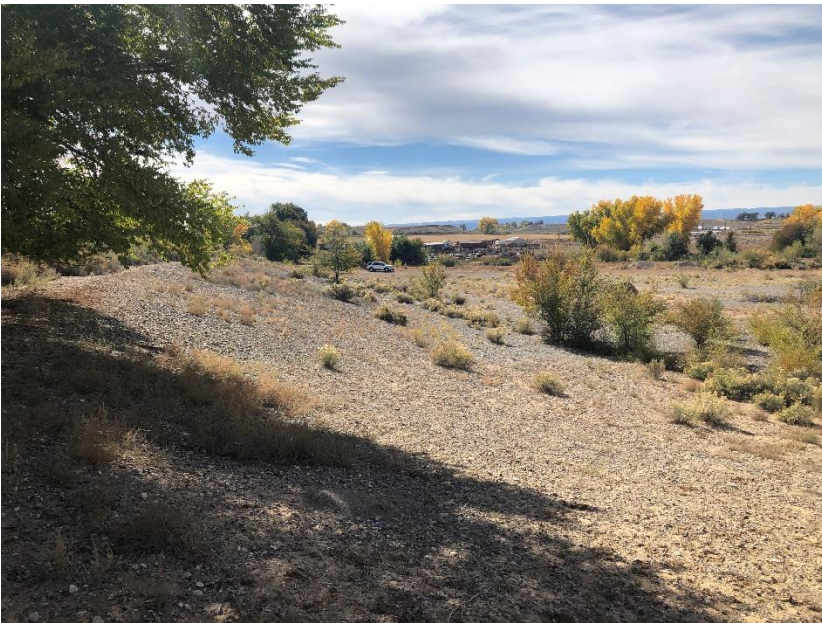
The reclaimed area near the northeast corner of the site has been graded well (approximately 3H:1V), but it still requires topsoil and vegetation. No erosion problems were seen on these slopes.

**Reclaimed slope on east side (looking south from NE corner)**

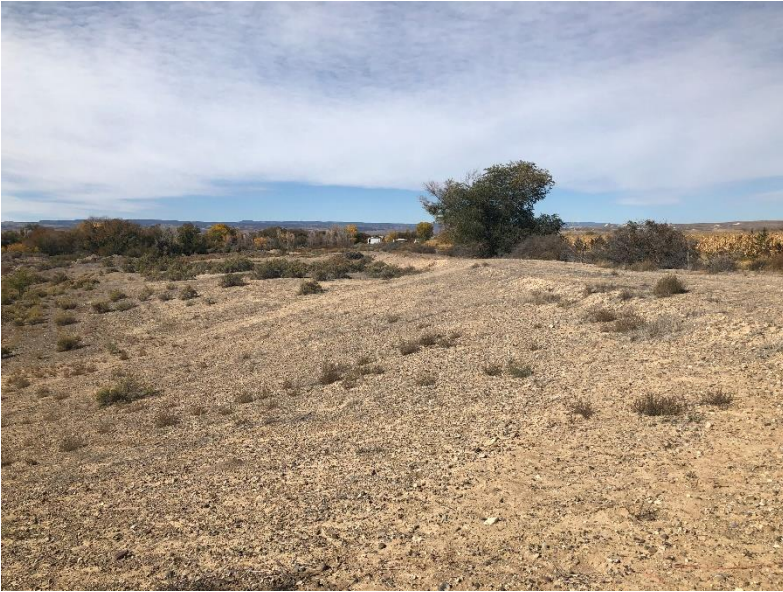
**Reclaimed slope on north side (looking west from NE corner)**

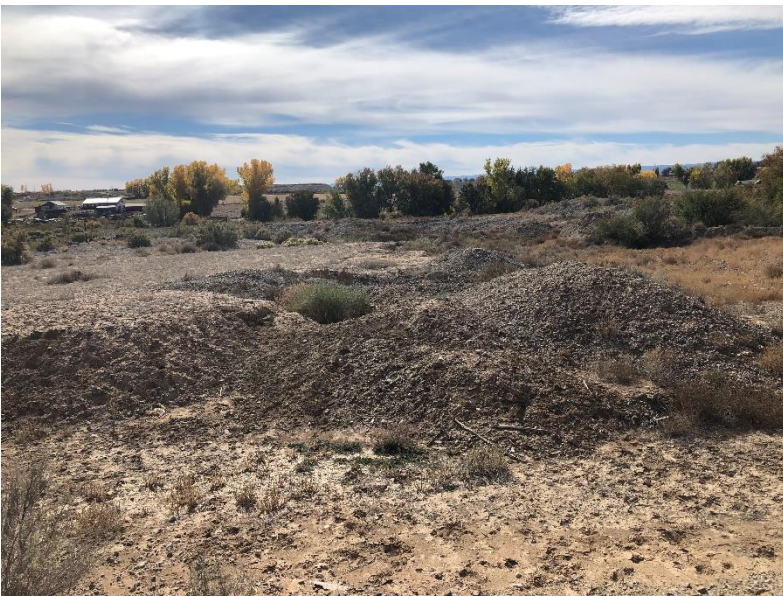
A large volume of overburden is stockpiled onsite, and the volume of material looks to be sufficient to perform final grading, although (as mentioned elsewhere in this report) the final reclamation plan needs to be clarified.

**Overburden and gravel at center of site (looking south)**

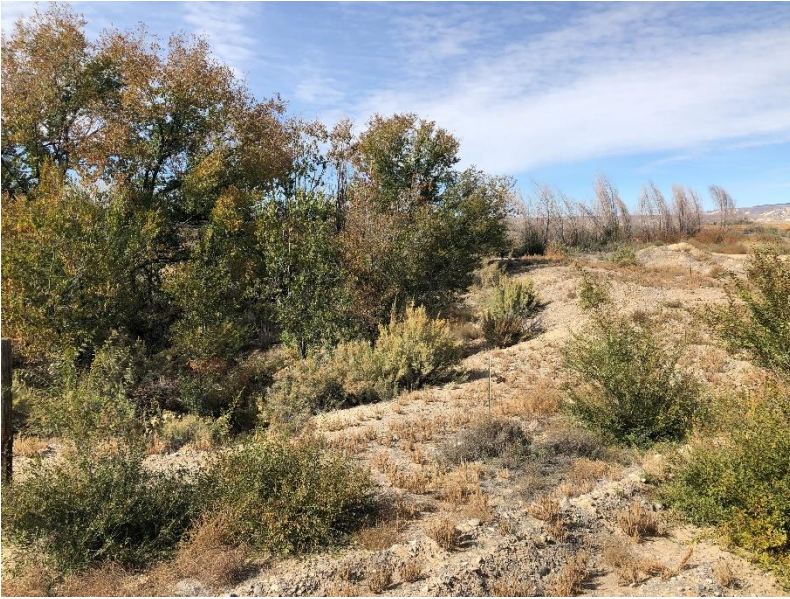
Currently, there is a pit onsite that is about 10 - 15 feet below the surrounding slopes, and there is no way for runoff to drain, other than infiltration. In past documentation for Technical Revision 2 (TR-02 approved in 2006) there is text indicating that after reclamation the entire site will drain to the central area and runoff will exit the site. However, the Reclamation Plan Map does not adequately show this plan for drainage. The operator needs to submit another Technical Revision updating the Reclamation Plan Map, and this map must clearly indicate:

**Area where Frank Gilmore indicated that reclaimed site will drain  
(live trees are off site and approximately 20 feet from the boundary)**

- The final topography of the site after reclamation
- The direction of runoff flow, shown with arrows
- Any structures that need to be added, such as culverts.

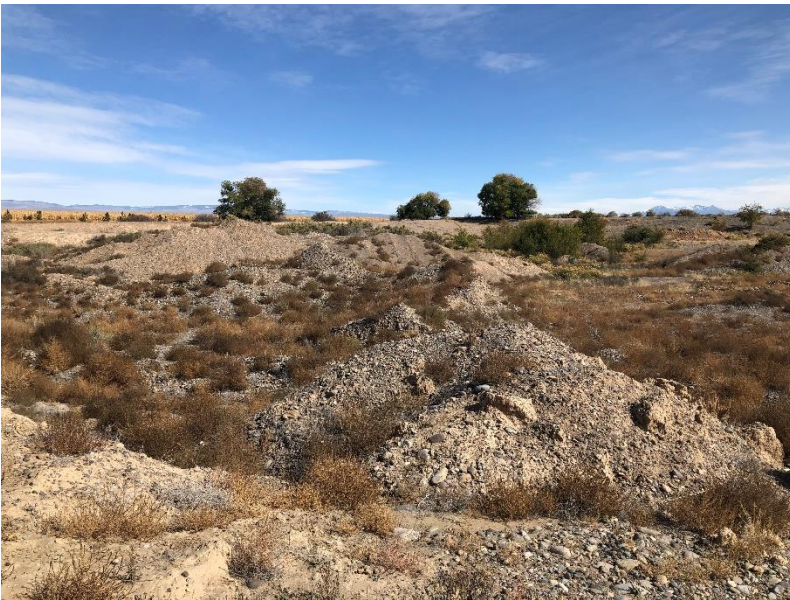
**Low area in center of site**
