MINERALS PROGRAM INSPECTION REPORT
PHONE: (303) 866-3567

MINE NAME: Golden Mine	MINE/PROSPECTING ID#: M-1976-007-UG	MINERAL: Clay (general)	COUNTY: Jefferson
INSPECTION TYPE: Preoperation Inspection	INSPECTOR(S): Eric Scott	INSP. DATE: October 26, 2021	INSP. TIME: 13:00
OPERATOR: The Denver Brick Company	OPERATOR REPRESENTATIVE: Jason McGraw	TYPE OF OPERATION: 112c - Construction Regular Operation	
REASON FOR INSPECTION: CN1 Preoperation Inspection	BOND CALCULATION TYPE: None	BOND AMOUNT: \$24,400.00	
DATE OF COMPLAINT: NA	POST INSP. CONTACTS: None	JOINT INSP. AGENCY: County	
WEATHER: Clear	INSPECTOR'S SIGNATURE:

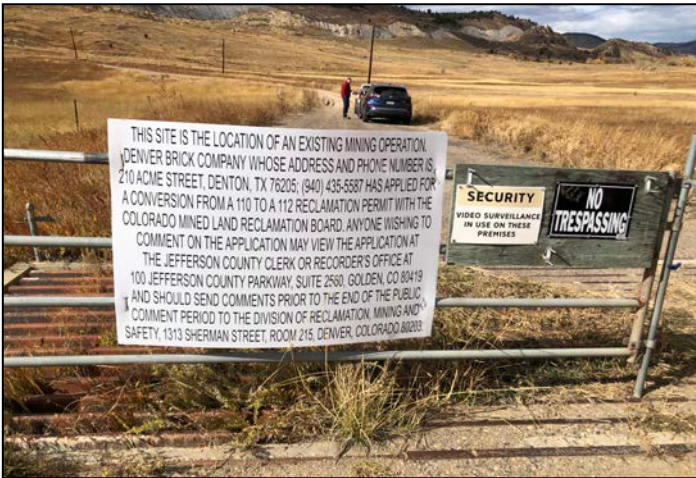
Photo 1 – “Notice of Conversion Applied For” sign at entrance from Hwy 93.

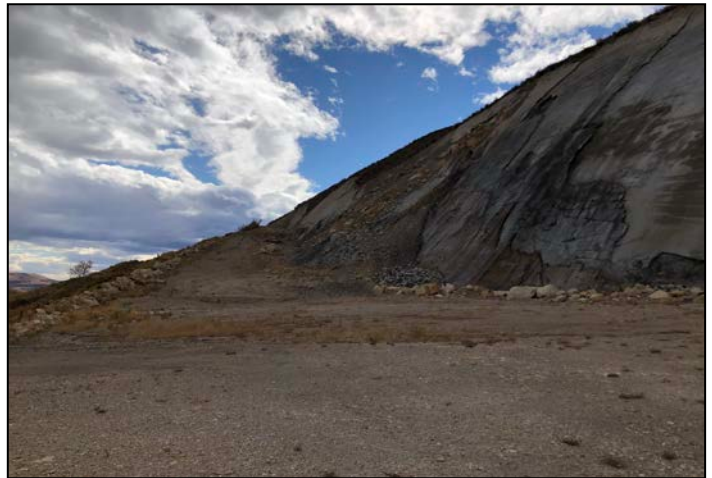
It was noted that the proposed permit boundary, including access roads, was clearly marked by T-posts with white PVC pipe placed over them. The group parked at the base of the working face of the existing permit and conducted the remainder of the inspection by foot. There was no mining activity taking place during the inspection, and no mining equipment present on site (photo 2). The product stockpile that was present during the previous DRMS site inspection had been removed. This type of clay mining operation only conducts mining activity as needed, as little as several weeks a year, to produce a product (clay) stockpile from which material is removed and utilized on an as-needed basis.

Photo 2 – Existing working face and stockpile area of current permit.

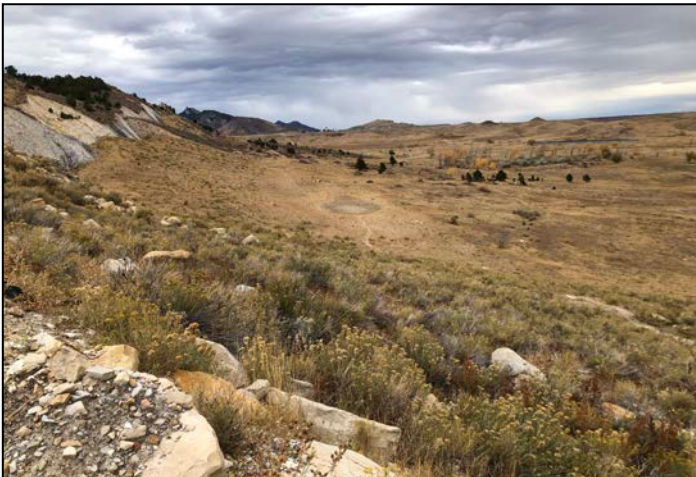
The State Land Board supports the increase in permitted area. They wish to see the “pre-law” historically mined/disturbed area of the property ultimately reclaimed to the same standard as the recently released site immediately to the north (photo 3). This would also eliminate the hazards posed by some historic mining features currently present on the property but outside of the existing 110c permit (photo 4). The DRMS Inactive Mines Program (IMP) has secured several historic mining features within the proposed permit to attempt to prevent unauthorized access. If CN1 is approved, these historic features will be mined through and reclaimed.

Photo 3 – Note difference in appearance between recently reclaimed area (previously the Flintlock Mine) at top of photo and existing historic mining disturbance at bottom of photo.

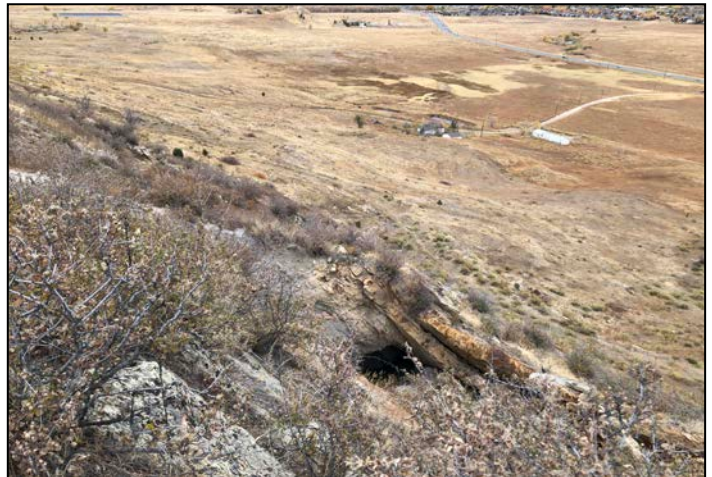
Photo 4 – Example of historic feature currently outside of existing permit that would be mined through and reclaimed if permit is expanded.
