COLORADO
Division of Reclamation,
Mining and Safety
Department of Natural Resources

Permit Number: C-1981-041 Mine Name: Roadside Portals Operator: Snowcap Coal Company, Inc. Operator Address: MS Tonya Hammond P.O. Box 1430 Palisade, CO 81526	County: Mesa Operation Type: Underground Permit Status: Active Ownership: Private
	Operator Representative Present: Tonya Hammond
Operator Representative Signature: (Field Issuance Only)

Inspection Start Date: November 1, 2021 Inspection Start Time: 09:00 Inspection End Date: November 1, 2021 Inspection End Time: 10:30		Inspection Type: Coal Complete Inspection Inspection Reason: Normal I&E Program Weather: Clear	
Joint Inspection Agency: None		Joint Inspection Contacts: None	
Post Inspection Agency: None		Post Inspection Contacts: None	
Inspector(s): Clayton Wein	Inspector's Signature: <i>Clayton Wein</i>		Signature Date: 11/5/2021

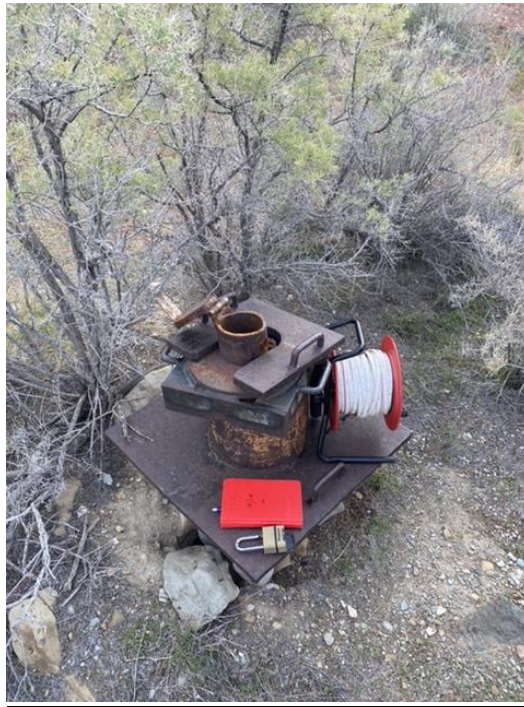
During the inspection the water level at the N1 Well was recorded (Photo 1). The depth to the water was 75.38 feet. The well cap is locked by SCC to prevent tampering. The well casing and cap was in good condition. No blockages in the well were observed.

Photo 1: The N1 Well.

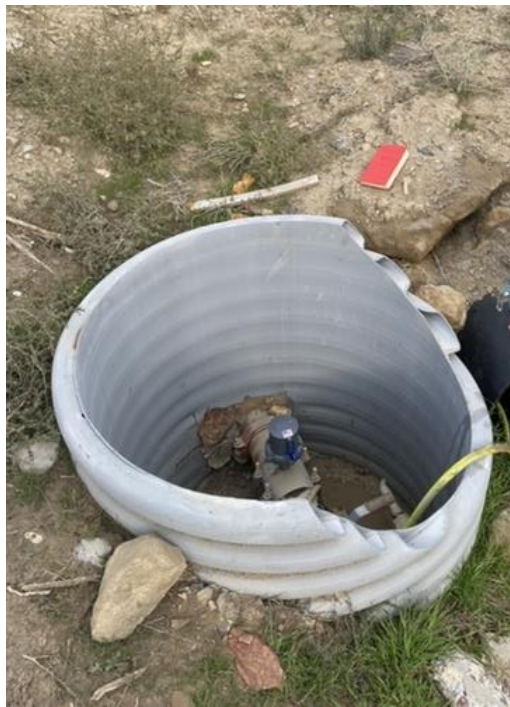
The monthly NPDES samples at the 016 discharge point were collected during the inspection (Photo 2). The instantaneous flow reading was 113 gpm. The temperature was 19 degrees C with a conductivity of 2000 US Units. The PH of the water was 7.08. The discharge point is located in the northeast portion of the permit boundary near Interstate 70. The discharge point's cap is locked by SCC for the same reason as the N1 Well. The meter for 016 is still giving fluctuating readings for the flow. SCC plans to conduct maintenance later this month to replace the section of 6 inch pipe to increase the length of the 6 inch pipe from the connection to the upstream 8 inch pipe. This should allow for the water in the pipe to flow smoothly by the time it reaches the meter.

Photo 2: The 016 discharge point.

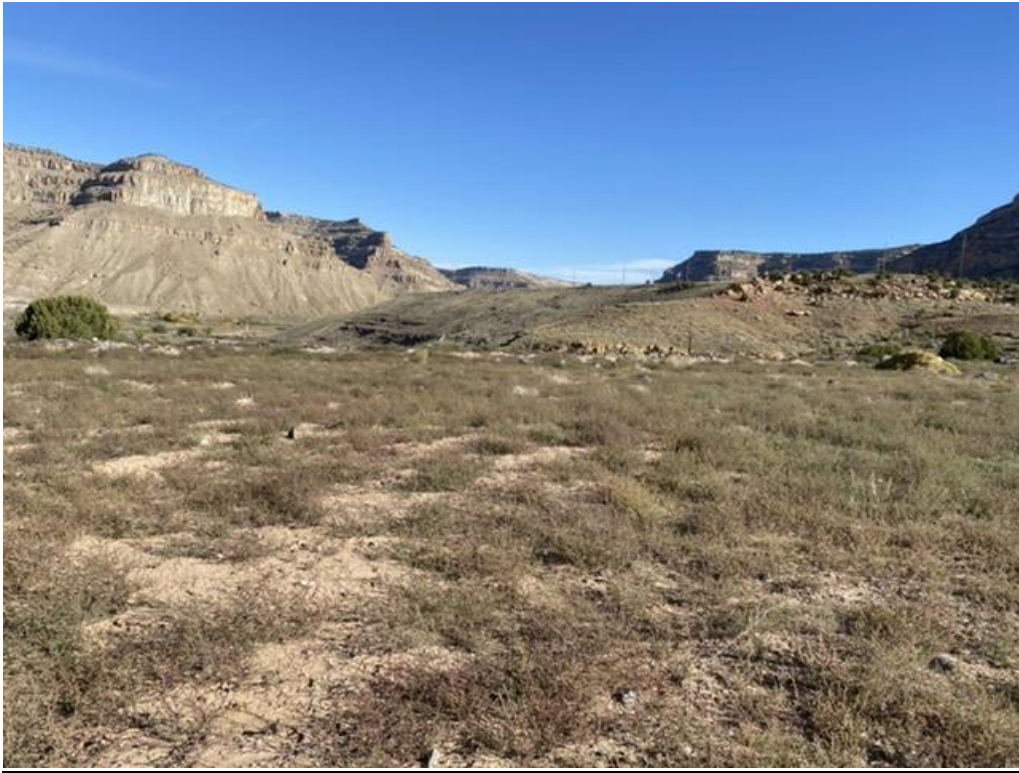
conducted for TR-69. The site was marked by a mine identification sign and numerous t-posts delineating the boundry of the disturbance. There were sediment logs in place along the down gradient portions of the area to prevent off site impacts of runoff. The sediment logs were in good condition and no off site impacts were observed. The site was stable with vegetative cover (Photo 3). There were no indications of erosional features. There were no observed signs of surface settling at the site.

Photo 3: The TR-69 Repair area looking to the north/northeast.
