**COLORADO**  
Division of Reclamation,  
Mining and Safety  
Department of Natural Resources

<b>Permit Number:</b> C-1980-004 <b>Mine Name:</b> McClane Canyon Mine <b>Operator:</b> ARC McClane Canyon, LLC <b>Operator Address:</b> Jim E Stover 2352 N 7th Street, Unit C Grand Junction , CO 81501	<b>County:</b> Garfield <b>Operation Type:</b> Underground <b>Permit Status:</b> Temporary Cessation <b>Ownership:</b> Private
	<b>Operator Representative Present:</b>  Chuck Selingo
<b>Operator Representative Signature:</b> (Field Issuance Only)

<b>Inspection Start Date:</b> October 29, 2021 <b>Inspection Start Time:</b> 10:05 <b>Inspection End Date:</b> October 29, 2021 <b>Inspection End Time:</b> 10:50		<b>Inspection Type:</b> Coal Complete Inspection <b>Inspection Reason:</b> Normal I&E Program <b>Weather:</b> Clear	
<b>Joint Inspection Agency:</b>  None		<b>Joint Inspection Contacts:</b>  None	
<b>Post Inspection Agency:</b>  None		<b>Post Inspection Contacts:</b>  None	
<b>Inspector(s):</b>  Clayton Wein	<b>Inspector's Signature:</b>  <i>Clayton Wein</i>		<b>Signature Date:</b>  11/5/2021

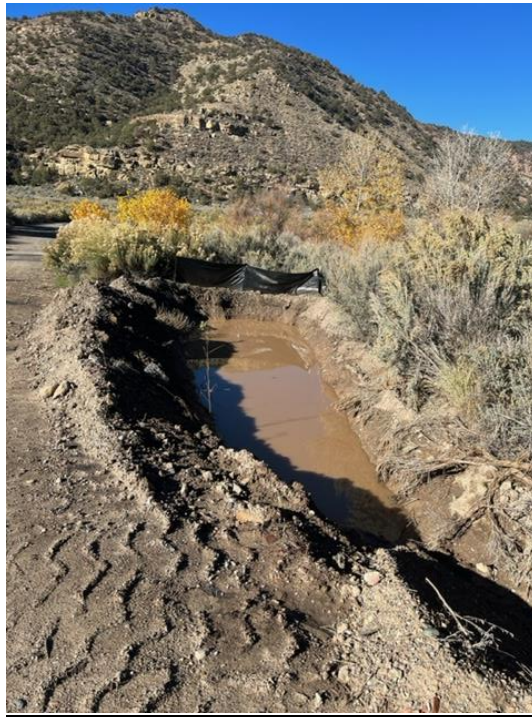
Two sumps are located at the west end of the office pad. There is one sump on the north side of the haul road (Photo 1) and one on the south side. Both sumps were holding water during the inspection. There was no discharge to East Salt Creek. The silt fences for the sumps were in good condition. There were no off site impacts observed.

**Photo 1:** The north office pad sump.

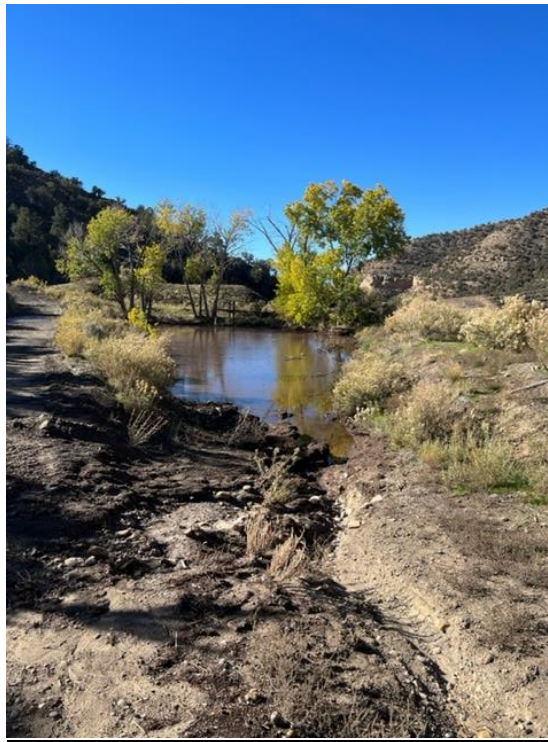
The Sediment pond was impounding water at the time of the inspection (Photo 2). The level of water impounded in the pond had not reached the primary spillway. The embankment was stable with vegetative cover. There were no erosional features observed. The pond has filled with sediment from recent precipitation events. Cleaning may be required when conditions allow.

**Photo 2:** The Sediment Pond.

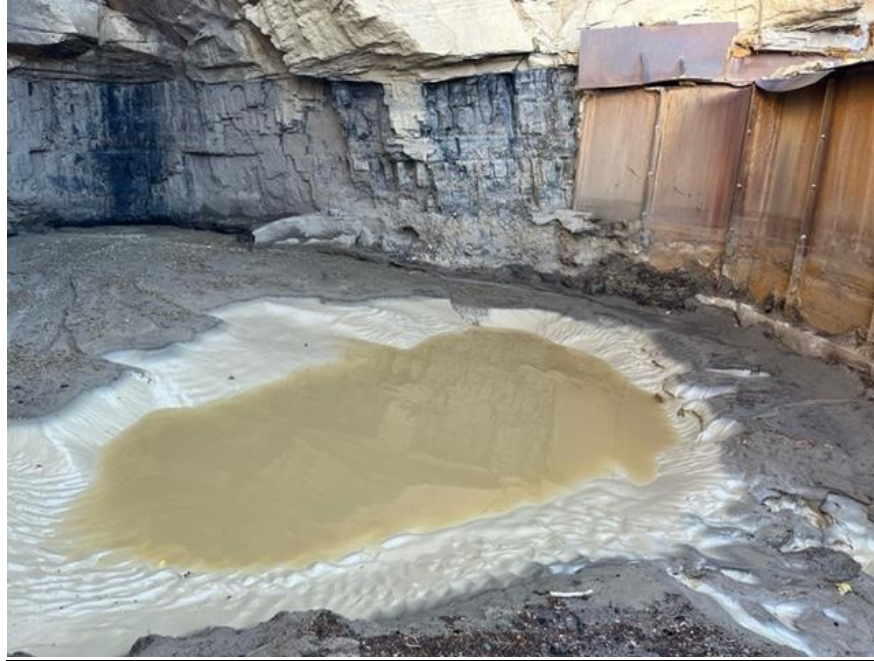
Two sumps are located at the top of the portals bench. One is located on the East side and the other is located on the north side. The East Sump has filled with sediment again (Photo 3). This area receives water from acreages that have been burned in a forest fire. There is no vegetation left in this area and every precipitation event deposits sediment into this sump. The sump is planned to be cleaned out as soon as equipment can be brought in. The sump was completely full, similar to the conditions observed during the Division's September 2021 inspection. The North sump was holding water with no discharge occurring. This sump receives water from areas not burned by a forest fire. Therefore the sump has plenty of capacity left. The Discharge outlet was unobstructed.

**Photo 3:** The eastern sump at the portals bench.

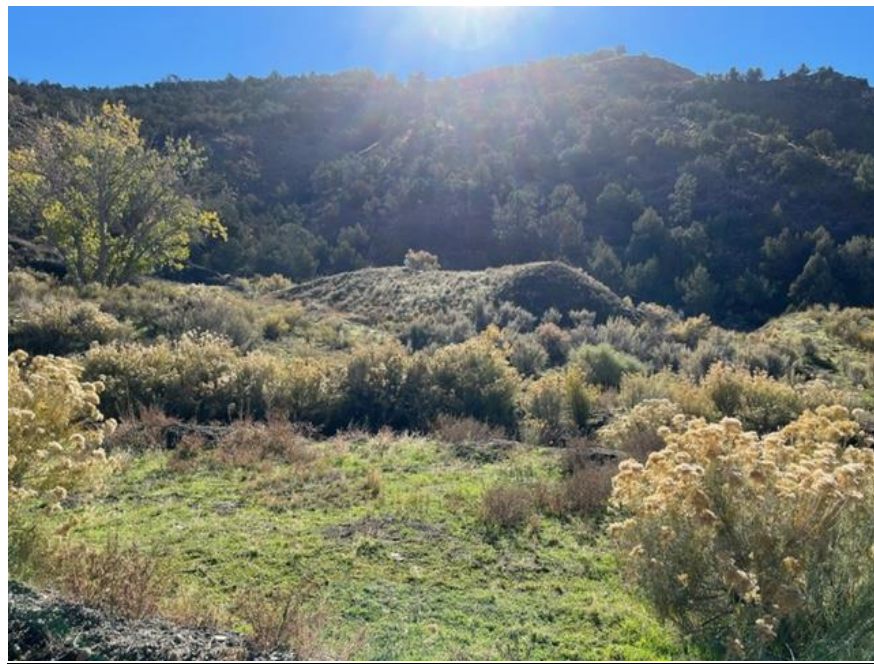
The topsoil pile was stable with vegetative cover (Photo 4). There were no erosional concerns noted. The topsoil marker was placed in a clear location on top of the pile. The perimeter berm was vegetated and stable. No loss of topsoil resources was observed.

**Photo 4:** The topsoil pile.
