MINERALS PROGRAM INSPECTION REPORT
PHONE: (303) 866-3567

MINE NAME: Klement Pit	MINE/PROSPECTING ID#: M-2007-076	MINERAL: Gravel and sand	COUNTY: Cheyenne
INSPECTION TYPE: Monitoring	INSPECTOR(S): Eric Scott	INSP. DATE: November 4, 2021	INSP. TIME: 13:30
OPERATOR: Cheyenne County	OPERATOR REPRESENTATIVE: Jim Brown	TYPE OF OPERATION: 110c - Construction Limited Impact	
REASON FOR INSPECTION: Normal I&E Program	BOND CALCULATION TYPE: Complete Bond	BOND AMOUNT: \$0.00	
DATE OF COMPLAINT: NA	POST INSP. CONTACTS: None	JOINT INSP. AGENCY: None	
WEATHER: Clear	INSPECTOR'S SIGNATURE:

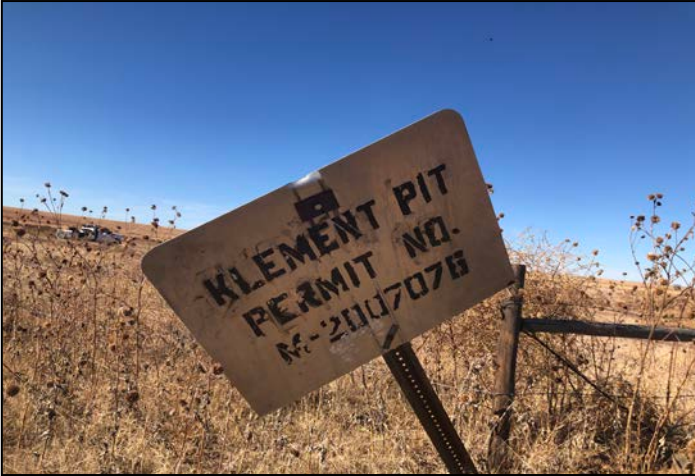
Photo 1 – Site identification sign at site entrance.

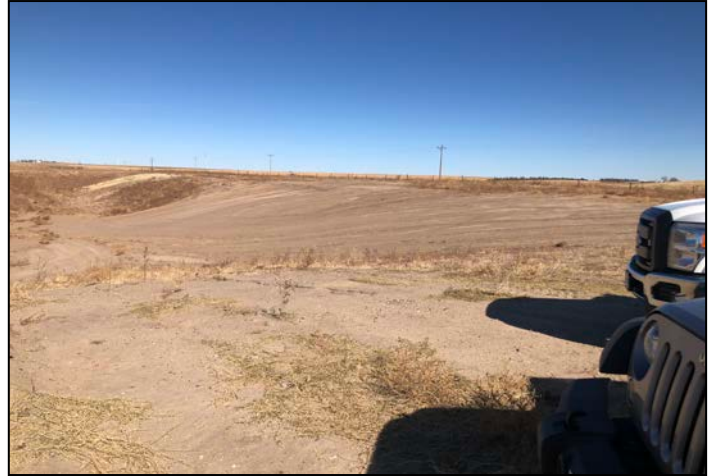
The site appears to have been mined north to south in a rather deep and narrow trench configuration. This resulted in long, steep slopes on the east and west sidePhoto 1s of the excavation, which will require re-sloping to a final grade no steeper than 3:1 H:V as required by the approved reclamation plan. The slopes of the north and south ends of the excavation appear to be near 3:1 at this time. During this inspection, a road-grader was present on-site and had recently begun working to push the east and west sides of the mined area down to the required 3:1 H:V slopes. Work was proceeding from the south end of the pit, moving to the north. DRMS discussed possible final reclamation options with the County. Mr. Brown stated that when the proper final slopes had been achieved, the site would be revegetated with the approved seed mix.

Photo 2 – South end of pit looking north at east side of excavated area.

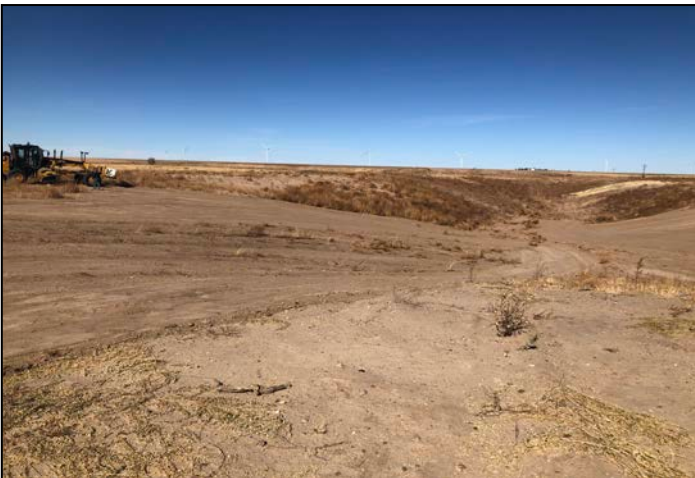
Photo 3 – South end of pit looking at west side of excavated area being pushed down by grader.
