MINERALS PROGRAM INSPECTION REPORT
PHONE: (303) 866-3567

MINE NAME: Munsch Pit	MINE/PROSPECTING ID#: M-2000-018	MINERAL: Sand and gravel	COUNTY: Cheyenne
INSPECTION TYPE: Monitoring	INSPECTOR(S): Eric Scott	INSP. DATE: November 4, 2021	INSP. TIME: 12:30
OPERATOR: Cheyenne County	OPERATOR REPRESENTATIVE: Jim Brown	TYPE OF OPERATION: 112c - Construction Regular Operation	
REASON FOR INSPECTION: Normal I&E Program	BOND CALCULATION TYPE: Complete Bond	BOND AMOUNT: \$0.00	
DATE OF COMPLAINT: NA	POST INSP. CONTACTS: None	JOINT INSP. AGENCY: None	
WEATHER: Clear	INSPECTOR'S SIGNATURE:

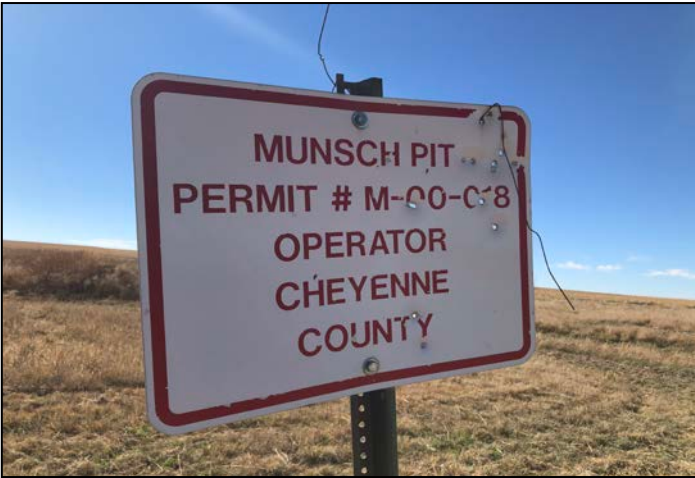
Photo 1 – Site identification sign next to County Rd M.

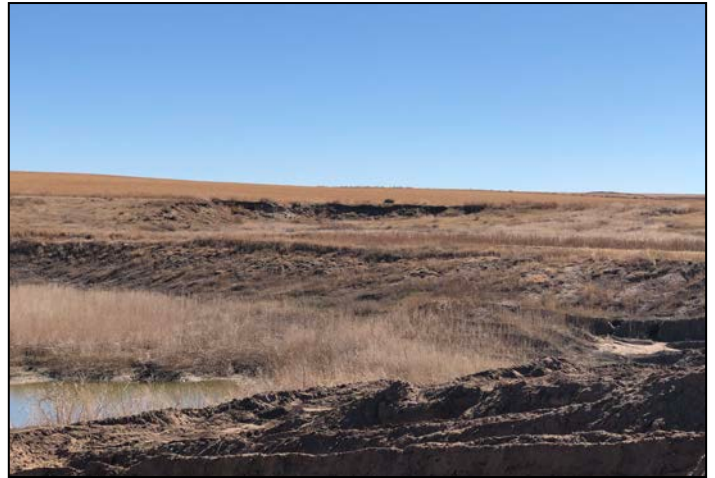
The permit identification sign was present and visible from the road, and the permit boundary was properly marked by green and white steel T-posts. Two small areas of standing water were present on-site, one on the south end near where prior flood damage had occurred, and one on the north end of the permit within the current work area. Both areas were due to storm water accumulation, and were observed to be drying out. Mr. Brown stated that a red clay layer at the base of the excavated material slowed the infiltration of precipitation from major storm events, but that these areas were normally dry.

Photo 2 – SW area of permit, looking south at where flood damage was repaired. Small area of standing storm-water in foreground of photo.

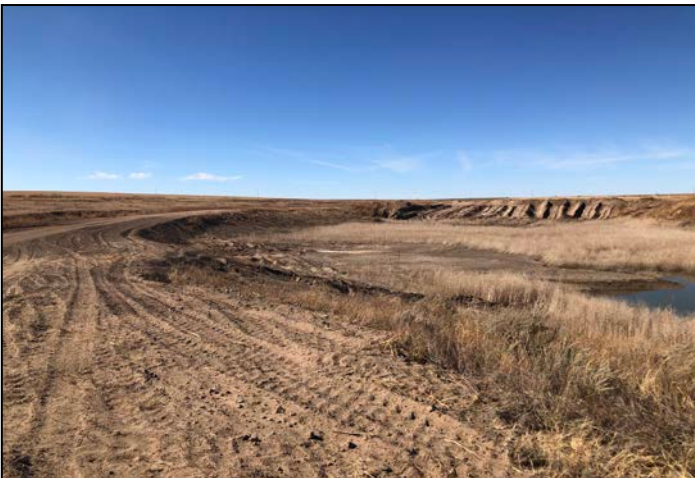
Photo 3 – SE area of permit, repaired access road looking west. Small area of standing storm-water on right side of photo.
