MINERALS PROGRAM INSPECTION REPORT
PHONE: (303) 866-3567

MINE NAME: Westhoff Pit	MINE/PROSPECTING ID#: M-1977-094	MINERAL: Sand and gravel	COUNTY: Morgan
INSPECTION TYPE: Monitoring	INSPECTOR(S): Brock Bowles	INSP. DATE: October 20, 2021	INSP. TIME: 09:00
OPERATOR: Morgan Sand & Gravel Inc	OPERATOR REPRESENTATIVE: Greg Westhoff	TYPE OF OPERATION: 112c - Construction Regular Operation	
REASON FOR INSPECTION: Normal I&E Program	BOND CALCULATION TYPE:	BOND AMOUNT: \$122,500.00	
DATE OF COMPLAINT: NA	POST INSP. CONTACTS: None	JOINT INSP. AGENCY: None	
WEATHER: Clear	INSPECTOR'S SIGNATURE:

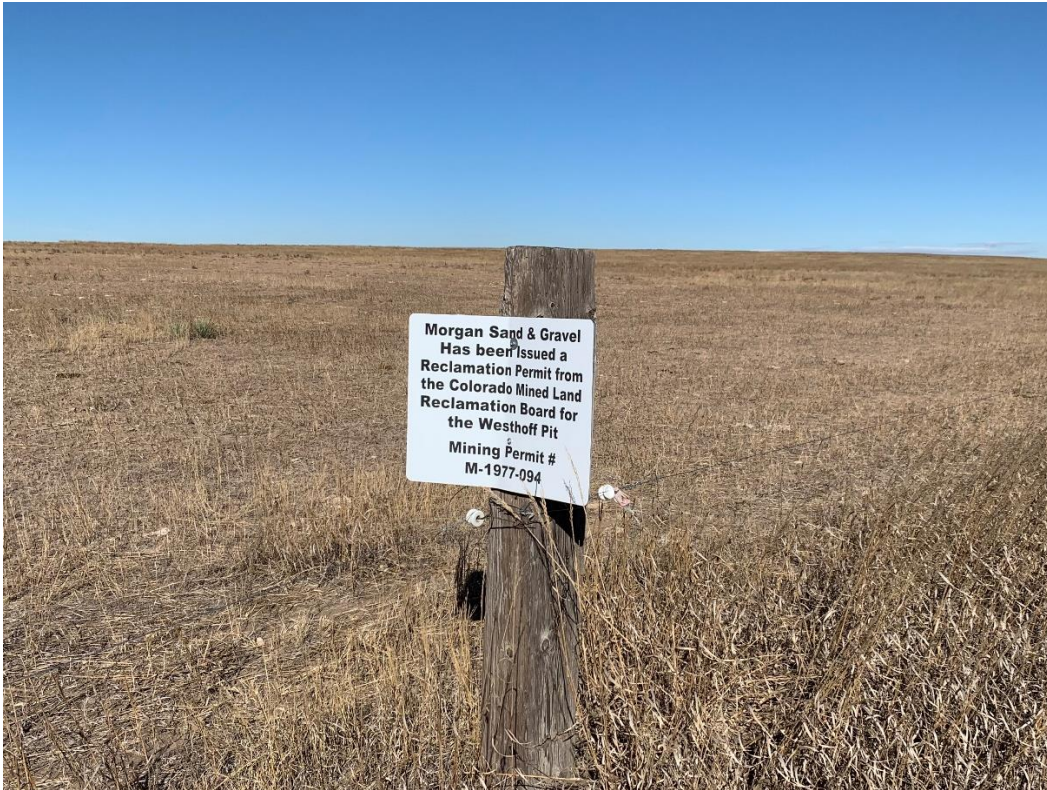
The permit entrance sign was in place (photo 1) and the permit boundary corner posts were in place (photo 2).

Photo 1 – Mine entrance sign

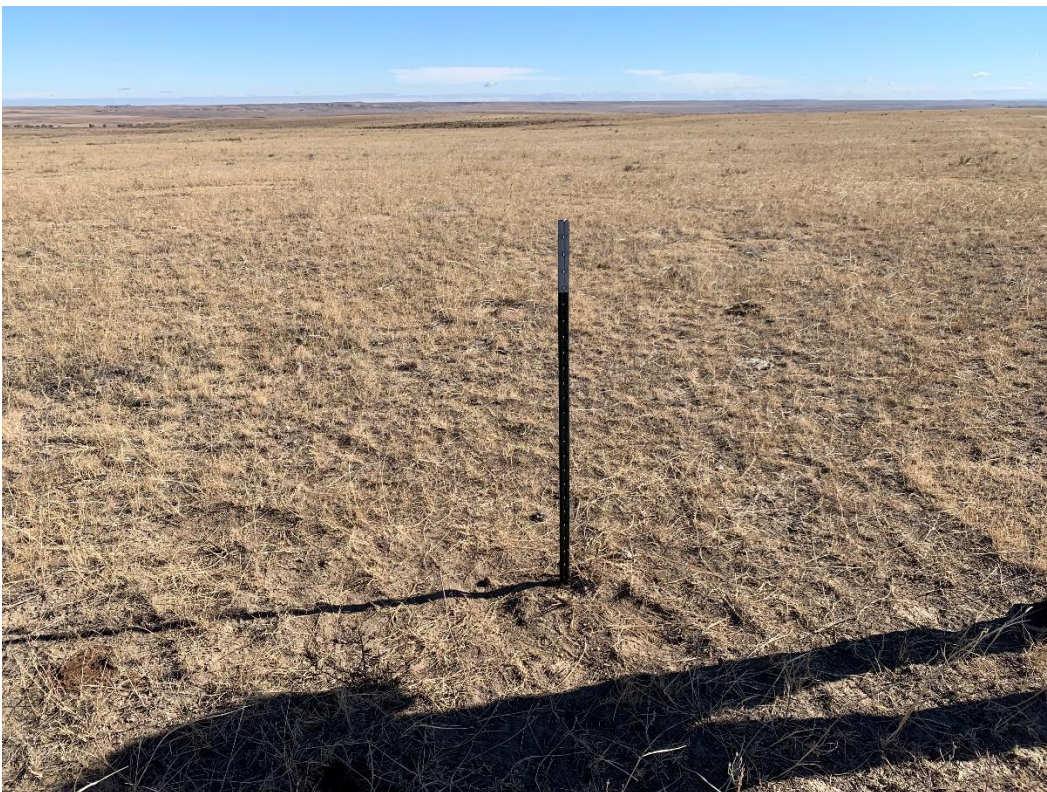
Photo 2 – NE corner marker

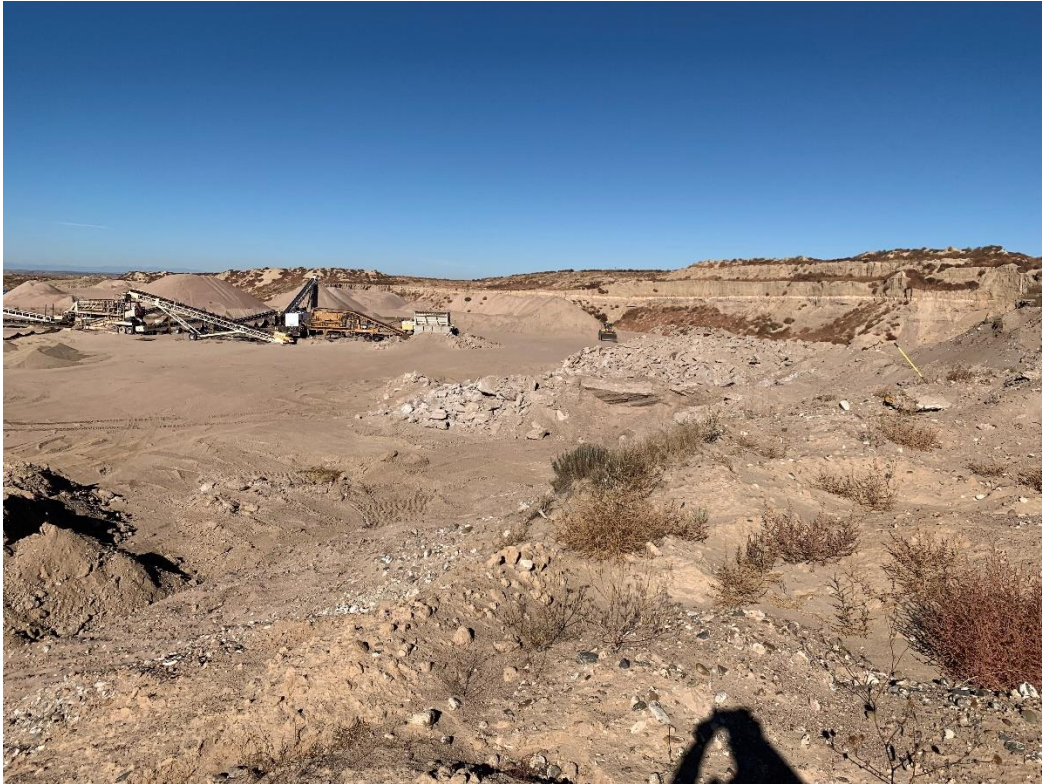
Several pieces of screening equipment, conveyors and a loader were onsite (photo 3). No mining was taking place during the inspection.

Photo 3 – Mining area, facing northwest

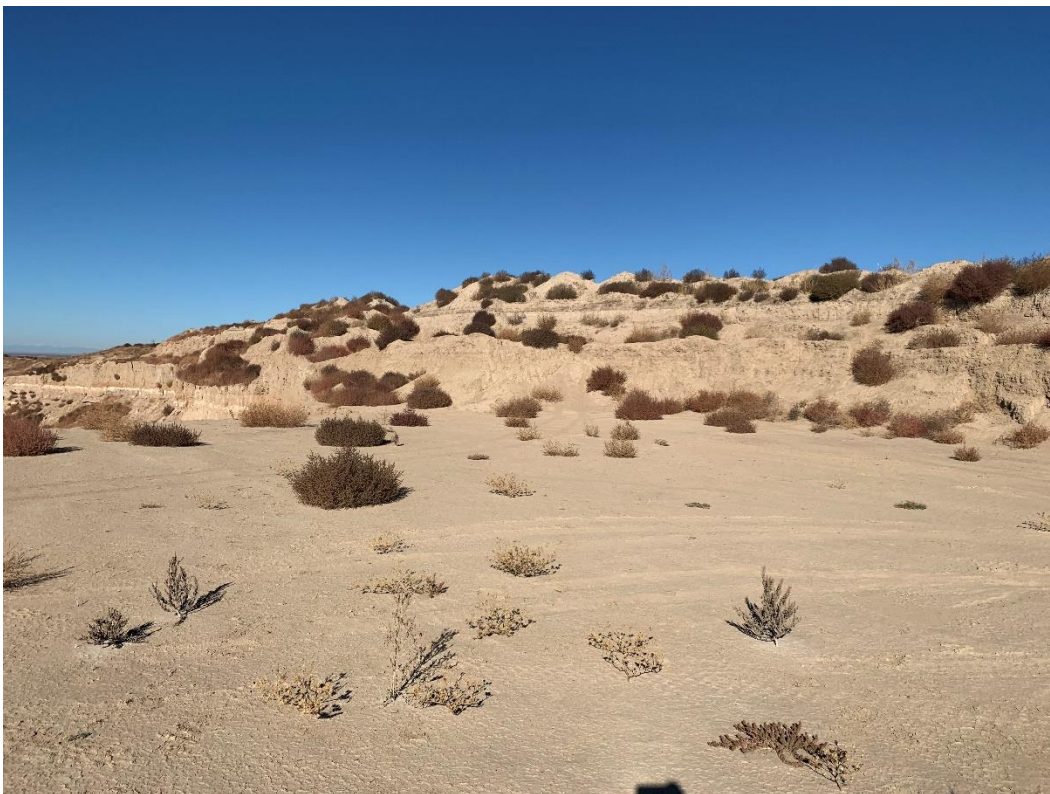
The area was being mined from west to east along the northern boundary into the phase 2 area. The topsoil and overburden had been removed from on top of the highwall (photo 4). The topsoil and overburden piles were on the west side of the mined area.

Photo 4 – Topsoil removed above highwall before mining.
