**COLORADO**  
Division of Reclamation,  
Mining and Safety  
Department of Natural Resources

<b>Permit Number:</b> C-1981-018 <b>Mine Name:</b> Deserado Mine <b>Operator:</b> Blue Mountain Energy, Inc. <b>Operator Address:</b> Mr. Kurtis Blunt 3607 County Road 65 Rangely, CO, 81648	<b>County:</b> Moffat, Rio Blanco <b>Operation Type:</b> Underground <b>Permit Status:</b> Active <b>Ownership:</b> Private
	<b>Operator Representative Present:</b>  Kurt Blunt
<b>Operator Representative Signature:</b> (Field Issuance Only)

<b>Inspection Start Date:</b> November 3, 2021 <b>Inspection Start Time:</b> 11:10 <b>Inspection End Date:</b> November 3, 2021 <b>Inspection End Time:</b> 12:50		<b>Inspection Type:</b> Coal Partial Inspection <b>Inspection Reason:</b> Normal I&E Program <b>Weather:</b> Clear	
<b>Joint Inspection Agency:</b>  None		<b>Joint Inspection Contacts:</b>  None	
<b>Post Inspection Agency:</b>  None		<b>Post Inspection Contacts:</b>  None	
<b>Inspector(s):</b>  Clayton Wein	<b>Inspector's Signature:</b>  <i>Clayton Wein</i>		<b>Signature Date:</b>  11/8/2021

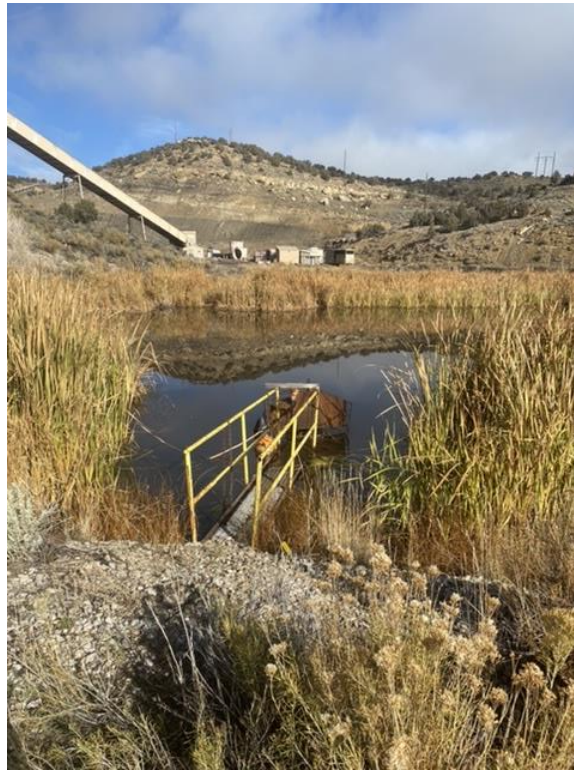
The three ponds located at the main facilities area were inspected. The DP-1 pond is located on the lower bench. The pond treats all runoff from the main facilities area. The pond was impounding water during the inspection. Discharge from the primary spillway was observed (Photo 1). The trash rack on the spillway was clear of debris and in good repair. The embankment for the pond was stable with vegetative cover. There were no indications of erosion. The PP-1 pond is located on the middle bench within the prep plant facility. The pond was holding some water. The pond had been cleaned since the previous Division inspection. The embankments were stable with no erosional features noted. There was no discharge from the pond. The PP-2 pond is located on the upper facilities bench. The pond was holding water and covered with algae. The outlet for the pond was unobstructed, with no discharge. The embankment was vegetated and stable. There were no erosional features identified.

**Photo 1:** The outlet of the DP-1 Pond.

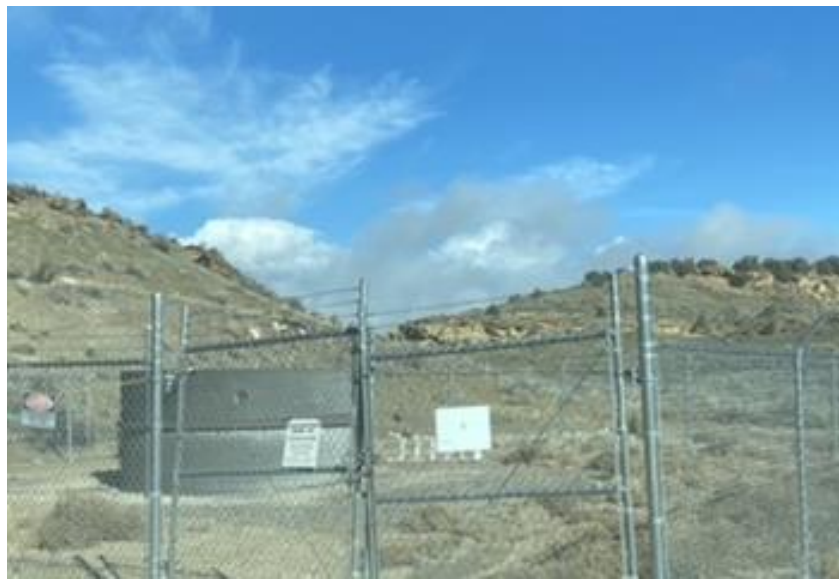
Support facilities inspected included; Explosives Storage, Main Facilities Area, B Seam Vent Shaft No. 1 (Photo 2), Rock Dust Tank No. 2, N12-53 Pad, LWB15-2 Pad, Slot Storage, Nitrogen Plant No. 2 and the Conveyor Corridor. Pads for the support facilities inspected were stable with no erosional concerns. Pads with cut and fill slopes were stable with no indications of sloughing. Berms on the pads were vegetated and stable. No off site impacts were observed.

**Photo 2:** The B Seam Vent Shaft No. 1 pad.

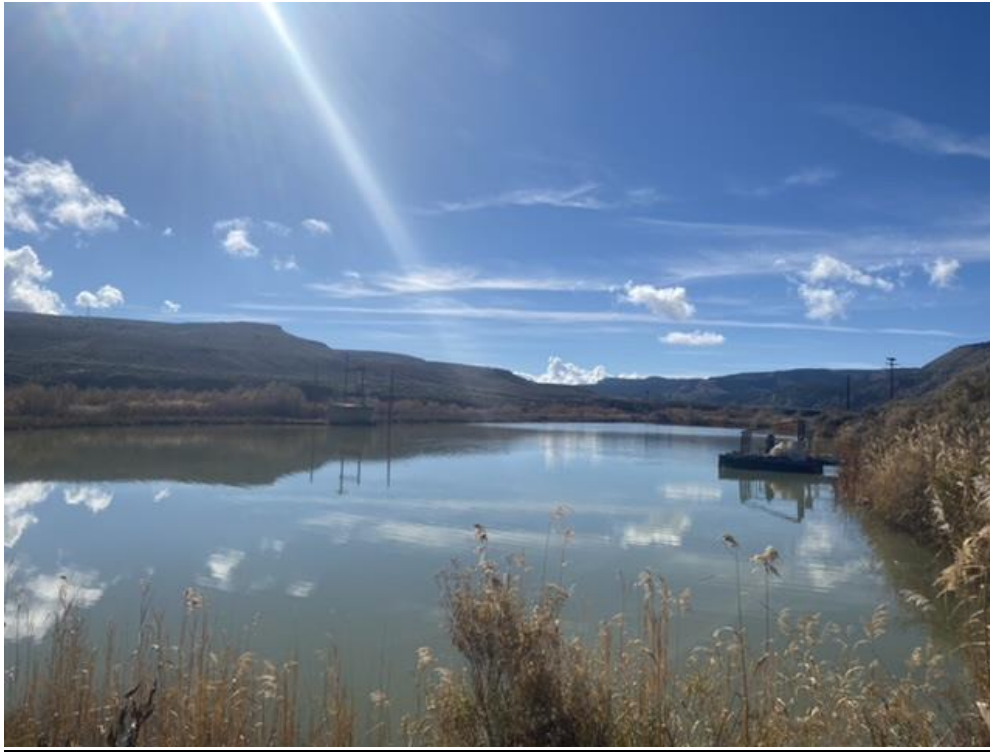
The Raw Water Lagoon is located in the southern portion of the permit boundary, just north of the White River. The lagoon was full at the time of the inspection (Photo 3). The Embankment had no indications of instability or erosion. The embankment had sufficient vegetative cover.

**Photo 3:** The Raw Water Lagoon Looking to the west.
