MINERALS PROGRAM INSPECTION REPORT
PHONE: (303) 866-3567

MINE NAME: Pheasant Run Gravel Pit	MINE/PROSPECTING ID#: M-2007-069	MINERAL: Gravel, sand borrow	COUNTY: Pueblo
INSPECTION TYPE: Monitoring	INSPECTOR(S): Patrick Lennberg	INSP. DATE: November 2, 2021	INSP. TIME: 08:00
OPERATOR: Tony J. Beltramo and Sons, Inc.	OPERATOR REPRESENTATIVE: None	TYPE OF OPERATION: 112c - Construction Regular Operation	
REASON FOR INSPECTION: Normal I&E Program	BOND CALCULATION TYPE: Complete Bond	BOND AMOUNT: \$74,895.00	
DATE OF COMPLAINT: NA	POST INSP. CONTACTS: None	JOINT INSP. AGENCY: None	
WEATHER: Cloudy	INSPECTOR'S SIGNATURE:

SIGNATURE DATE: November 9, 2021

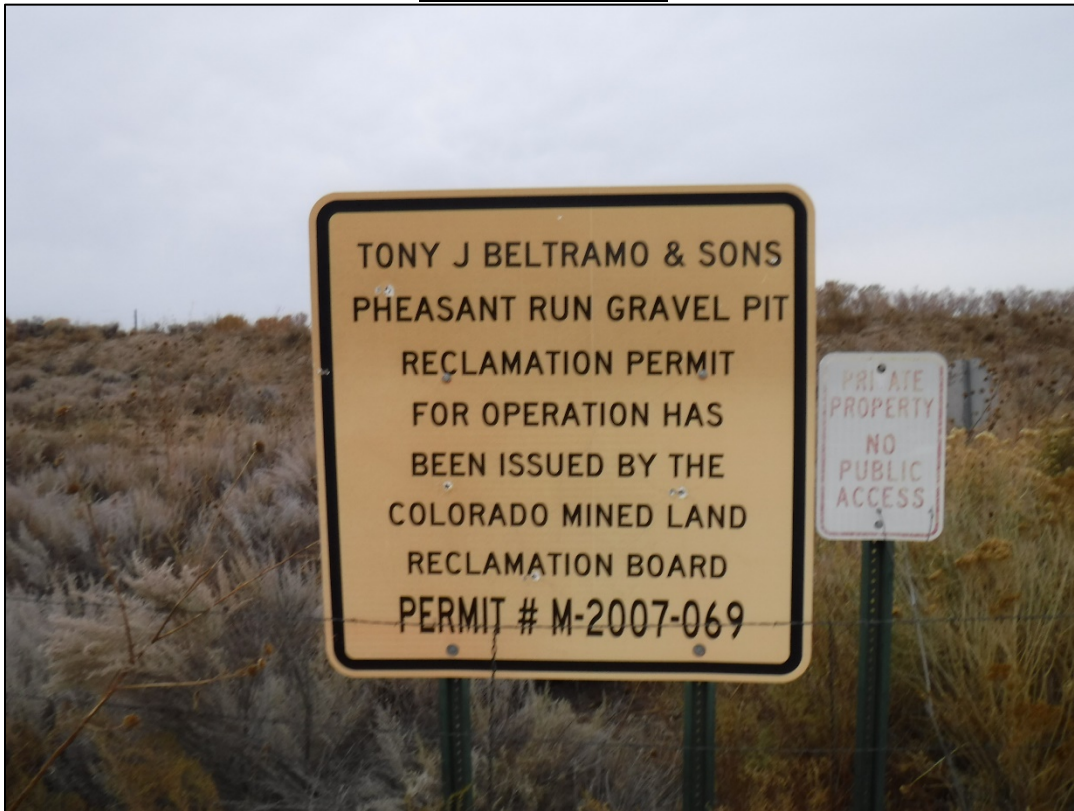
Photo 1: Mine sign at mine entrance location

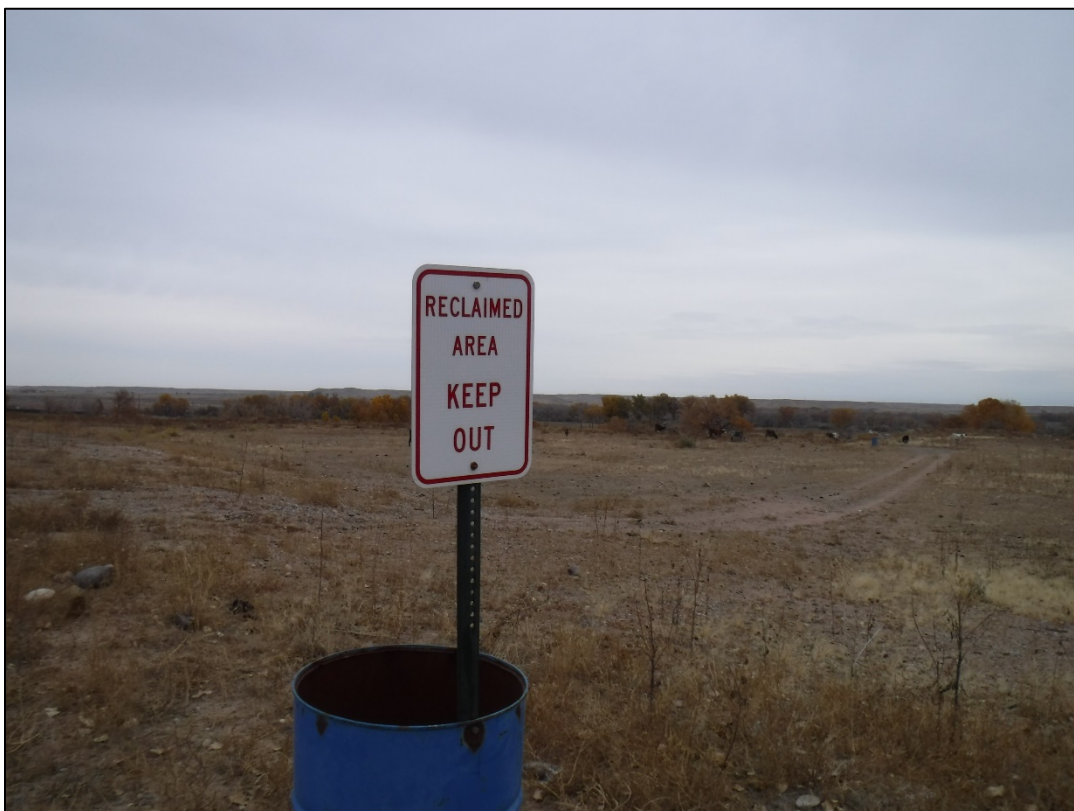
Photo 2: Reclamation sign near the 12 acres of reclaimed permit area

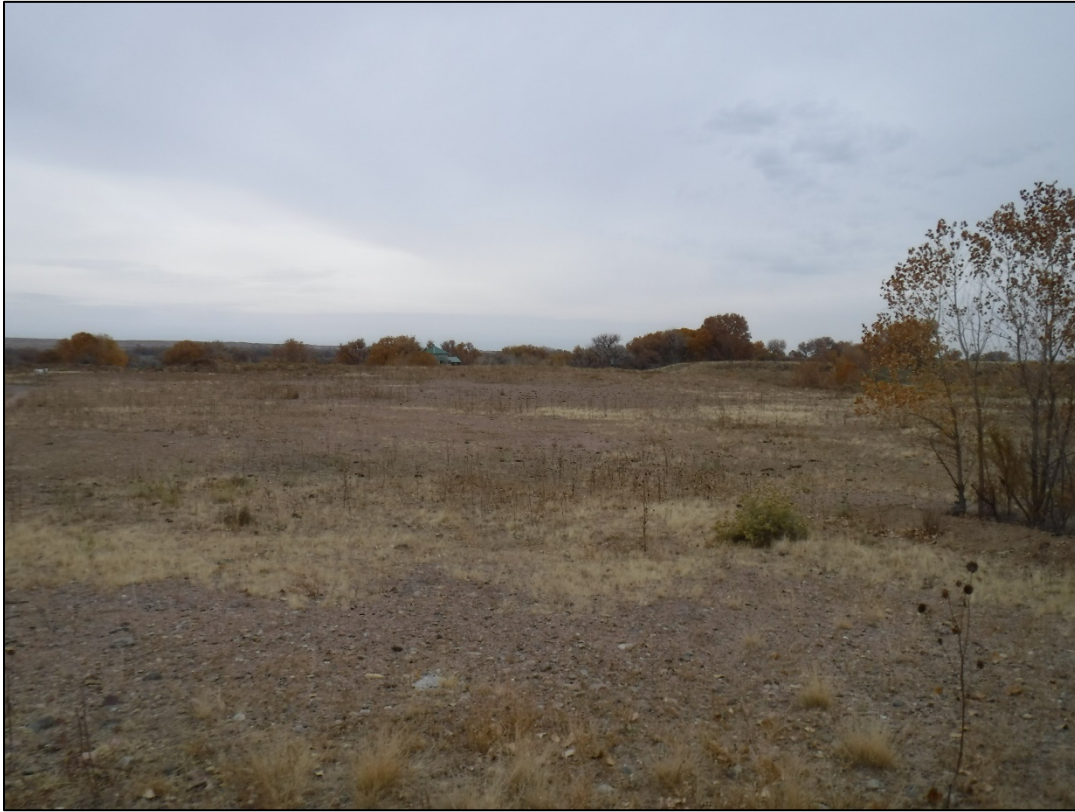
Photo 3: Vegetation establishing in reclaimed area

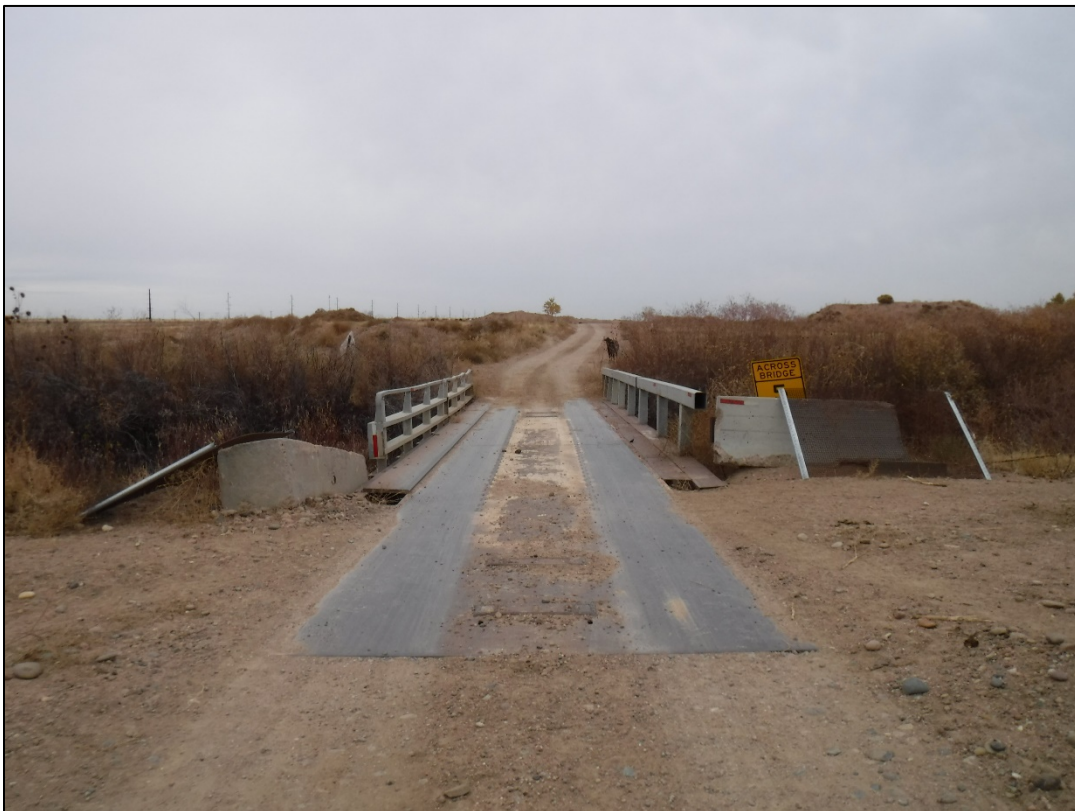
Photo 4: Bridge across High Line Canal

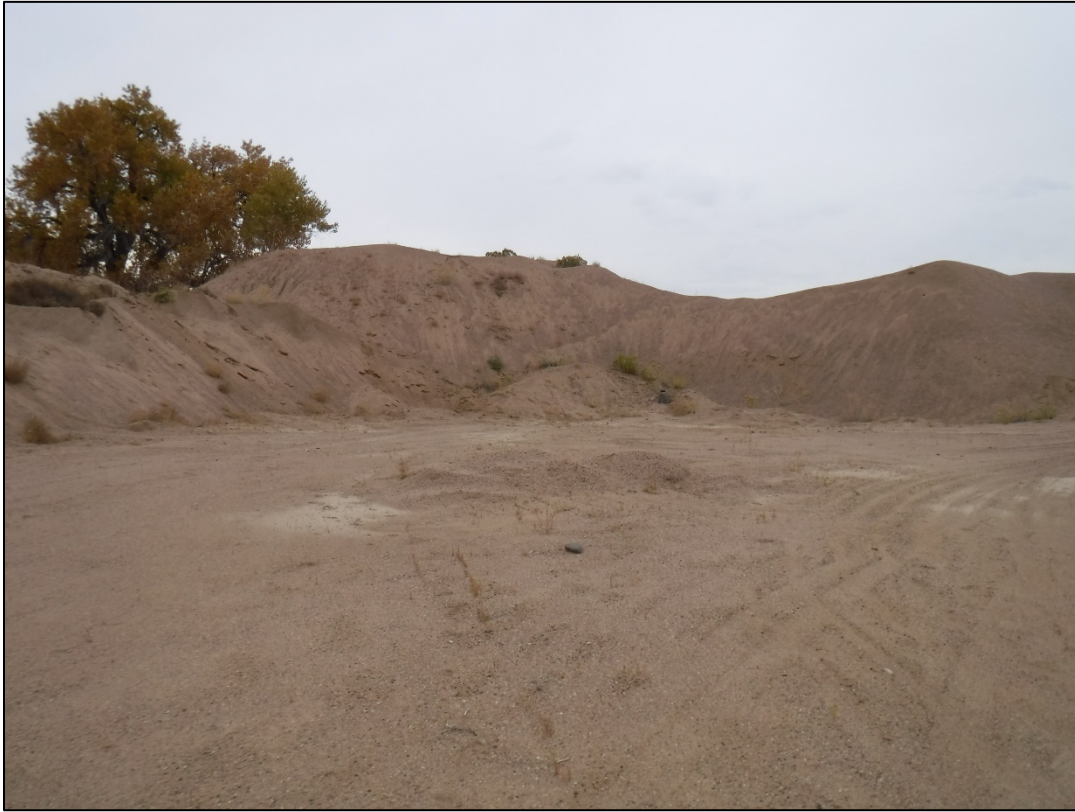
Photo 5: Northeast corner of pit area

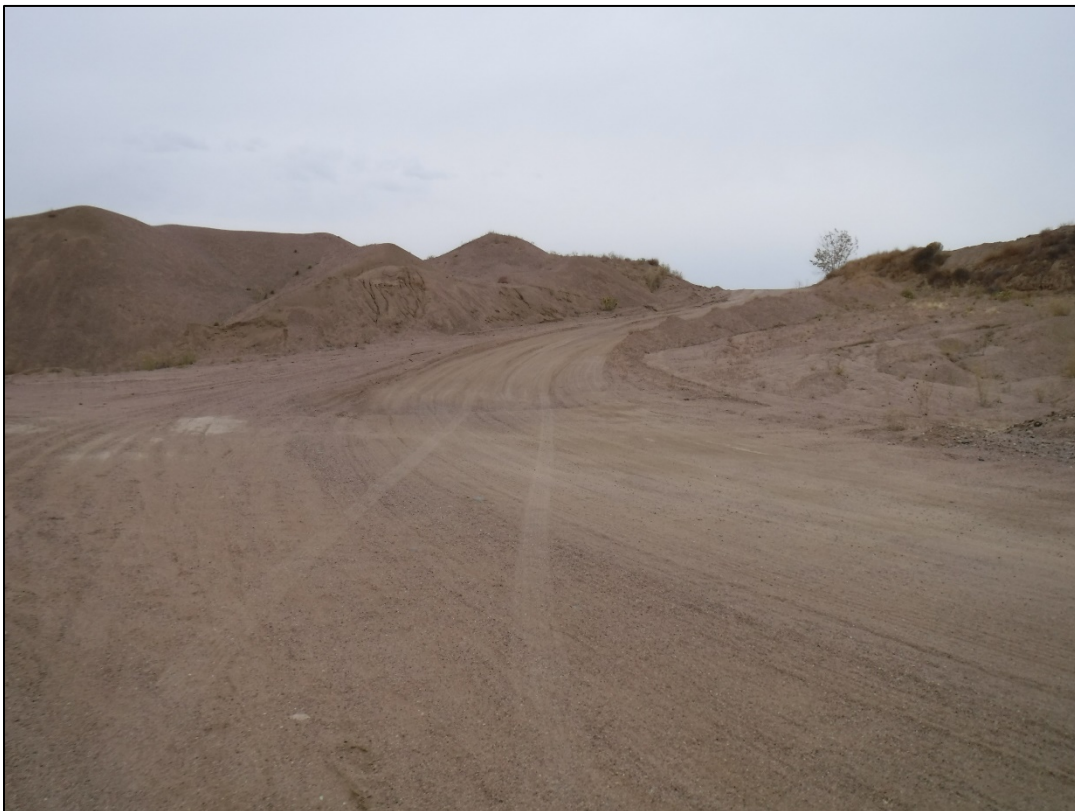
Photo 6: Haul road leading into pit area

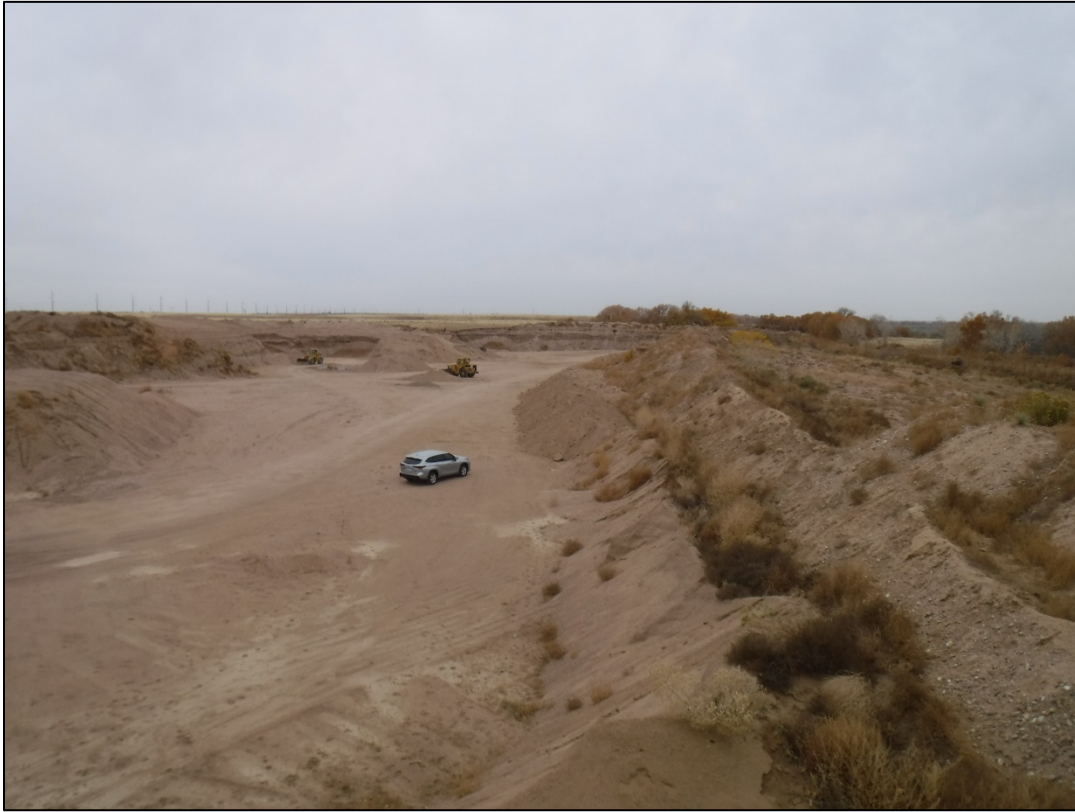
Photo 7: Northern high wall looking west

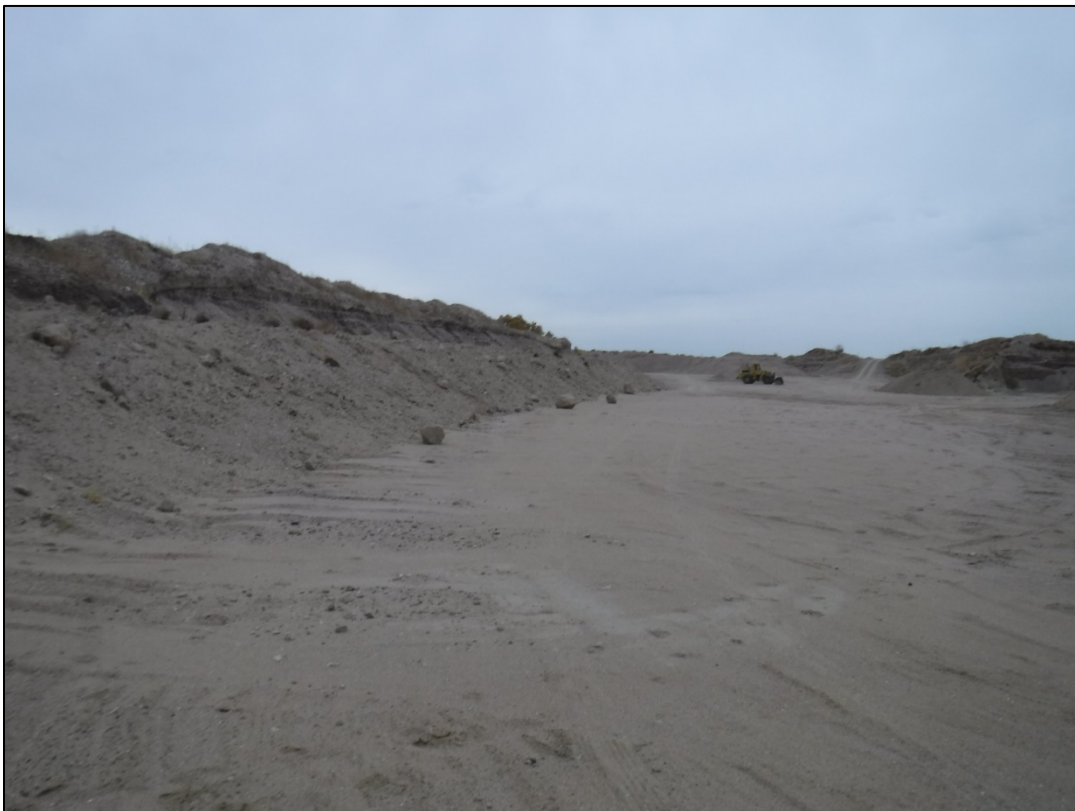
Photo 8: Northern highwall looking east from northwest corner of pit

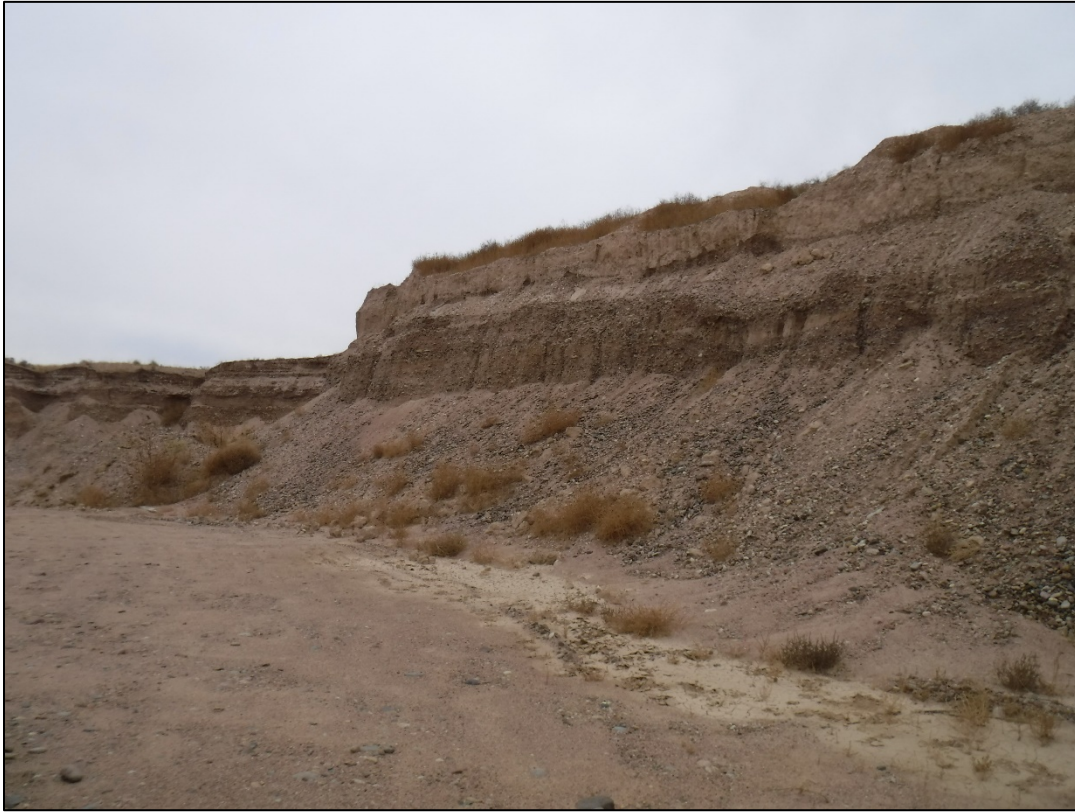
Photo 9: Typical highwall along southern pit area

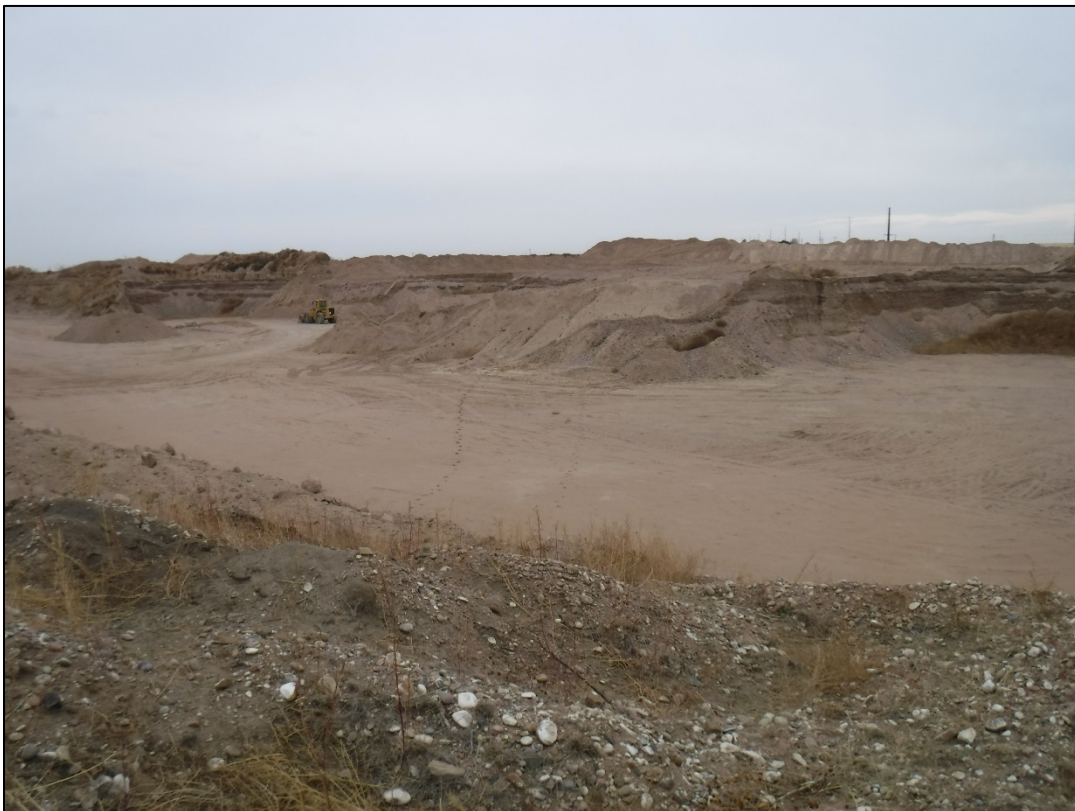
Photo 10: Looking south across the pit area

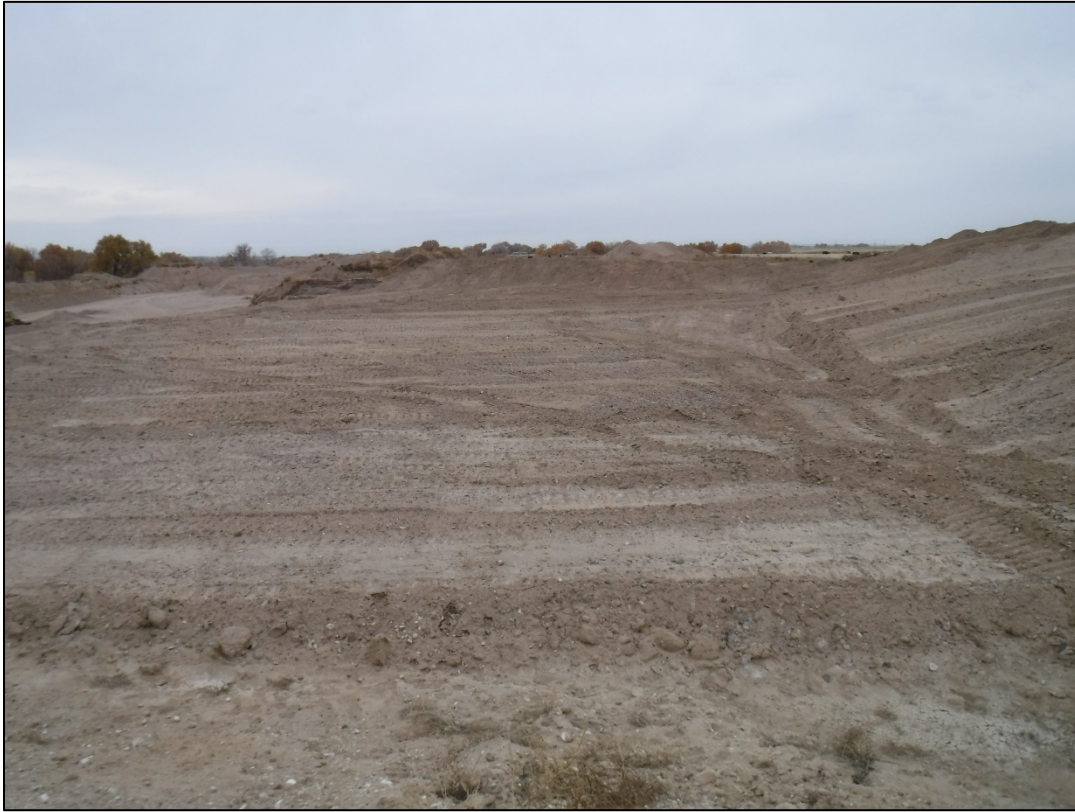
Photo 11: Area stripped ahead of mining

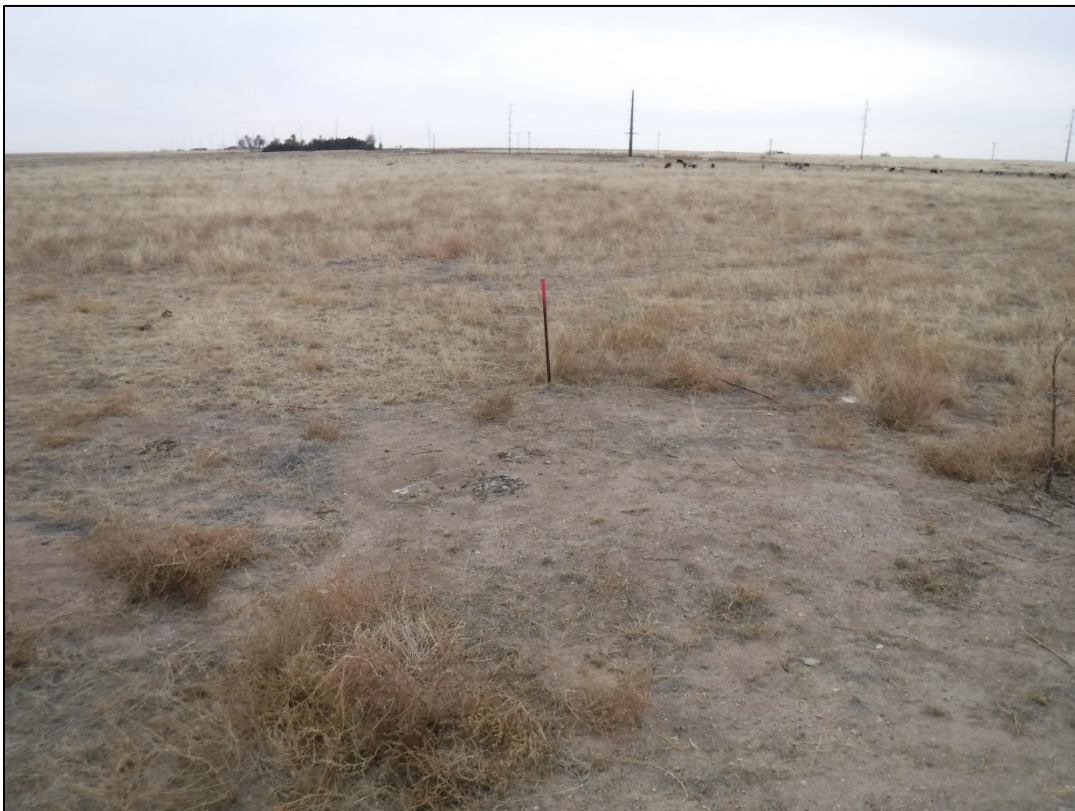
Photo 12: Typical permit boundary marker
