MINERALS PROGRAM INSPECTION REPORT
PHONE: (303) 866-3567

MINE NAME: Pueblo West Pit	MINE/PROSPECTING ID#: M-1977-573	MINERAL: Sand and gravel	COUNTY: Pueblo
INSPECTION TYPE: Surety Release Inspection	INSPECTOR(S): Patrick Lennberg	INSP. DATE: October 26, 2021	INSP. TIME: 08:00
OPERATOR: Continental Materials Corporation	OPERATOR REPRESENTATIVE: Jerry Schnabel, Kent Ricken, Bruce Humphries	TYPE OF OPERATION: 112c - Construction Regular Operation	
REASON FOR INSPECTION: Surety Release Requested	BOND CALCULATION TYPE: Complete Bond	BOND AMOUNT: \$343,323	
DATE OF COMPLAINT: NA	POST INSP. CONTACTS: None	JOINT INSP. AGENCY: None	
WEATHER: Clear	INSPECTOR'S SIGNATURE:

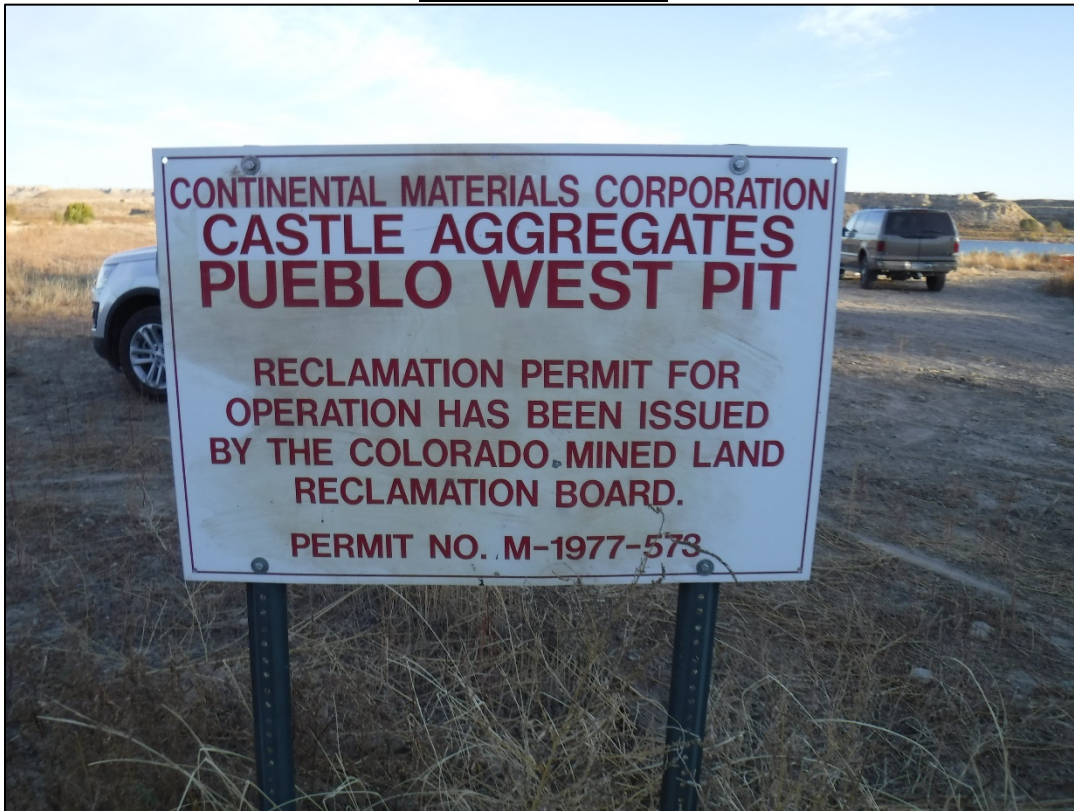
Photo 1: Mine sign at entrance

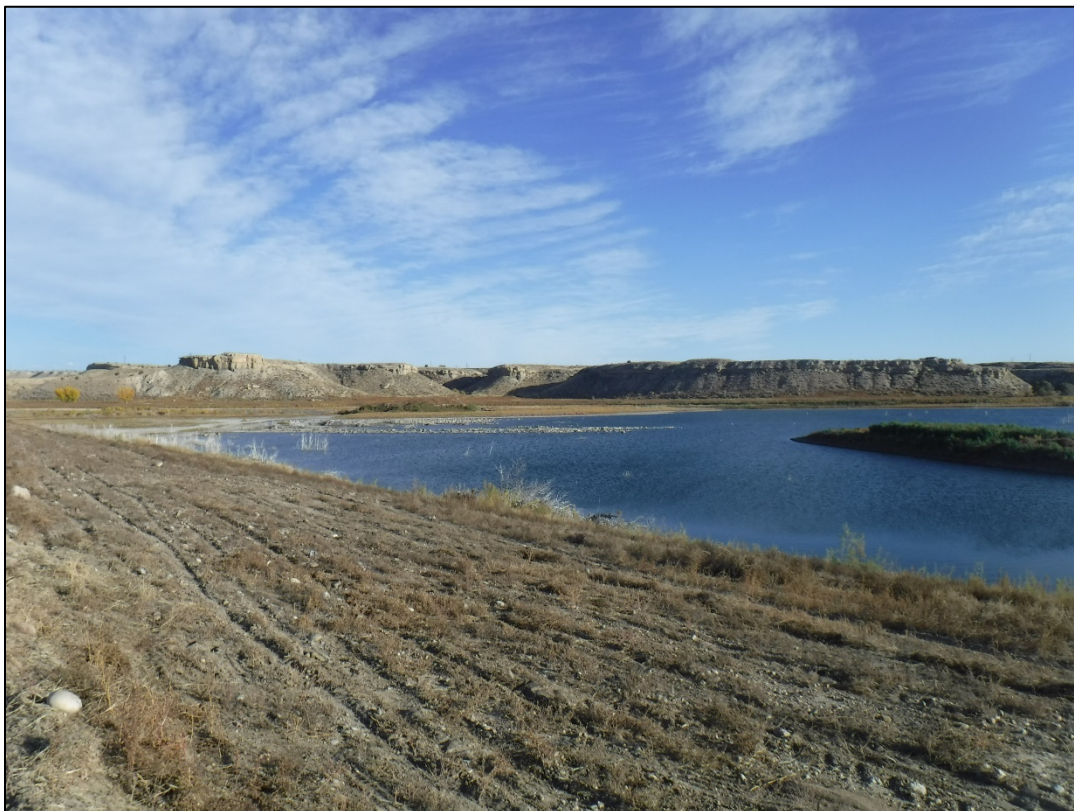
Photo 2: Typical shoreline conditions

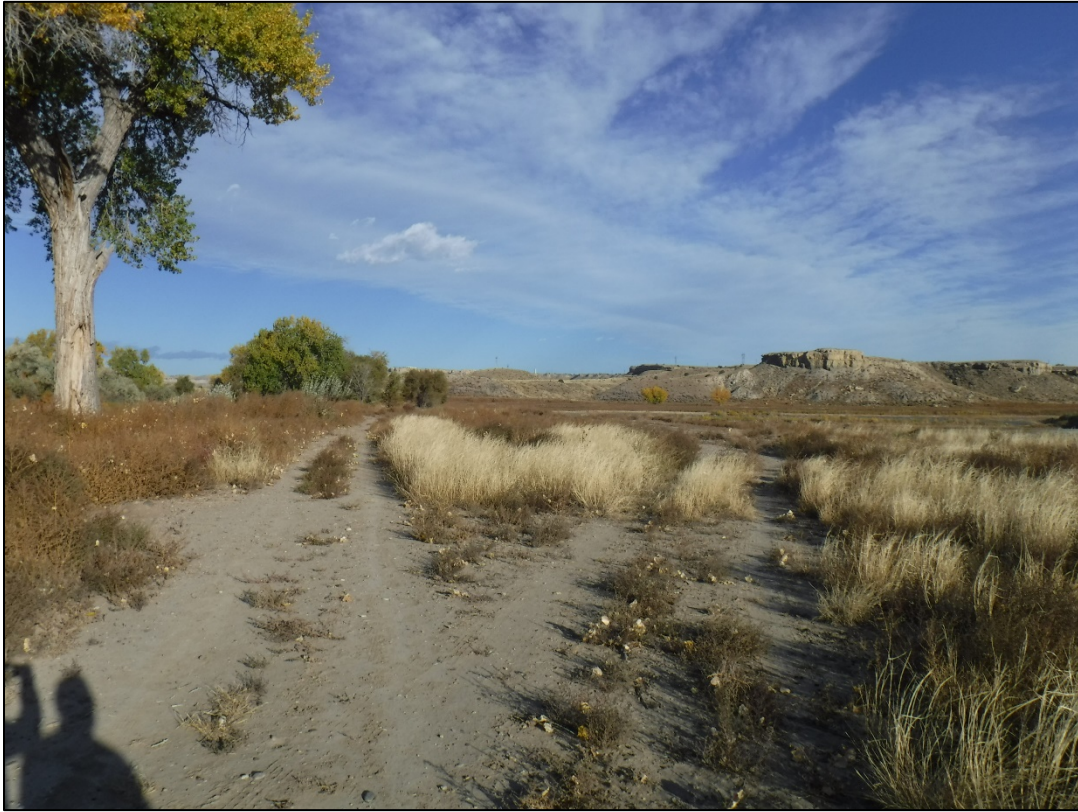
Photo 3: Typical conditions outside of the shoreline on the southwestern portion of reservoir

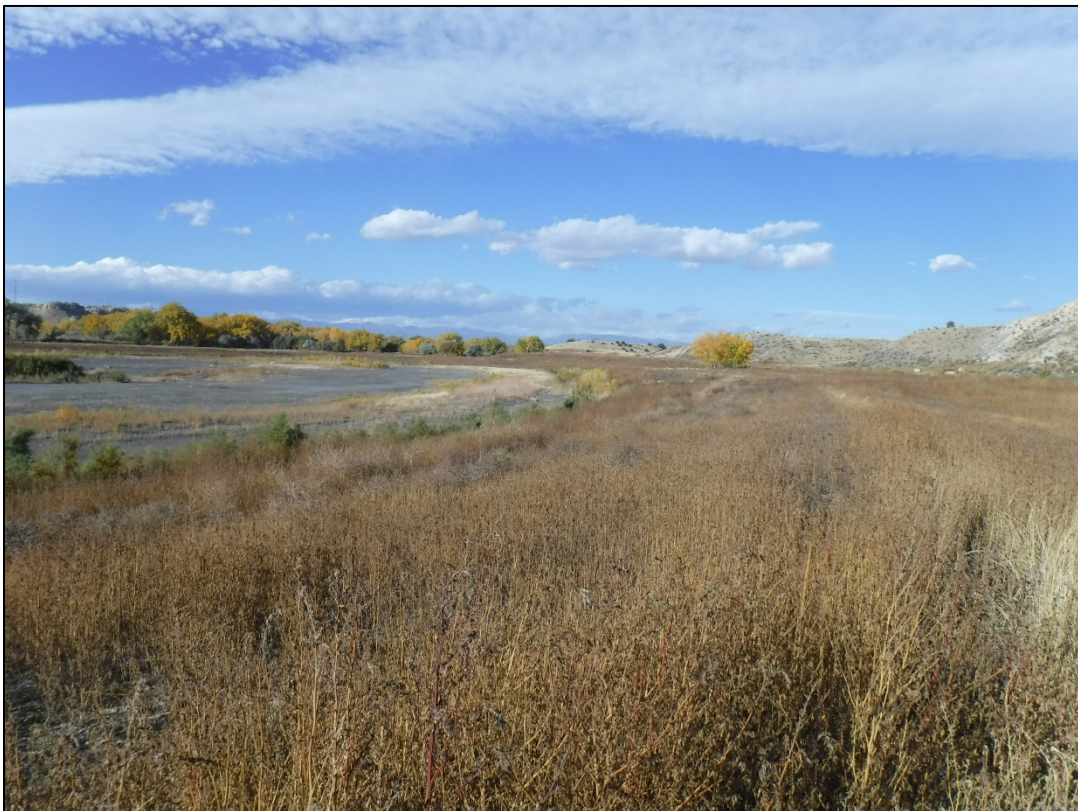
Photo 4: Typical shoreline conditions along the northern side of reservoir, conditions are similar outside of the shoreline

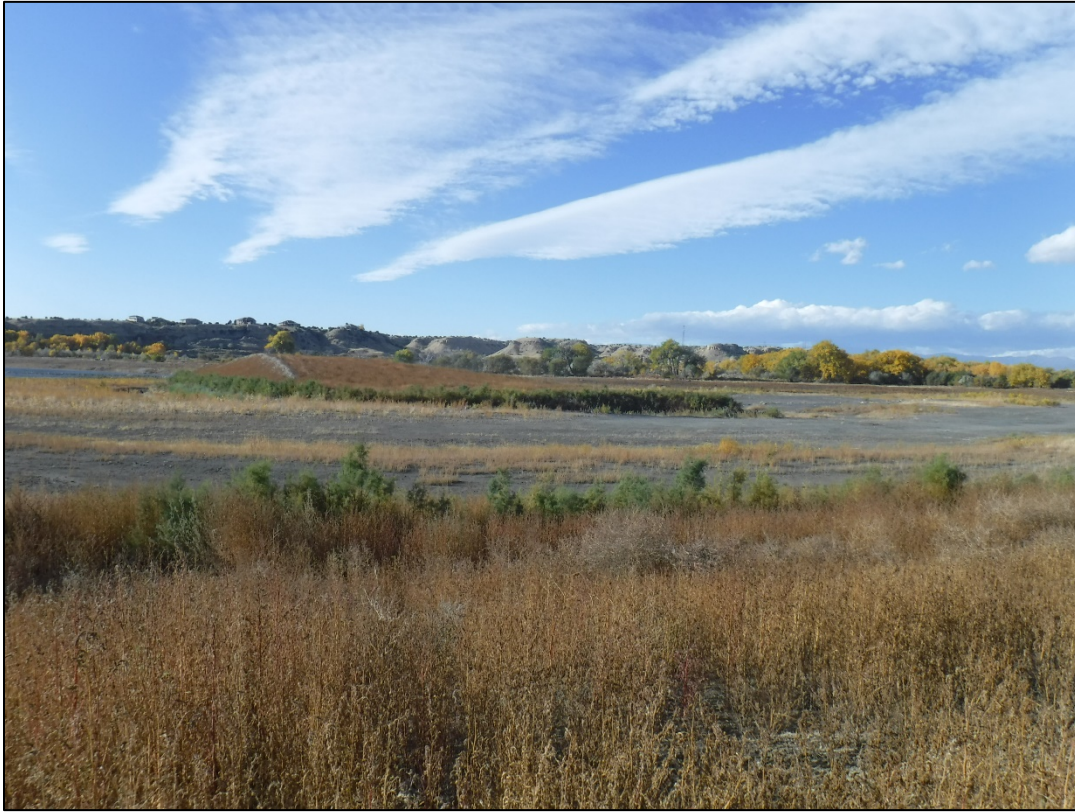
The mine site has not been active except for activities associated with reclamation. The surety reduction request is to release surety to account for reclamation completed to date. The operator also submitted a Technical Revision (TR-6) to update the reclamation seeding mix to one better suited for the location and allow for the maintenance road around the reservoir to remain after reclamation is complete. TR-6 was approved November 6, 2021. Currently, the operator is mowing areas where kochia is overgrowing areas and preparing for the new seeding mix to be drilled in. The previous seeding mix did not take very well at the site in 2018 for a variety reasons. The site is 122.1 acres in total with 30.1 acres makes up the shoreline area, include the road, and the rest of the area is reservoir. It should be noted, there is an island in the reservoir that is composed of topsoil material. Up until recently the topsoil island was to remain after mining and TR-6 originally included this change. However CWPDA is going to sell the material in the near future.

Photo 5: Topsoil island center of photo

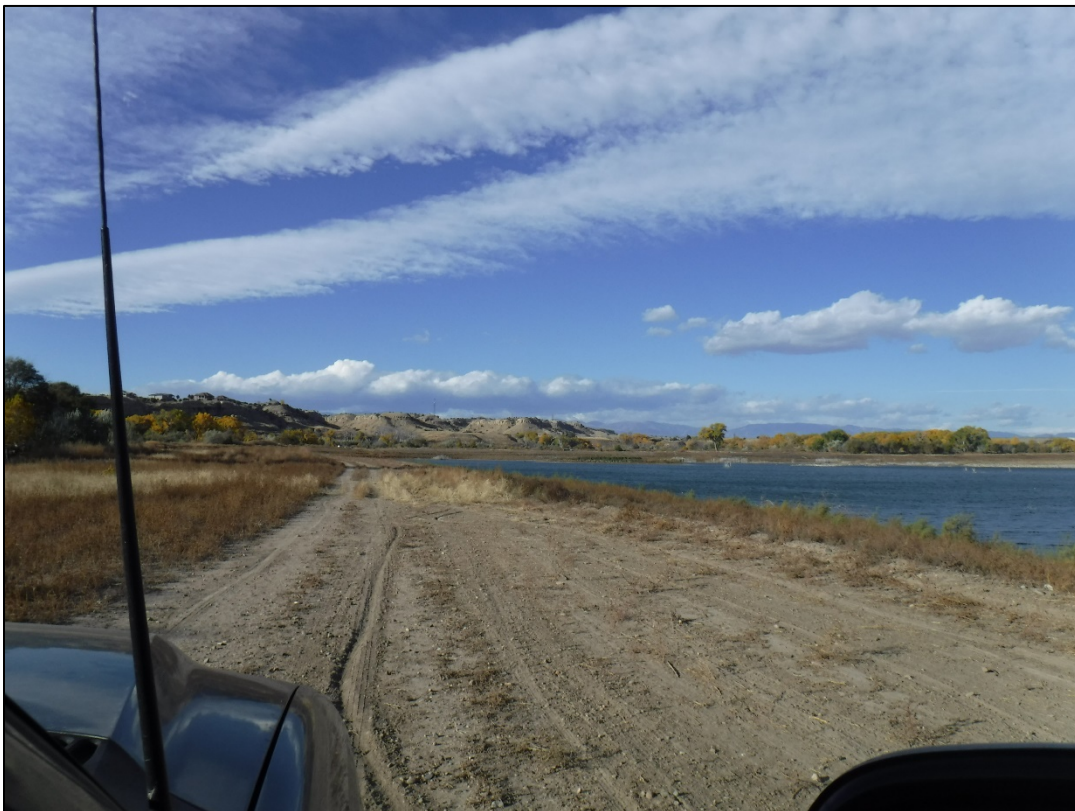
Photo 6: Conditions along the eastern portion of the reservoir

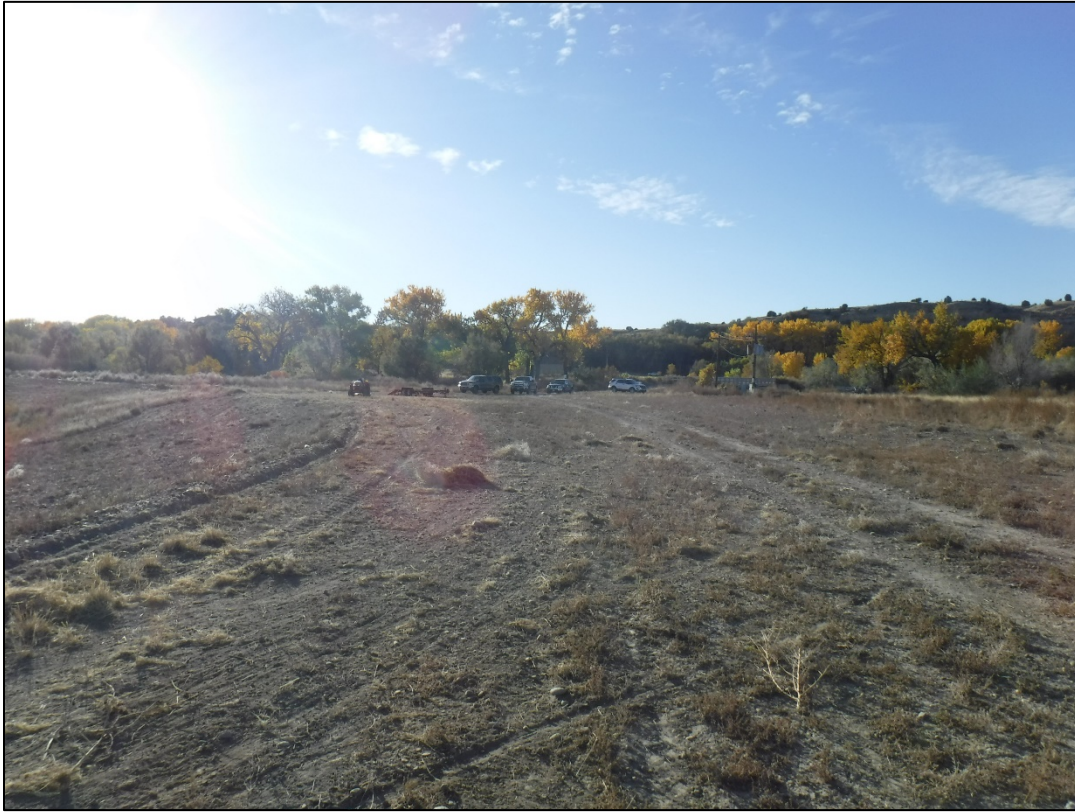
Photo 7: Looking east towards the mine entrance area

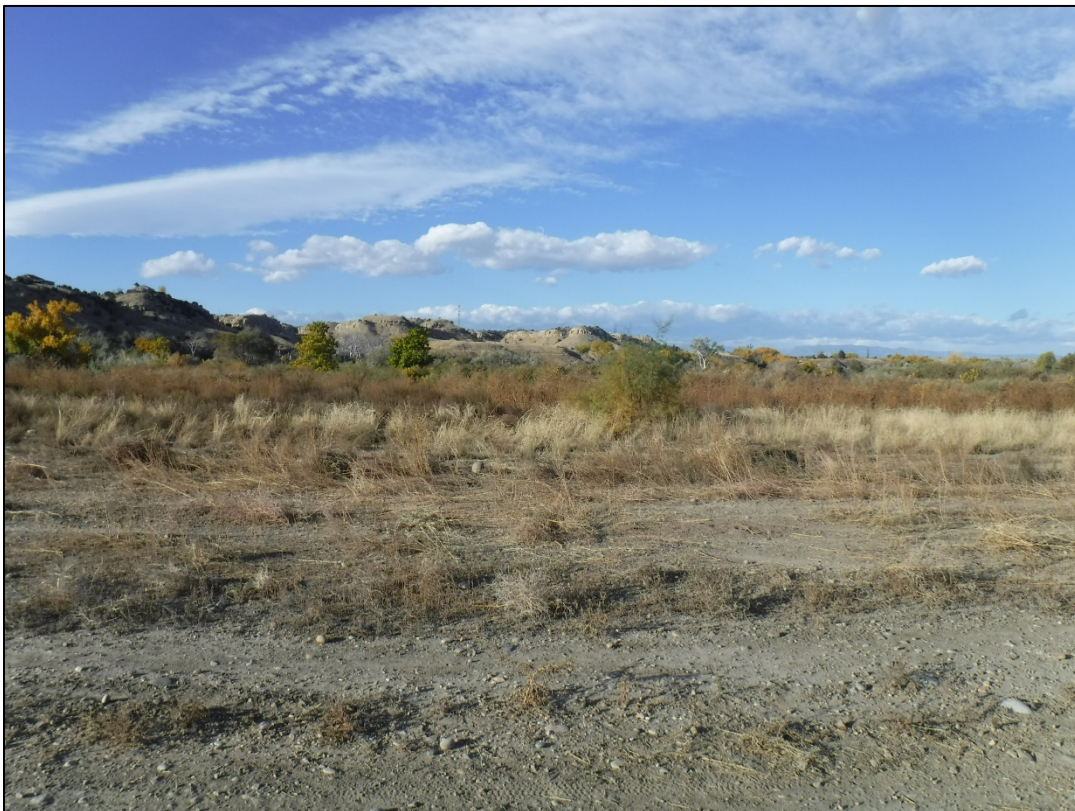
Photo 8: Looking along the area adjacent to the river where vegetation is becoming established
