**MINERALS PROGRAM INSPECTION REPORT**  
**PHONE: (303) 866-3567**

<b>MINE NAME:</b> Beaver Creek Clay Mine	<b>MINE/PROSPECTING ID#:</b> M-1977-322	<b>MINERAL:</b> Clay (general)	<b>COUNTY:</b> Fremont
<b>INSPECTION TYPE:</b> Monitoring	<b>INSPECTOR(S):</b> Timothy Cazier, P.E.	<b>INSP. DATE:</b> June 15, 2021	<b>INSP. TIME:</b> 14:30
<b>OPERATOR:</b> Summit Brick & Tile Co.	<b>OPERATOR REPRESENTATIVE:</b> Julie Welte	<b>TYPE OF OPERATION:</b> 110c - Construction Limited Impact	
<b>REASON FOR INSPECTION:</b> Normal I&E Program	<b>BOND CALCULATION TYPE:</b>	<b>BOND AMOUNT:</b> \$11,300.00	
<b>DATE OF COMPLAINT:</b> NA	<b>POST INSP. CONTACTS:</b> U.S.BLM	<b>JOINT INSP. AGENCY:</b> None	
<b>WEATHER:</b> Cloudy	<b>INSPECTOR'S SIGNATURE:</b>

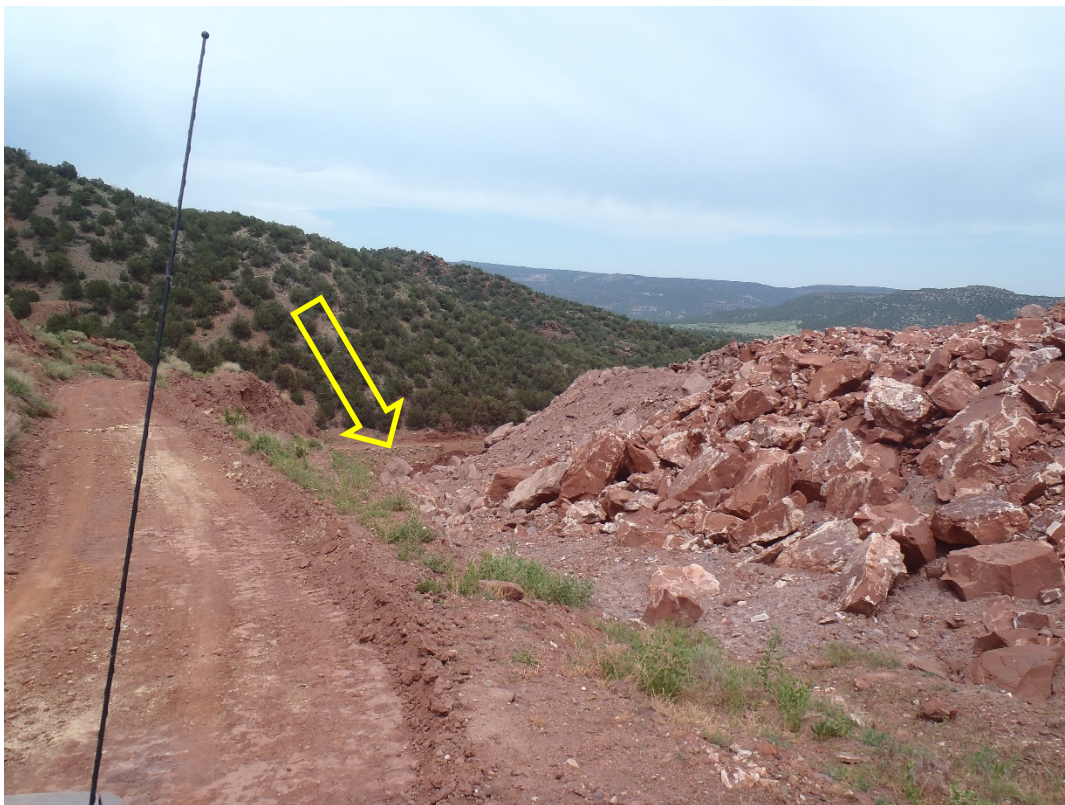
Excess Spoil and Dev. Waste: Ms. Welte stated overburden is pushed into areas requiring backfill (see **Photo 1**).

Reclamation Success: Other than the aforementioned pre-law reclaimed areas, the only reclamation currently under way is the backfilling of the gully (see **Photo 1**).

Photo 1. Backfill in gully between access road and working bench (a.k.a. NW facing highwall, looking NE).

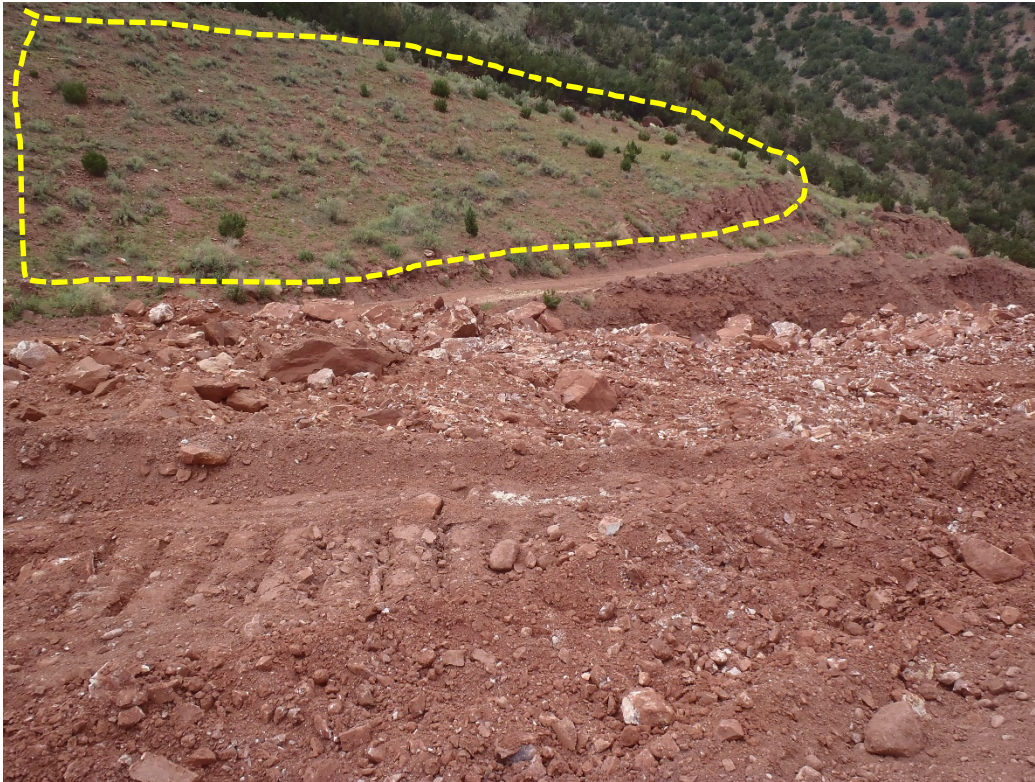
Photo 2. Pre-law reclaimed area & access road (looking NE from above gully backfill).

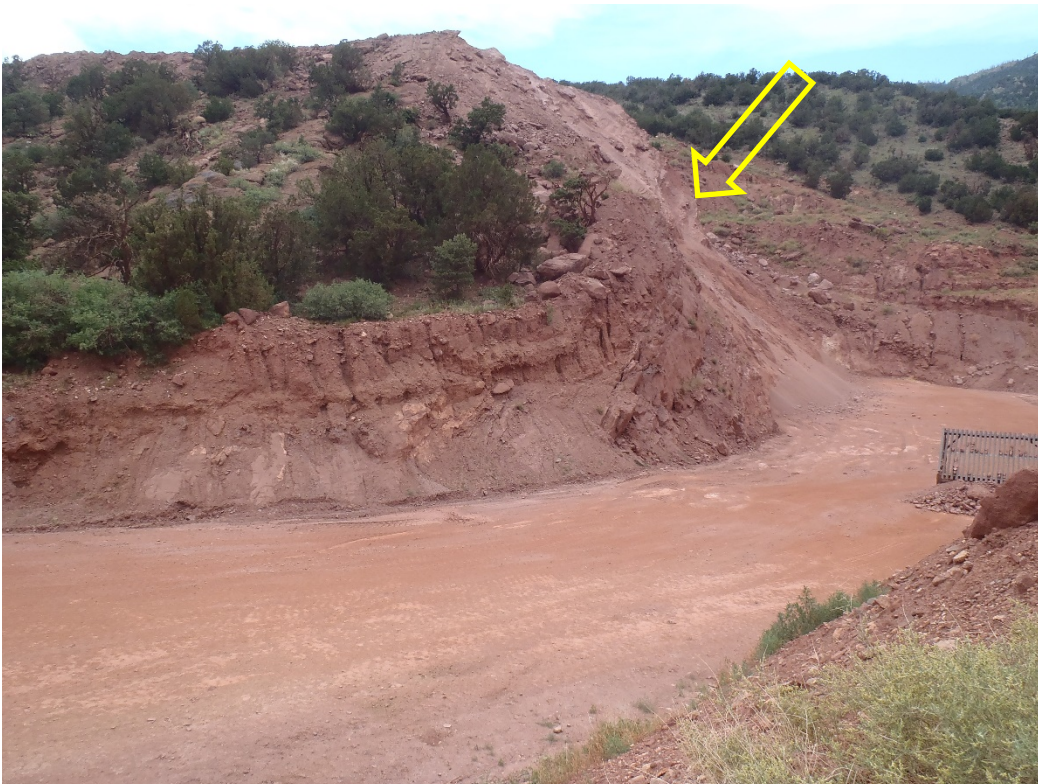
Photo 3. NE facing highwall (looking NW from access road to top of mine, note grizzly screen).

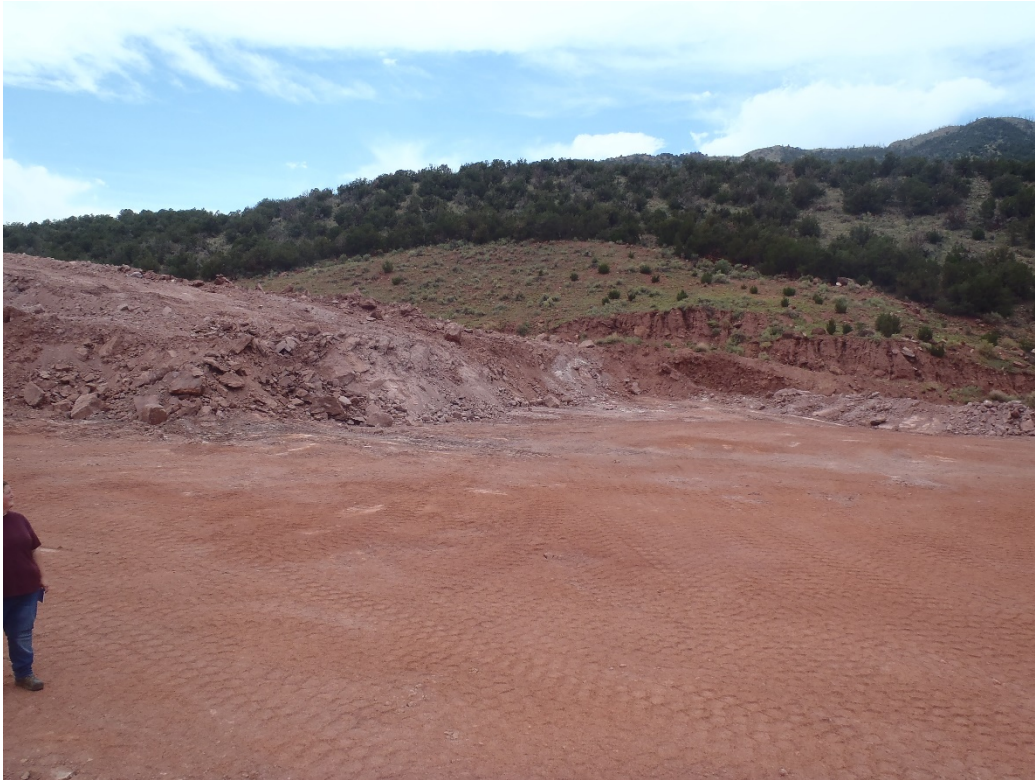
Photo 4. Temporary bench above NE facing highwall (looking NW).

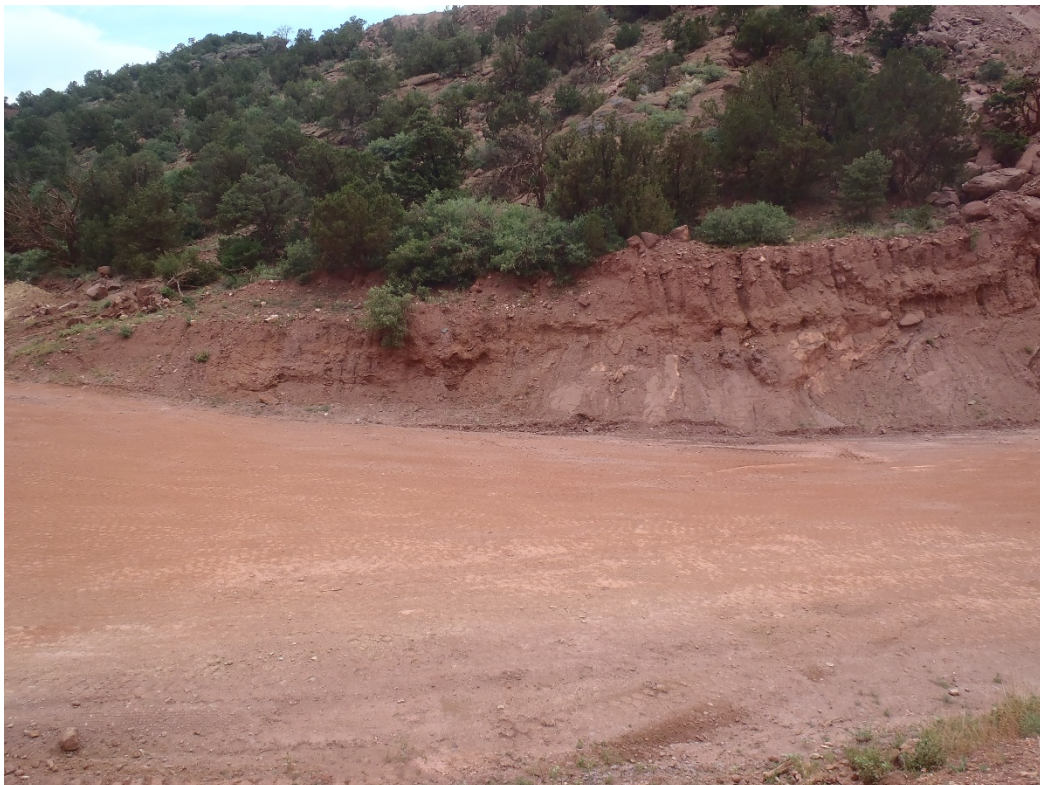
Photo 5. SE facing highwall (looking west from near pit floor entrance).

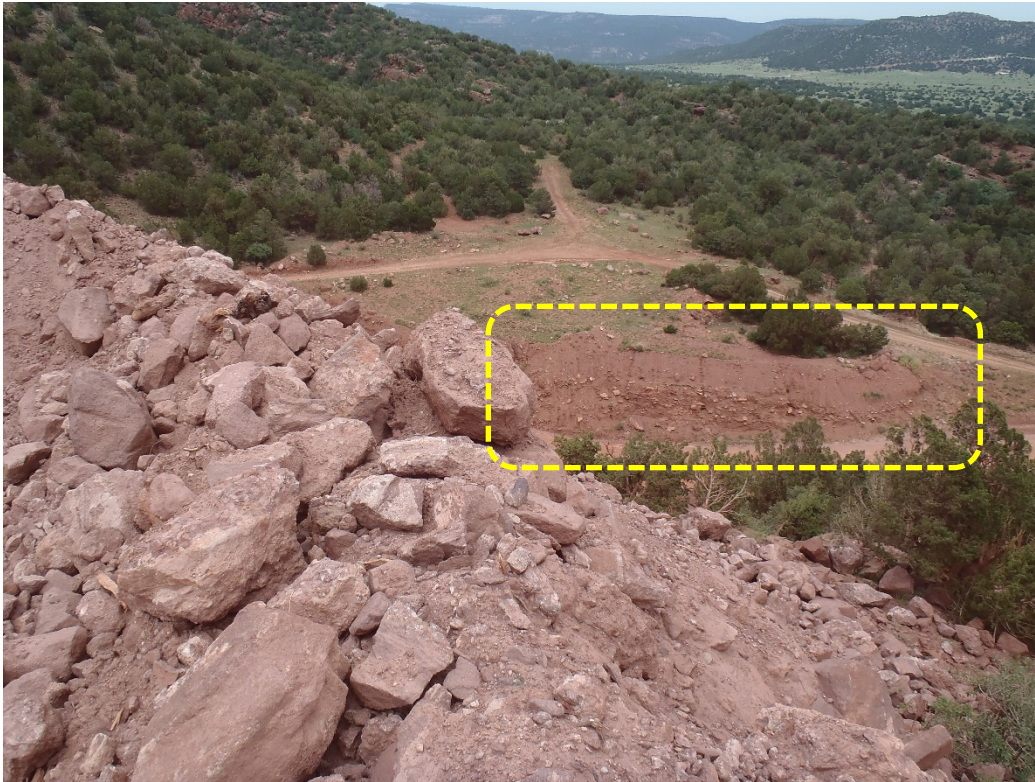
Photo 6. West facing highwall (looking east from NE facing highwall bench).

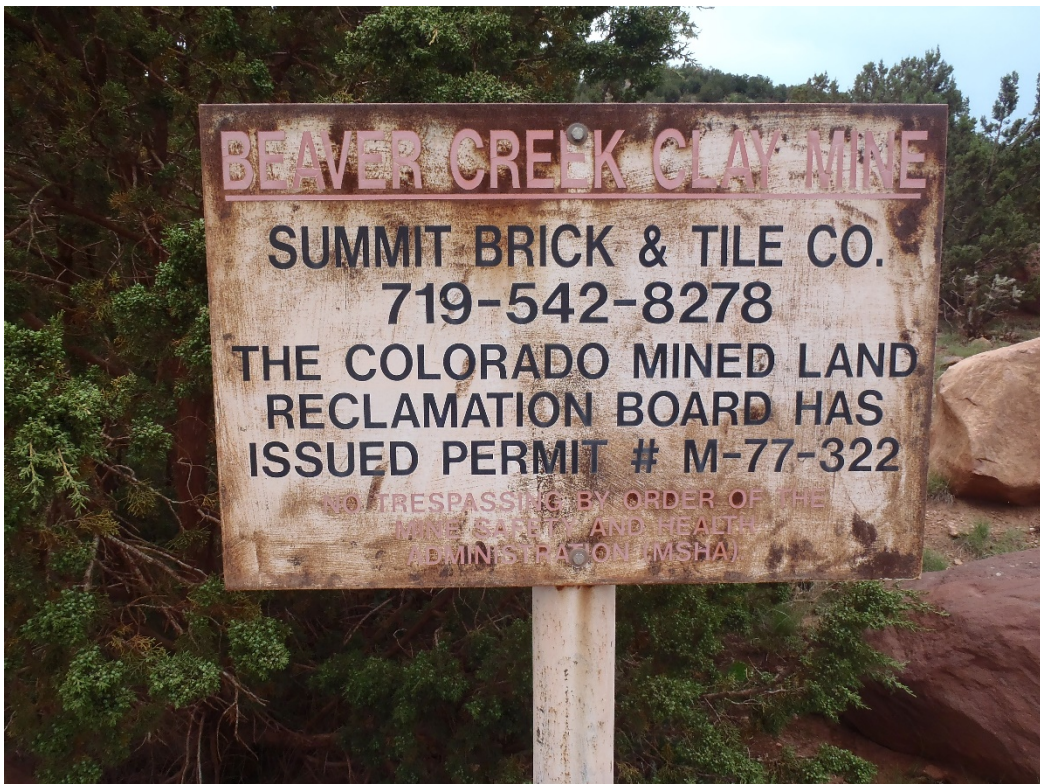
Signs and Markers: The permit sign was properly posted (see **Photo 7**) and boundary markers were observed to delineate the permit boundary (see **Photo 8**).

Photo 7. Permit sign (near pit floor entrance).

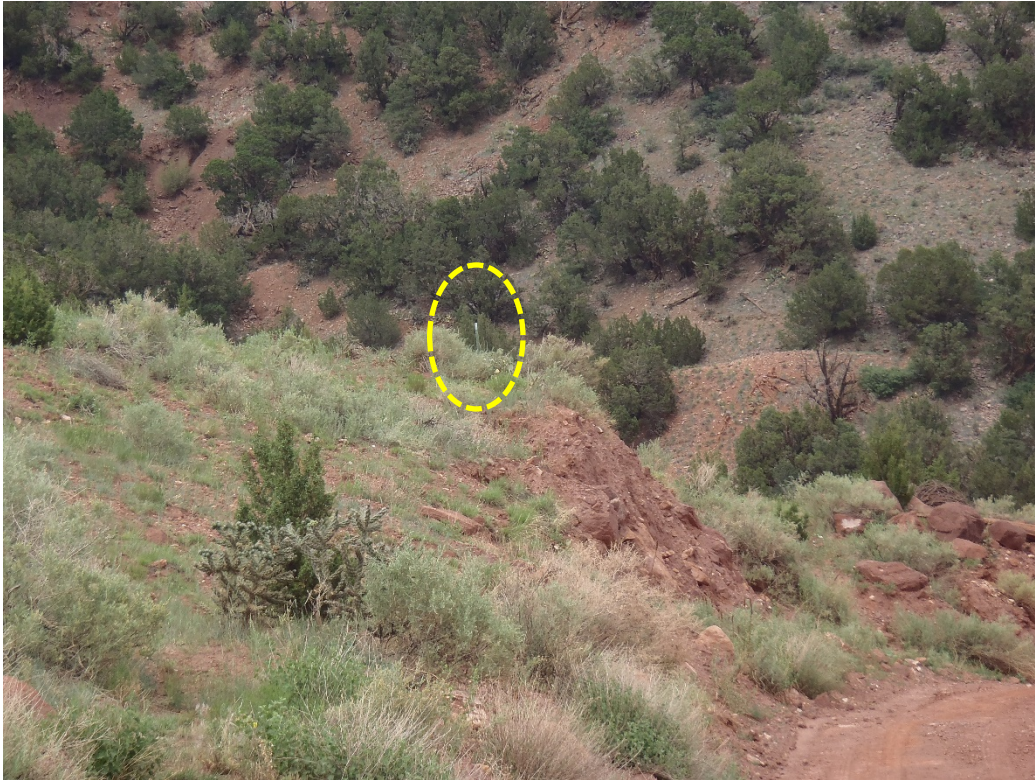
Photo 8. Typical boundary marker T-post (NE corner).
