MINERALS PROGRAM INSPECTION REPORT
PHONE: (303) 866-3567

MINE NAME: Nahcolite Project	MINE/PROSPECTING ID#: M-1983-194	MINERAL: Carbonates	COUNTY: Rio Blanco
INSPECTION TYPE: Monitoring	INSPECTOR(S): Amy Yeldell	INSP. DATE: November 5, 2021	INSP. TIME: 10:00
OPERATOR: Natural Soda LLC	OPERATOR REPRESENTATIVE: Kirk Daehling	TYPE OF OPERATION: 112d-3 - Designated Mining Operation	
REASON FOR INSPECTION: Normal I&E Program	BOND CALCULATION TYPE: None	BOND AMOUNT: \$3,671,965.00	
DATE OF COMPLAINT: NA	POST INSP. CONTACTS: None	JOINT INSP. AGENCY: U.S.BLM	
WEATHER: Clear	INSPECTOR'S SIGNATURE:

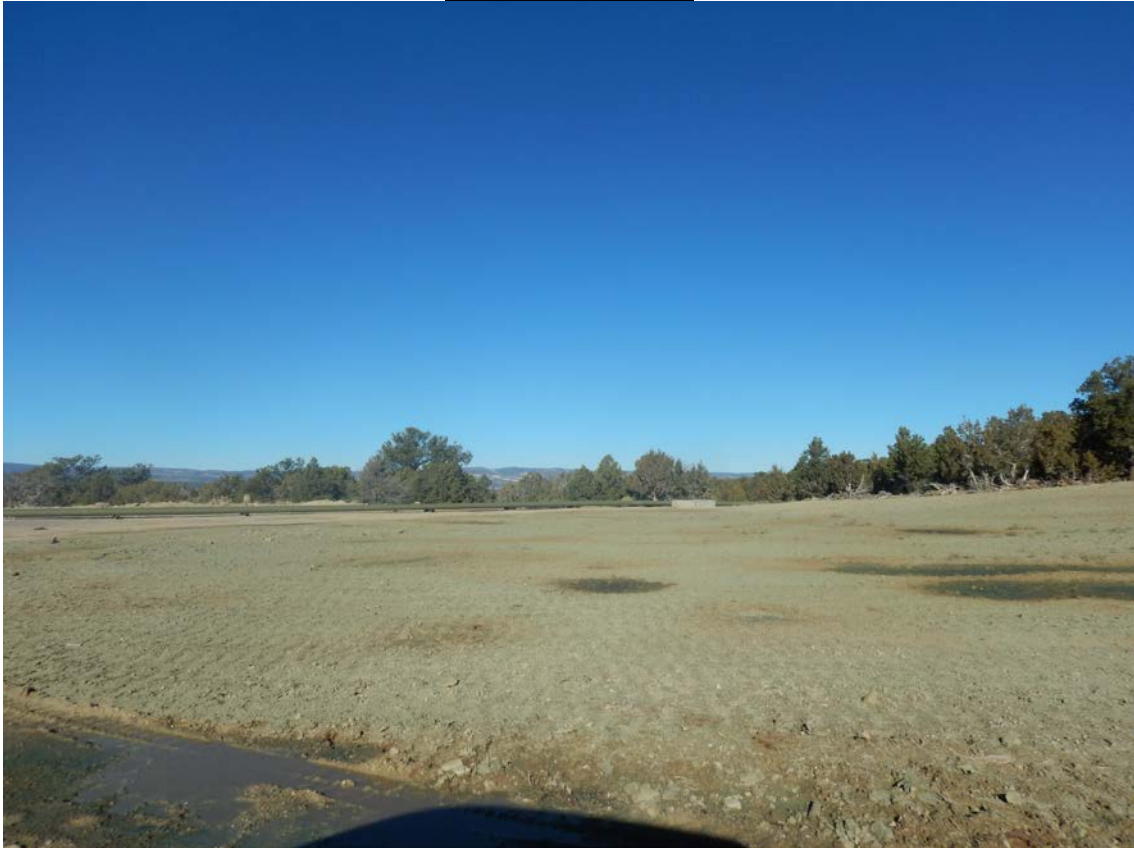
Pad 8 and surrounding areas has been recently hydroseeded. The access road to pad 15-17 bisects the reclaimed areas.

Hydroseeded Pad 8

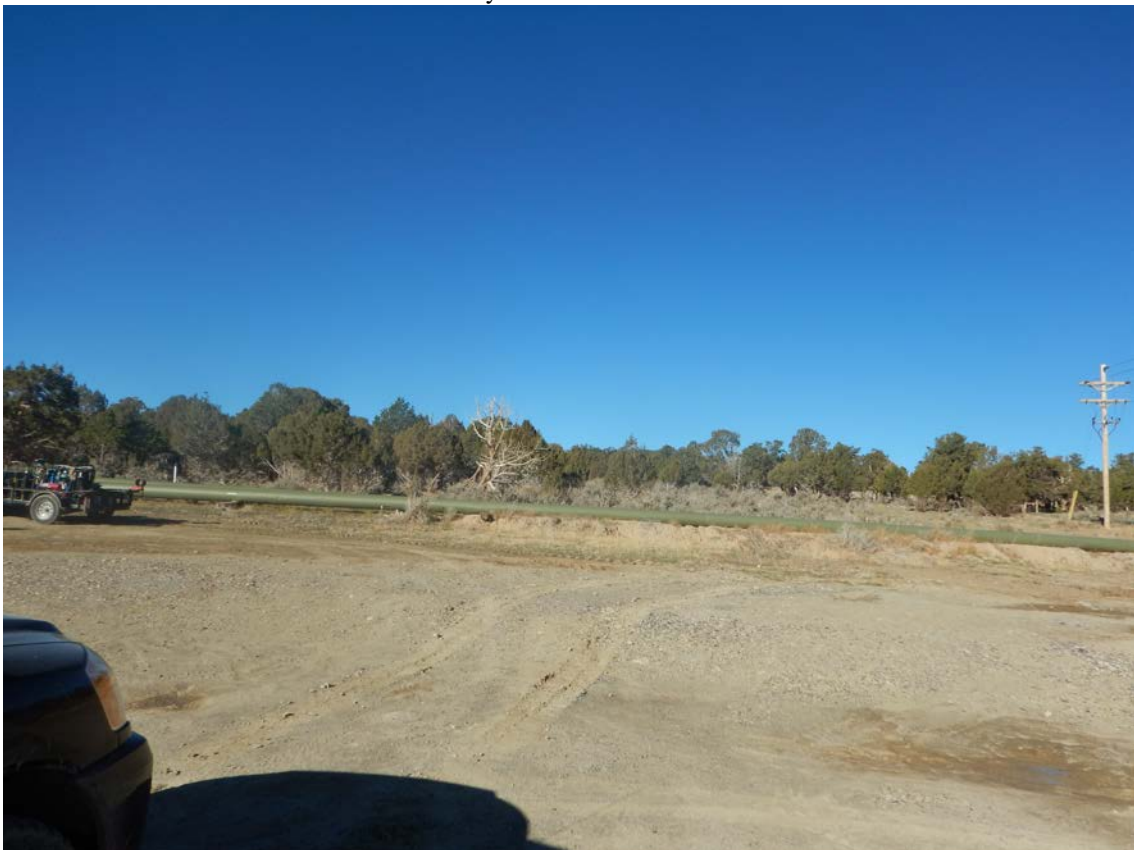
IRI-8, IRI-9 and EX-2 wells have all been plugged and abandoned. The Division has received abandonment reports. EX-2 is located within the staff parking lot on northwest side and no surface reclamation will be required. IRI-8 and IRI-9 consist of minimal surface disturbance. Grading has been completed and spot/hand seeding will be applied as weather conditions allow.

EX-2 well pad disturbance within parking lot

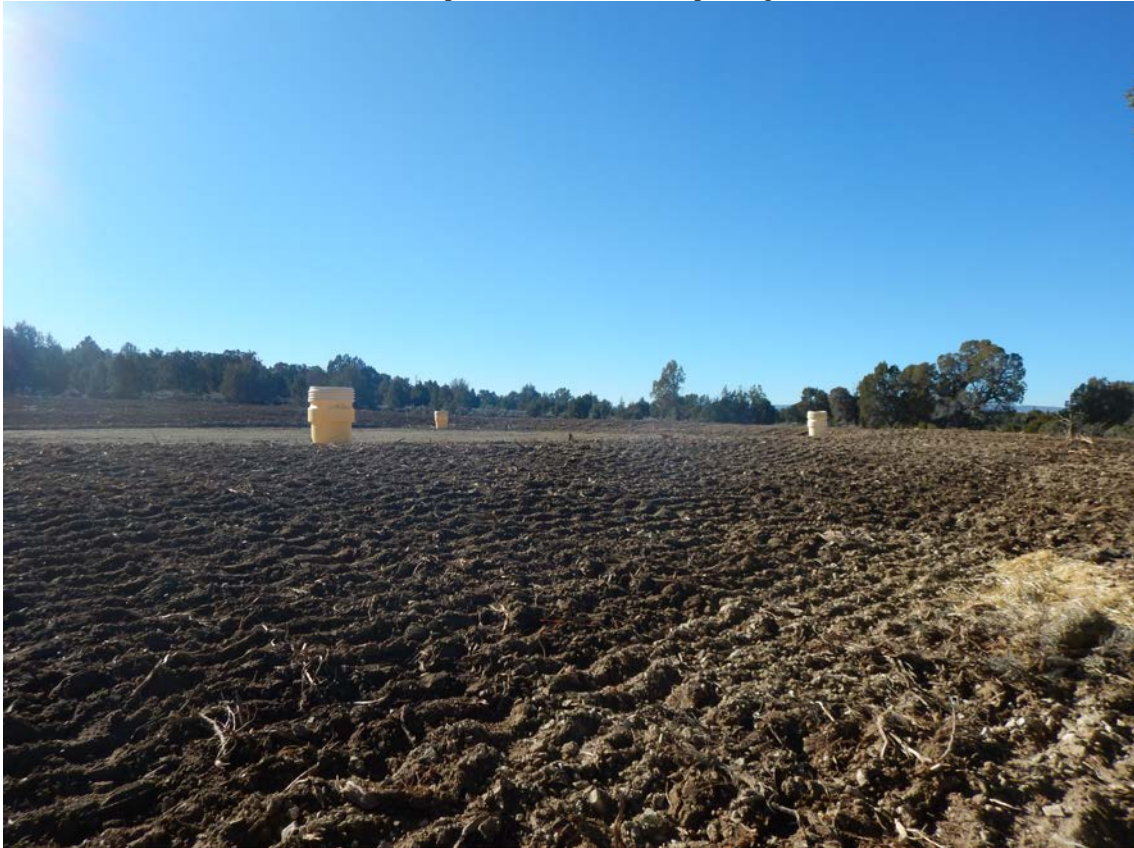
All three wells (PA-1, AG-2 and BG-10) on the new up-gradient well pad approved under TR-46 have been completed. Completion reports were received by the Division. Grading on the pad is excellent with cross-tracking to prevent slope erosion. Seeding will occur just before snow.

New up-gradient well pad

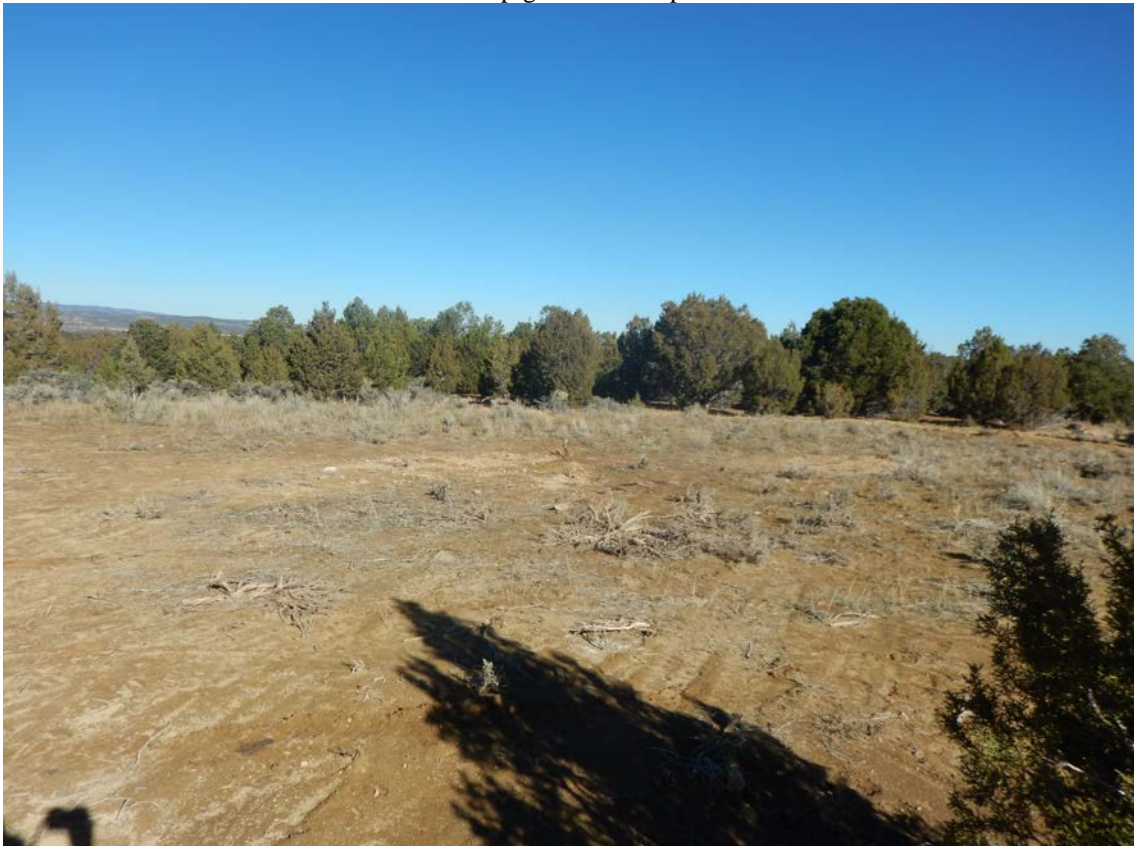
IRI-9 surface disturbance
