October 21, 2021

Mr. Eric Leigh
Monarch Mountain Mineral and Aggregate
2660 West 64th Avenue
Denver, CO 80221

Subject: Geologic Hazards and Highwall Stability Study
Lilly Mines
Garfield, Colorado
Project No. 21.6087

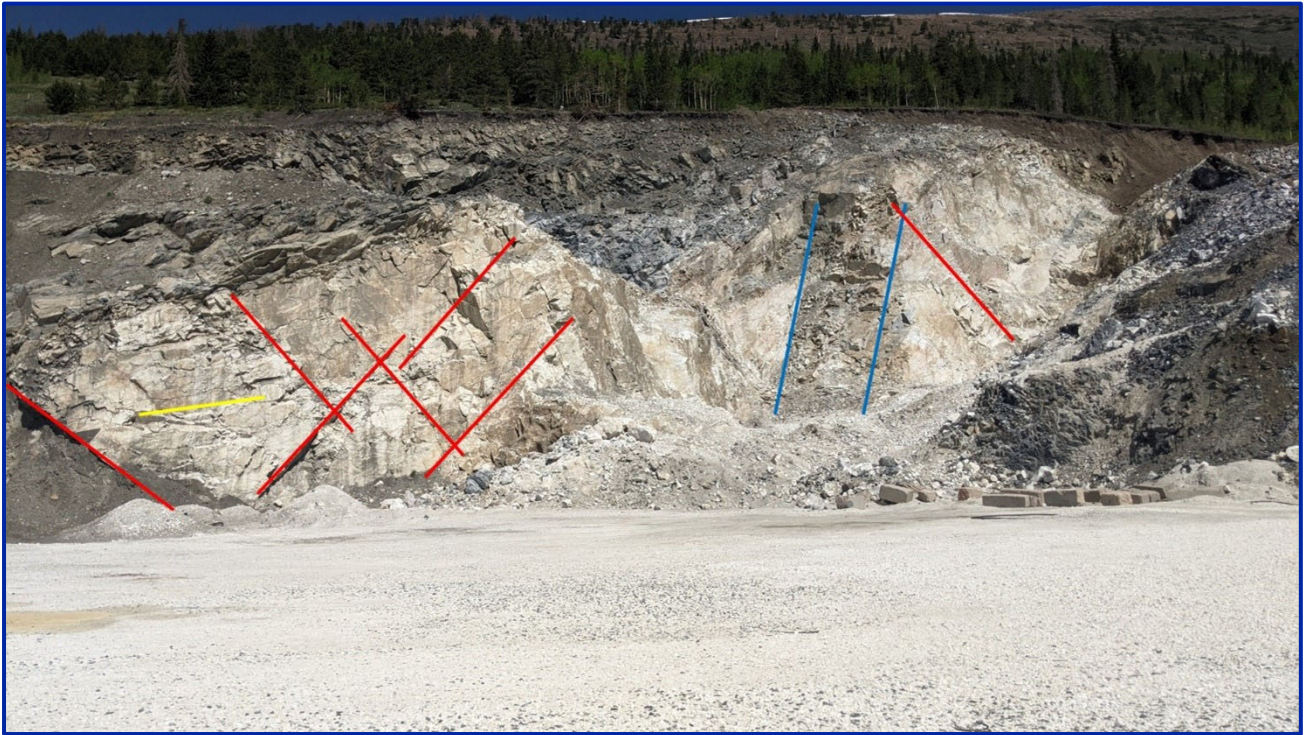
The marble formation has several major joint sets and fracture patterns. The main joint set dips 43 degrees N10W and the secondary joint set dips 48 degrees S15W. This intersecting joint pattern indicates some degree of potential wedge failure of blocks (Exhibit 2). A third joint set follows strike of the bedding and has a nearly vertical dip (Exhibit 3) This fracture creates 1.5 to 6 foot blocks. The marble unit becomes highly fractured in areas along the highwall. The highly fractured zones occur about every 100 feet along the strike of the outcrop (Exhibit 2). These fracture zones have four fracture sets that break the rock into blocks 1 foot or less on their long axis. The probability of rockfall in these zones is increased, although the hazard is from smaller blocks. Local areas of this highly fractured and jointed marble limit the long-term stability of the overall rock mass. The strike of the unit and the strike of the joint sets provide short-term control of the highwall face.

EXHIBIT 2. The main fracture sets of the working highwall at Lilly Mines. The red lines are the main intersecting fracture sets in this area. These fracture sets tend to be larger and more persistent in the rock mass. Smaller fractures, like the one represented by the yellow line, are not persistent throughout the rock mass. The blue lines indicate a more highly fractured zone where rock blocks are smaller.

The black altered quartzite and other overburden material that outcrops west of the white marble bed is exposed along the contact at the top of the highwall (Exhibit 2). This unit is highly fractured and is a potential source for rockfall into the mine working area. It was observed that this overburden had been cut back away from the highwall working area and does not pose a significant hazard.

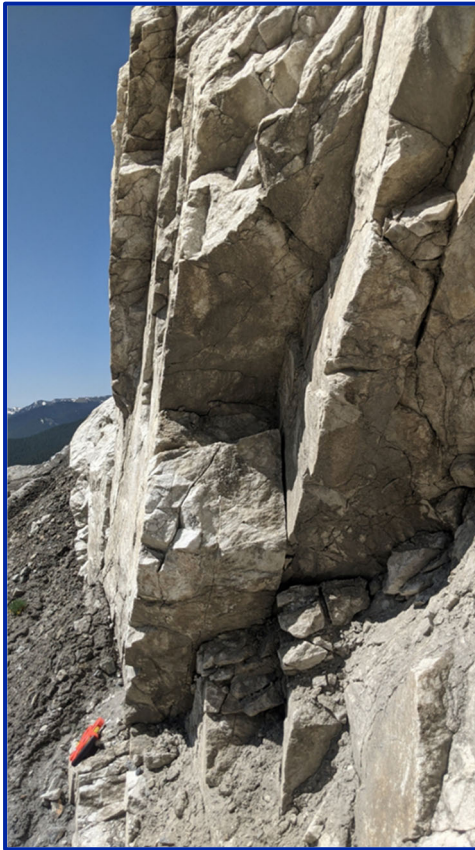
EXHIBIT 3. The joint set that aligns along the strike of the highwall and dips nearly vertically. This joint set creates layers that range from 1.5 to 6 feet thick.

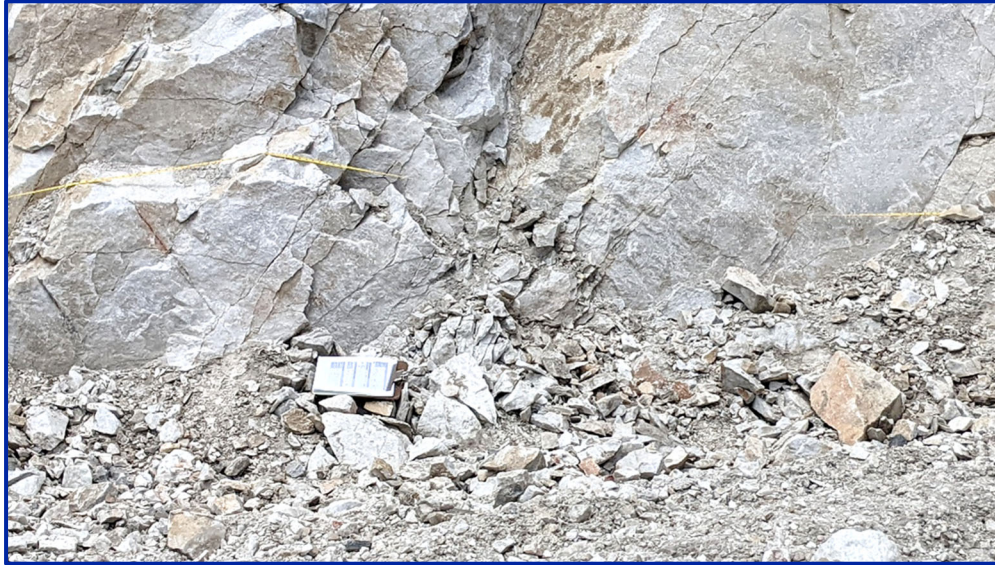
A scanline survey of a portion of the highwall was conducted in an area that was safe to access (Exhibit 4). A 25 foot section was laid out and all intersecting fractures were measured for dip and dip direction. A total of 23 data points plus the cut face itself were recorded.

EXHIBIT 4. Scanline survey conducted on a portion of the highwall. Scanline is 25 feet. All intersection fractures were measured for dip and dip direction.

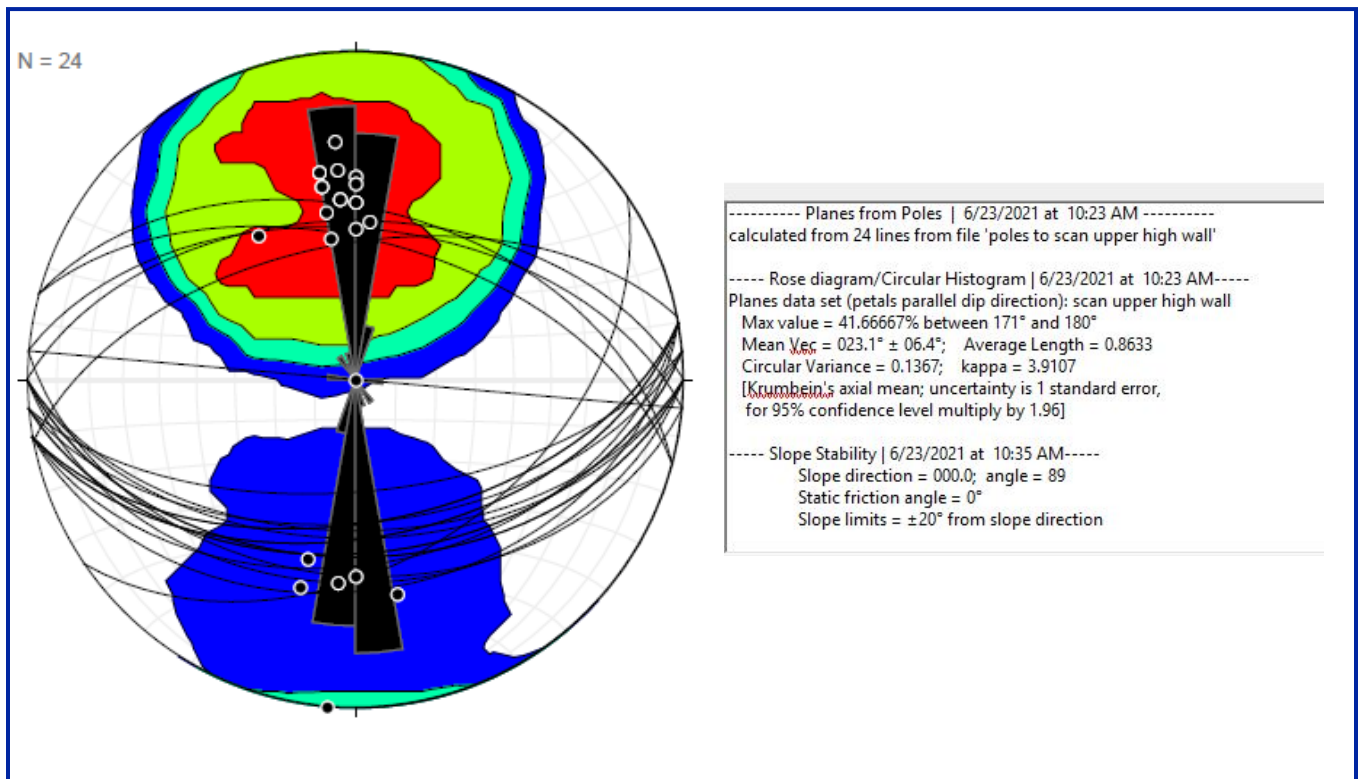
A kinematic stereonet analysis of the scan line data was completed (Exhibit 5). The interpretation of the slope stability for this data set is that the cut face will be stable within plus or minus 20 degrees of the present slope direction. If the highwall continues to follow the present strike, or within 20 degrees of the present cut face than there should be no changes in the slope stability.

EXHIBIT 5. Stereonet analysis of the scanline data for the portion of the highwall that was accessible. Rockfall hazards come from the intersection of the fracture planes and the cut face. In this case, they are not intersecting in such a way as to create a large wedge that could slide or topple from the cut face.

As operations continue along the marble outcrop and new highwall areas are quarried, the recommendation is to update the highwall control plan as new areas are uncovered that may have different joint sets or more highly fractured rock faces.

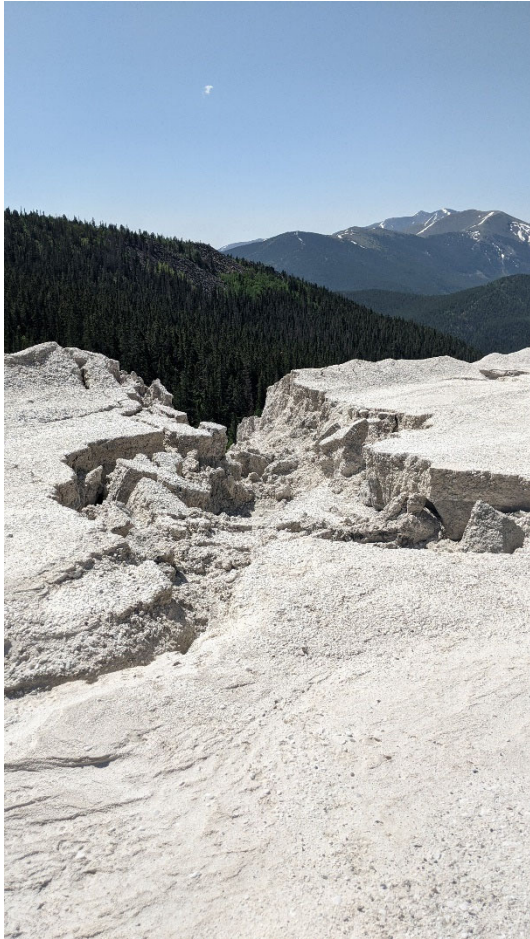
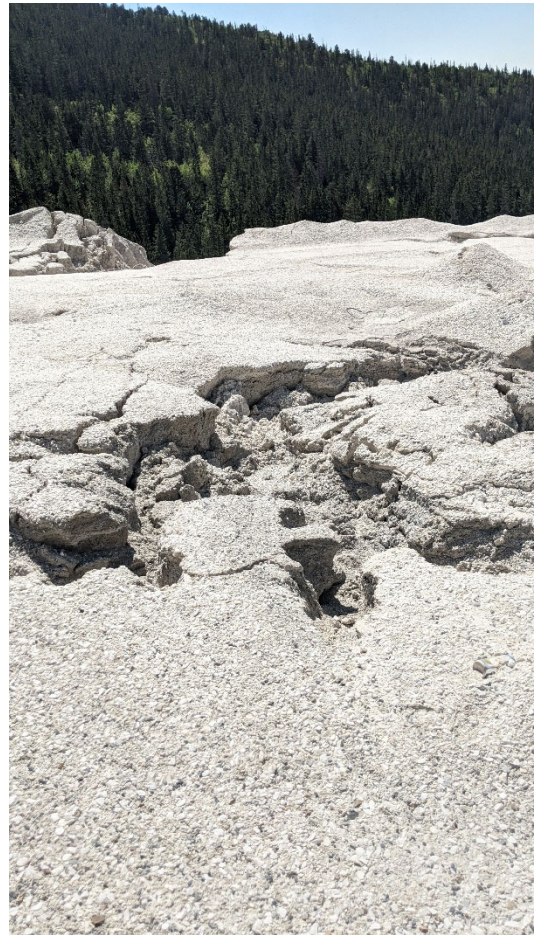
The spoils of the quarry that are being used to create the working platform area are crushed stone. On June 15, 2021, Cesare observed the spoils have erosion and rilling along the edge of the platform (Exhibit 6). This poses a geologic hazard for the platform, slope, and areas below. This may have occurred during high spring runoff or snowmelt conditions.

EXHIBIT 6. Erosion and rilling of material was observed in the platform edge. The erosion of this material poses a hazard for the site and areas below.

Cesare's engineering geologist concluded that highwall at the Lilly Mines operation remains stable due to the strike of the highwall not creating a planar or wedge failure from the persistent fracture sets. The RMR of the rock in the highwall indicates a high stand up time. Smaller hazards, like the overburden and the rilling, can easily be remedied through grading.
