Daniels Sand Pit 2, Permit No. M-1973-007-SG: Monthly Monitoring Report

November 12, 2021

Project No.: 19125

Regarding: Daniels Sand Pit 2, Permit No. M-1973-007-SG
Slope Stability Monthly Monitoring Report

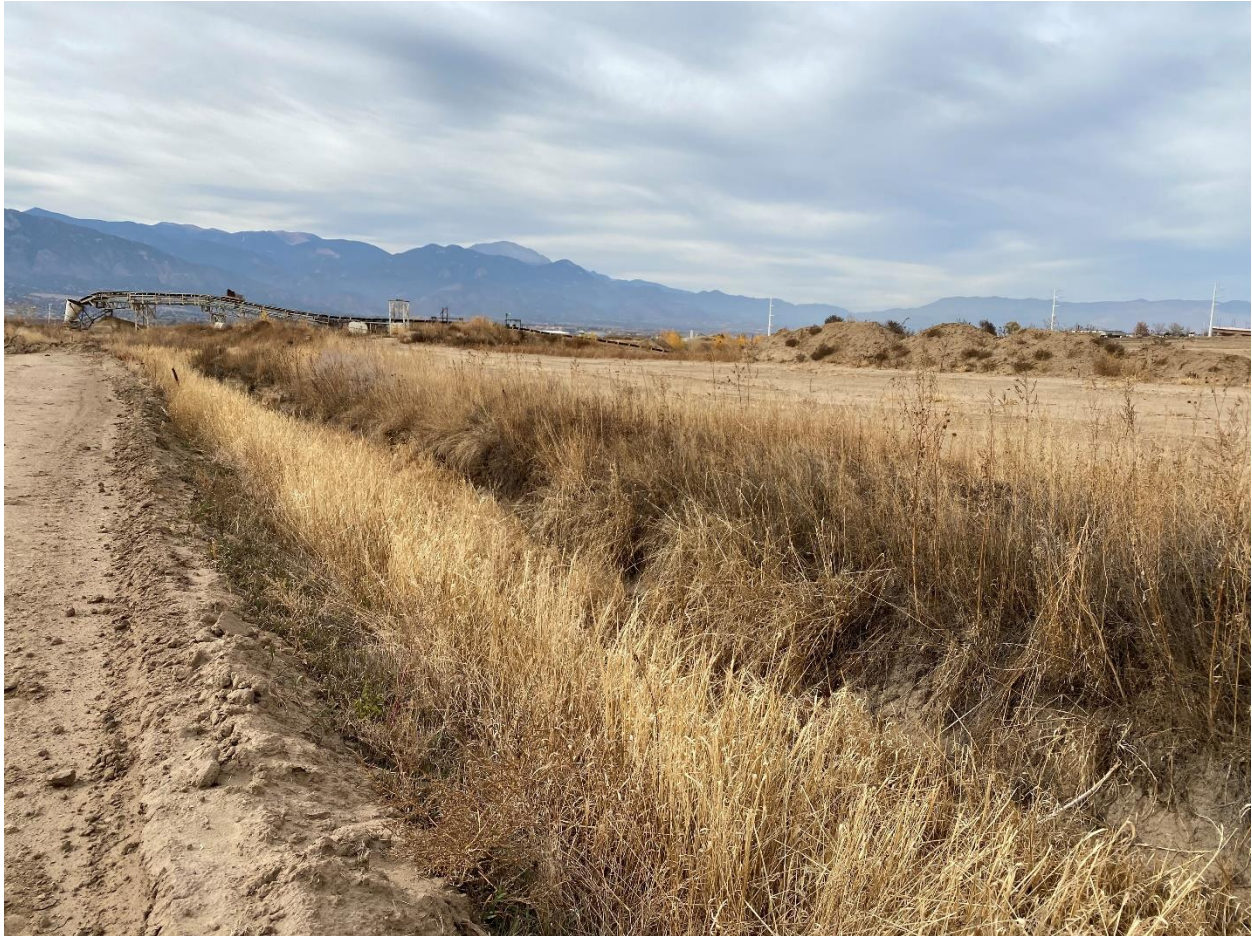
- Weather: 42-56°, partially cloudy, wind 10-15 mph
- Visual observation of the Fountain Mutual Ditch:
 - No tension cracks
 - No toe erosion
 - No moisture changes, ditch is dry
 - No sloughed slope surfaces

Photo 1. Fountain Mutual Ditch looking west

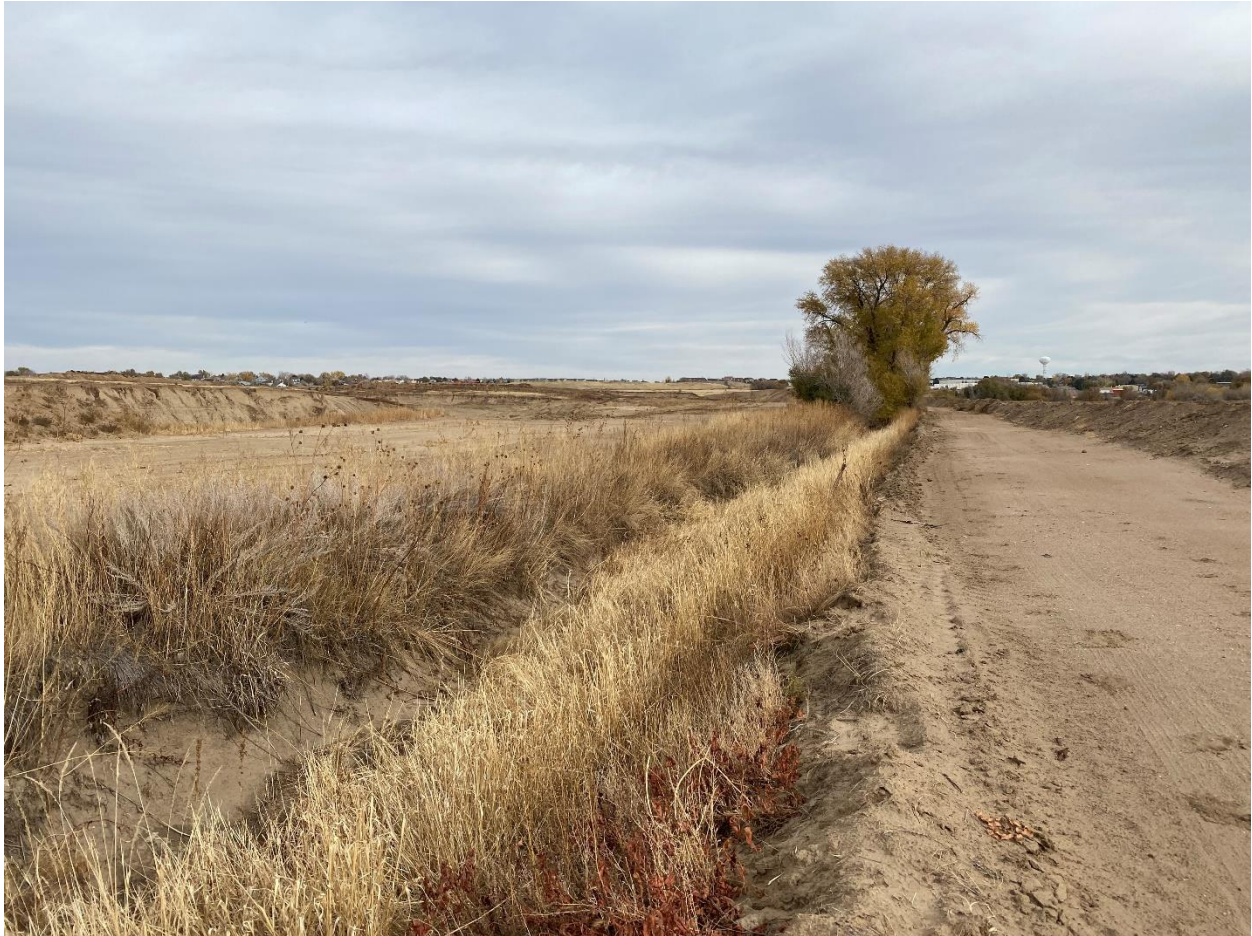
Photo 2. Fountain Mutual Ditch looking east

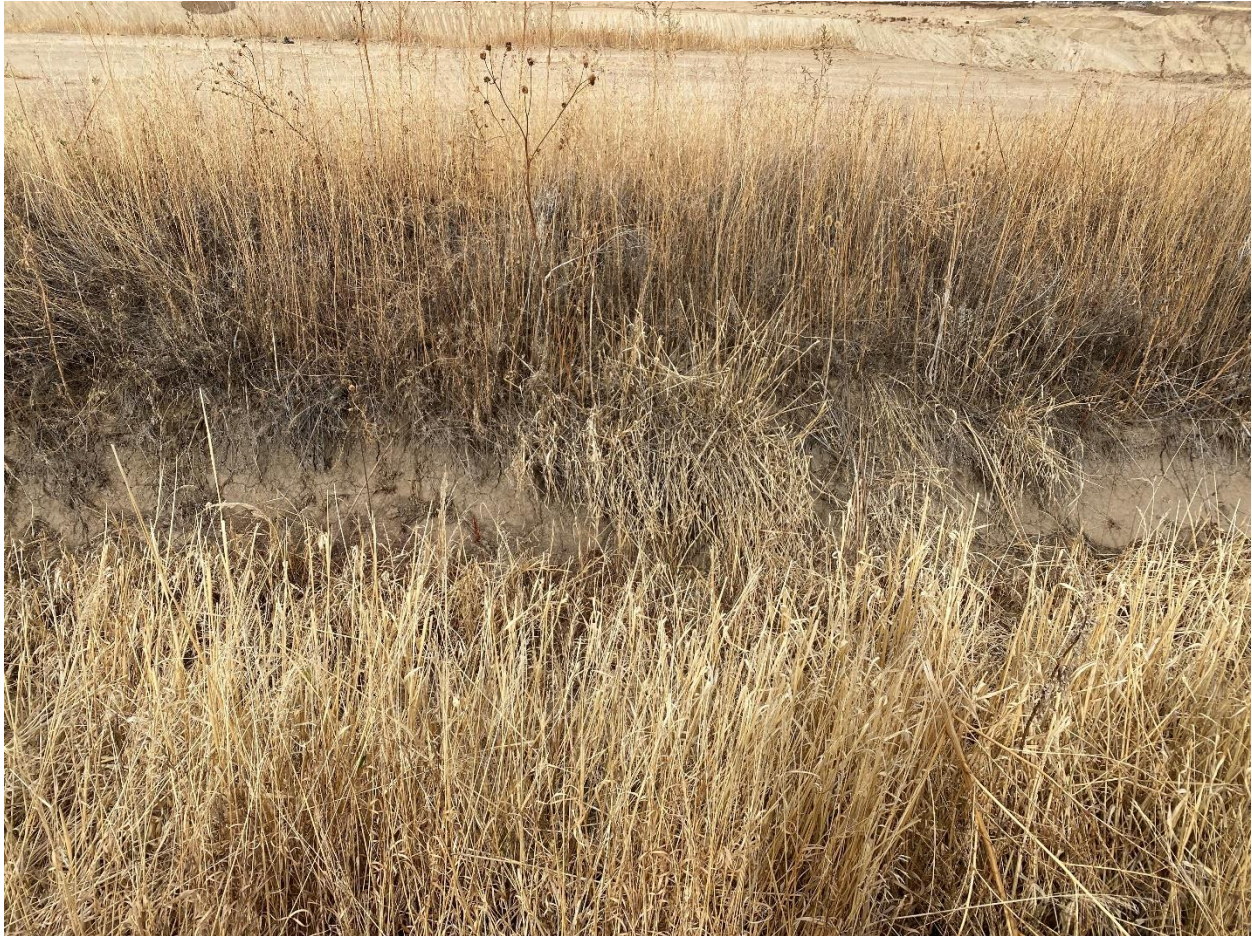
Photo 3. Fountain Mutual Ditch looking north

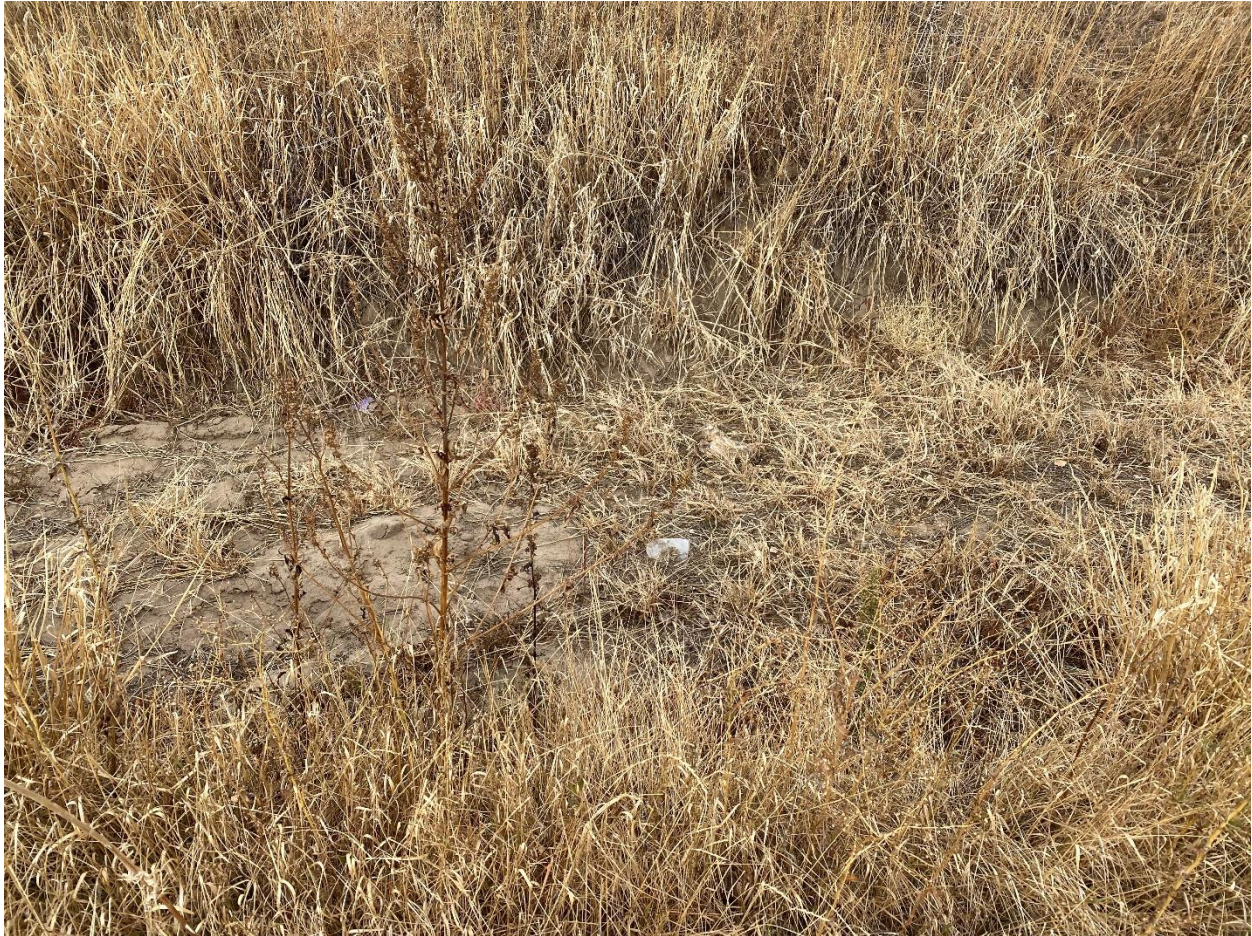
Photo 4. Fountain Mutual Ditch invert

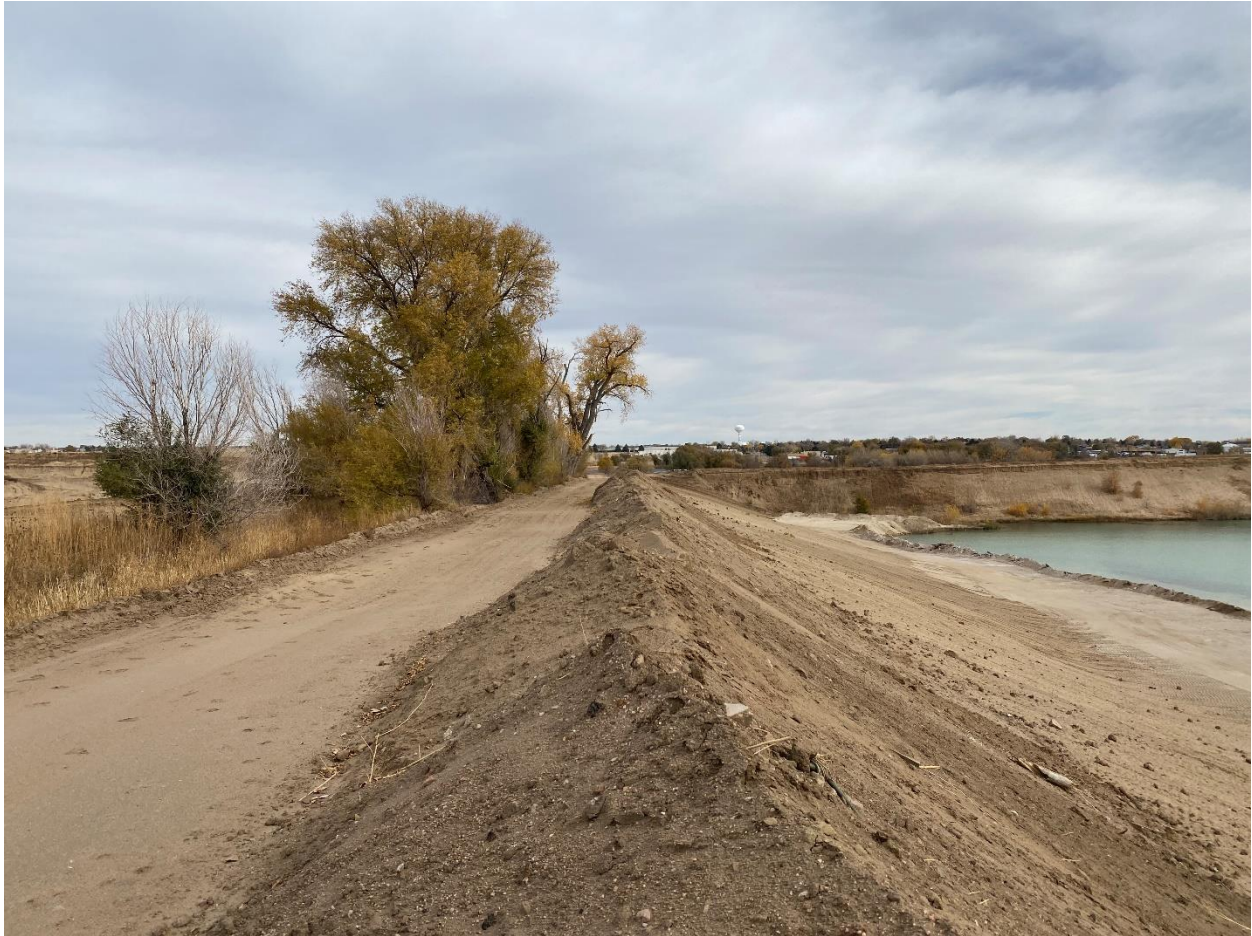
- Construction sequence
 - At this time, the buttress slope varies from 3H:1V to 4H:1V
 - Preparation for final lift
 - Stockpiled sand located at crest of embankment for the whole length

Photo 5. Stockpiled sand for final lift, access road and ditch (looking east)

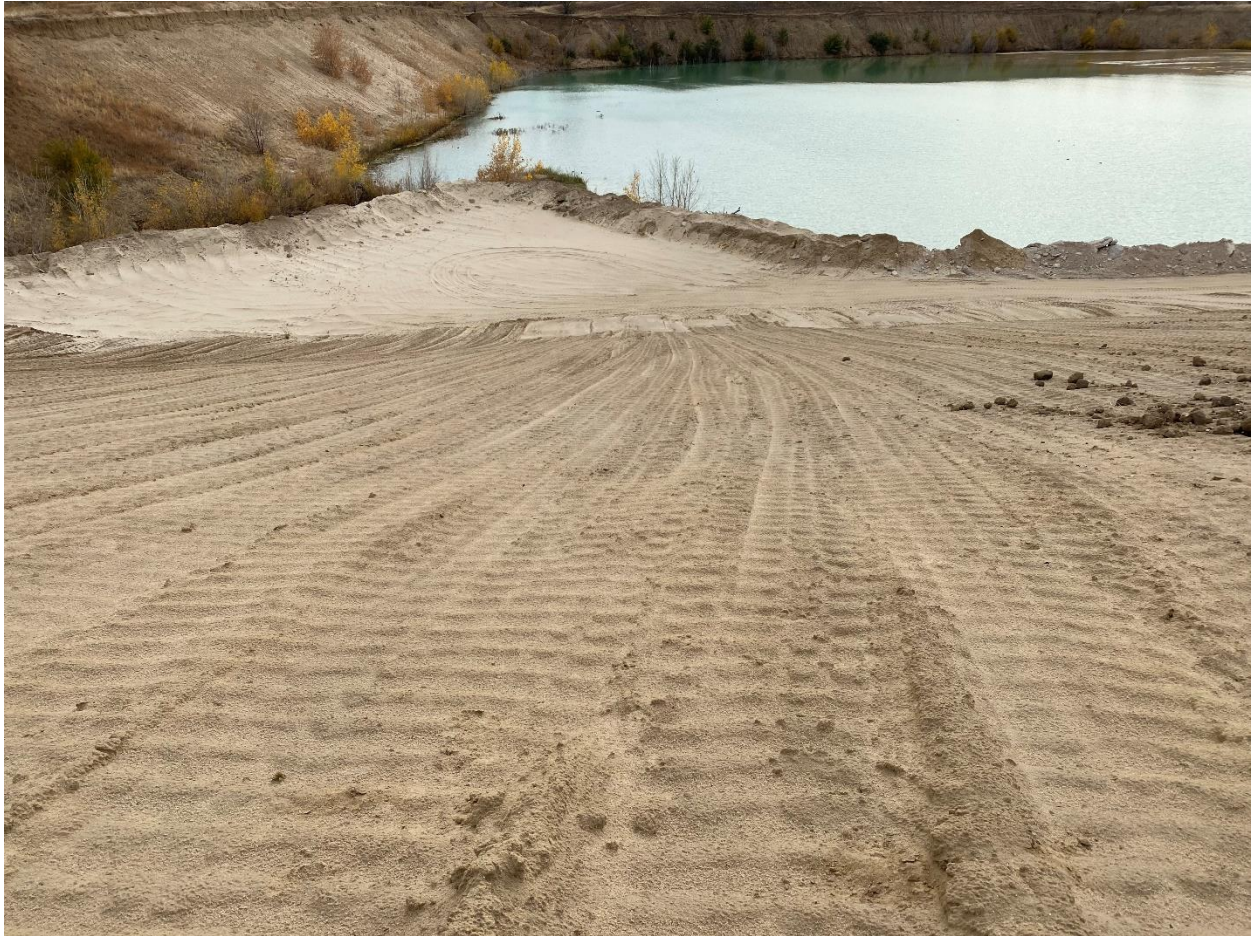
Photo 6. Buttress slope
