COLORADO
Division of Reclamation,
Mining and Safety
Department of Natural Resources

Permit Number: C-1981-018 Mine Name: Deserado Mine Operator: Blue Mountain Energy, Inc. Operator Address: Mr. Kurtis Blunt 3607 County Road 65 Rangely, CO, 81648	County: Moffat, Rio Blanco Operation Type: Underground Permit Status: Active Ownership: Private
	Operator Representative Present: Kurt Blunt
Operator Representative Signature: (Field Issuance Only)

Inspection Start Date: November 9, 2021 Inspection Start Time: 09:50 Inspection End Date: November 9, 2021 Inspection End Time: 15:30		Inspection Type: OSM Complete Inspection Inspection Reason: OSM Oversight Inspection Weather: Cloudy	
Joint Inspection Agency: OSM		Joint Inspection Contacts: Daniel MacKinnon Brook Zeller	
Post Inspection Agency: OSM		Post Inspection Contacts: Daniel MacKinnon Brook Zeller	
Inspector(s): Clayton Wein	Inspector's Signature: <i>Clayton Wein</i>		Signature Date: 11/17/2021

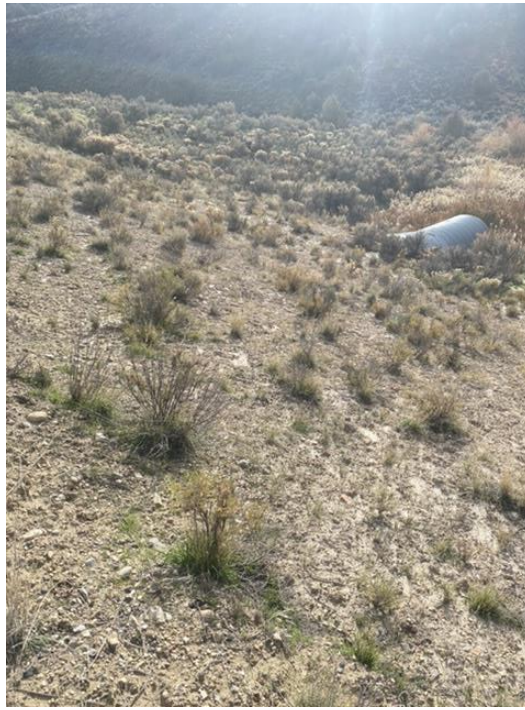
Three ponds are located within the main facilities/portals area. The DP-1 pond is located on the lowest bench and receives all runoff from the main facilities area. The pond was impounding water during the inspection. The water level in the pond had reached the primary spillway and was discharging to Scullion Gulch. The trash rack on the outlet was clear of debris. The embankment of the pond was stable with vegetative cover (Photo1). There were no erosional features observed. The PP-1 Pond is located on the middle bench within the prep plant area. The pond was holding water at the time of the inspection. There was no discharge from the pond. The embankments were stable and no erosional features were identified. The PP-2 Pond is located on the upper bench. The pond was holding water. No discharge was occurring. The embankment was stable and vegetated. No erosional features were observed.

Photo 1: The DP-1 Pond embankment.

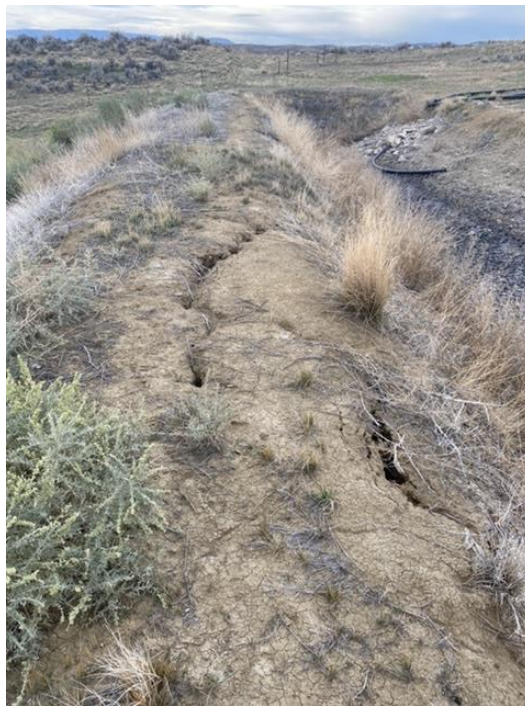
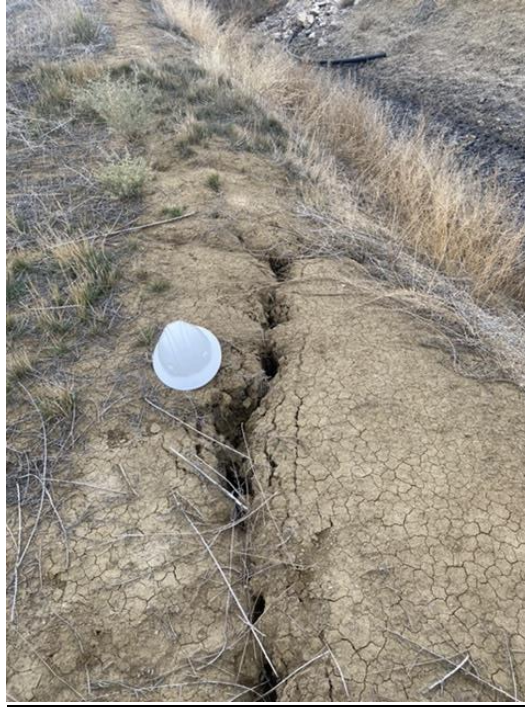
The B Seam Dewatering System No. 2 was inactive during the inspection. All cells of the system were dry. The upper cell of the system was stable and had sufficient vegetative cover on the embankment. **There were large rills and holes observed on the east embankment of the upper cell (Photos 2 and 3). Please repair this section of the embankment as soon as possible. Please reseed this portion of the embankment after completing the repairs and submit photographs to the Division once finished.**

Photo 2: The cracks on top of the embankment of B Seam Dewatering System's 1st cell.

Photo 3: A hardhat for scale next to the cracks on top of the B Seam Dewatering System No. 2's 1st cell.

- 2. B Seam Dewatering System No. 2: There were large rills and holes observed on the east embankment of the upper cell. Please repair this section of the embankment as soon as possible. Please reseed this portion of the embankment after completing the repairs and submit photographs to the Division once finished.**

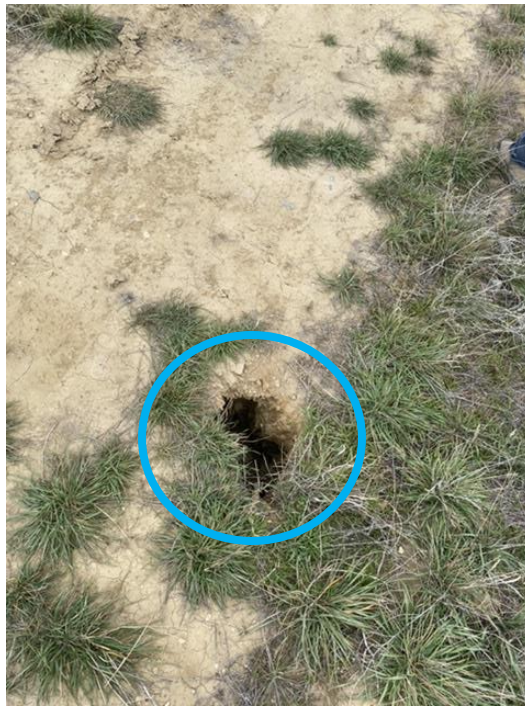
All cells of the B Seam Dewatering System No. 1 were holding water. The discharge outlet at the Last Chance Pond was discharging. The embankments of the system were observed to be stable and vegetated. There were no indications of erosional features. **During the inspection of the embankment of the Last Chance pond a burrow or small hole in the top of the southeastern portion of the embankment was identified (Photo 4). Please repair and plug this hole. Once the repairs have been completed, please submit photos to the Division of the completed maintenance item.**

Photo 4: The hole or burrow on top of the Last Chance Pond's embankment outlined by the blue circle.

- 3. B Seam Dewatering System No.1/Last Chance Pond: On the embankment of the Last Chance pond a burrow or small hole in the top of the southeastern portion of the embankment was identified. Please repair and plug this hole. Once the repairs have been completed, please submit photos to the Division of the completed maintenance item.**

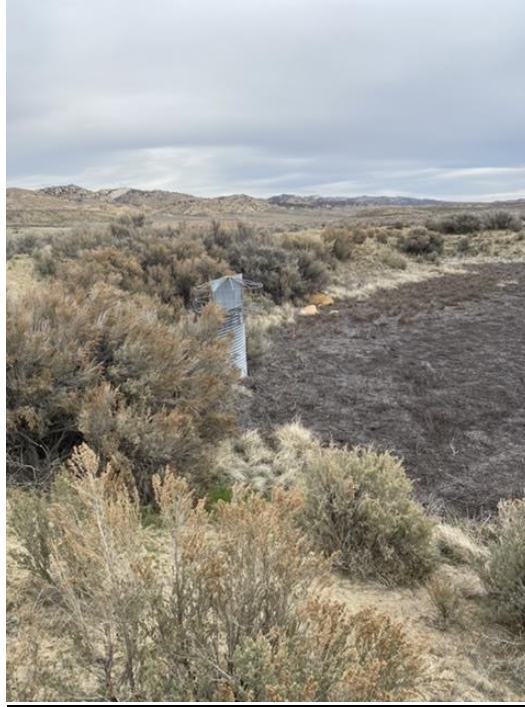
The RP-1 pond is located at the northern base of the reclaimed RP-1 Refuse Pile. The pond was dry during the inspection. The trash rack on the spillway was clear of debris (Photo 5). The embankment was stable with vegetative cover. There were no indications of erosion.

Photo 5: The outlet of the RP-1 Pond.

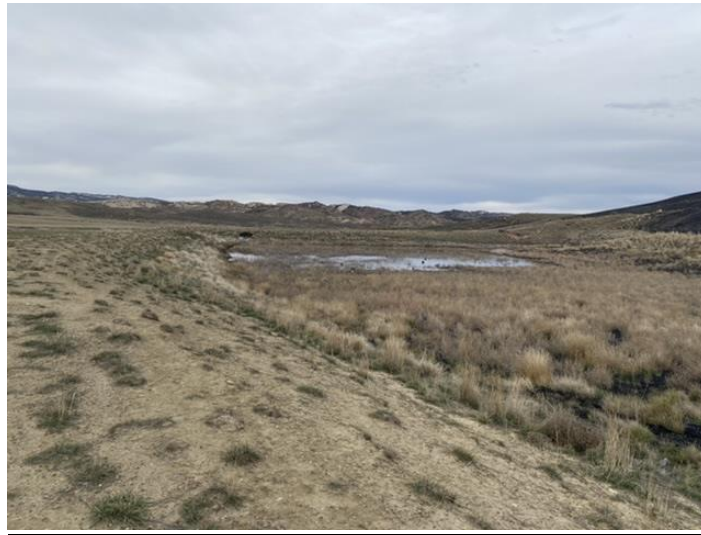
The RP-4 Pond is located at the northwestern base of the RP-2/3/4 Refuse Pile. The pond was holding a small amount of water in it (Photo 6). The level of the water was below the elevation of the discharge outlet. The trash rack on the outlet was unobstructed. The embankment was observed to be stable with vegetative cover. There was no evidence of erosion.

Photo 6: The RP-4 Pond.

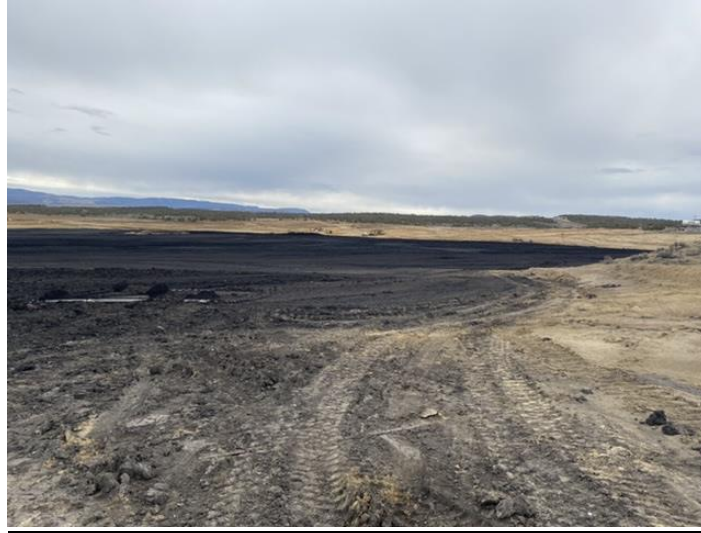
Earthwork was continuing at the RP-A Refuse Area to create the base of the pile (Photo 7). The site was stable and there were no indications of erosion.

Photo 7: The RP-A Refuse Disposal Area.

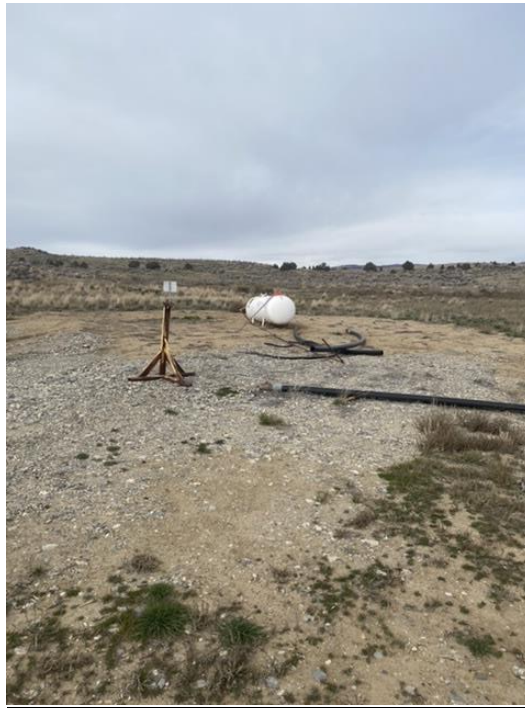
Nitrogen Injection Well Pads, 14L-XC-48 and 13L-XC-60 (Photo 8) were inspected. The pads were stable with no erosional features. The gravel on the pads was in good repair and there was no rutting observed.

Photo 8: The 13L-XC-60 Nitrogen Injection well pad.

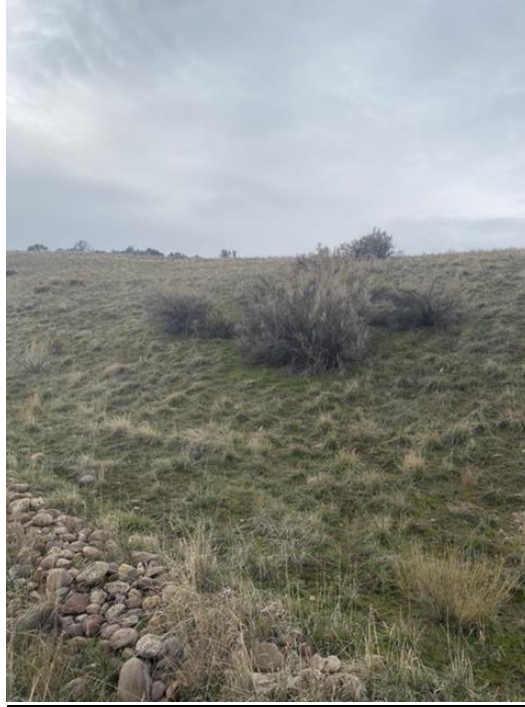
The topsoil pile for the Main Facilities/Portals Area is located above the upper bench. The topsoil pile was stable with vegetative cover (Photo 9). Topsoil markers were placed in easily identifiable locations. The perimeter ditch was stable with no erosional concerns. The slope below the topsoil pile, between the upper and middle bench has riling on it (Photo 10). The rills are not affecting the drainage control structures or the stability of the topsoil resource. If these rills enlarge to gullies, the Division will request the operator to repair the slope.

Photo 9: The Main Facilities/Portals Area Topsoil Stockpile.

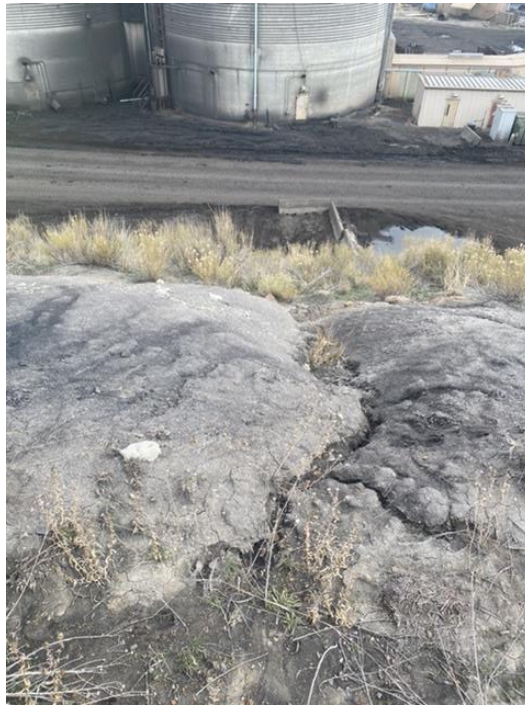
Photo 10: The rills on the slope between the upper and middle benches at the Main Facilities/Portals Area.

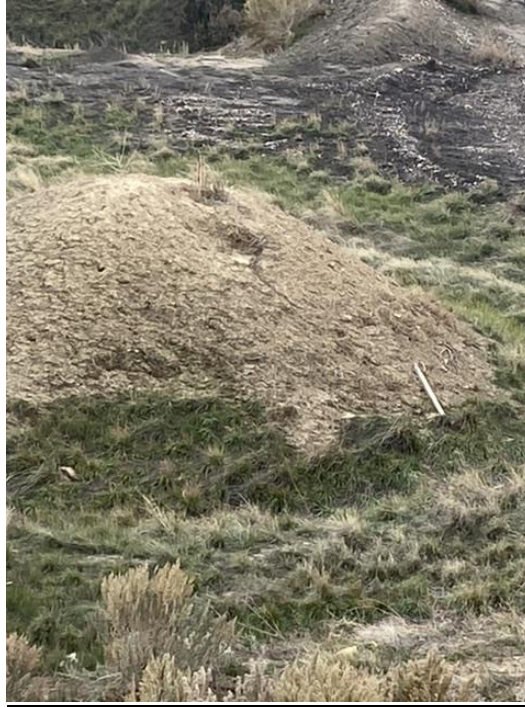
The topsoil pile located next to the RR-1 Pond was vegetated and stable. There was no evidence of erosion or a loss of topsoil resource. **The white pvc pipe over the topsoil marker had broken and fallen off the pile (Photo 11). Please preplace the pvc marker on top of the pile. Please provide the Division with a photo once the marker has been replaced.**

Photo 11: The topsoil stockpile next to the RR-1 Pond needs to have the topsoil pile marker replaced.

- 4. RR-1 Topsoil Pile: The white PVC pipe over the topsoil marker had broken and fallen off the pile. Please preplace the PVC marker on top of the pile. Please provide the Division with a photo once the marker has been replaced.**
