Bowie 1 inspection

Permit Number: C-1981-038 Mine Name: Bowie No. 1 Mine Operator: Bowie Resources, LLC Operator Address: Mr. Basil R Bear P.O. Box 1488 Paonia, CO 81428	County: Delta Operation Type: Underground Permit Status: Active Ownership: Private
	Operator Representative Present: Basil Bear
Operator Representative Signature: (Field Issuance Only)

Inspection Start Date: November 16, 2021 Inspection Start Time: 12:20 Inspection End Date: November 16, 2021 Inspection End Time: 15:30	Inspection Type: Coal Complete Inspection Inspection Reason: Normal I&E Program Weather: Cloudy
Joint Inspection Agency: None	Joint Inspection Contacts:
Post Inspection Agency: OSM	Post Inspection Contacts:
Inspector(s): Robert Zuber, P.E.	Inspector's Signature: <i>Robert D. Zuber</i> Signature Date: 11/18/2021

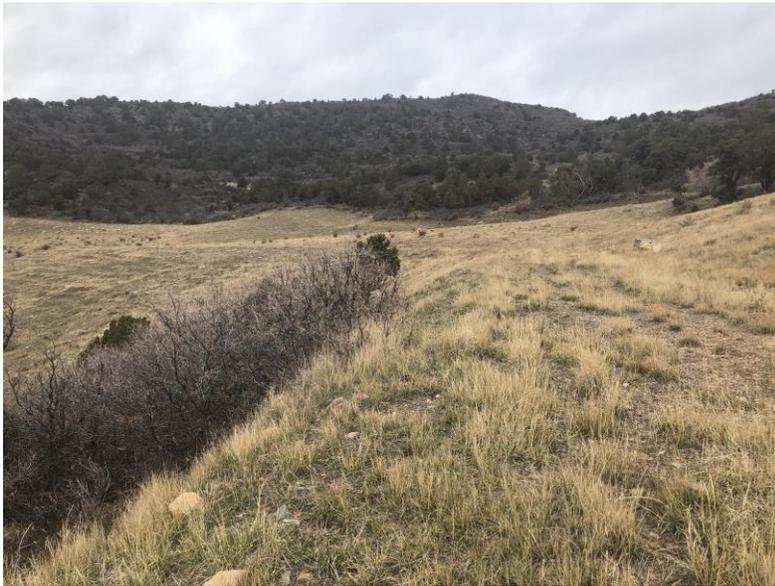
East Mine, upper portion

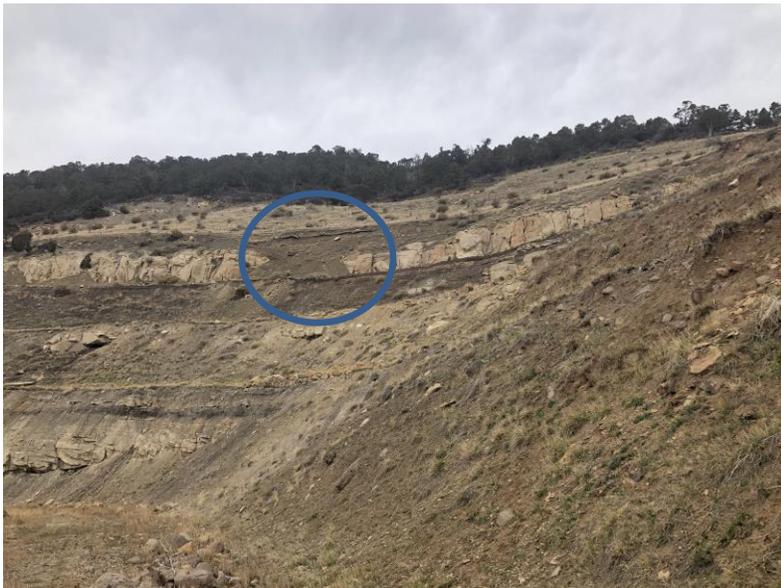
No erosion was seen at the reclaimed area of the East Mine, although an area on the upper part (on the very steep slope near the reclaimed portal bench) requires monitoring and possibly some maintenance. There is a fallen fence (chain link and t-posts) that is mostly buried but partially exposed. Ideally, the fencing material should be removed to protect wildlife, and this part of the hillside should be further stabilized to prevent erosion. This issue requires future coordination between BRL, the Division, and (as appropriate) OSM. The Division recognizes that safety is a concern if BRL works in this area.

East Mine, area of concern (circled)

Basil, please put some thought into options to address the fallen fence near the upper end of the East Mine. Perhaps you could hire tree trimmers or other folks with climbing equipment and expertise to help resolve the safety issue.

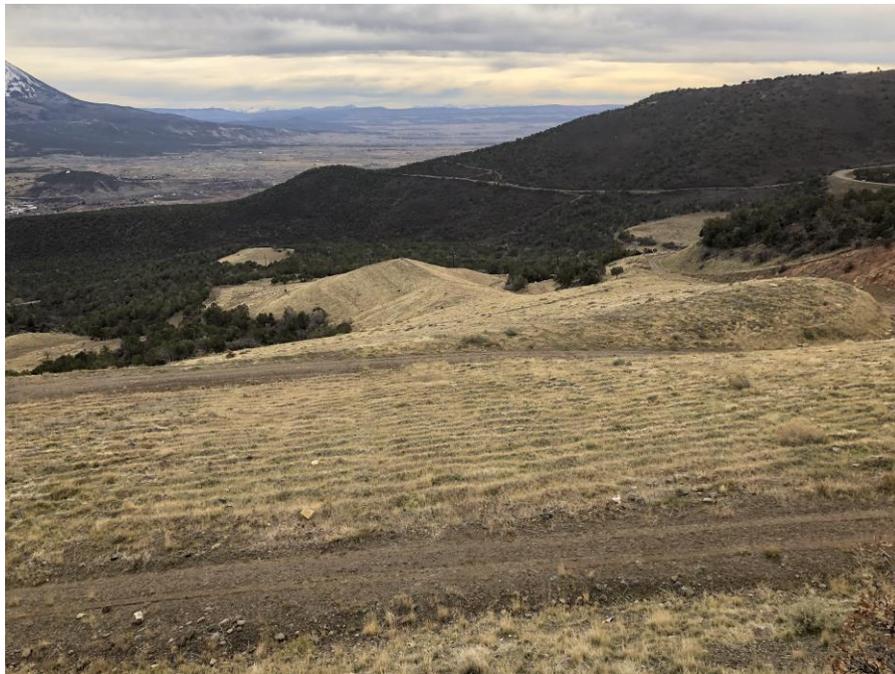
East Mine, lower portion including RDA

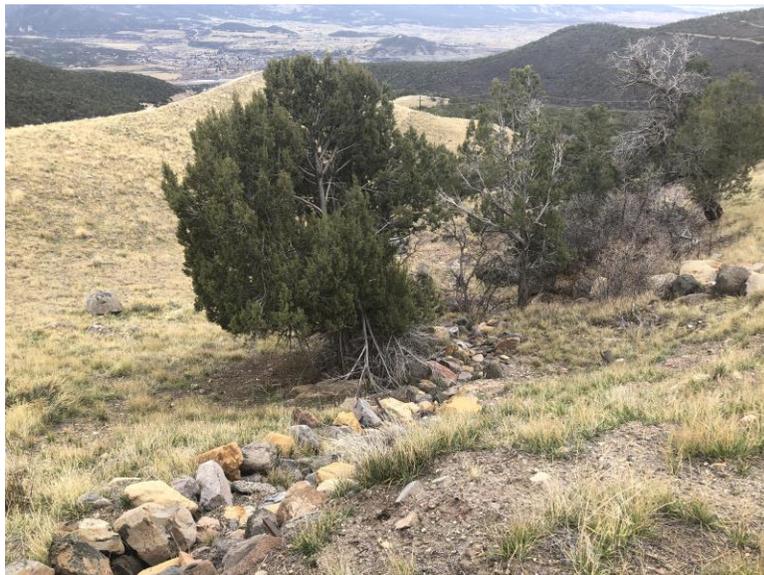
Riprap ditches at the East Mine are stable.

Riprap channel above RDA

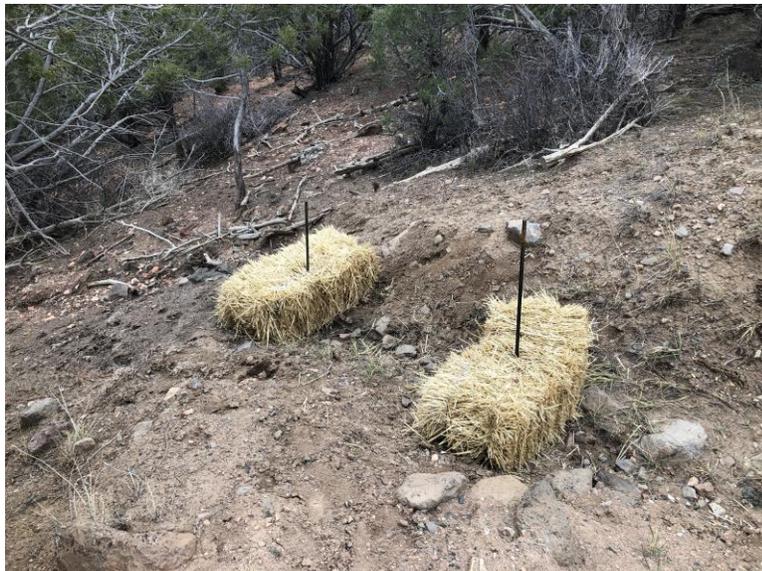
The newly installed straw bales east of the RDA should be monitored closely. It is not apparent that they were installed deep enough in the soil, and undercutting could occur. Also, it would be better if more bales (or wattles) were added on the sides, extending up the bank.

Newly installed straw bales southeast of RDA

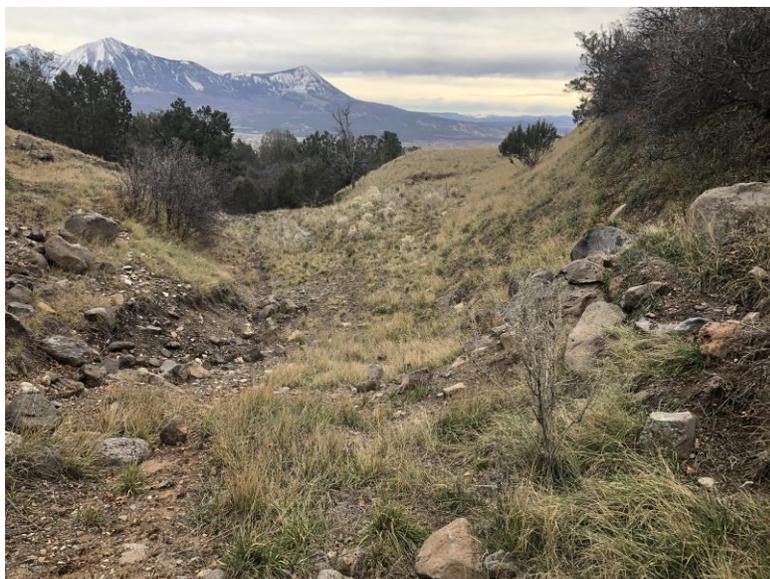
The drainage below the East Mine where the reclaimed ponds (Ponds 1 – 4) are located was in good shape, including the straw bales at the Pond 4 area.

Reclaimed Pond 2 at East Mine

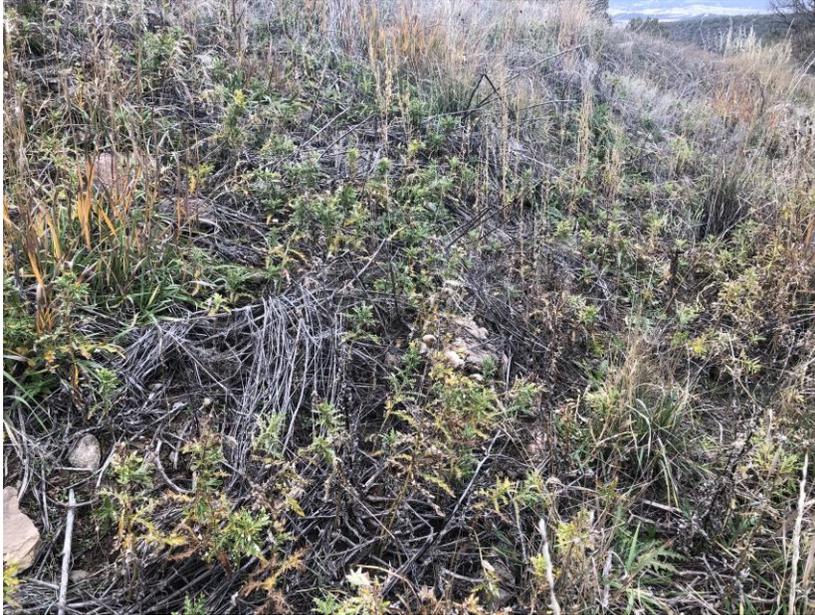
At Ponds 3 and 4, many thistle plants were seen, including Canada thistle and another species (possibly Scotch thistle). These should be sprayed, spring 2022 at the latest.

Canada thistle at reclaimed Pond 3

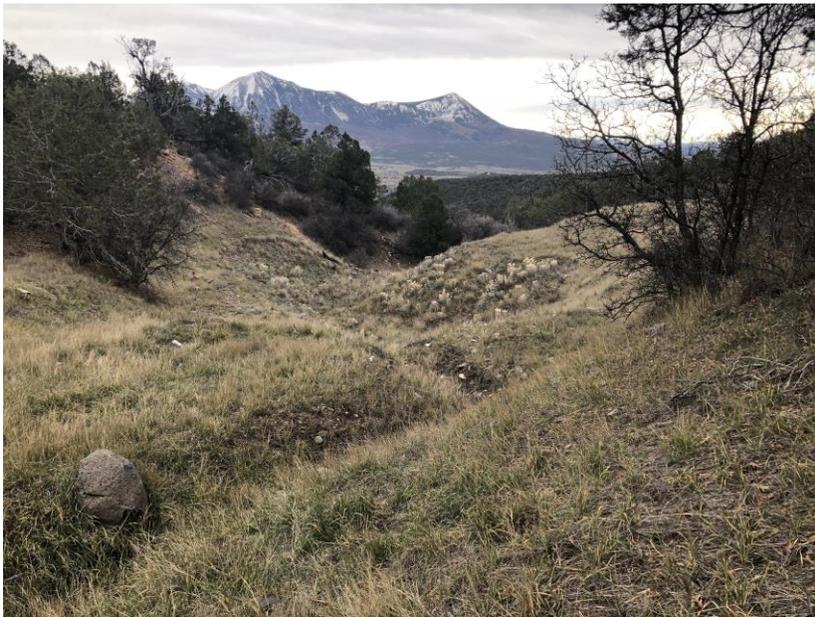
Reclaimed Pond 4

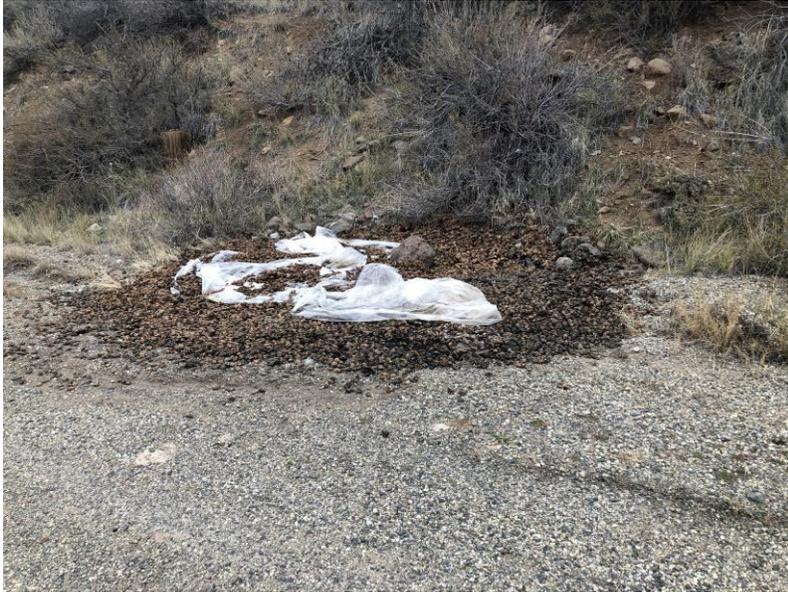
Roads at the East Mine are in good shape. The road to the ROM area is also in good shape, although the operator should remove trash (plastic and peach pits) that were dumped there.

Trash at ROM road

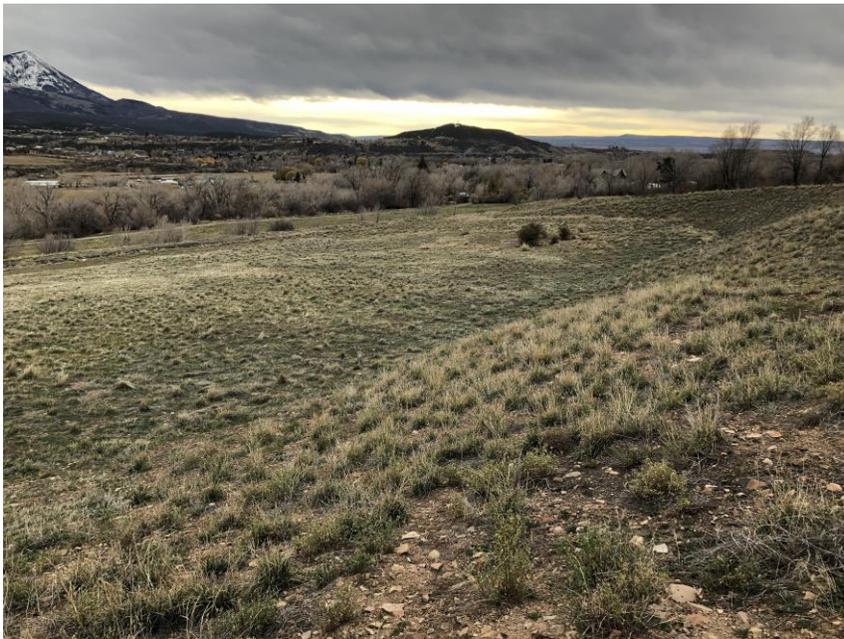
No problems were seen with the Coal Storage Area by Black Bridge Road. Vegetation cover is good.

Coal Storage Area by Black Bridge Road
