Bowie 2 inspection report

COLORADO
Division of Reclamation,
Mining and Safety
Department of Natural Resources

Permit Number: C-1996-083 Mine Name: Bowie No. 2 Mine Operator: Bowie Resources, LLC Operator Address: Mr. Basil Bear P.O. Box 1488 Paonia, CO 81428	County: Delta Operation Type: Underground Permit Status: Active Ownership: Private
	Operator Representative Present: Basil Bear
Operator Representative Signature: (Field Issuance Only)

Inspection Start Date: November 17, 2021 Inspection Start Time: 06:50 Inspection End Date: November 17, 2021 Inspection End Time: 10:30		Inspection Type: Coal Complete Inspection Inspection Reason: Normal I&E Program Weather: Clear	
Joint Inspection Agency: None		Joint Inspection Contacts: 	
Post Inspection Agency: None		Post Inspection Contacts: 	
Inspector(s): Robert Zuber, P.E.	Inspector's Signature: <i>Robert D. Zuber</i>		Signature Date: 11/18/2021

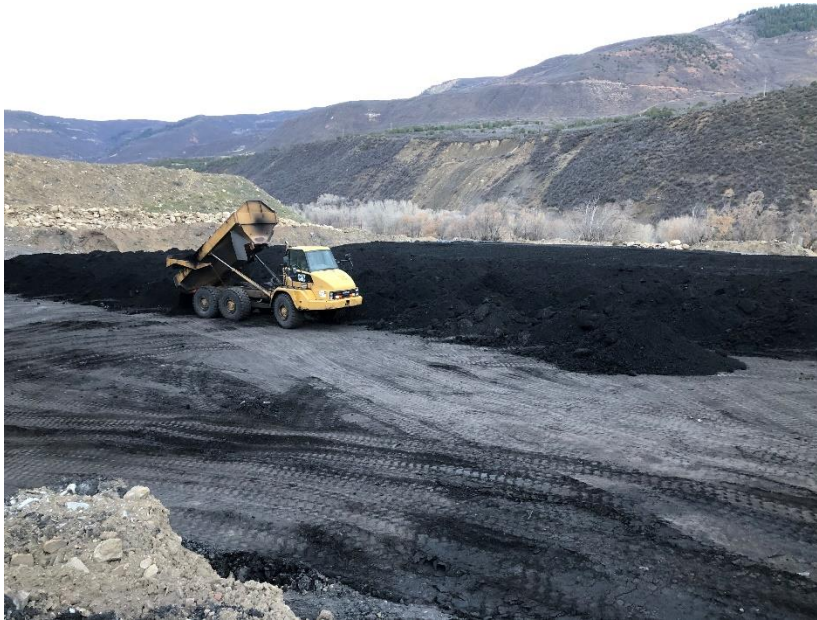
BRL continues to focus their efforts on Gob Pile #3. During the inspection, BRL staff were hauling material from the top of the pile to the eastern side. Basil indicated that they have removed approximately six feet off the top of the pile in the past two months. Basil also indicated that BRL's engineering consultant (Huddleston-Berry Engineering & Testing) plans to perform compaction testing on the east portion of the pile on November 22, 2021.

No issues were seen at Gob Pile #3, where BRL staff have been focusing their reclamation activities. Per Basil Bear, the material moved to the east side to be spread and compacted contains a good amount of moisture, not too dry or too wet. .

Material dumping on Gob Pile #3, prior to spreading and compacting

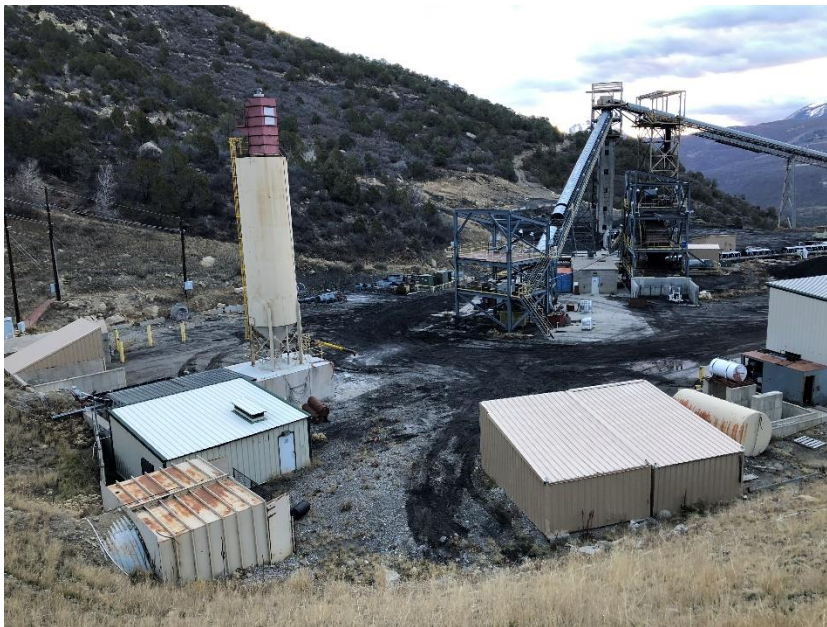
All benches appeared stable with no signs of erosion. These include the pads for the Utility Bench, B Portal bench and the D Portal bench. Other comments on facilities:

Upper portion of D Portal bench

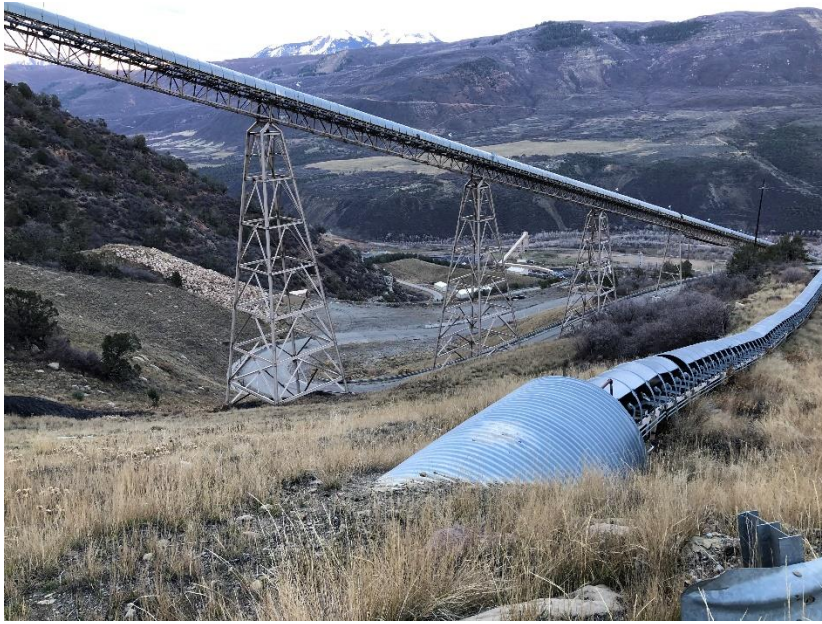
Slope below the D Portal bench

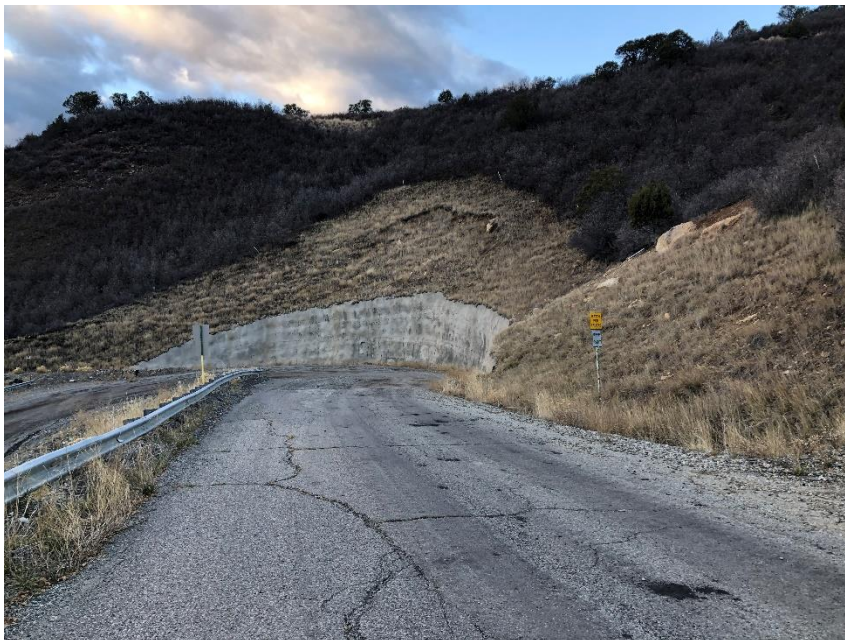
It appears that slumps have not moved significantly in the recent past. These include slumps by the B Portal and by Curve Number 11 along the Haul Road. The Division recommends that these continue to be monitored closely by BRL.

Slump at Curve 11

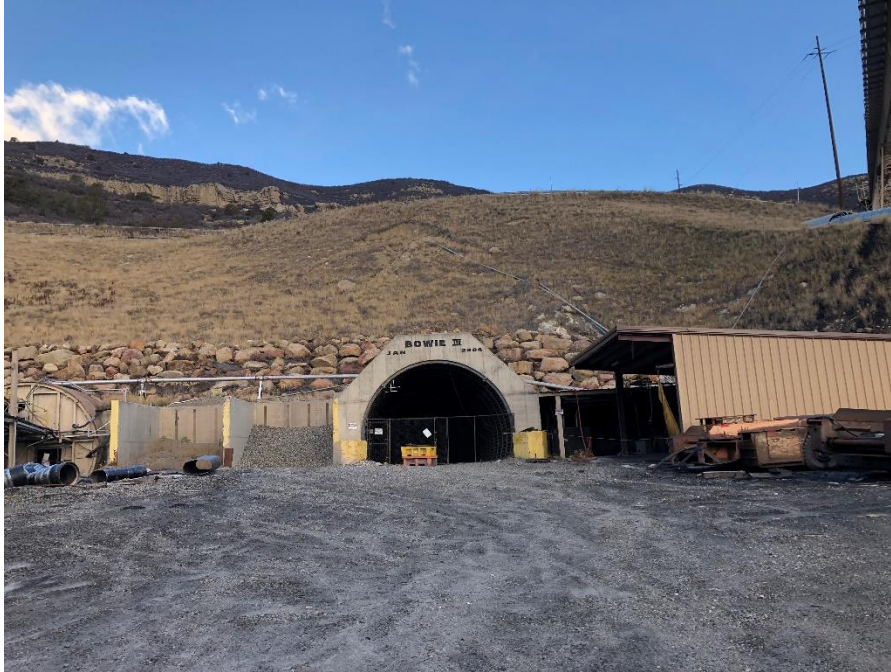
Slump above B Portal

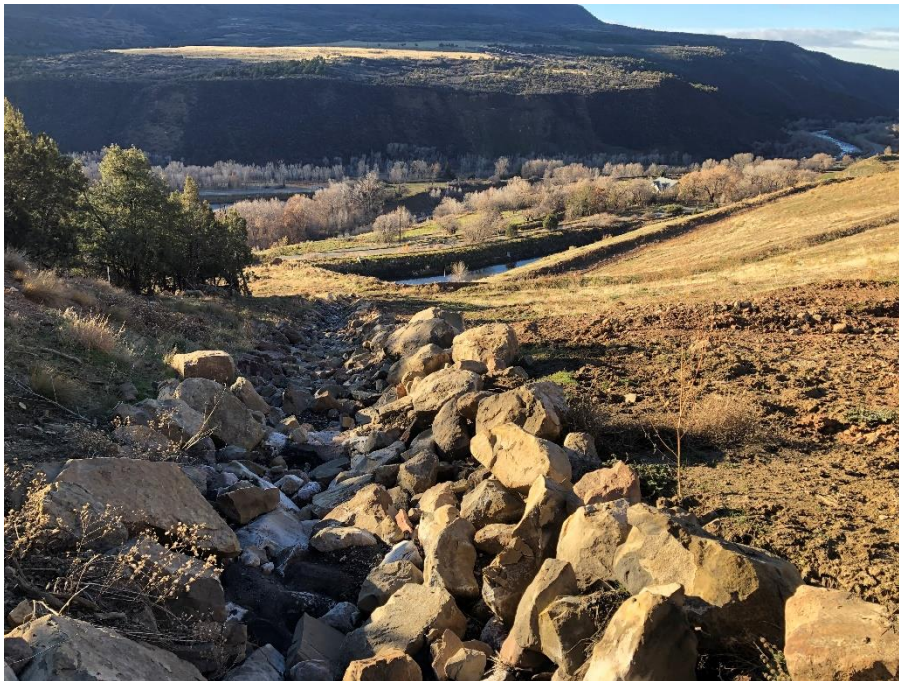
Channel above Pond F

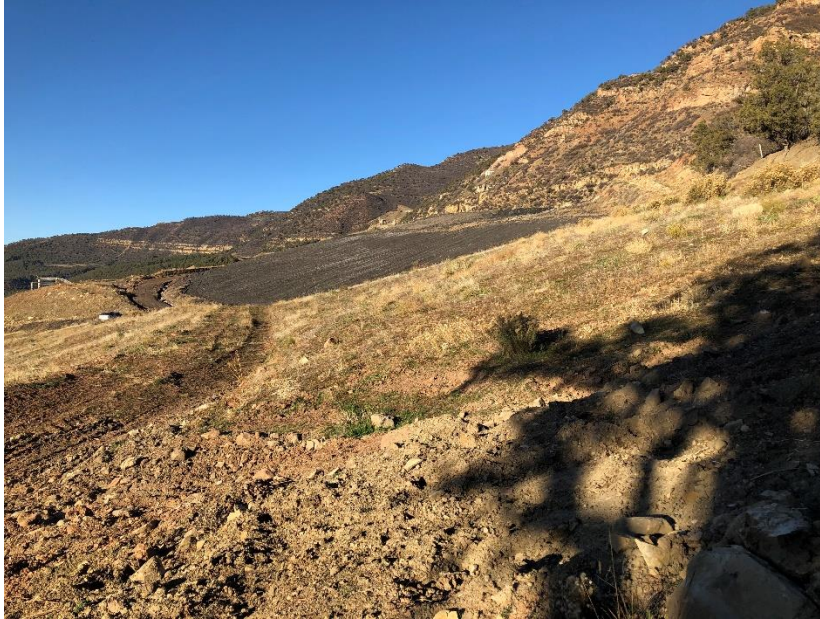
On the upper and lower lifts of Gob Pile #2 only small rills were observed. Overall the pile appeared stable. The drainage control practices on the upper (flat) portion of this pile appear to be functioning well, although it is recommended that BRL create a ditch to prevent erosion at the east end of the pile. No puddles were observed on the pile.

Gob Pile #2, middle portion

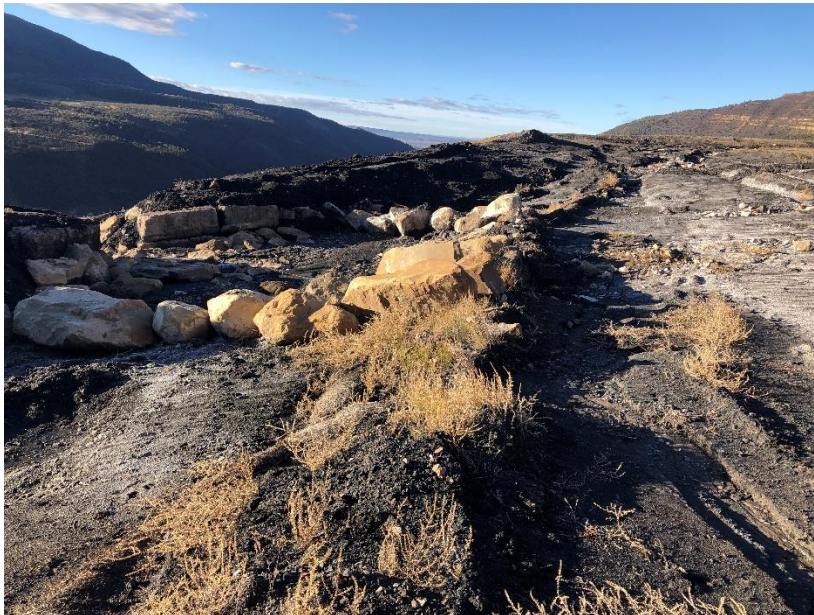
Gob Pile #2, sediment sump

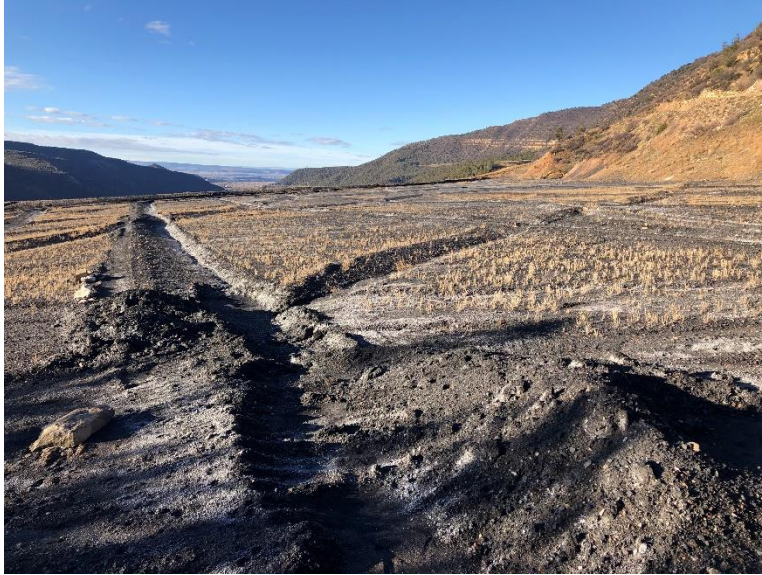
Gob Pile #2, upper portion

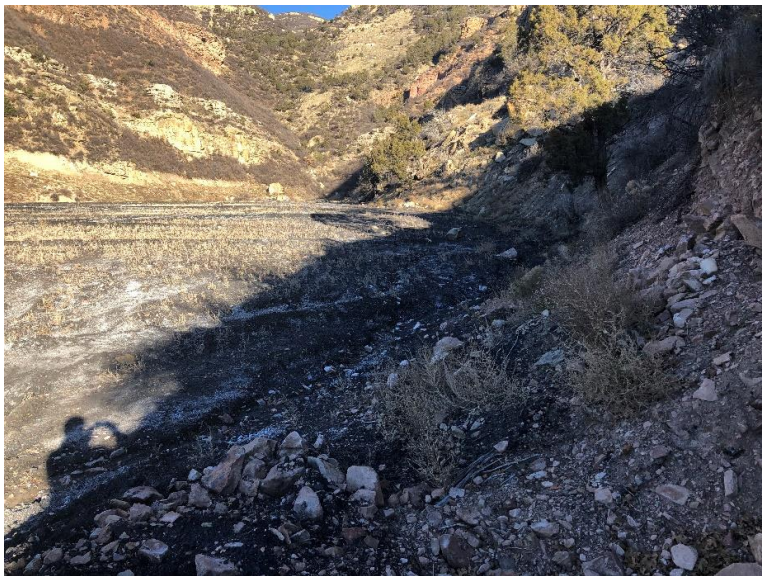
Gob Pile #2, area where a new ditch is recommended

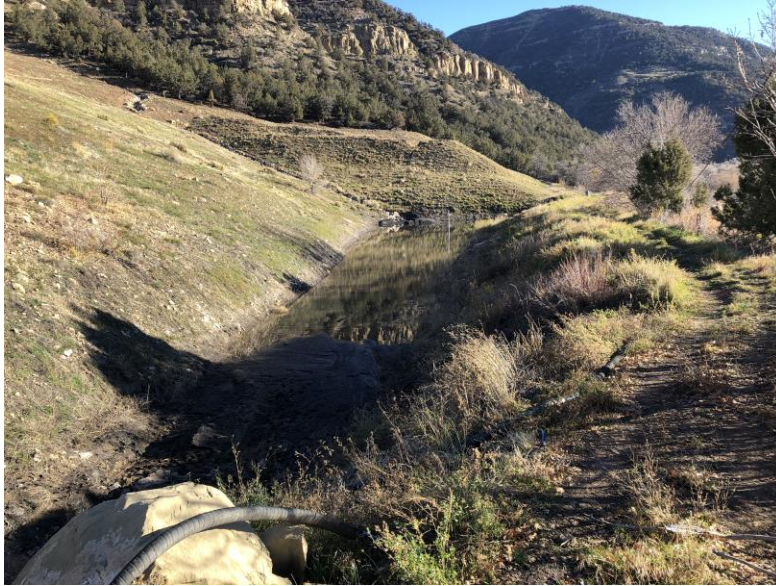
Six sediment ponds were inspected: B, C, D, F, J, and K. None of the ponds were discharging. All of the ponds contained water from recent precipitation, but none of the ponds were close to full. (In Pond K, there was no standing water but the soil was muddy.) The water in Pond J was approximately 8 feet below the emergency spillway. No significant problems were identified with embankments, spillways, inlet channels, or other features of the ponds. The amount of vegetation in the Pond J should be monitored, and some vegetation should be removed if the amount significantly impacts the storage capacity of the pond.

Pond F

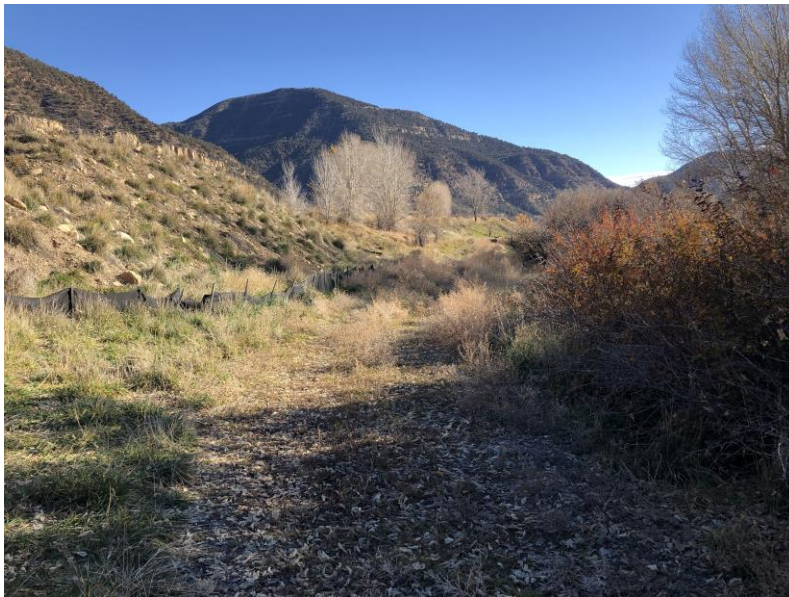
At topsoil stockpiles and coverfill piles, berms, vegetation, and silt fence are keeping these resources in place.

Topsoil stockpile near Pond J
