MINERALS PROGRAM INSPECTION REPORT**PHONE: (303) 866-3567**

MINE NAME: C-LP-21 Mine	MINE/PROSPECTING ID#: M-1977-305	MINERAL: Uranium and vanadium	COUNTY: Montrose
INSPECTION TYPE: Monitoring	INSPECTOR(S): Dustin M. Czapla	INSP. DATE: November 9, 2021	INSP. TIME: 12:00
OPERATOR: Highbury Resources, Inc.	OPERATOR REPRESENTATIVE: Scott Pottorffs	TYPE OF OPERATION: 112d-1 - Designated Mining Operation	
REASON FOR INSPECTION: Normal I&E Program	BOND CALCULATION TYPE: None	BOND AMOUNT: \$48,100.00	
DATE OF COMPLAINT: NA	POST INSP. CONTACTS: None	JOINT INSP. AGENCY: None	
WEATHER: Clear	INSPECTOR'S SIGNATURE:

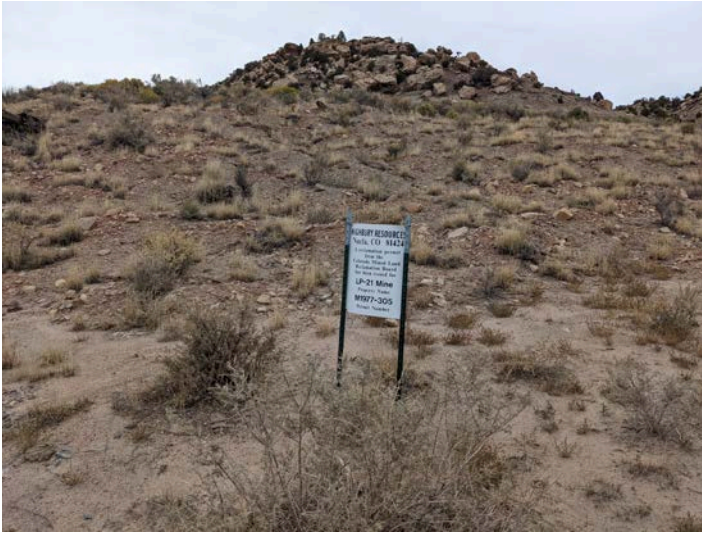
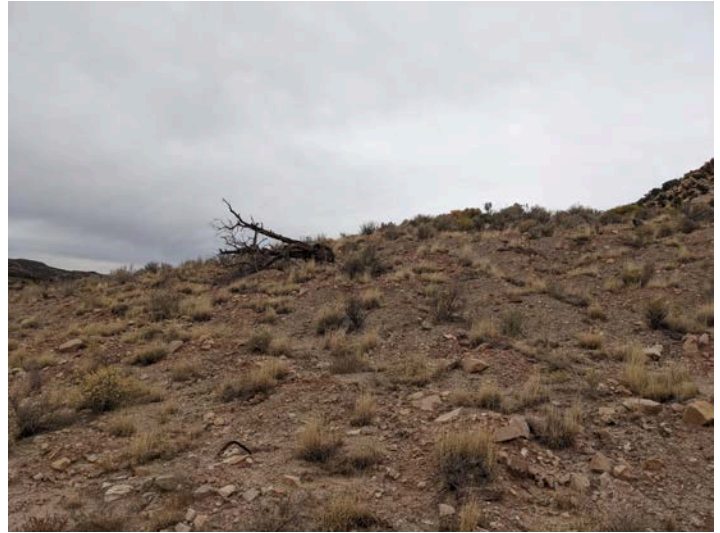
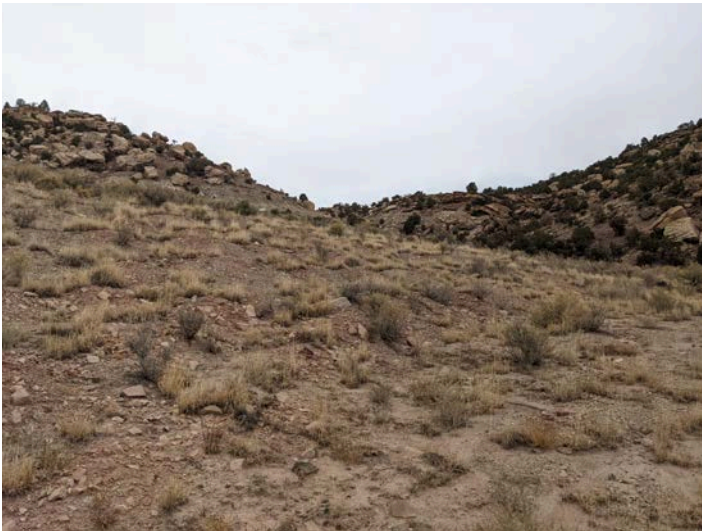
According to the operator's annual reports, final reclamation was completed at this site in February, 2003. All reclaimed slopes appeared stable and vegetation is well established over the reclaimed areas.
