MINERALS PROGRAM INSPECTION REPORT
PHONE: (303) 866-3567

MINE NAME: CM-25 Mine	MINE/PROSPECTING ID#: M-1977-307	MINERAL: Uranium and vanadium	COUNTY: Montrose
INSPECTION TYPE: Monitoring	INSPECTOR(S): Dustin M. Czapla	INSP. DATE: November 9, 2021	INSP. TIME: 11:30
OPERATOR: Highbury Resources, Inc.	OPERATOR REPRESENTATIVE: Scott Pottorffs	TYPE OF OPERATION: 110d - Designated Limited Impact

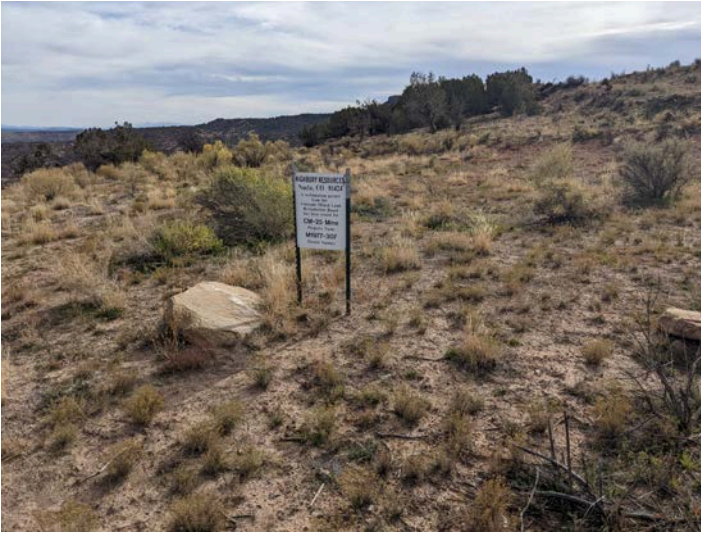
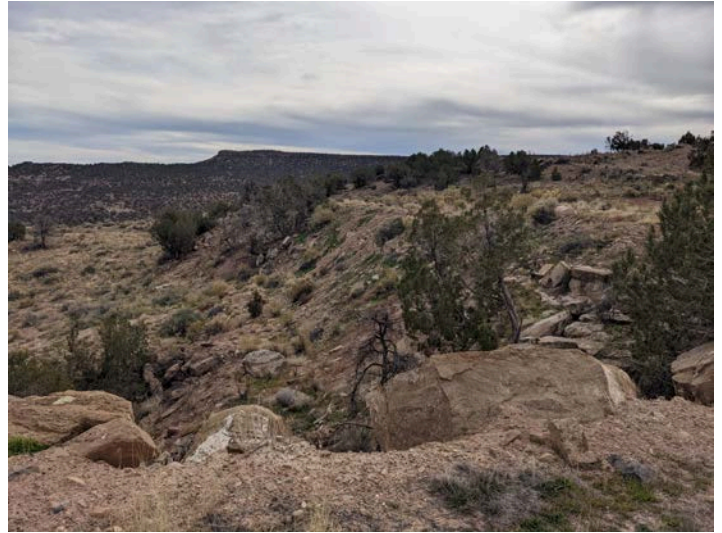
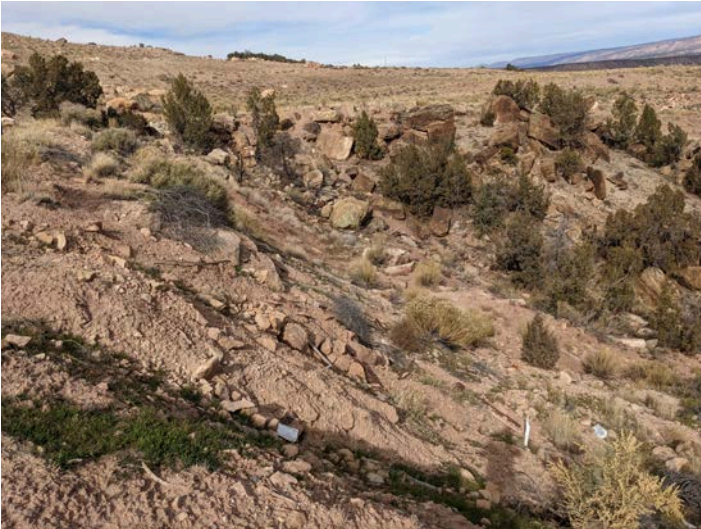
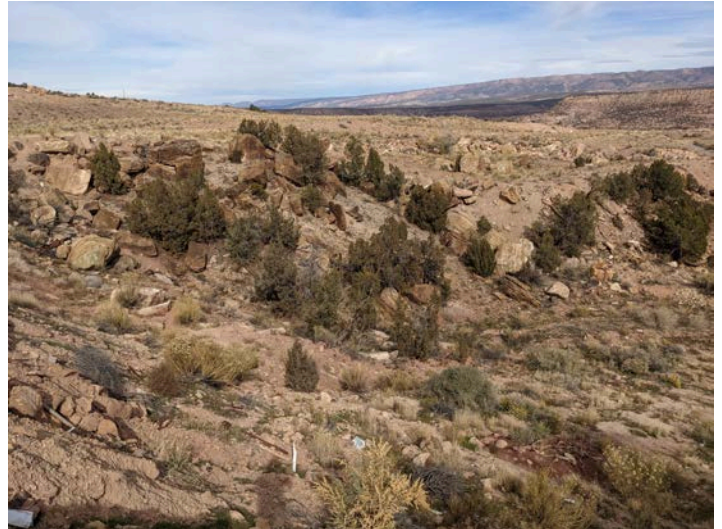
According to the operator's annual reports, final reclamation was completed at this site in February, 2003. This inspection verified reclamation is complete. Slopes appeared stable and vegetation is well established over the reclaimed areas.
