MINERALS PROGRAM INSPECTION REPORT
PHONE: (303) 866-3567

MINE NAME: C-JD-5	MINE/PROSPECTING ID#: M-1977-248	MINERAL: Uranium and vanadium	COUNTY: Montrose
INSPECTION TYPE: Monitoring	INSPECTOR(S): Dustin Czapla	INSP. DATE: November 9, 2021	INSP. TIME: 13:00
OPERATOR: Gold Eagle Mining, Inc.	OPERATOR REPRESENTATIVE: None	TYPE OF OPERATION: 112d-1 - Designated Mining Operation	
REASON FOR INSPECTION: Normal I&E Program	BOND CALCULATION TYPE: None	BOND AMOUNT: \$100.00	
DATE OF COMPLAINT: NA	POST INSP. CONTACTS: None	JOINT INSP. AGENCY: DOE	
WEATHER: Clear	INSPECTOR'S SIGNATURE:

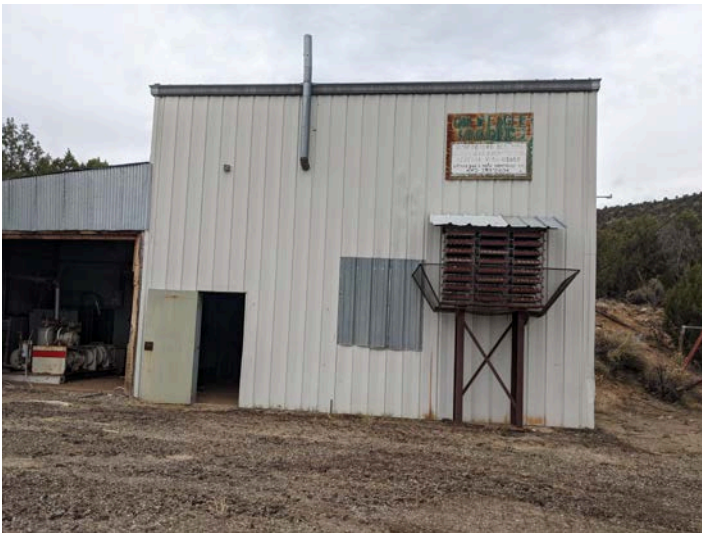
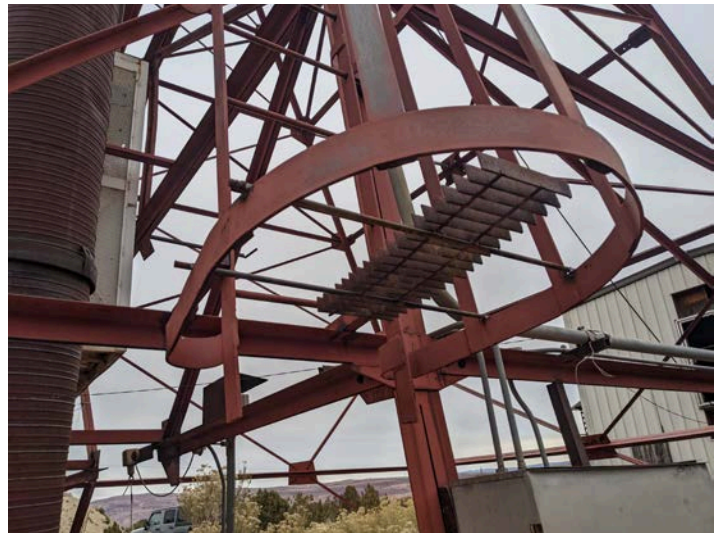
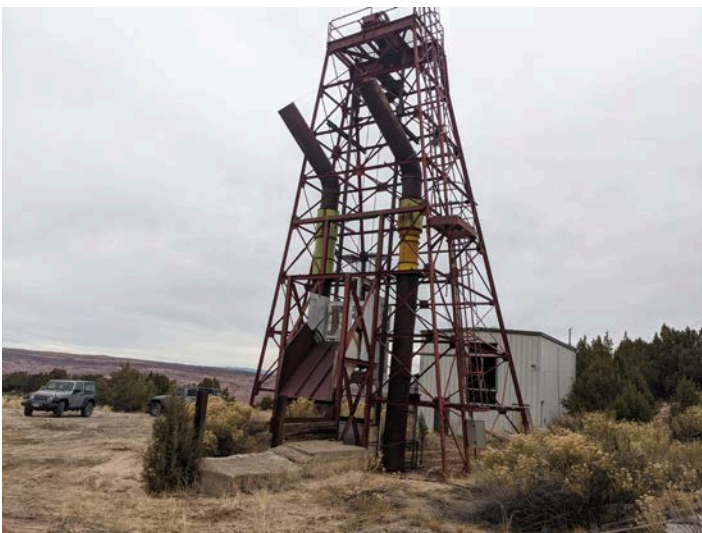
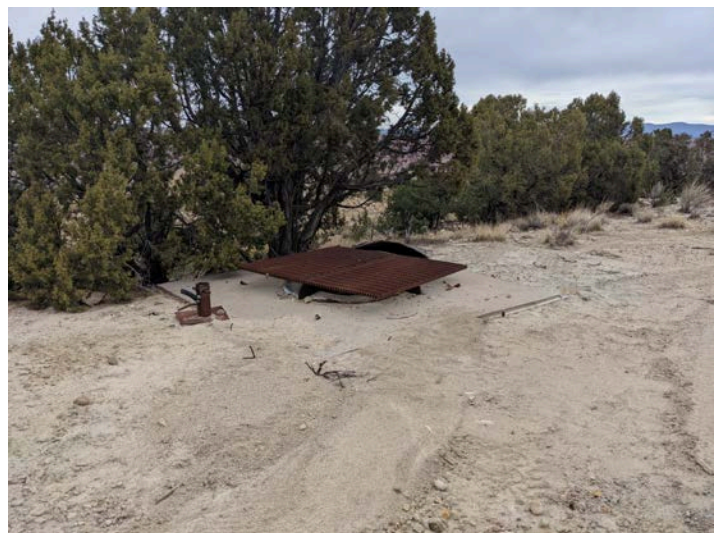
Limited site maintenance has occurred at the site since the Division's last inspection. Some minor grading occurred on the north side of the steel building. Steel grating was welded onto the hoist ladder and a steel grate was welded over the vent hole on the east side of the building in order to inhibit unauthorized entry.
