## MINERALS PROGRAM INSPECTION REPORT

| <b>MINE NAME:</b><br>Schwartzwalder Mine | <b>MINE/PROSPECTING ID#:</b><br>M-1977-300 | <b>MINERAL:</b><br>Uranium | <b>COUNTY:</b><br>Jefferson |
| <b>INSPECTION TYPE:</b><br>Monitoring | <b>INSPECTOR(S):</b><br>Amy Eschberger, Michael Cunningham | <b>INSP. DATE:</b><br>November 3, 2021 | <b>INSP. TIME:</b><br>12:30 |

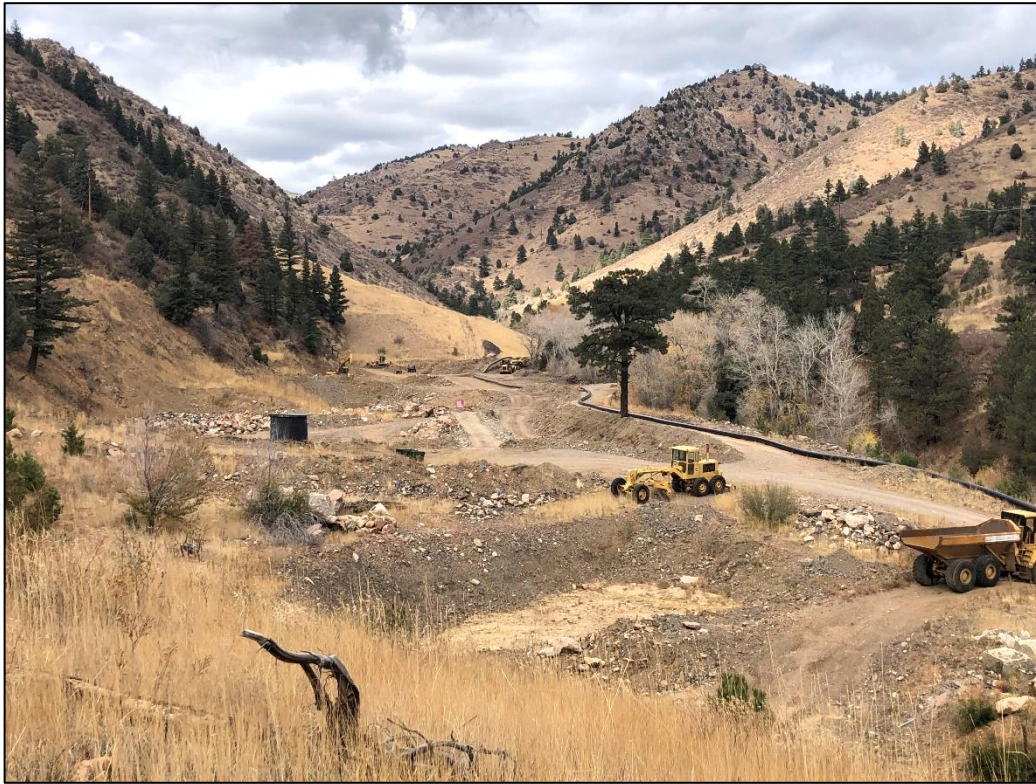
The valley excavation project, in which, radionuclide-impacted alluvial valley soils are excavated and disposed of underground (on site), was underway during the inspection. Excavation activities were occurring at the far northwestern edge of the project area, near the southeastern edge of the South Waste Rock Pile (SWRP). The operation was excavating soils from beneath the area where the access road had been located. Because of this, the northwestern portion of the permit area (with the waste rock piles) must be accessed by foot at this time. Since the Division's last inspection of the site (on September 14, 2021), excavation activities in the northwestern project area have been focused in areas along the western edge of Ralston Creek, which has included excavating through a portion of the existing access road. A temporary access road has been constructed to the west/southwest of the current excavation areas (up to the SWRP, where there was insufficient space to relocate the road). The bypass pipeline that routes water from the creek around the mine site has been temporarily relocated for the excavation project. This pipeline is still functional, although the creek was dry during the inspection.

**Photo 1.** View looking northwest (from top of mesa with water treatment plant) across northwestern valley excavation project area. Excavated soils are currently being disposed of inside Black Forest Mine, per AM-5.

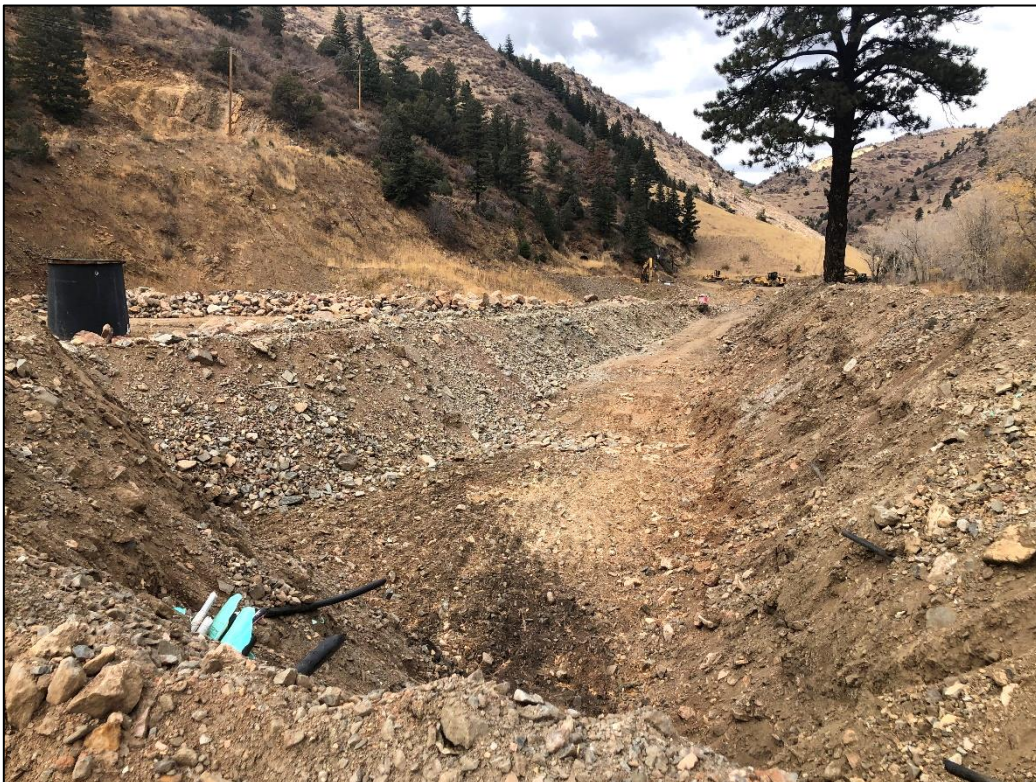
**Photo 2.** View looking northwest across recent excavation area along western edge of creek channel (in northwestern project area), approximately 4-6 feet in depth.

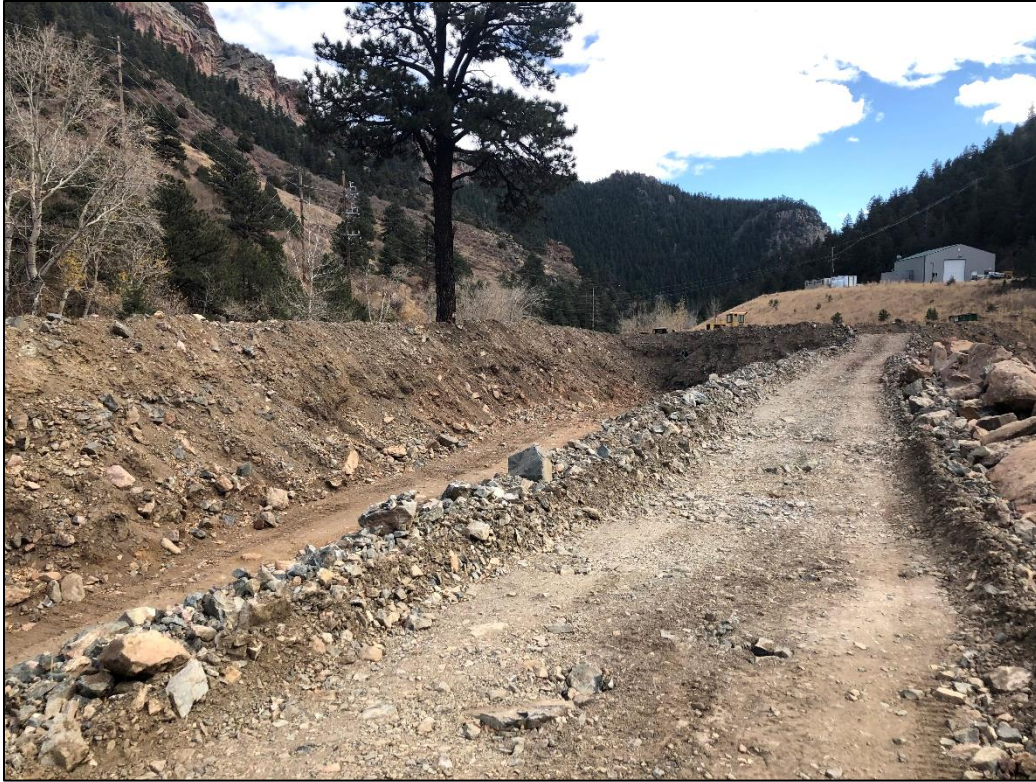
**Photo 3.** View looking southeast across recent excavation area along western edge of creek channel (in northwestern project area), showing temporarily relocated access road (at right).

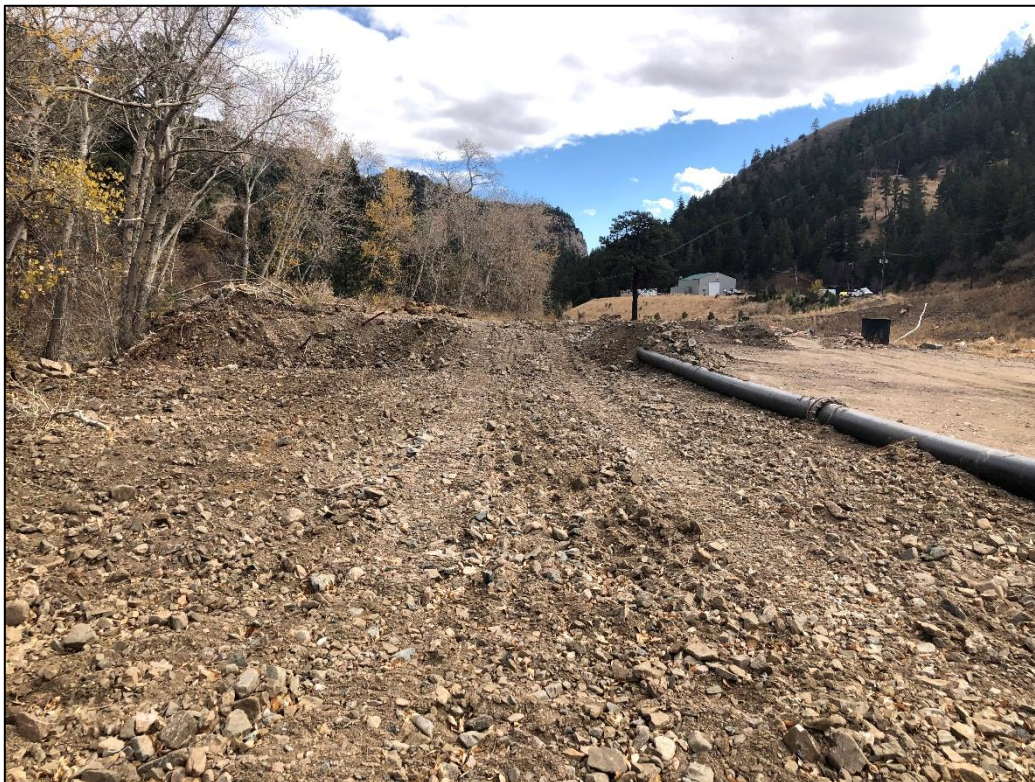
**Photo 4.** View looking southeast across recent excavation area along western edge of creek channel (in northwestern project area). Note bypass pipeline (at right) temporarily relocated.

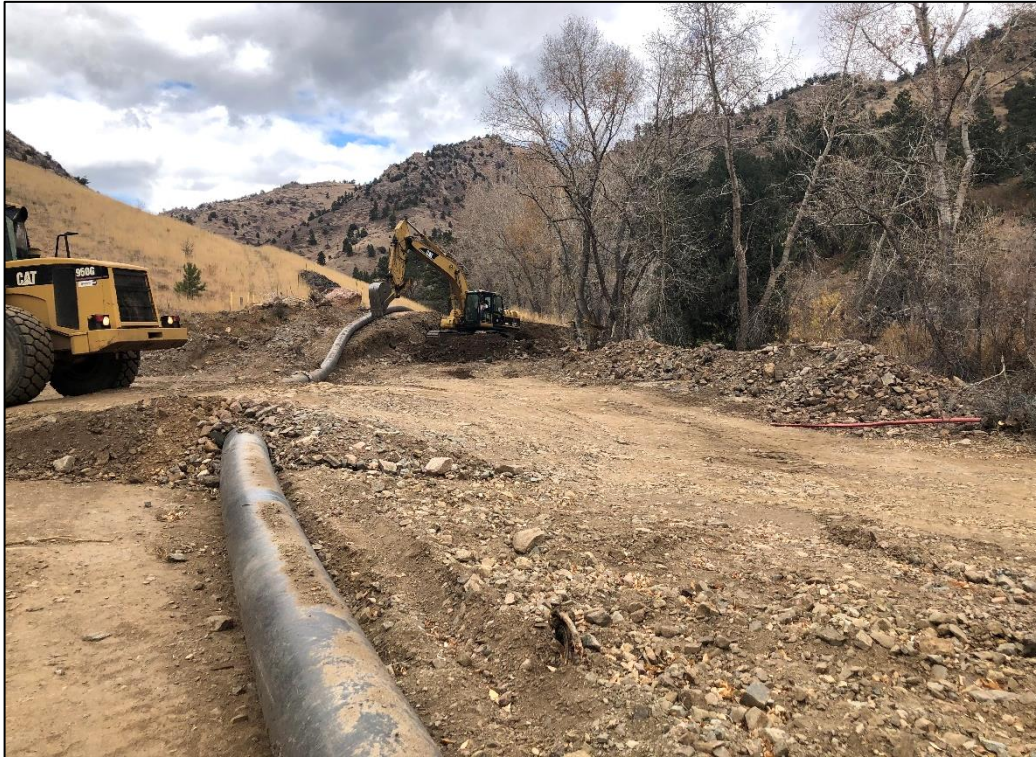
**Photo 5.** View looking north at current excavation activities (in northwestern project area) adjacent to southeastern toe of SWRP (slope visible left of excavator). Note bypass pipeline (in foreground) temporarily relocated.

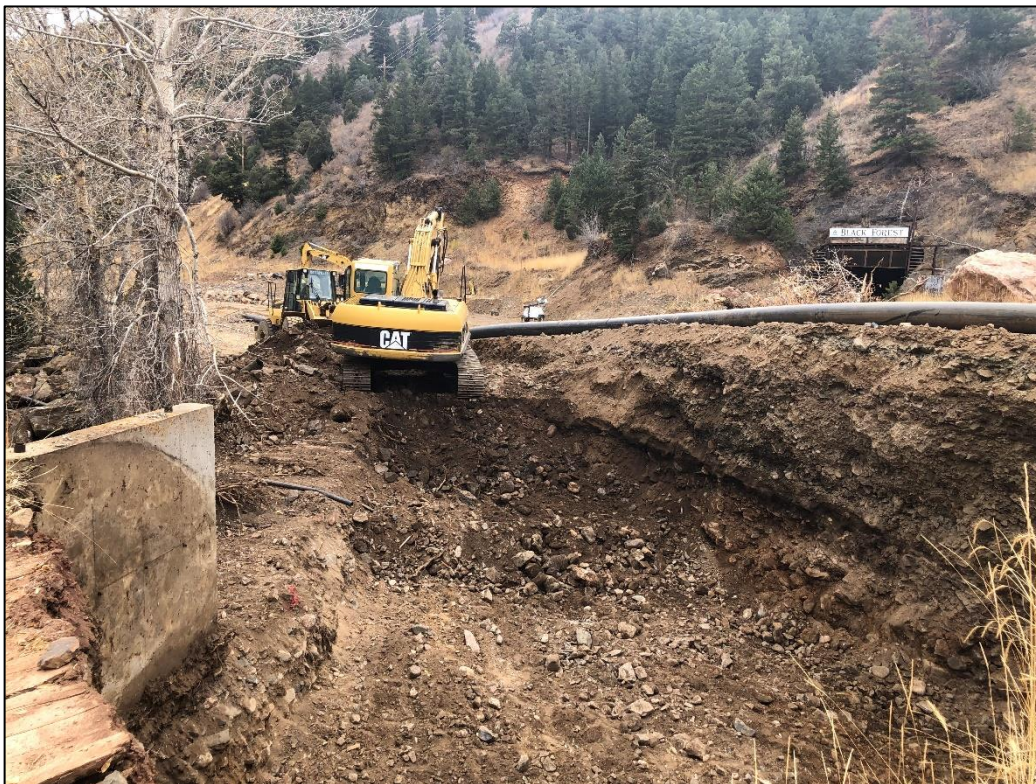
**Photo 6.** Closer view of current excavation activities (in northwestern project area) adjacent to southeastern toe of SWRP (and bridge access to storage area north of creek; portion of bridge visible at bottom, left).

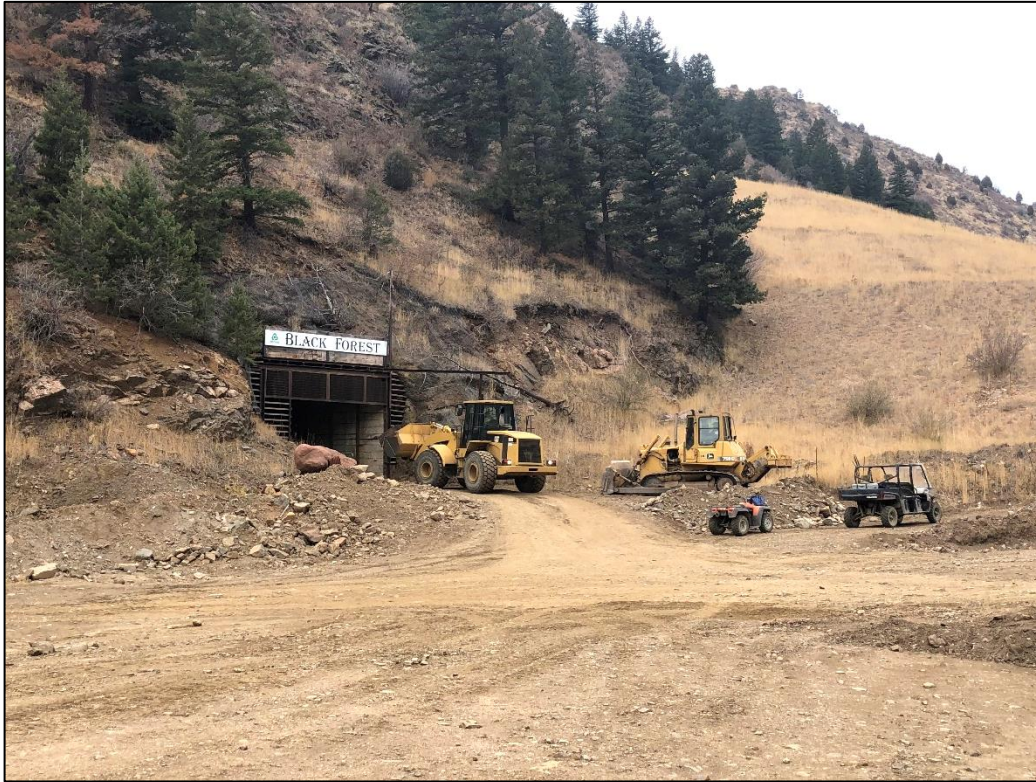
**Photo 7.** View looking northwest at main entrance to Black Forest Mine, in which, excavated soils are being placed, per AM-5.

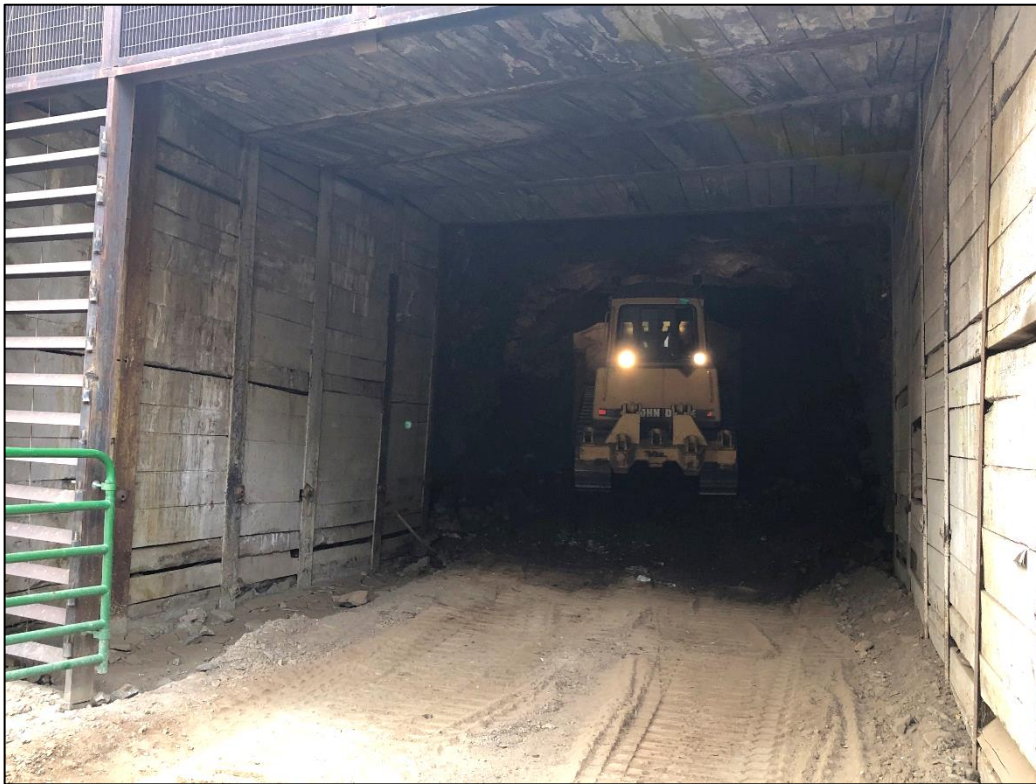
The excavated soils were being hauled to the Black Forest Mine for disposal, per Amendment No. 5 (AM-5; approved on January 13, 2021). During the inspection, only approximately 50 feet remained between the toe of the backfilled material inside the mine and the gated entrance to the mine. In AM-5, the operator committed to maintaining a 25 foot buffer between the toe of the backfill and the gate. The approved backfill closure plan includes removing the existing gates from the mine openings, backfilling the adits with large diameter rock (> 1 foot) sourced from on site, placing a layer of rockfill mixed with common fill over the large rock to minimize visible void space between the rocks, then covering the backfill with a minimum of one foot of growth medium. Any backfill areas will be revegetated along with the valley disturbances.

According to the operator, the Black Forest Mine will reach capacity within a few days of the inspection.

**Photo 8.** View looking inside Black Forest Mine, in which, excavated soils are being placed, per AM-5. At time of inspection, toe of backfilled material was approx. 50 feet from mine entrance gate.

However, as discussed during the previous inspection, the excavation project will produce additional material (currently estimated at approximately 5,000 cubic yards) that will not fit inside the approved underground disposal locations (Black Forest Mine and CV Glory Hole in the Minnesota Mine). During the previous inspection, the operator was considering placing this additional material on top of one of the existing waste rock piles. While the operation was previously approved to do this, given the reclaimed state of the waste rock piles, the Division informed the operator any proposal to redisturb the piles must be submitted in a Technical Revision. During the current inspection, the operator discussed placing the additional excavated material along the southeastern edge of the SWRP, and possibly tying it into the adjacent Black Forest Mine backfill area (once completed). This new disturbance to the SWRP would be "capped" with a minimum of one foot of growth medium and revegetated. The existing waste rock piles were reclaimed in this manner and now have an established vegetative cover. This alternative disposal plan for excavated alluvial valley soils will need to be submitted in a Technical Revision for Division review and approval.

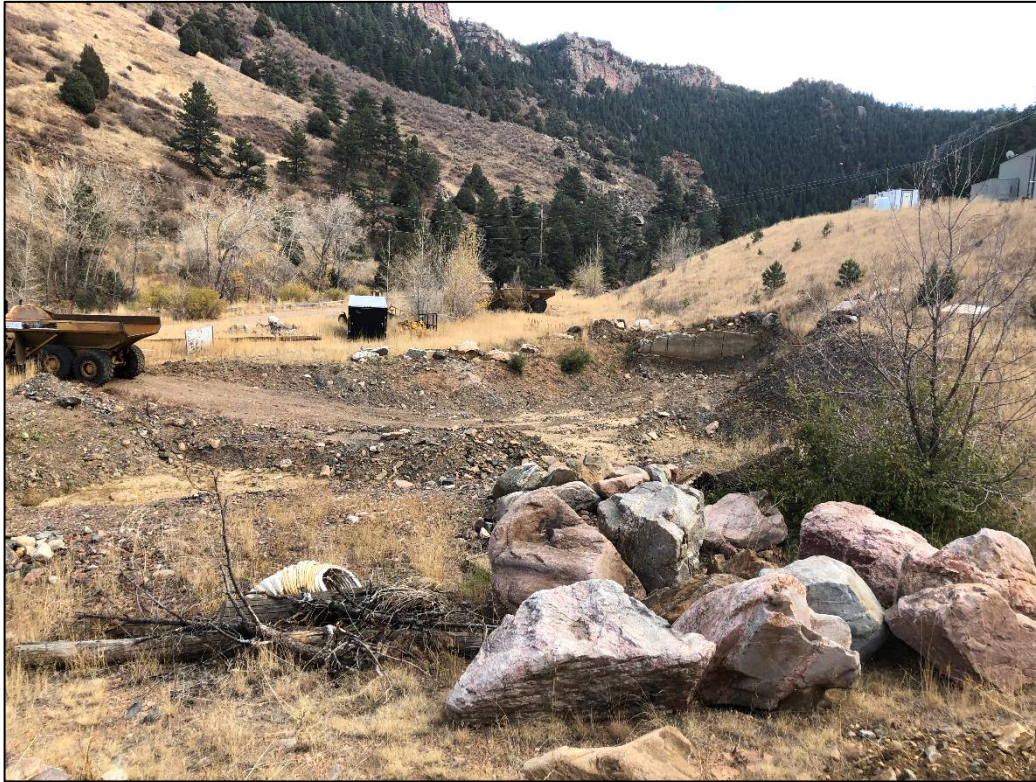
**Photo 9.** View looking southeast across excavation area (in northwestern project area) at toe of mesa with water treatment plant.

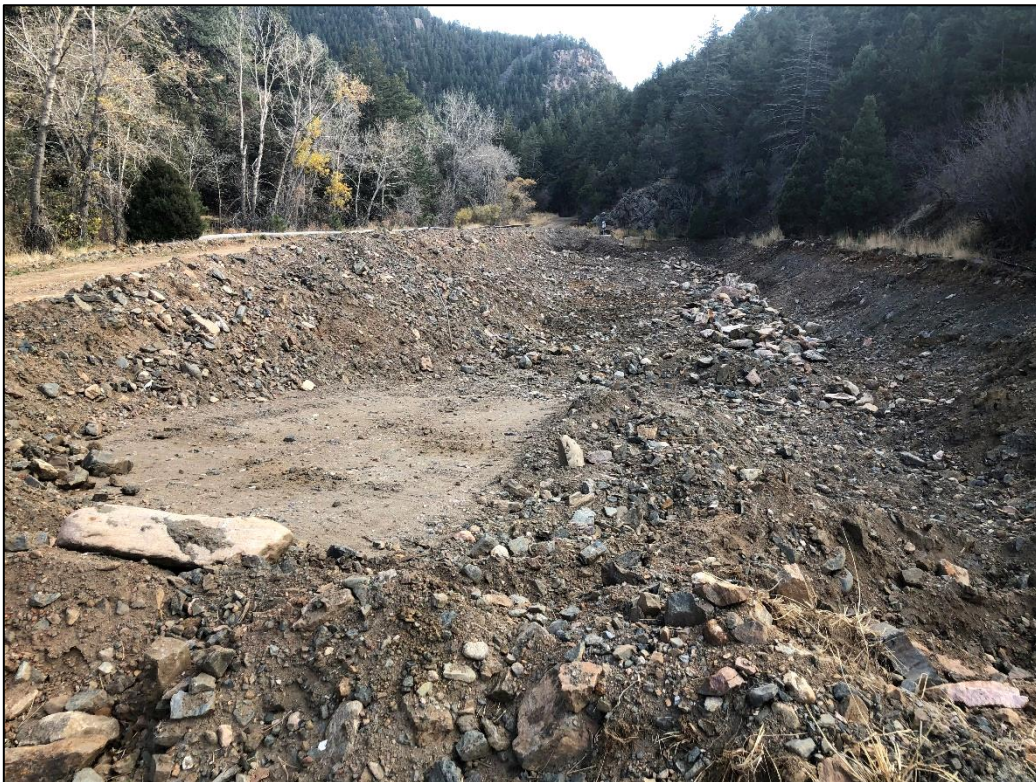
Since the Division's last inspection, additional excavation activities have also occurred in the southeastern project area (near the eastern permit boundary), where an elongated pit approximately 5-6 feet deep has been created along the western/southwestern edge of the access road. The operation will most likely need to temporarily relocate the access road and bypass pipeline in this area in order to excavate contaminated soils beneath these features. As previously discussed, the operator will need to abandon the alluvial groundwater monitoring wells MW-6 and MW-7 in this area in order to ensure the surrounding contaminated soils are appropriately excavated. This proposed change to the approved groundwater monitoring program must be submitted in a Technical Revision. As discussed during the inspection, one revision may be submitted to propose this change as well as the proposed alternative disposal location for the additional excavated soils. The alluvial valley excavation project is still on schedule to conclude in January of 2022, with final surveys to be completed that spring/summer. The final grading plan for the valley will be submitted in a Technical Revision.

**Photo 10.** View looking southeast across recent excavation area (in southeastern project area) adjacent to access road, approximately 5-6 feet in depth.

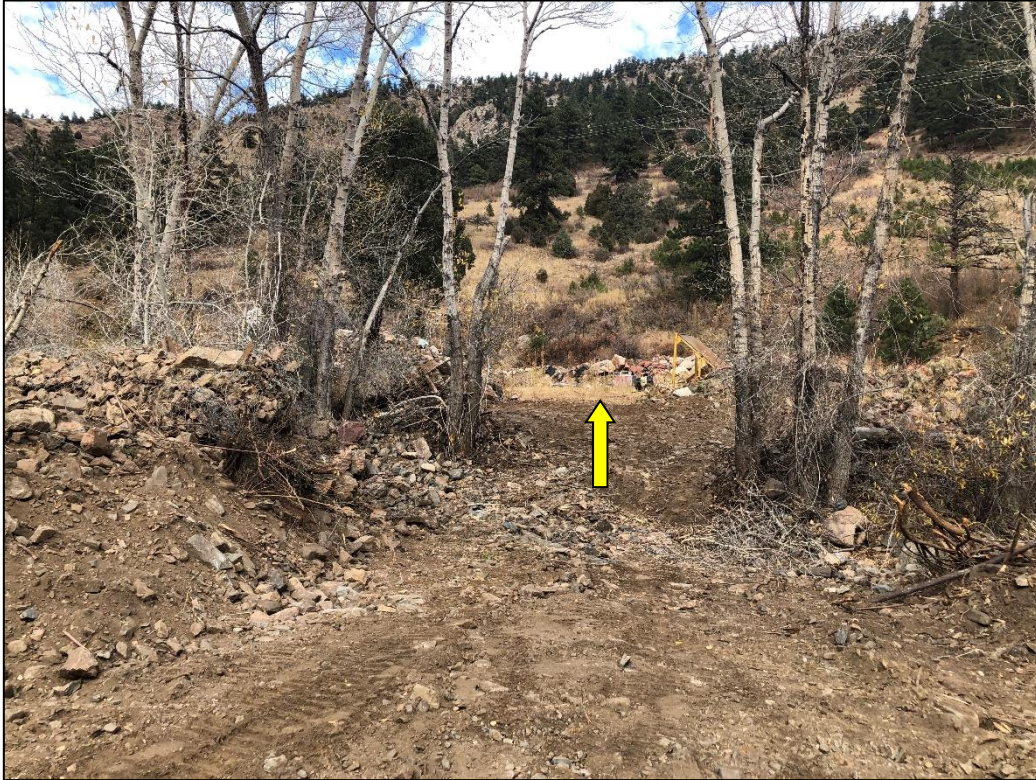
**Photo 11.** View looking east at new access (indicated) to storage area located north of creek, as existing bridge access is restricted by adjacent excavation activities.

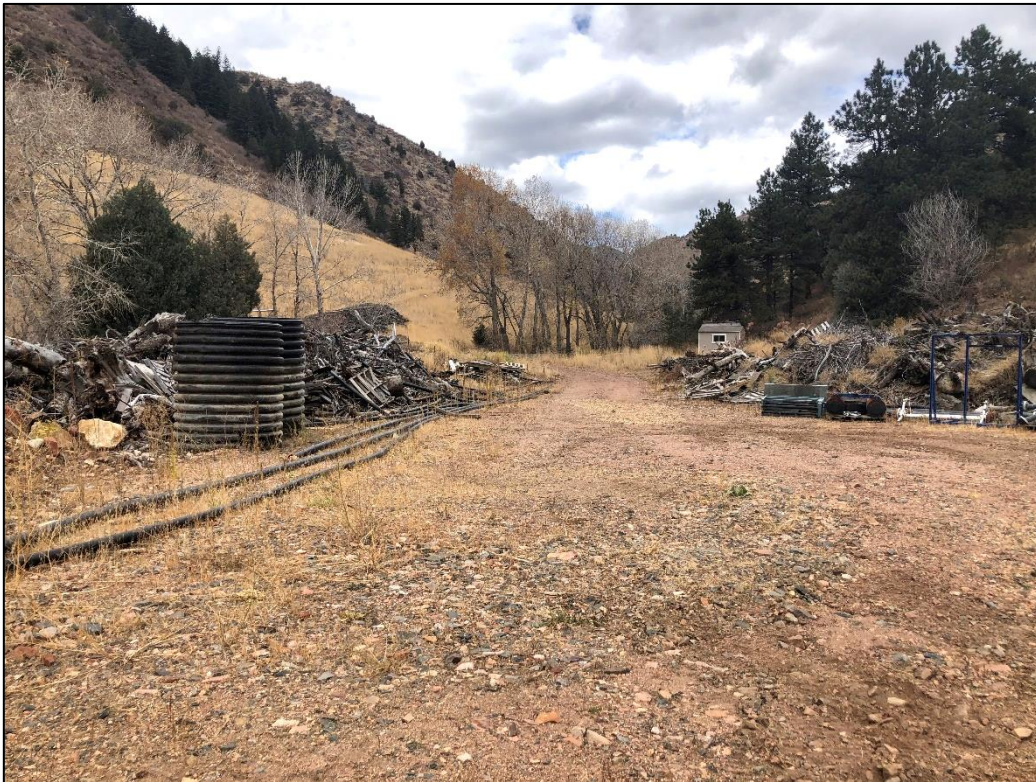
The Division observed the storage area located north of the creek (across from the Black Forest Mine). The Division estimates the disturbance in this area to cover approximately one acre. Since the existing bridge access to this area is currently restricted due to the excavation activities occurring nearby, an additional access (across the dry creek channel) has been created to the southeast. The operator is currently storing woody debris, rocks, and various pieces of equipment and empty storage containers in this area. A small shed and tank are present in the northwestern portion of this area. The operator has plans to remove all equipment from this storage area in the coming months, and to chip the wood for use in reclamation (as mulch). The rocks stored in this area can also be used for reclamation (e.g., adit backfill closures). Through its review of AM-6, the Division has requested additional information on how this area will be reclaimed. The Division has also inquired about where growth medium required for reclamation will be obtained, given the lack of any salvaged topsoil stored on site. During the inspection, the operator explained the necessary growth medium will be borrowed from the hillside adjacent to the storage area. They believe enough growth medium is available within the permit area at this location to reclaim the site, including the borrow area(s). For reclamation, all disturbances in the storage area north of the creek will be scarified, retopsoiled, and revegetated in the same manner as the valley disturbances will be reclaimed. Additional details on this plan will be provided in AM-6.

**Photo 12.** View looking northwest across storage area located north of creek showing woody debris, rocks, and various pieces of equipment and empty storage containers stored in this area. All equipment will be removed from this area. Woody debris will be chipped for mulch, and rocks will be used for reclamation backfill.

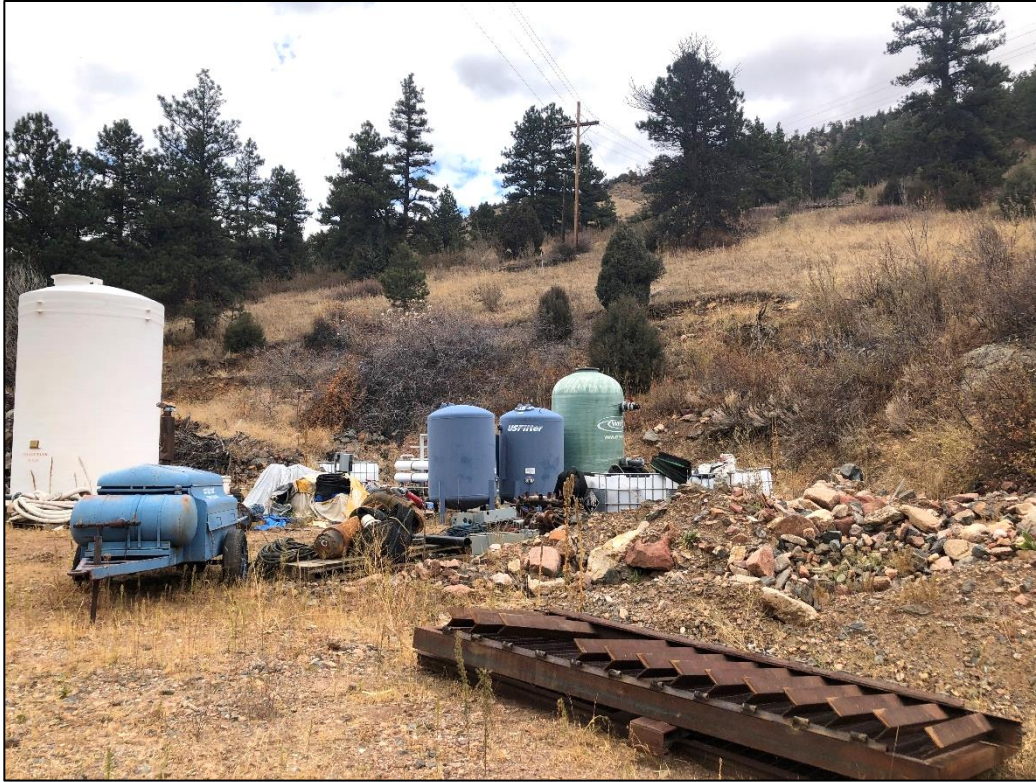
**Photo 13.** View looking east at storage area located north of creek showing woody debris, rocks, and various pieces of equipment and empty storage containers stored in this area. Adjacent undisturbed hillside (in background) may be used as a topsoil borrow area.

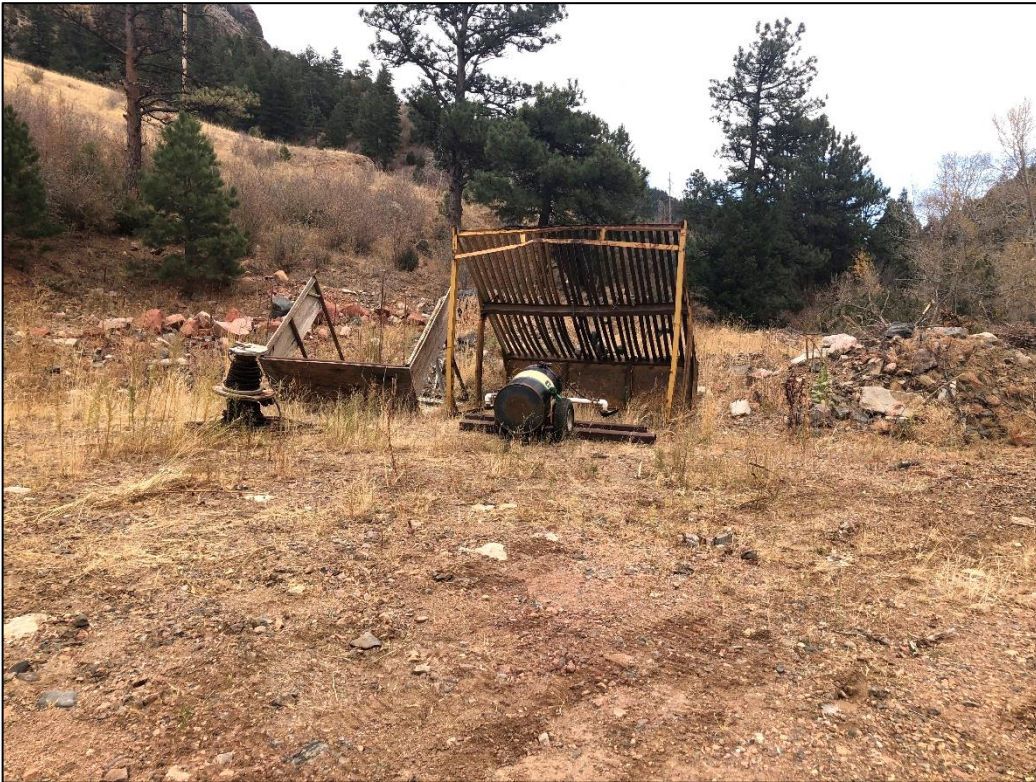
**Photo 14.** View looking southeast at storage area located north of creek, showing equipment and rocks stored at southern edge of this area.

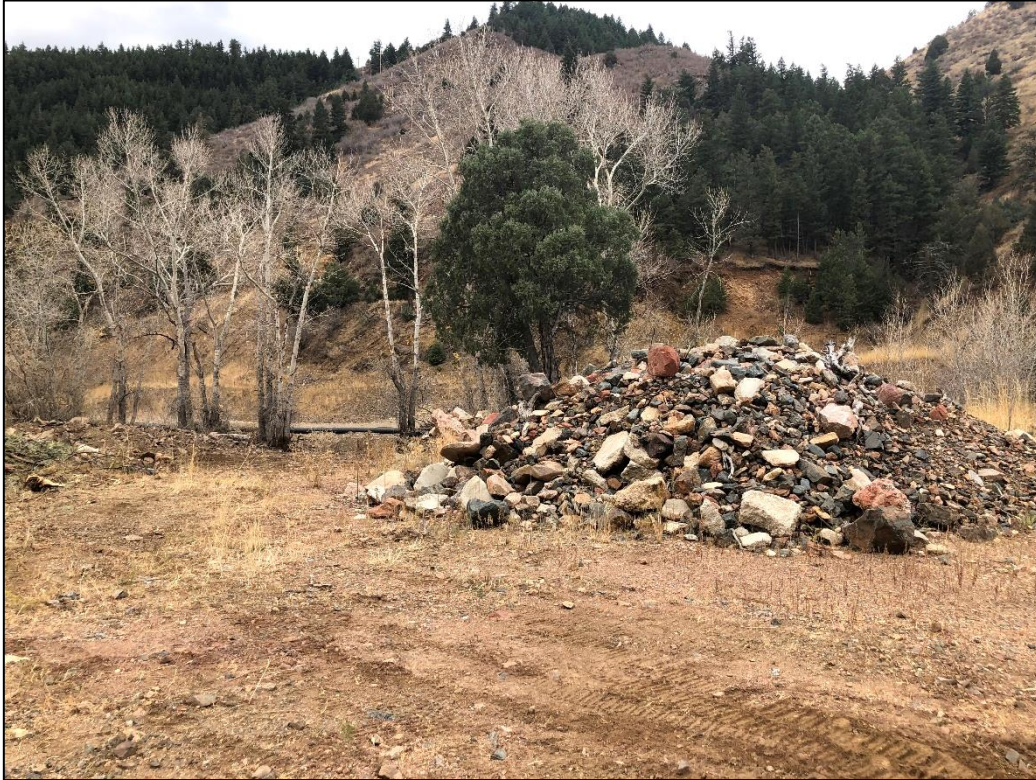
**Photo 15.** View looking west at storage area located north of creek, showing rocks stored in this area.

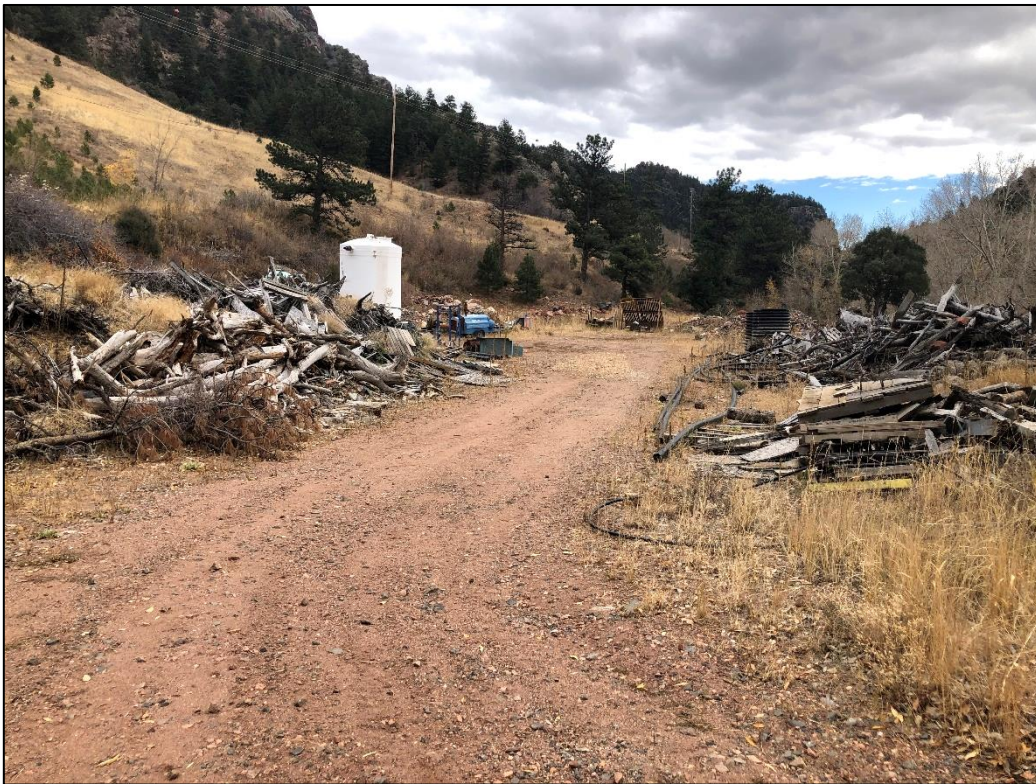
**Photo 16.** View looking southeast across storage area located north of creek, showing woody debris, rocks, and various pieces of equipment and empty storage containers stored in this area.

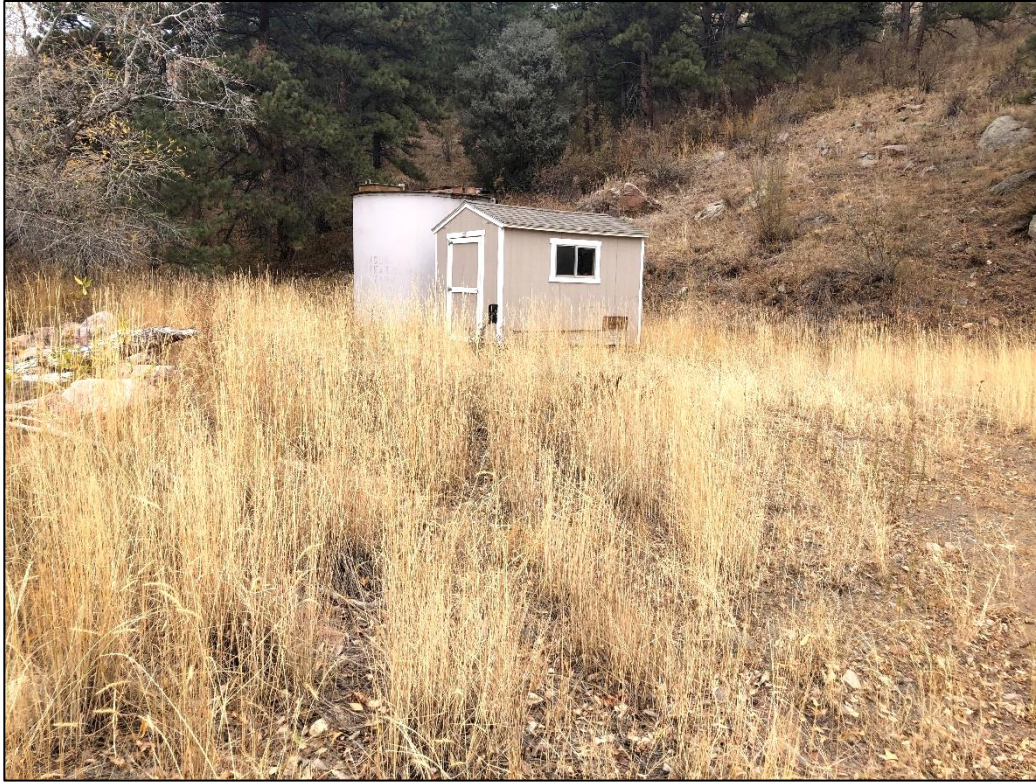
**Photo 17.** View looking northwest at storage area located north of creek, showing small shed and tank stored at northern edge of this area.

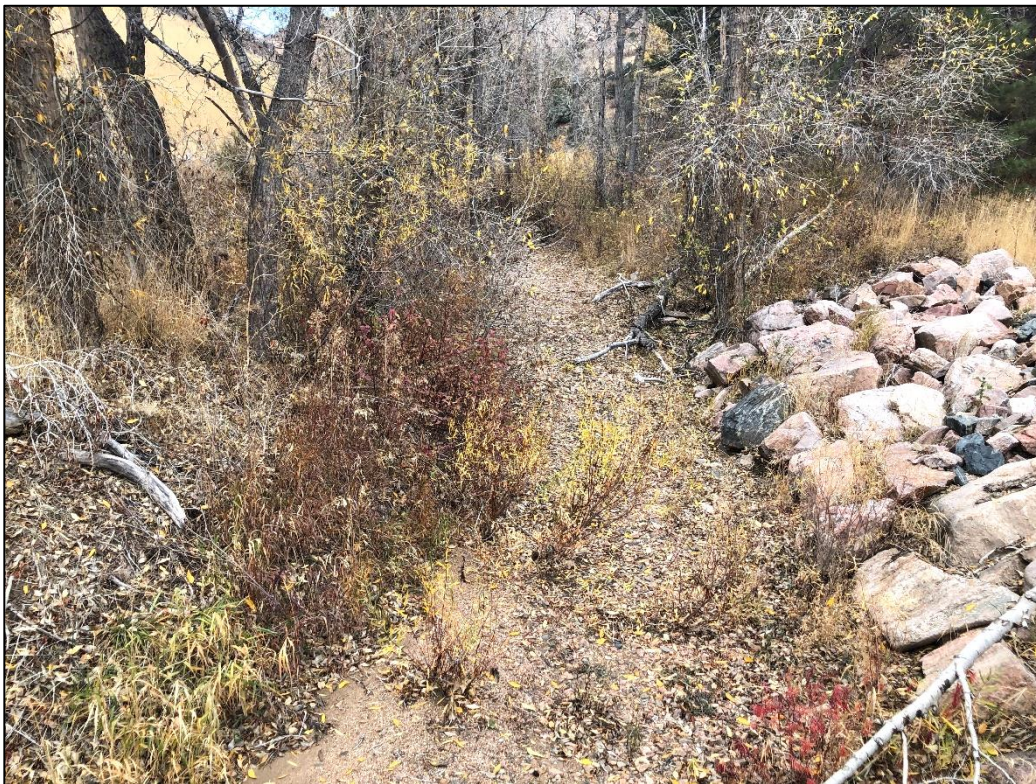
**Photo 18.** View looking northwest at Ralston Creek channel just upstream of bridge access to storage area (upgradient cutoff wall is located further upstream). Creek was dry during inspection.
