MINERALS PROGRAM INSPECTION REPORT
PHONE: (303) 866-3567

MINE NAME: Dotsero Quarry	MINE/PROSPECTING ID#: M-1987-074	MINERAL: Volcanic Materials	COUNTY: Eagle
INSPECTION TYPE: Surety Release	INSPECTOR(S): Dustin M. Czaplá	INSP. DATE: November 17, 2021	INSP. TIME: 11:00
OPERATOR: Mayne Block and Stone Company	OPERATOR REPRESENTATIVE: None	TYPE OF OPERATION: 112c-Construction Regular Operation	
REASON FOR INSPECTION: Surety Release Requested	BOND CALCULATION TYPE: None	BOND AMOUNT: \$12,373.51	
DATE OF COMPLAINT: NA	POST INSP. CONTACTS: None	JOINT INSP. AGENCY: None	
WEATHER: Clear	INSPECTOR'S SIGNATURE:

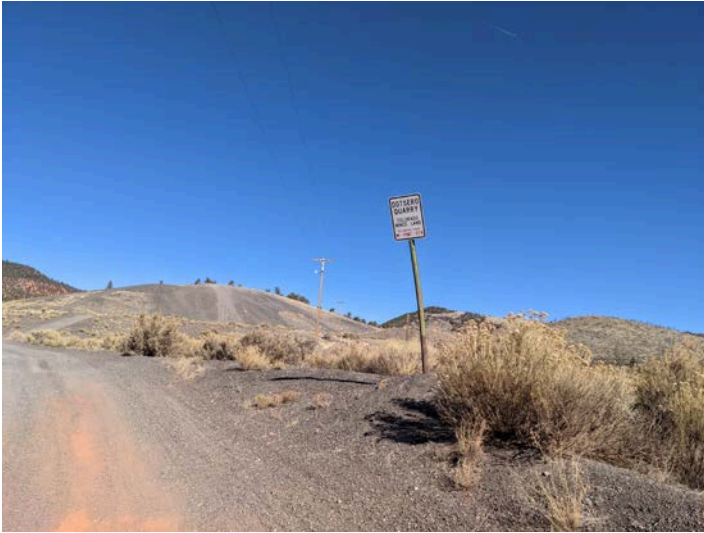
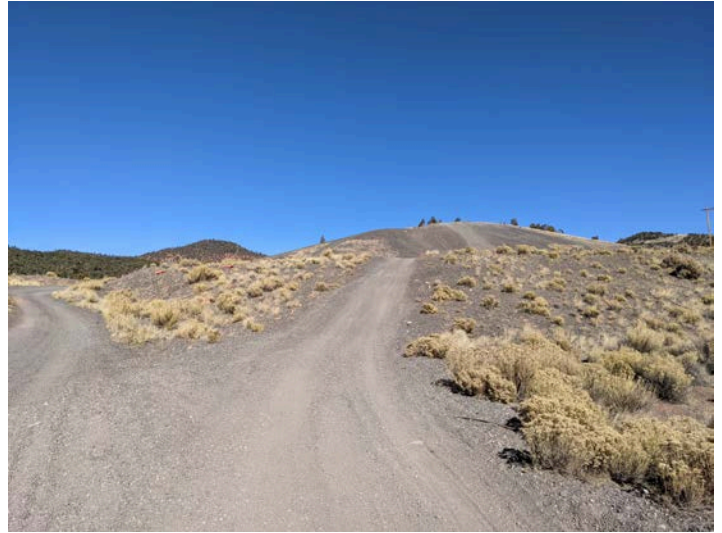
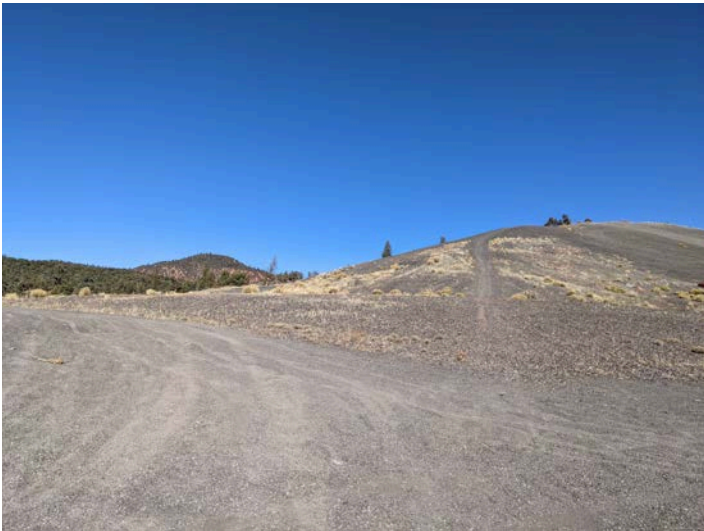
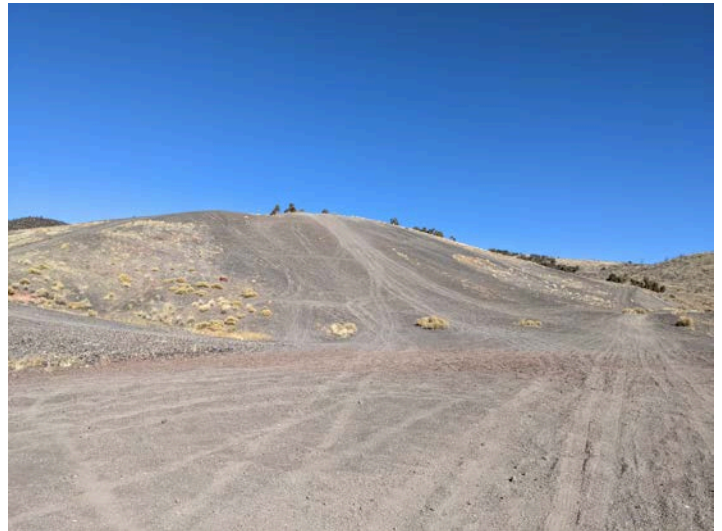
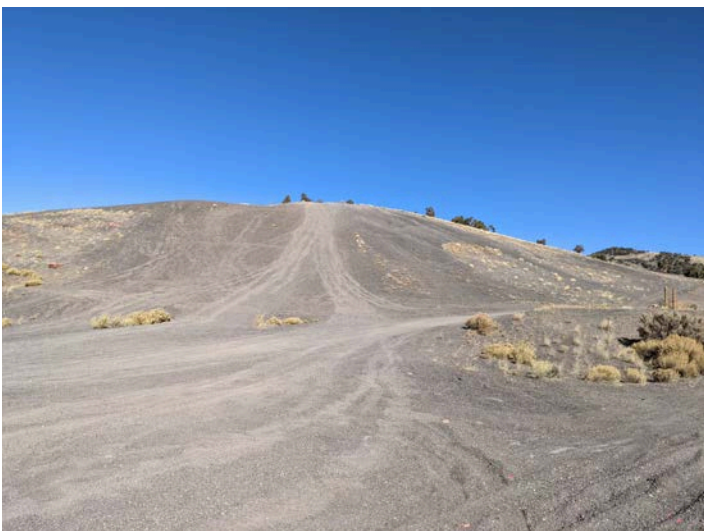
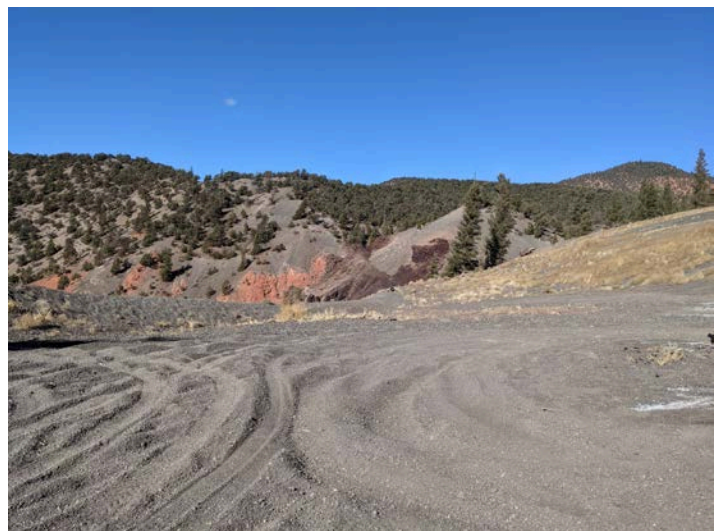
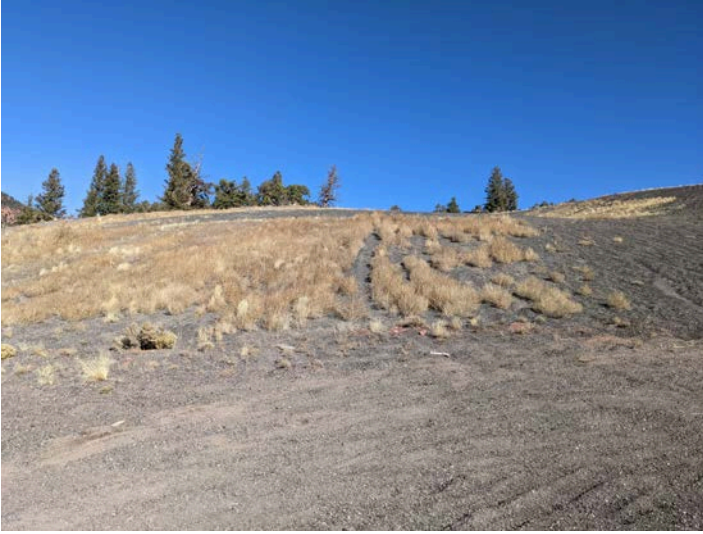
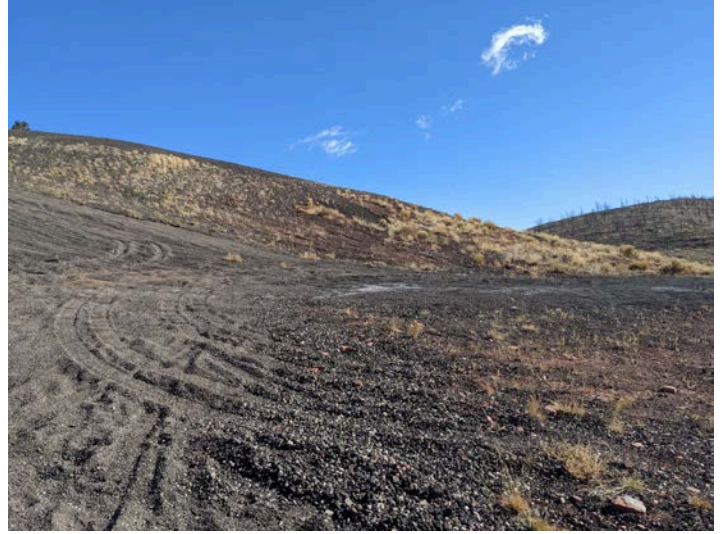
Reclamation has been completed at the site. The areas disturbed by mining have been graded to blend well with the surrounding topography. No significant erosion or stability issues were noted. Little to no topsoil exists at the site so vegetation is sparse, but similar in extent of coverage to that of the surrounding area. The site sees significant atv traffic and trails are scattered throughout the site.
