**NEW ELK MINE**  
**Permit No. C-1981-012**

**QUARTERLY COAL WASTE BANK INSPECTION REPORT**  
**November 8, 2021**

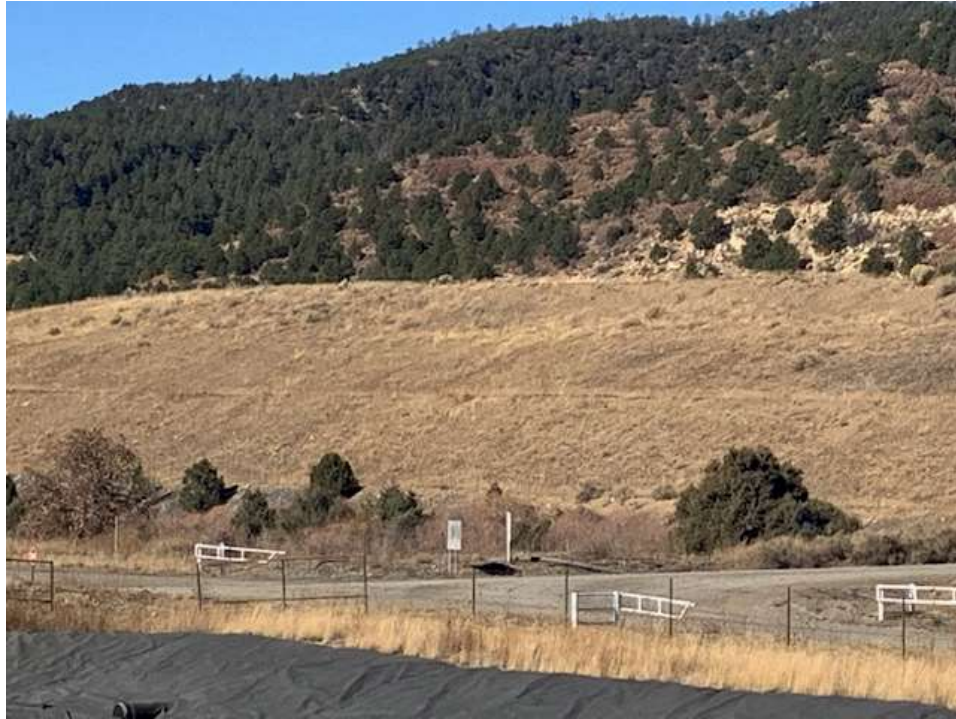
**DWDA #1**

Surface and out slopes of the pile were inspected for visible signs of potential failure or instability. None were observed.

Overall the disposal area is in good condition.

None at this time.

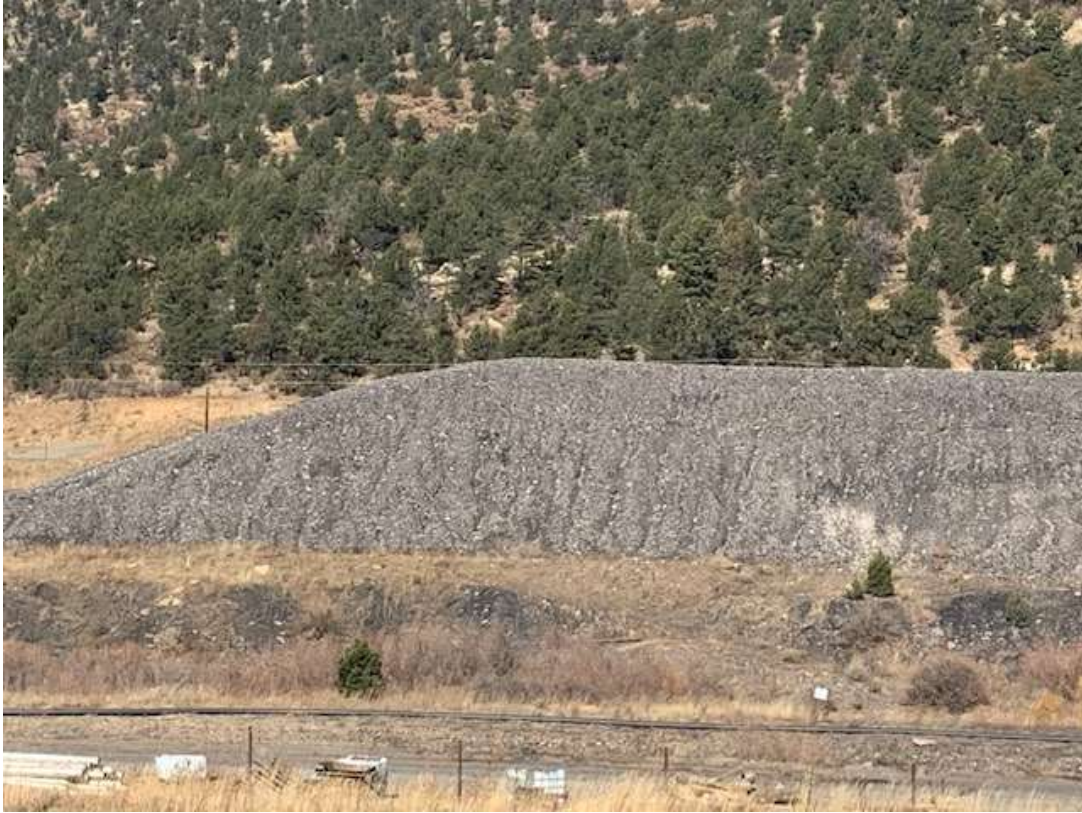
**DWDA #2**

Positive Drainage is maintained on the surface of the DWDA. Sump on East end of pile was being cleaned at time of inspection. Rills on the disposal area are being monitored. No evidence of springs nor seeps were observed.

Surface and out slopes of the pile were inspected for visible signs of potential failure or instability. There was some surface erosion but not enough to make the area unstable. In all no signs of failure or instability were observed.

Overall the disposal area is in good condition. The sign with the name of the area was recently replaced.

The Rills are being monitored and have not gotten any bigger and there is no sediment loading. Operator is evaluating either reclamation of the area or permitting alternative uses of the land north of the Purgatoire River and south of Highway 12. The sump at the end of the area was being cleaned as annual maintenance.

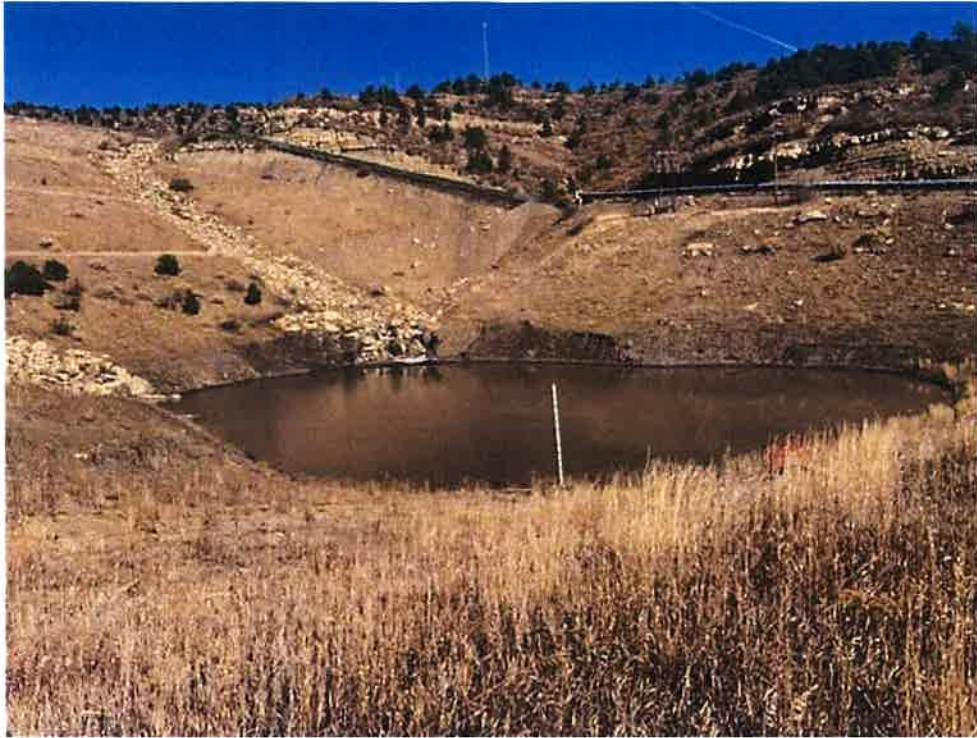
**Face of Refuse Disposal Area**

None observed.

Overall the site is in good condition. Compaction test from this quarter is attached.

None required at this time.
