QUARTERLY SEDIMENTATION POND INSPECTION REPORT

Mine: Lorencito

Inspection Period: Fourth Quarter 2021

QUARTERLY SEDIMENTATION POND INSPECTION REPORT
Lorencito Canyon Mine- November 8, 2021

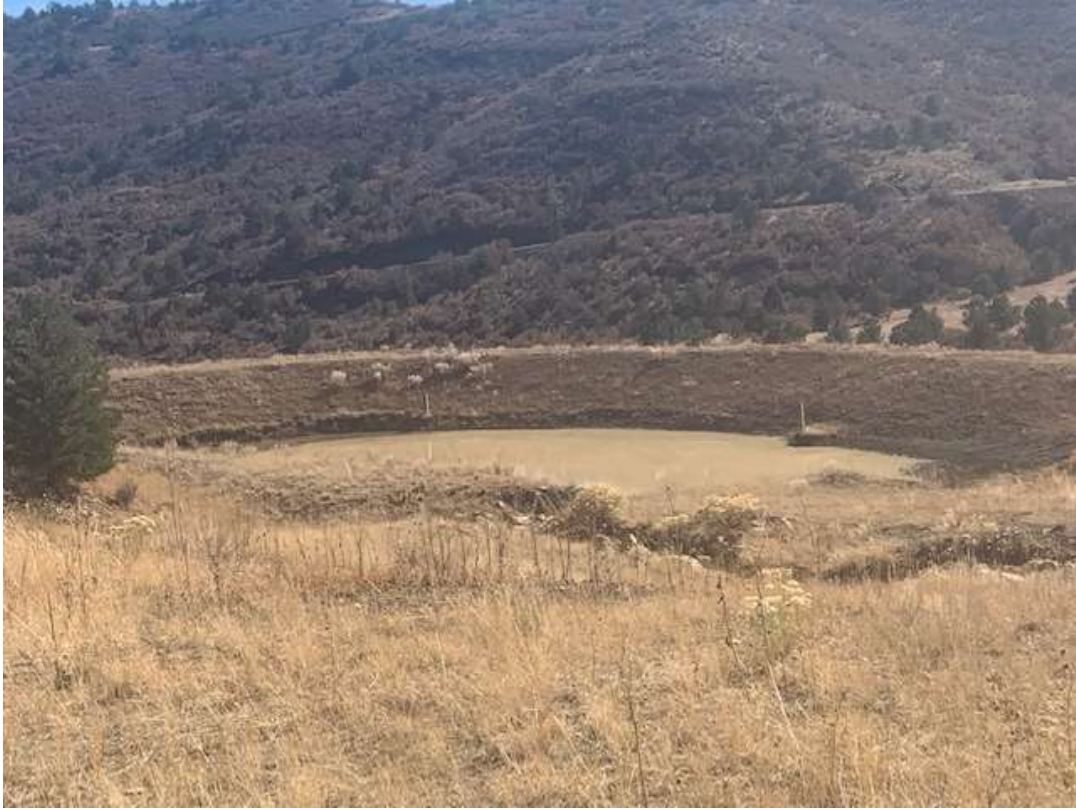
Pond 6

Pond was holding water but not near the level of the decant.

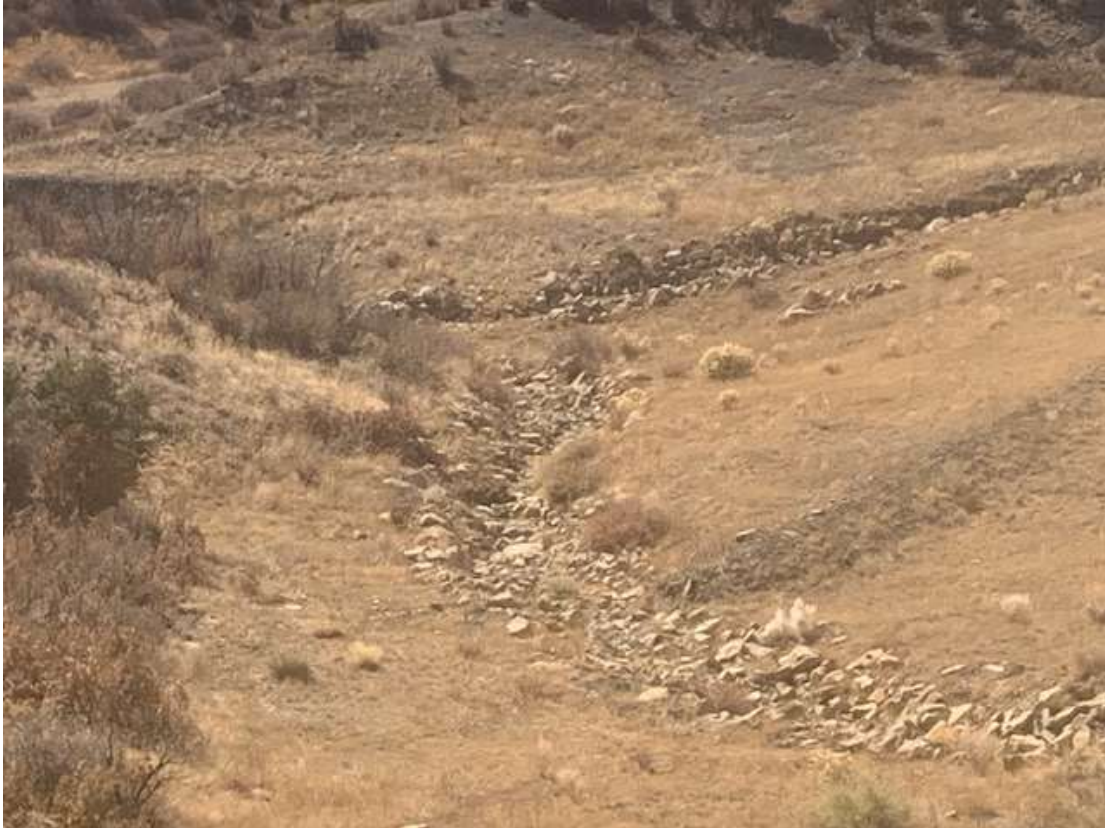
Pond 7 Armored Drains

Pond was holding some water but not near the level of the decant.

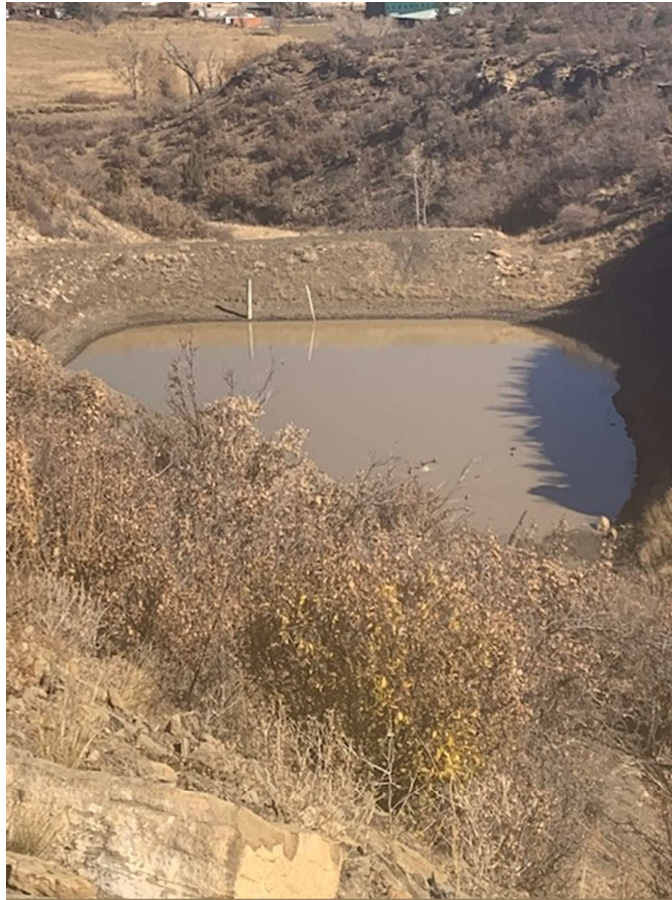
Pond 8

Pond was holding water to the decant level, but the pond was not discharging at the time of

inspection.

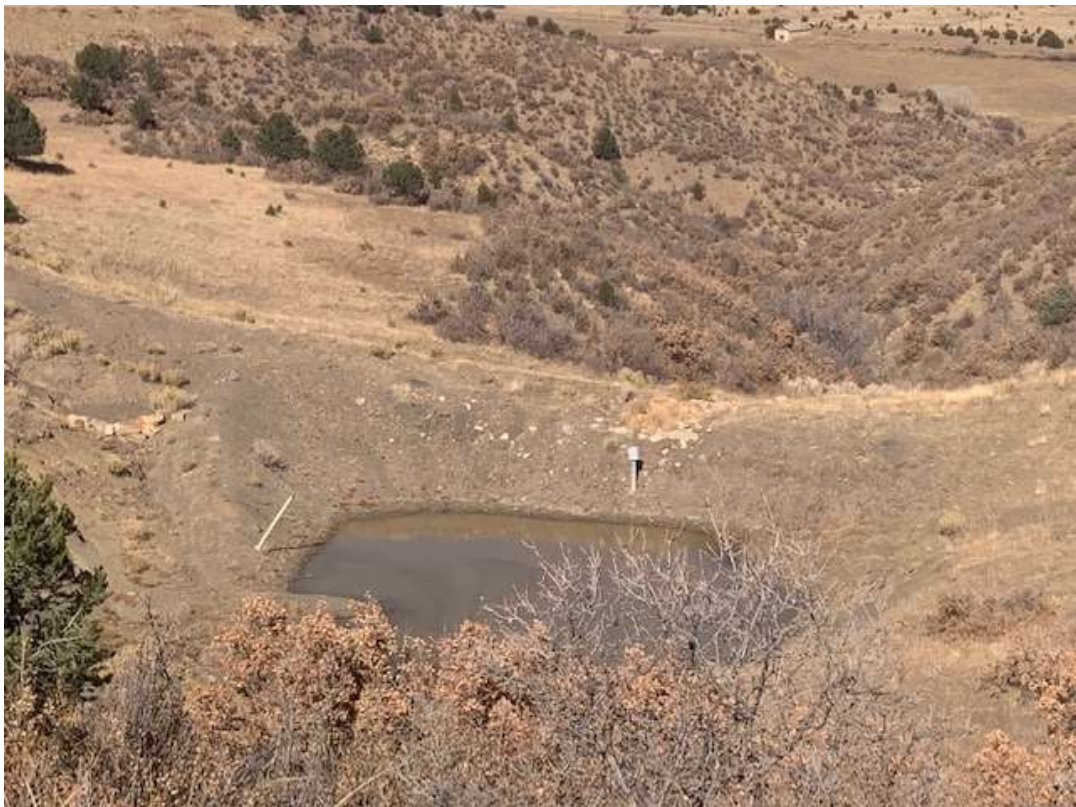
Pond 9

Pond was holding water but not near discharging at time of inspection.

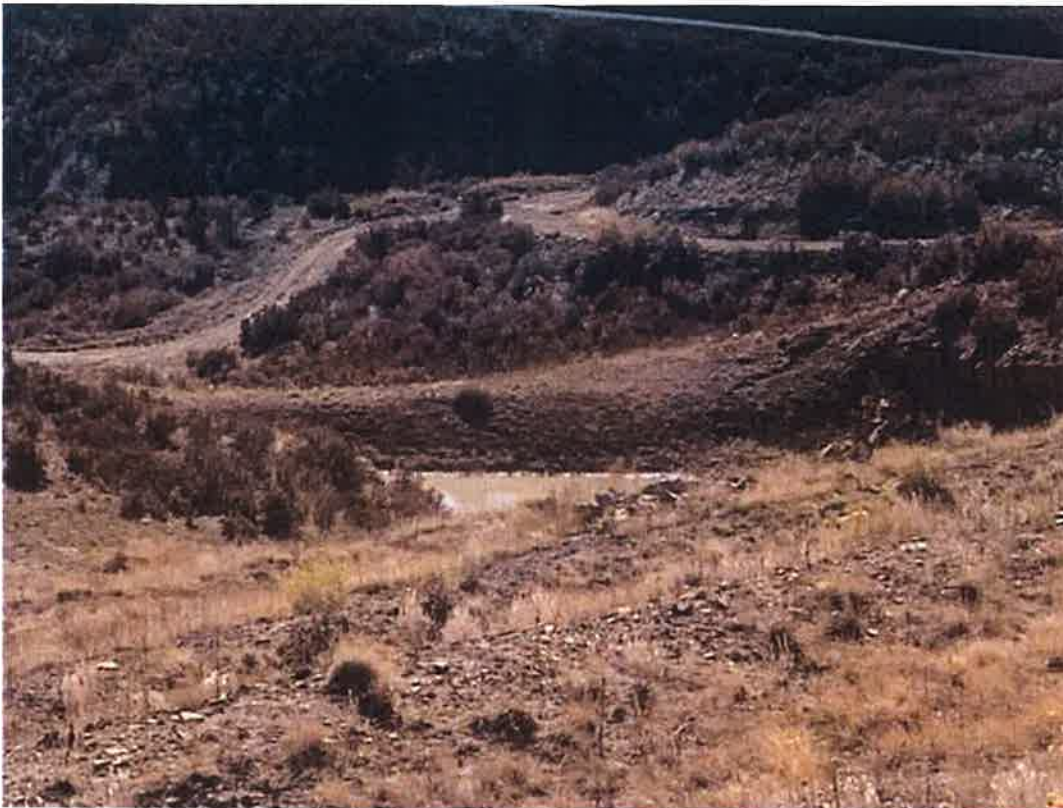
Pond 9a

Pond was holding water but not near discharging at time of inspection.
