**LORENCITO CANYON MINE**  
**Permit No. C-1996-084**

**INSPECTION OF EXCESS SPOIL-FILLS 7, 8, & 9**  
**November 8, 2021**

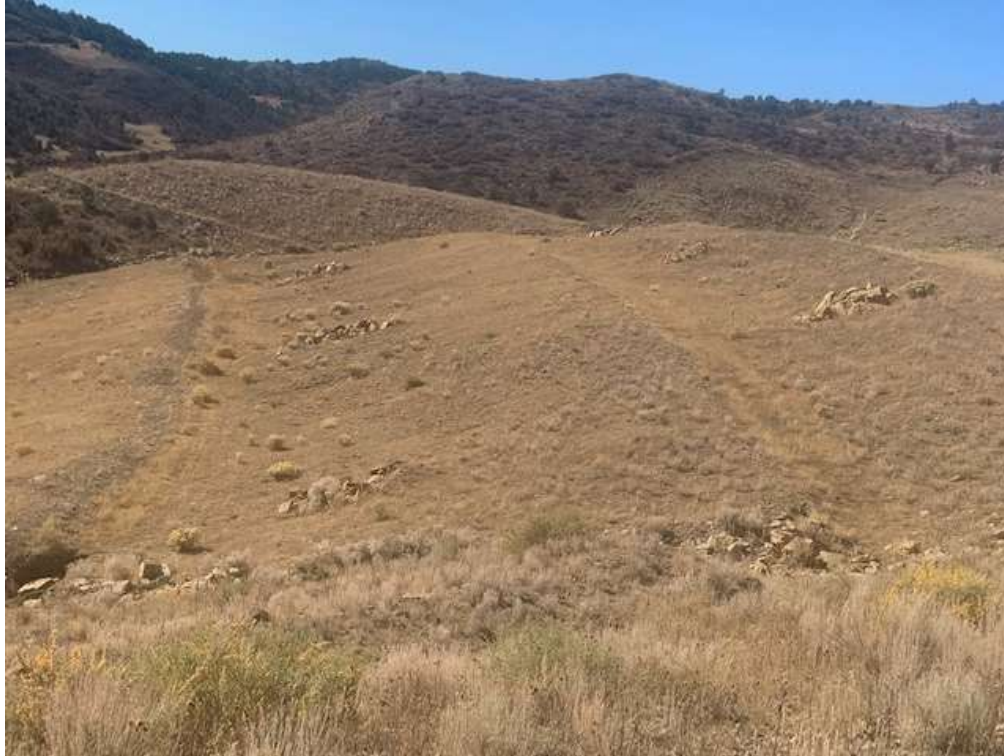
**Fill #7**

The entire excess spoil fill facility was examined for signs of failure and instability such as tension cracks, ground movement, springs and seeps, and standing water. There was no indication of potential instability at time of inspection.

Overall the site is in good condition. The vegetation on the fill is encouraging.

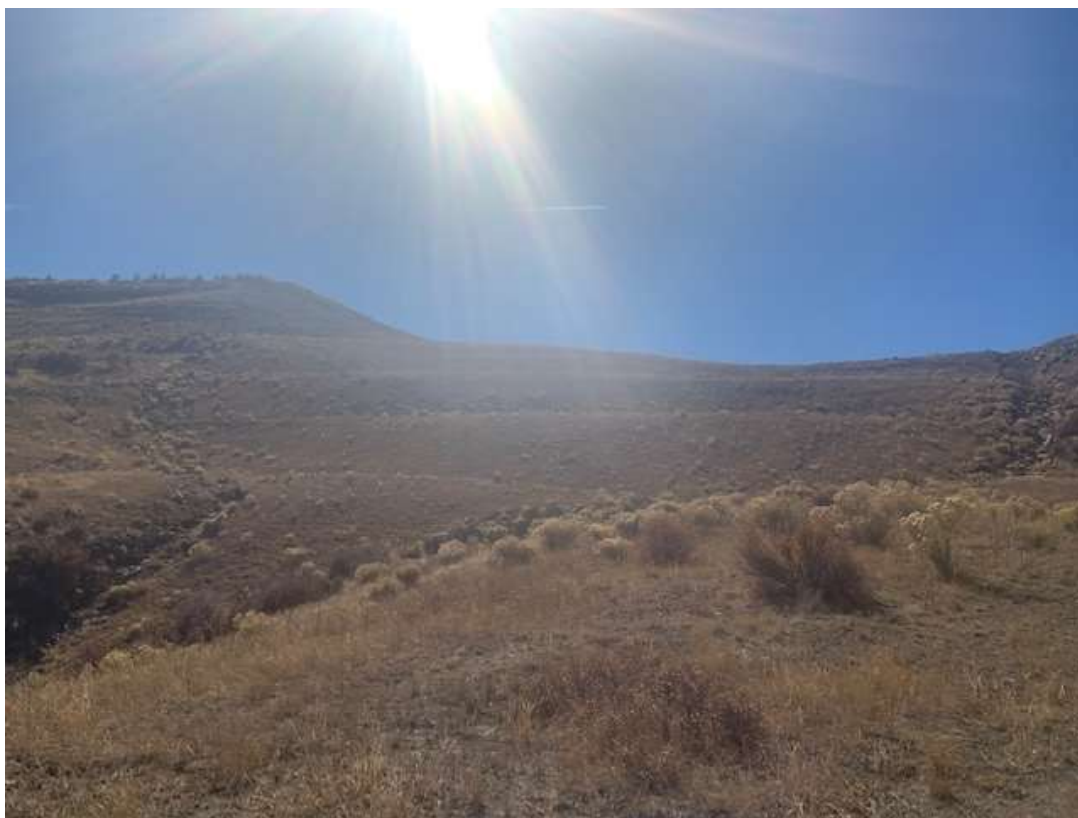
**Pond at bottom of Fill #8**

Sediment pond construction has been completed in accordance with plans submitted to and approved by the DMG and as-constructed survey\drawings certified by a Registered Land Surveyor an\or a Professional Engineer. All surface run-off from the fill area is directed to this sediment control facility known as Pond 8.

Overall the site is in good condition. Vegetation is very good on the fill.

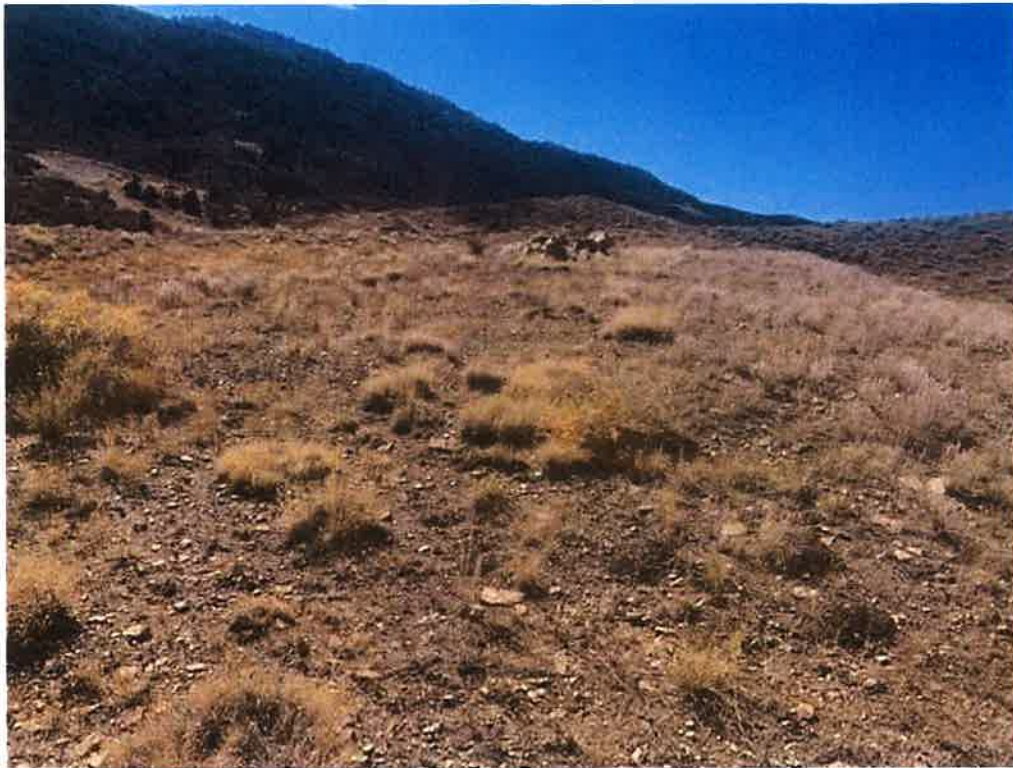
Fill #9

The entire excess spoil fill facility was examined for signs of failure and instability such as tension cracks, ground movement, springs and seeps, and standing water. There was no indication of potential instability at time of inspection.

Overall the site is in good condition.
