QUARTERLY SEDIMENTATION POND INSPECTION REPORT

Mine: New Elk

Inspection Period: Fourth Quarter 2021

QUARTERLY SEDIMENTATION POND INSPECTION REPORT
New Elk Mine- November 8, 2021

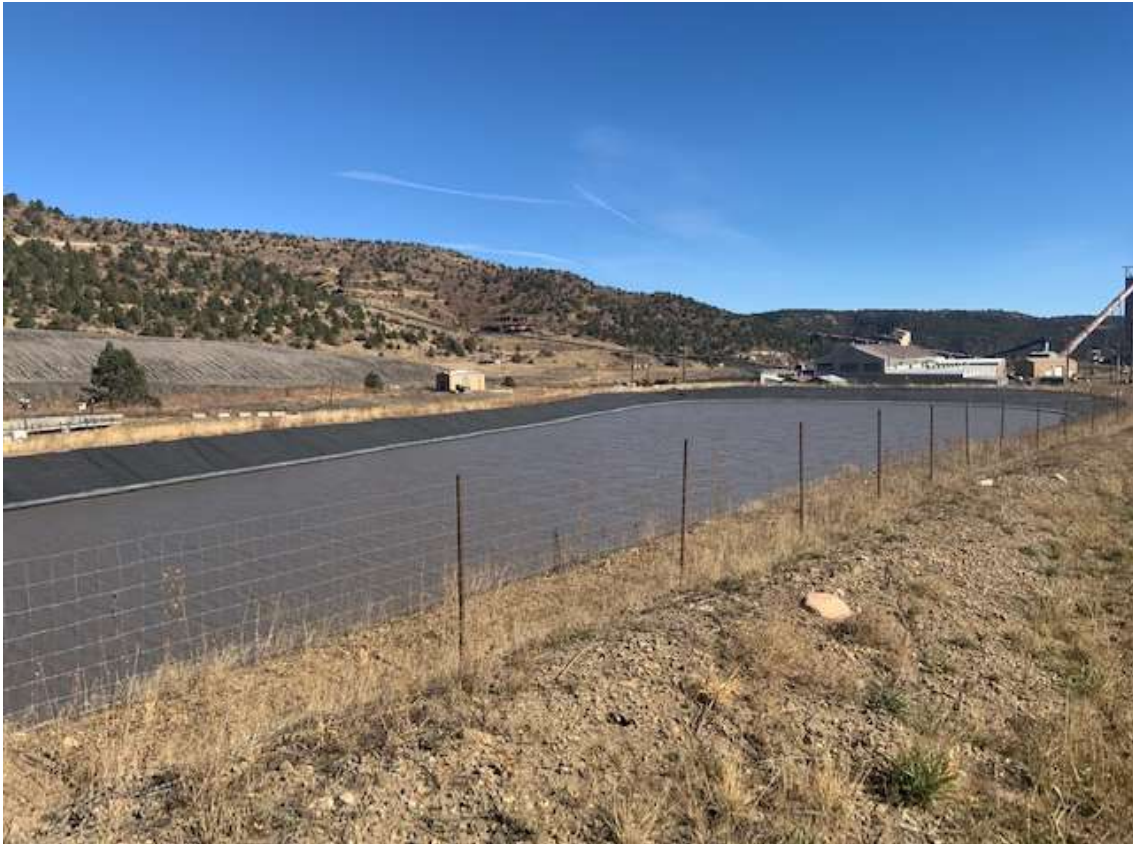
Pond 1

Pond liner is in good working condition at time of inspection. Pond was holding water at time of
inspection. The mine is putting water into the pond. Water level has not raised much since mining
began in late May.

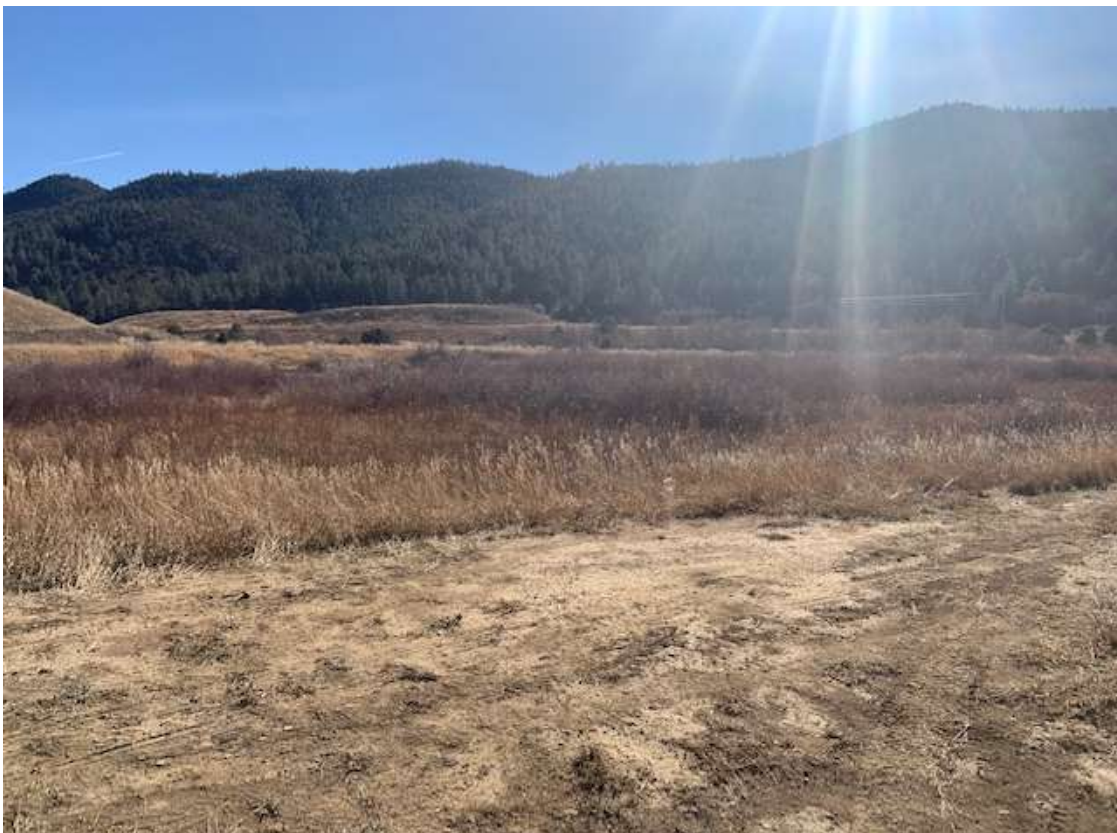
Pond 4

Pond is holding a very little amount water and is not close to discharging. Area around decant

needs to be cleaned of vegetation.

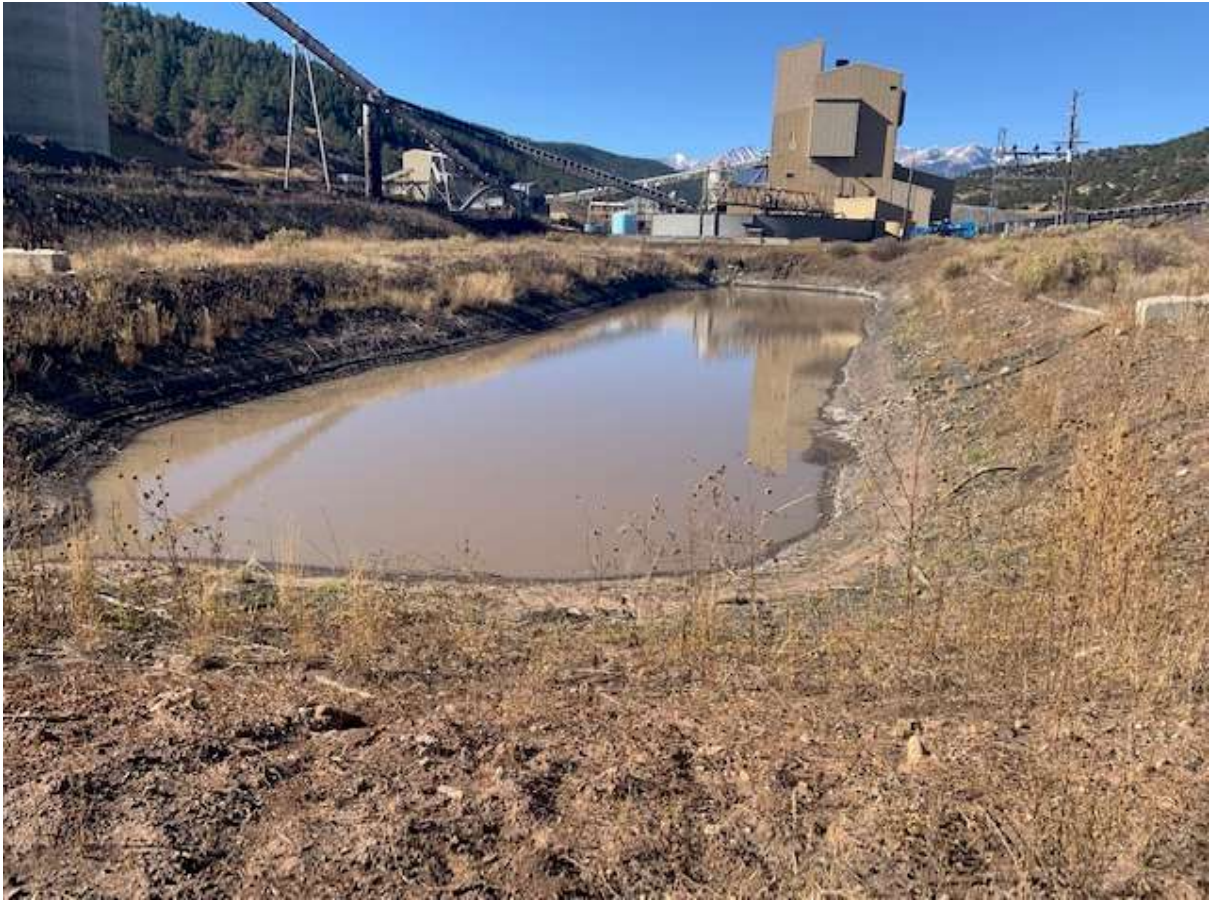
Pond 6

Pond is holding water, but it is not close to full.

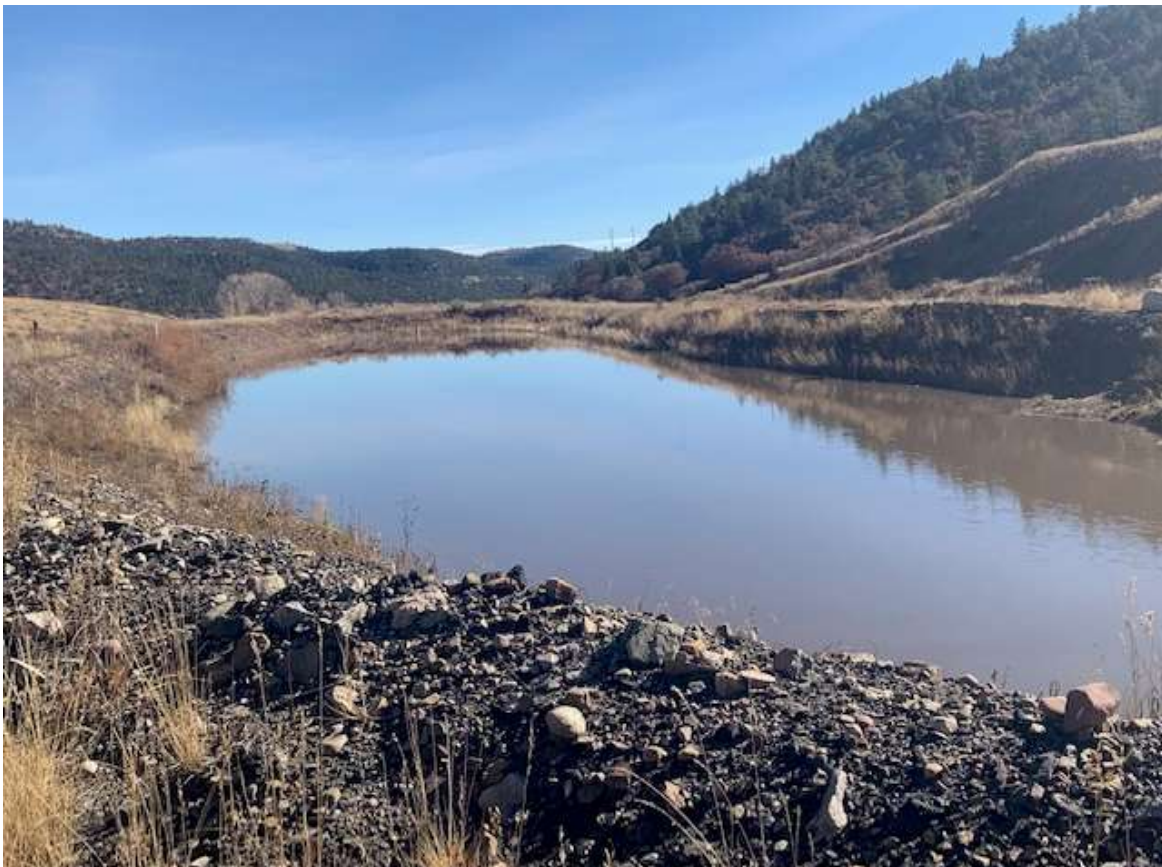
Pond 7

Pond is holding water, not near the decant level. The pond is in good working condition.

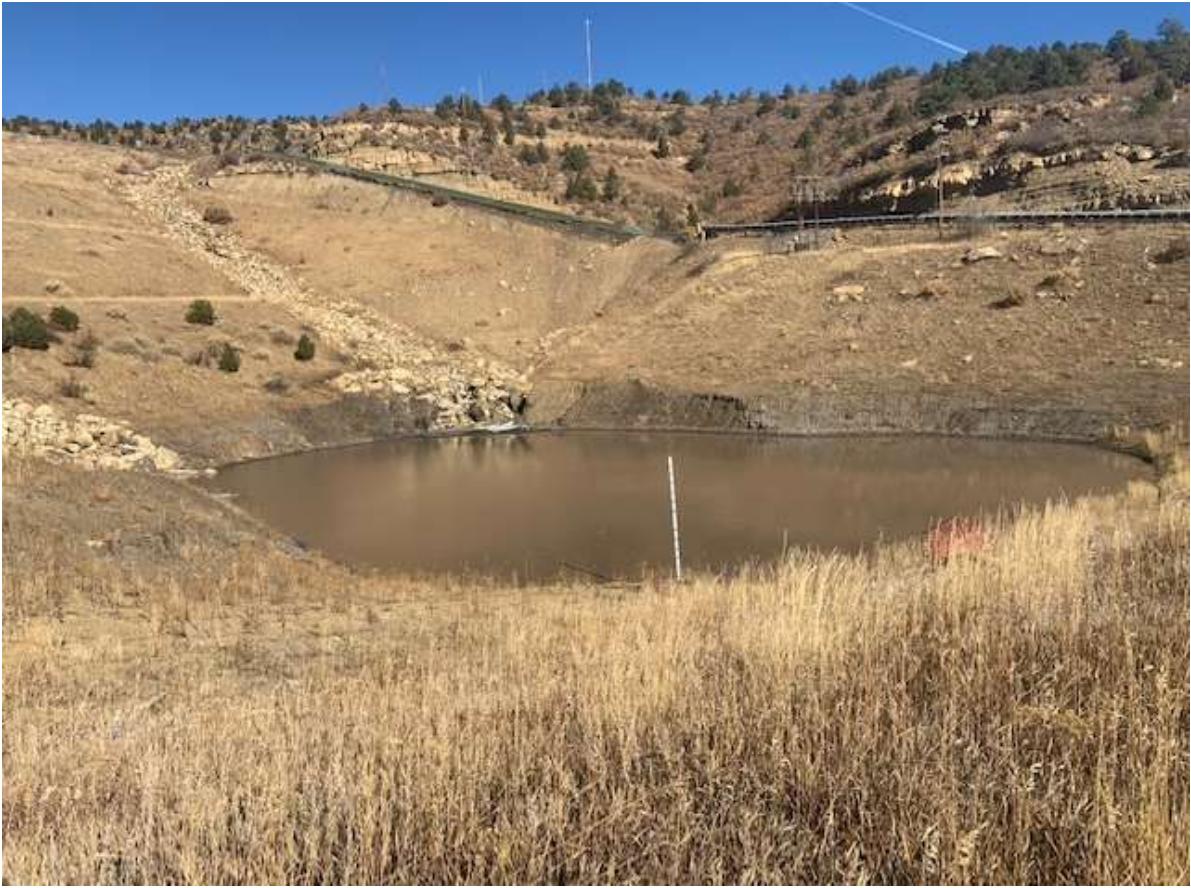
Pond 8

Pond is holding water, not near the decant level. No new sediment has been deposited.

There is very little sediment in the pond.

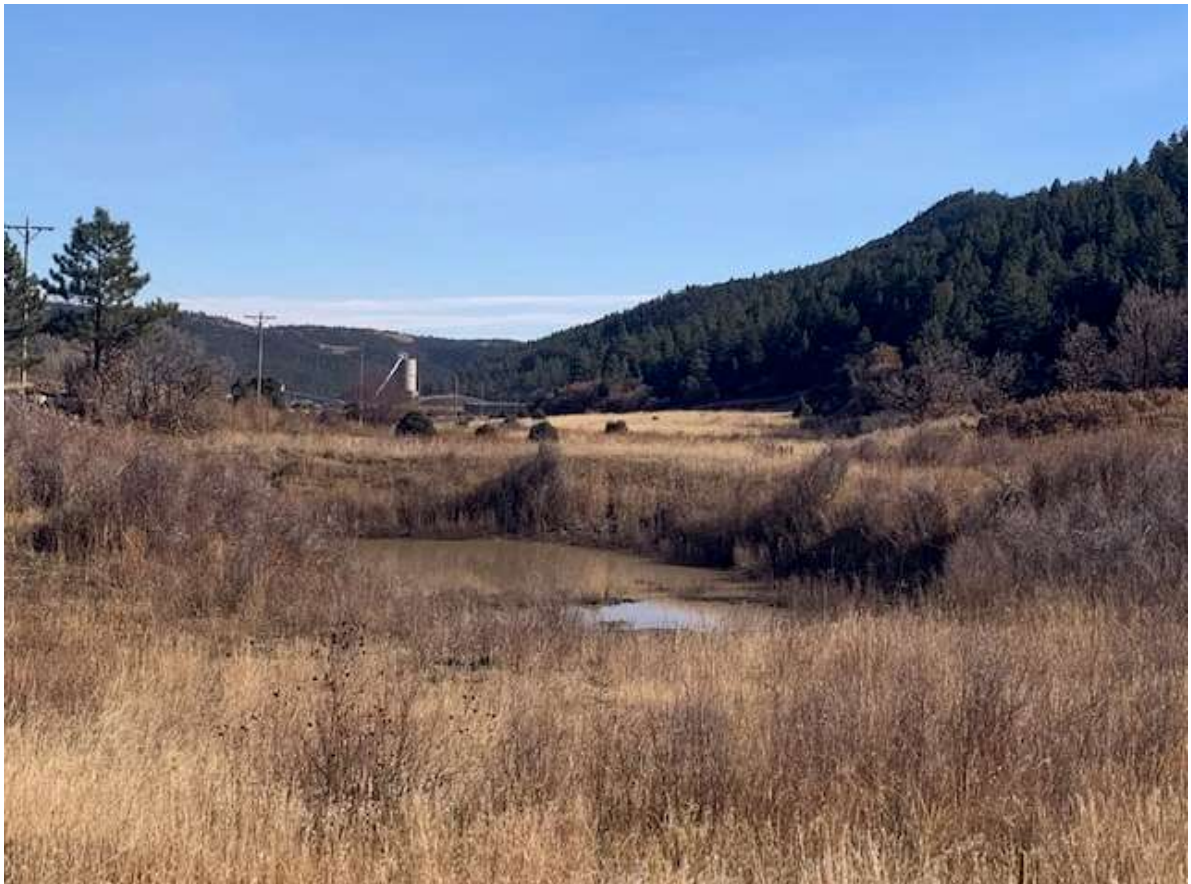
Containment Area #1

Containment area was holding water at the time of inspection. Not near top of embankment.

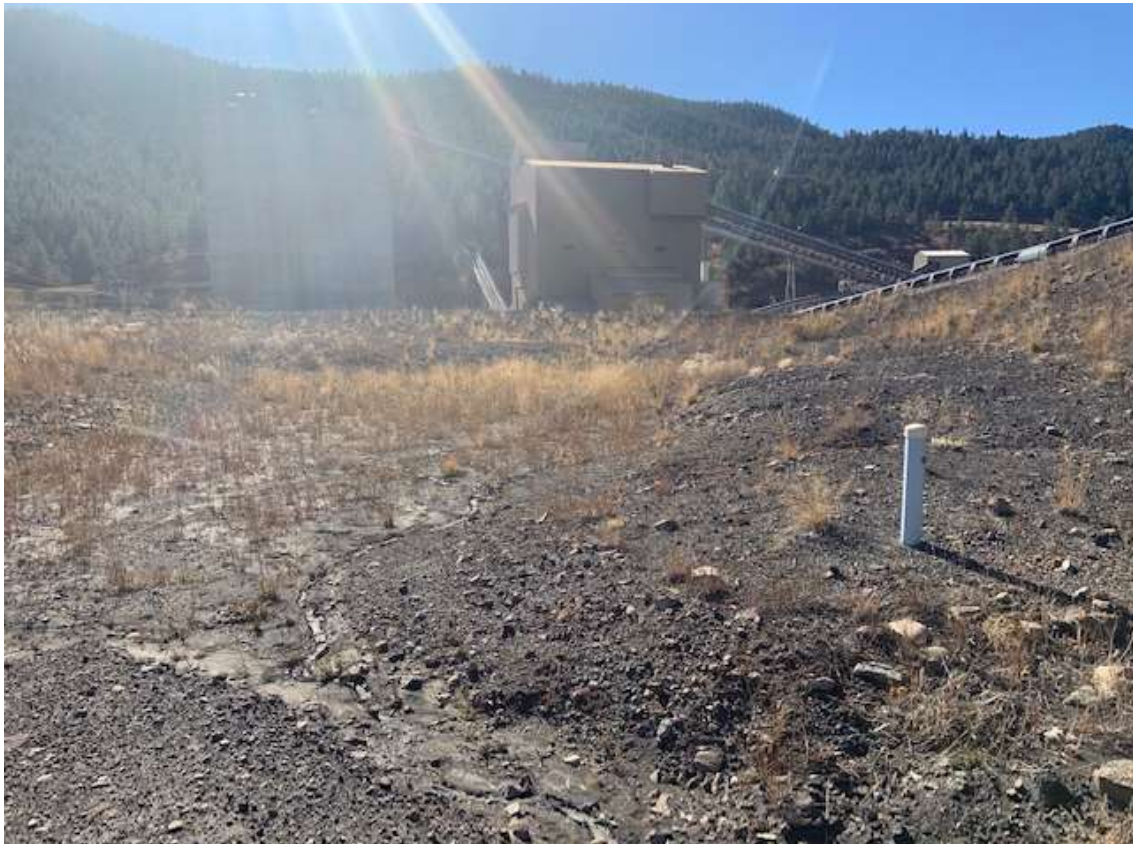
Containment Area #3

Containment Area was dry at time of inspection.

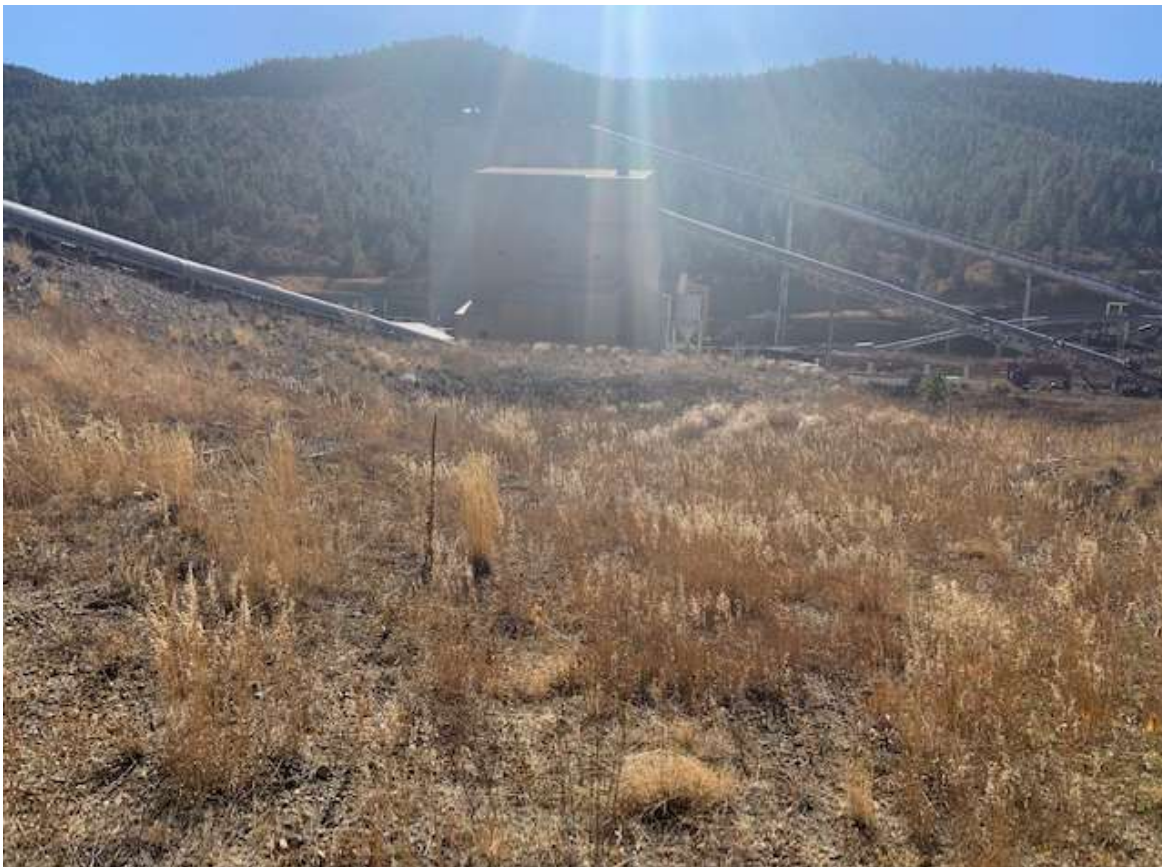
Containment Area #4

Containment Area was dry at time of inspection.
