MINERALS PROGRAM INSPECTION REPORT
PHONE: (303) 866-3567

MINE NAME: Schmidt Site	MINE/PROSPECTING ID#: M-2011-014	MINERAL: Borrow material for	COUNTY: Archuleta
INSPECTION TYPE: Surety Release Inspection	INSPECTOR(S): Lucas West	INSP. DATE: November 16, 2021	INSP. TIME: 11:35
OPERATOR: Dale and Ellen Schmidt	OPERATOR REPRESENTATIVE: Dale and Ellen Schmidt	TYPE OF OPERATION: 110c - Construction Limited Impact	
REASON FOR INSPECTION: Surety Release Requested	BOND CALCULATION TYPE: None	BOND AMOUNT: \$15,140.00	
DATE OF COMPLAINT: NA	POST INSP. CONTACTS: None	JOINT INSP. AGENCY: None	
WEATHER: Clear	INSPECTOR'S SIGNATURE:

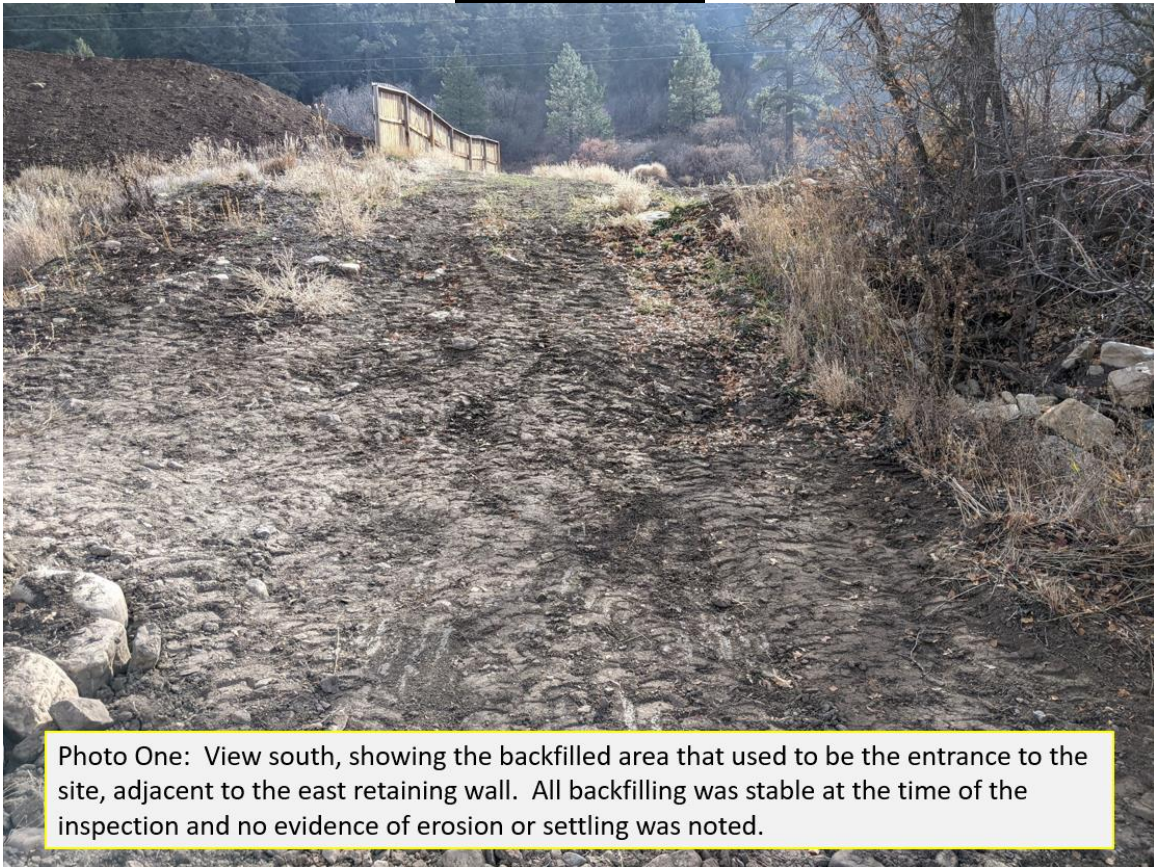
For the last few years this site has been in varying degrees of final reclamation. All reclamation tasks have been completed, the most recent being the backfilling and grading, weed control and stabilization of the east highwall after the driveway relocation project. The details of this project were associated with Technical Revision 2 and involved the installation of a tire bale retaining wall, backfilling and stabilizing the slope. The backfilled area above the east highwall was observed and in good condition. The Operator has diligently removed all weed species from the area, installed a weed barrier and covered the area with rock generated from on site. Photos One and Two show the area above the east retaining wall. This area including the retaining wall appeared to be stable and showed no signs of settling, slumping or erosion. The completion of this task marks the completion of final reclamation of the site.

Photo One: View south, showing the backfilled area that used to be the entrance to the site, adjacent to the east retaining wall. All backfilling was stable at the time of the inspection and no evidence of erosion or settling was noted.

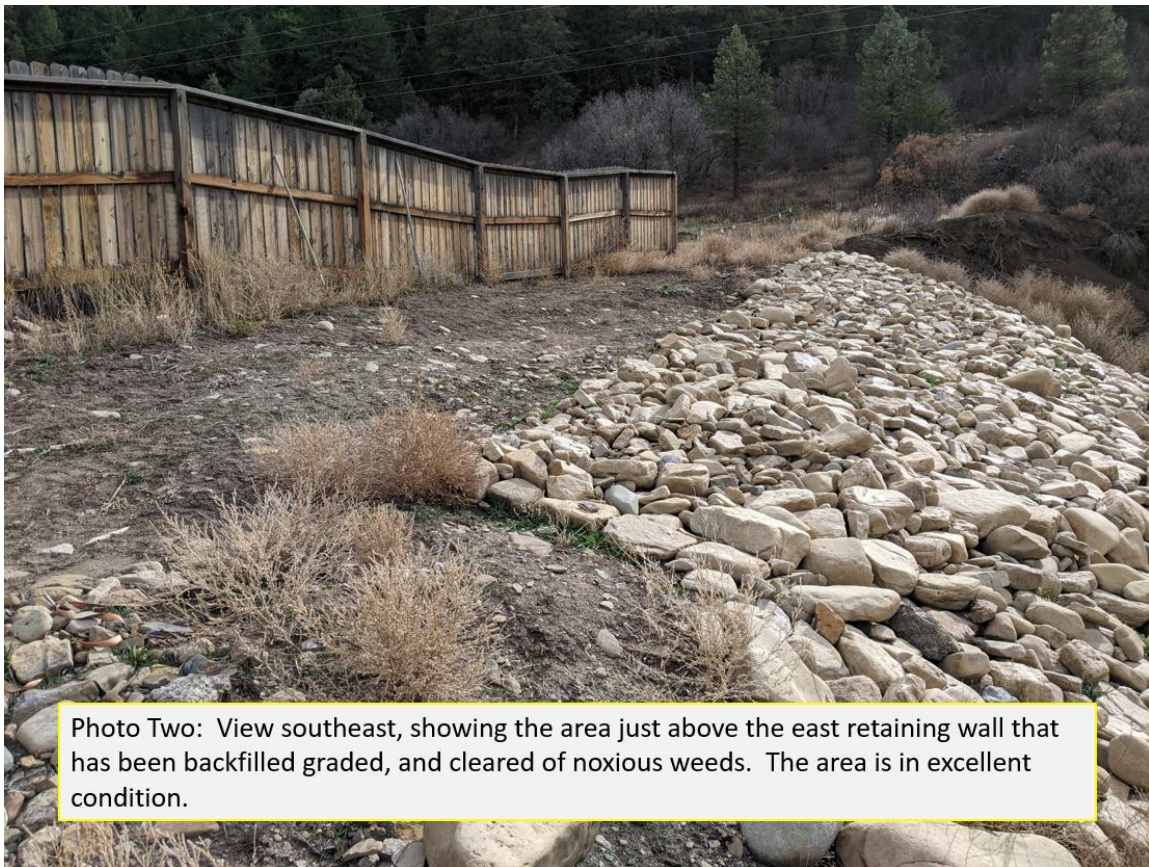
Photo Two: View southeast, showing the area just above the east retaining wall that has been backfilled graded, and cleared of noxious weeds. The area is in excellent condition.

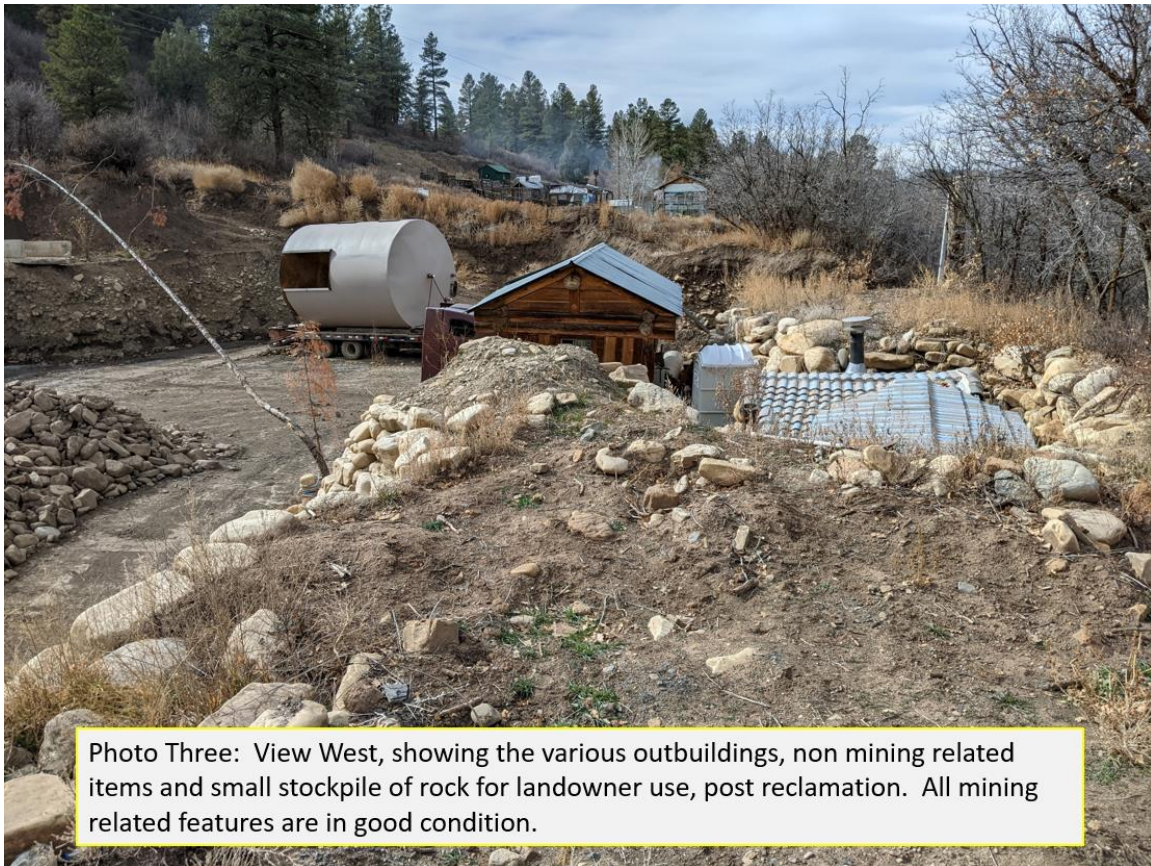
The excavated area in the center and southern sections of the site were stable at the time of inspection. In the main excavated area, various items are being stored but are not mining related and not considered a problem at this time. The various rock walls and structures, shown in Photo Three, are in good condition and approved to remain post reclamation. All other areas of the site are well vegetated and were stable at the time of the inspection. Also located in the main excavated area is a small stockpile of rock material that is to remain on site for use on the property.

Photo Three: View West, showing the various outbuildings, non mining related items and small stockpile of rock for landowner use, post reclamation. All mining related features are in good condition.
