MINERALS PROGRAM INSPECTION REPORT
PHONE: (303) 866-3567

MINE NAME: Stevens Clay Lease	MINE/PROSPECTING ID#: M-1996-064	MINERAL: Clay (general)	COUNTY: Douglas
INSPECTION TYPE: Surety Release Inspection	INSPECTOR(S): Elliott Russell	INSP. DATE: October 13, 2021	INSP. TIME: 07:30
OPERATOR: The Denver Brick Company	OPERATOR REPRESENTATIVE: None	TYPE OF OPERATION: 112c - Construction Regular Operation	
REASON FOR INSPECTION: Surety Release Requested	BOND CALCULATION TYPE: None	BOND AMOUNT: \$148,000.00	
DATE OF COMPLAINT: NA	POST INSP. CONTACTS: None	JOINT INSP. AGENCY: None	
WEATHER: Clear	INSPECTOR'S SIGNATURE:

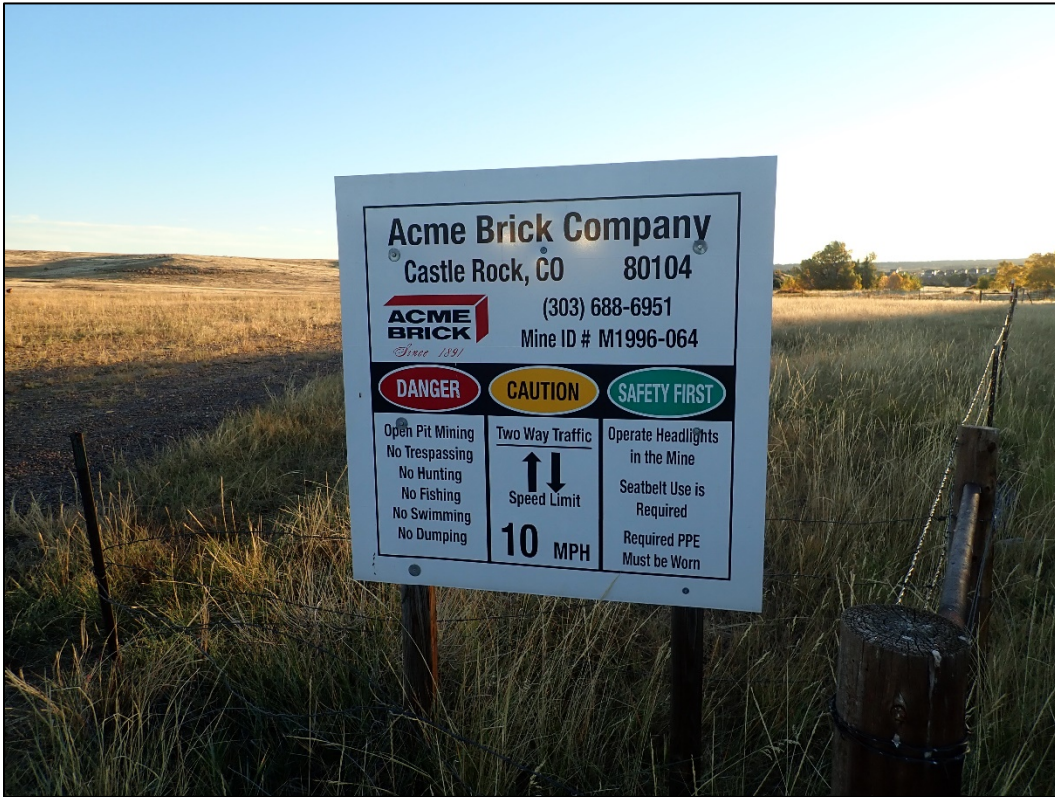
Photo 1. Mine identification sign; looking northeast.

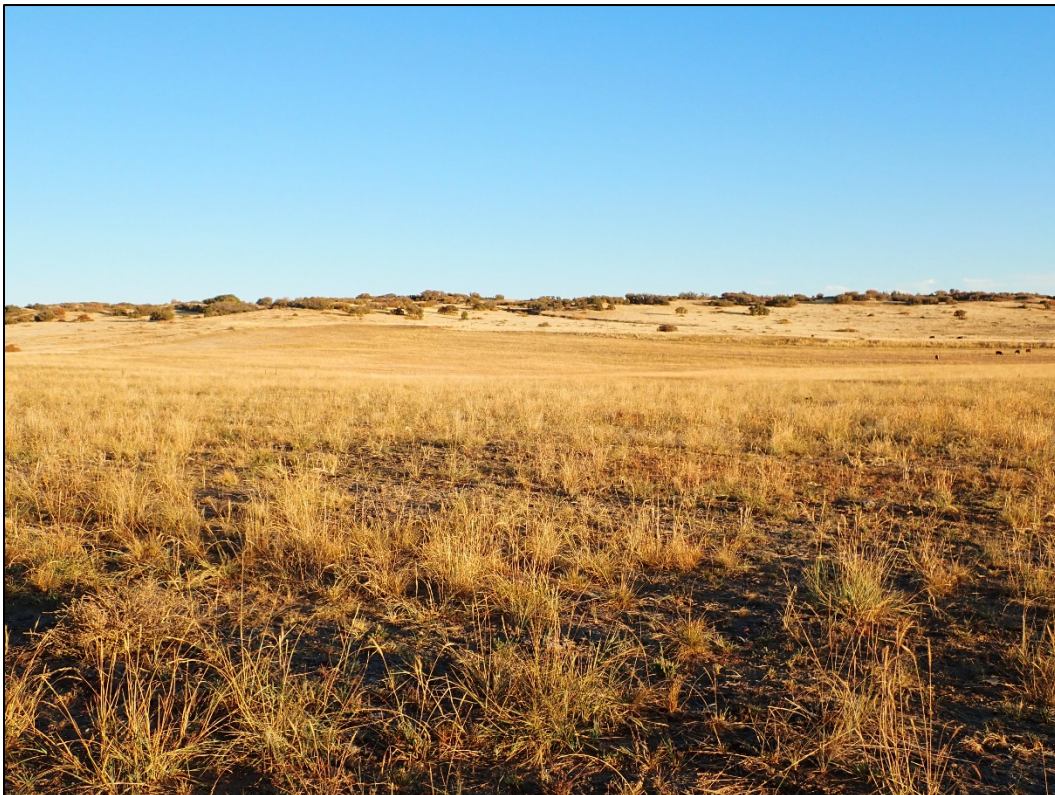
Photo 2: Sample photo of reclaimed mine disturbance; looking northwest.

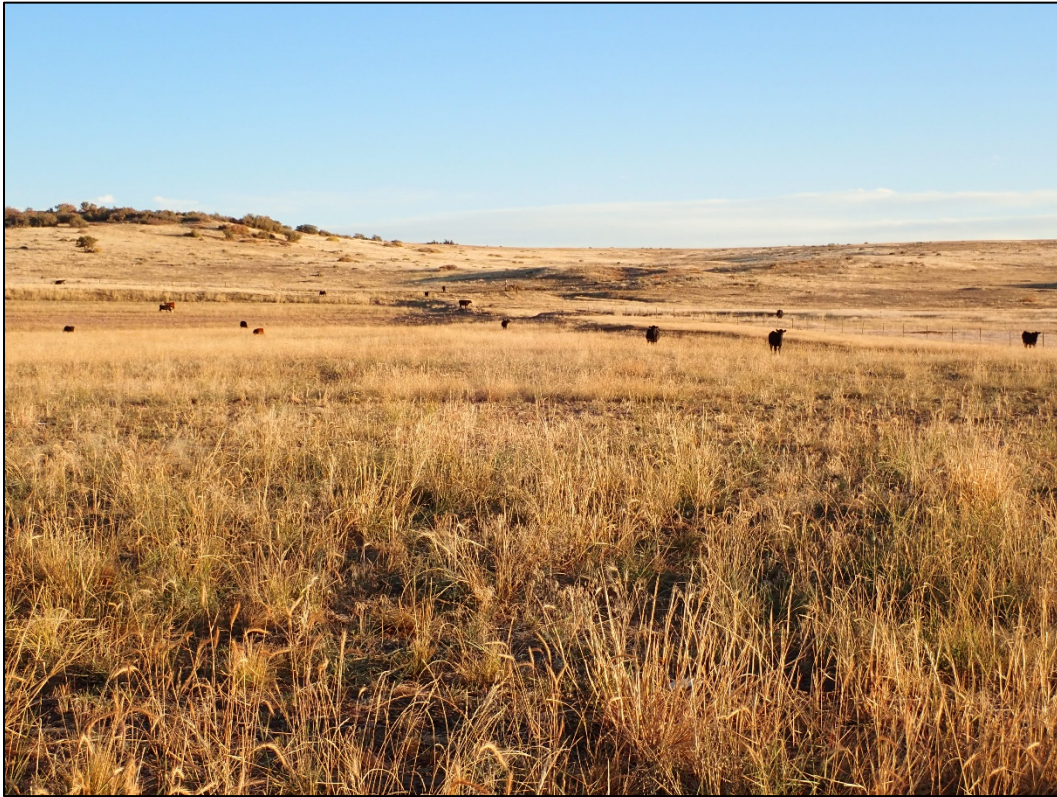
Photo 3. Sample photo of reclaimed mine disturbance; looking north.

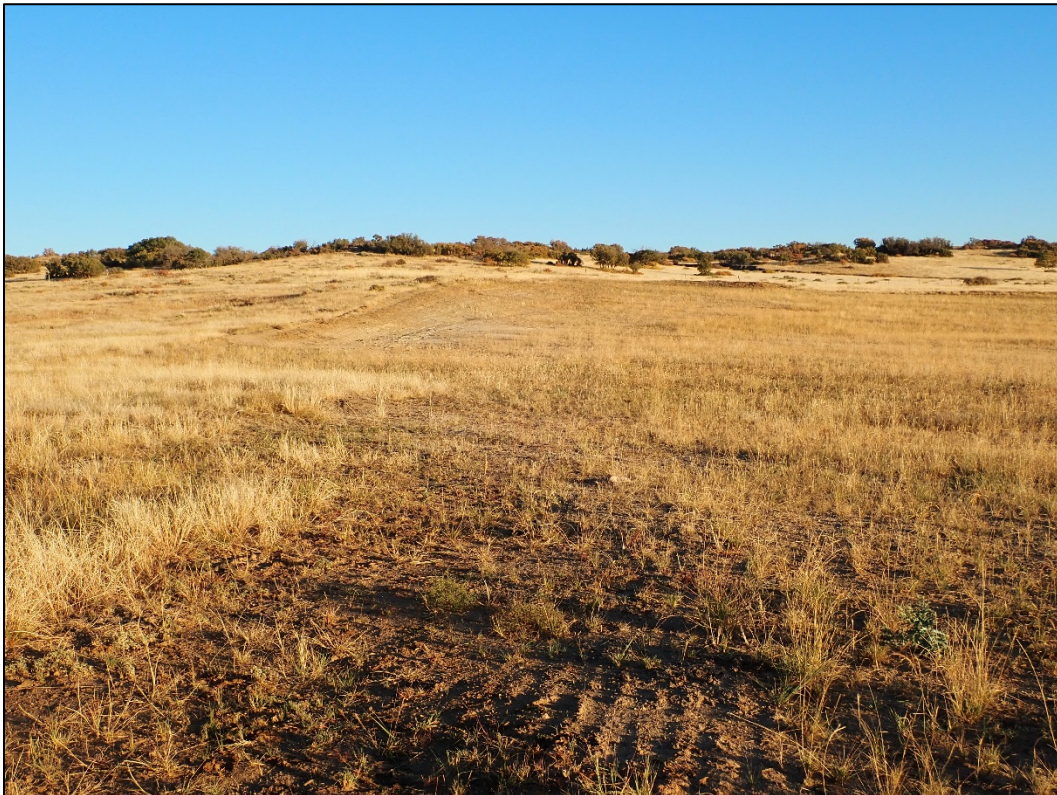
Photo 4. Sample photo of reclaimed mine disturbance; looking northwest.

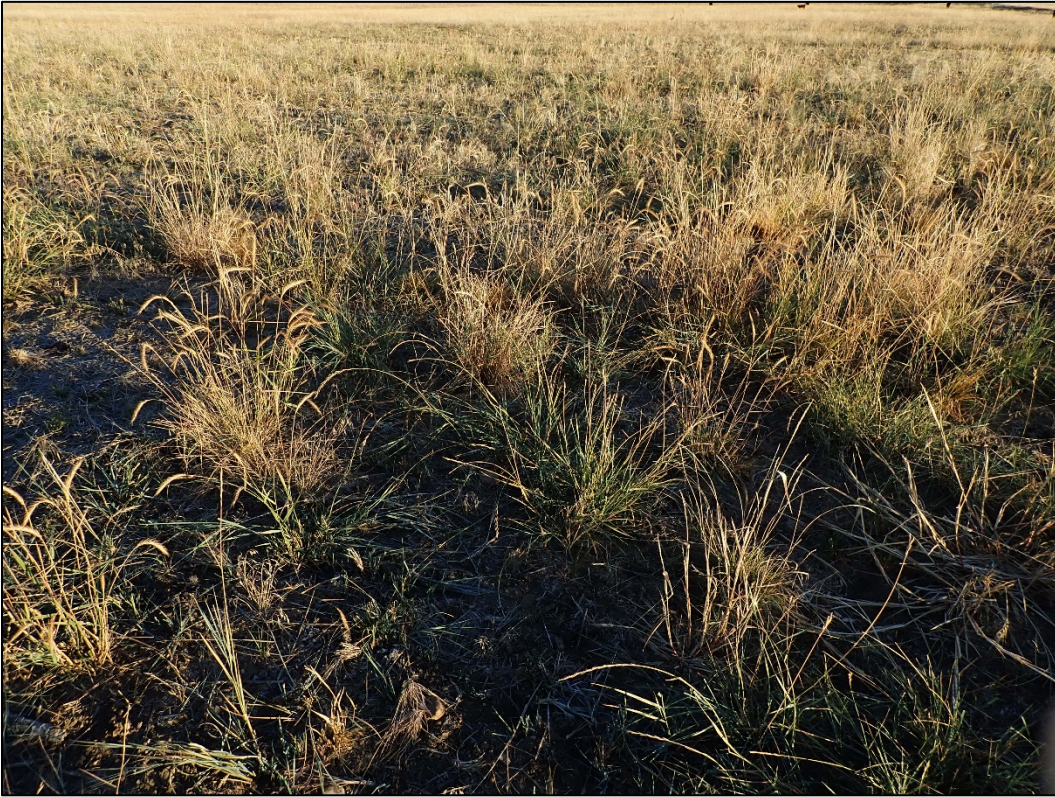
Revegetation: The affected lands were vegetated with a diverse community of grasses. Vegetative cover appeared to match adjacent off-site areas. The noxious weeds that were observed during the previous inspection had been appropriately treated and no further infestations were observed. The site was actively being grazed at the time of the inspection by cattle.

Photo 5. Sample photo of reclamation grasses and reestablished vegetative cover; looking north.

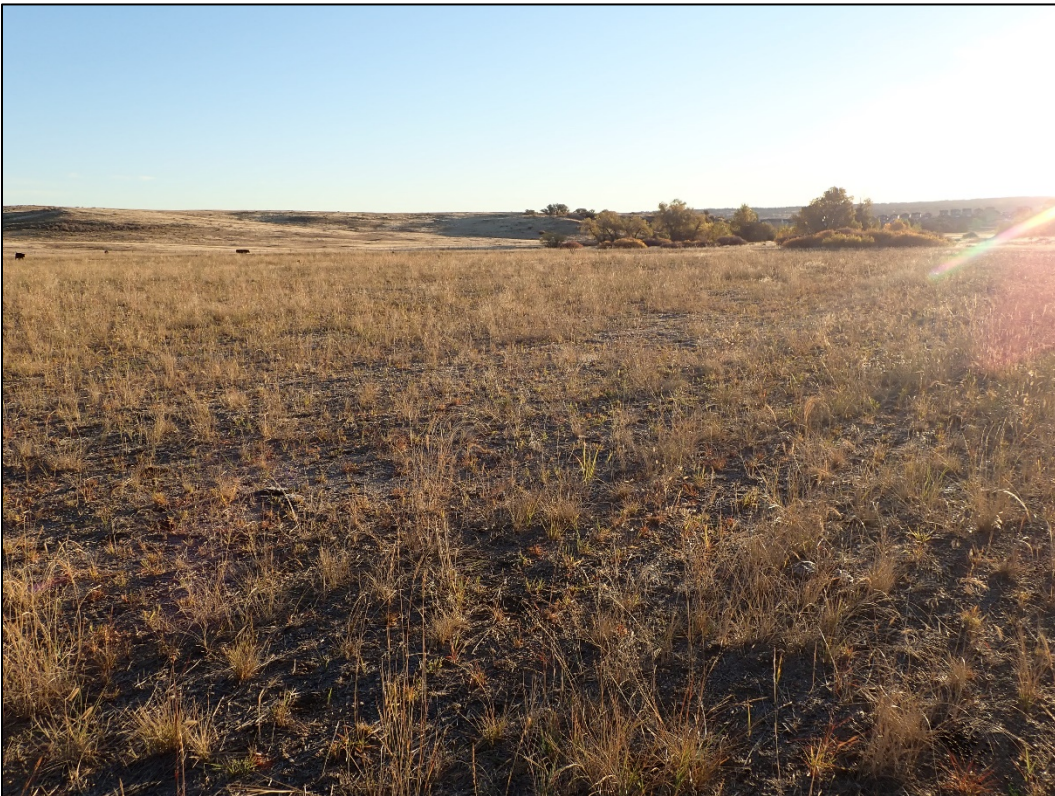
Photo 6. Sample photo of reclaimed mine disturbance; looking northeast..

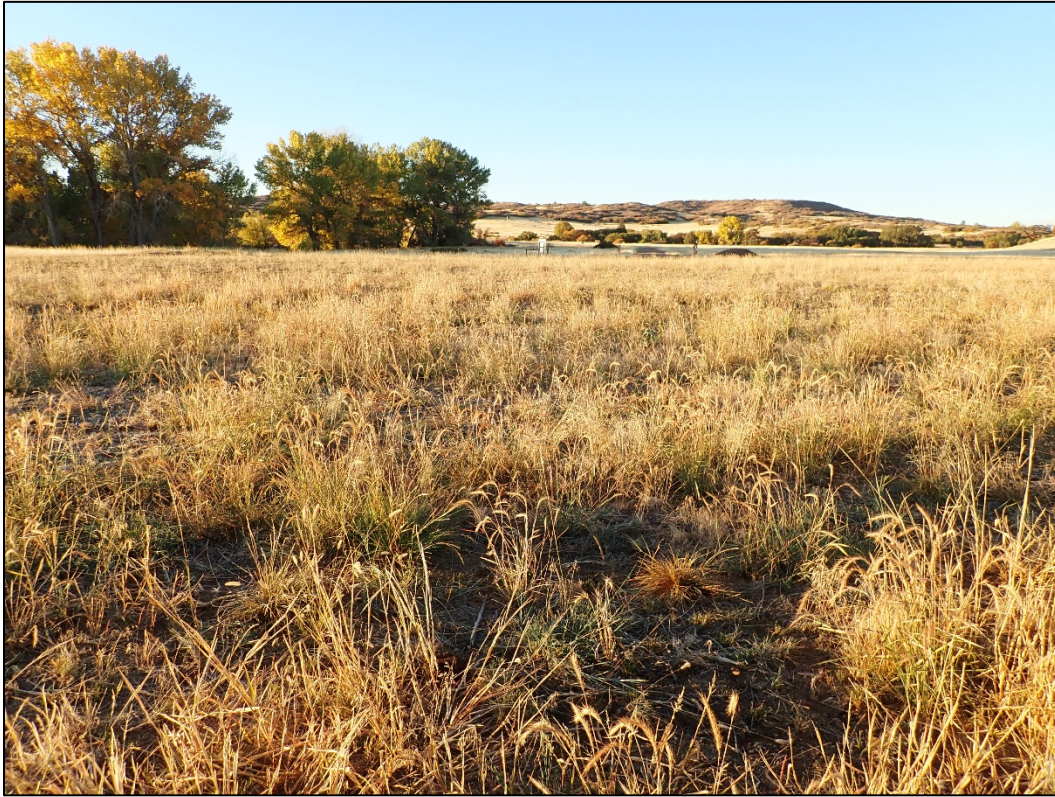
Photo 7. Sample photo of reclaimed mine disturbance; looking south.
