MINERALS PROGRAM INSPECTION REPORT
PHONE: (303) 866-3567

MINE NAME: Climax Mine	MINE/PROSPECTING ID#: M-1977-493	MINERAL: Molybdenum	COUNTY: Lake, Summit
INSPECTION TYPE: Monitoring	INSPECTOR(S): Lucas West	INSP. DATE: November 15, 2021	INSP. TIME: 09:41
OPERATOR: Climax Molybdenum Company	OPERATOR REPRESENTATIVE: Diana Kelts	TYPE OF OPERATION: 112d-3 - Designated Mining Operation	
REASON FOR INSPECTION: Normal I&E Program	BOND CALCULATION TYPE: None	BOND AMOUNT: \$91,011,850.00	
DATE OF COMPLAINT: NA	POST INSP. CONTACTS: None	JOINT INSP. AGENCY: None	
WEATHER: Clear	INSPECTOR'S SIGNATURE:

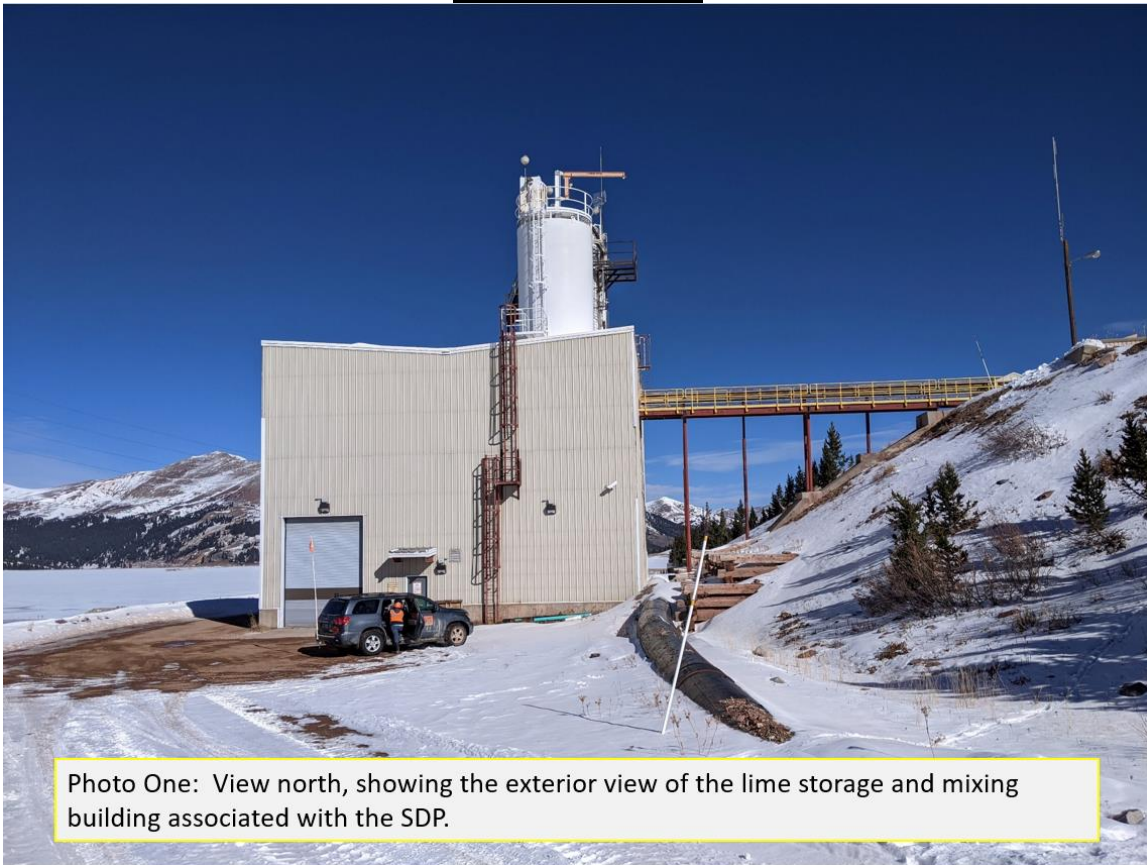
Photo One: View north, showing the exterior view of the lime storage and mixing building associated with the SDP.

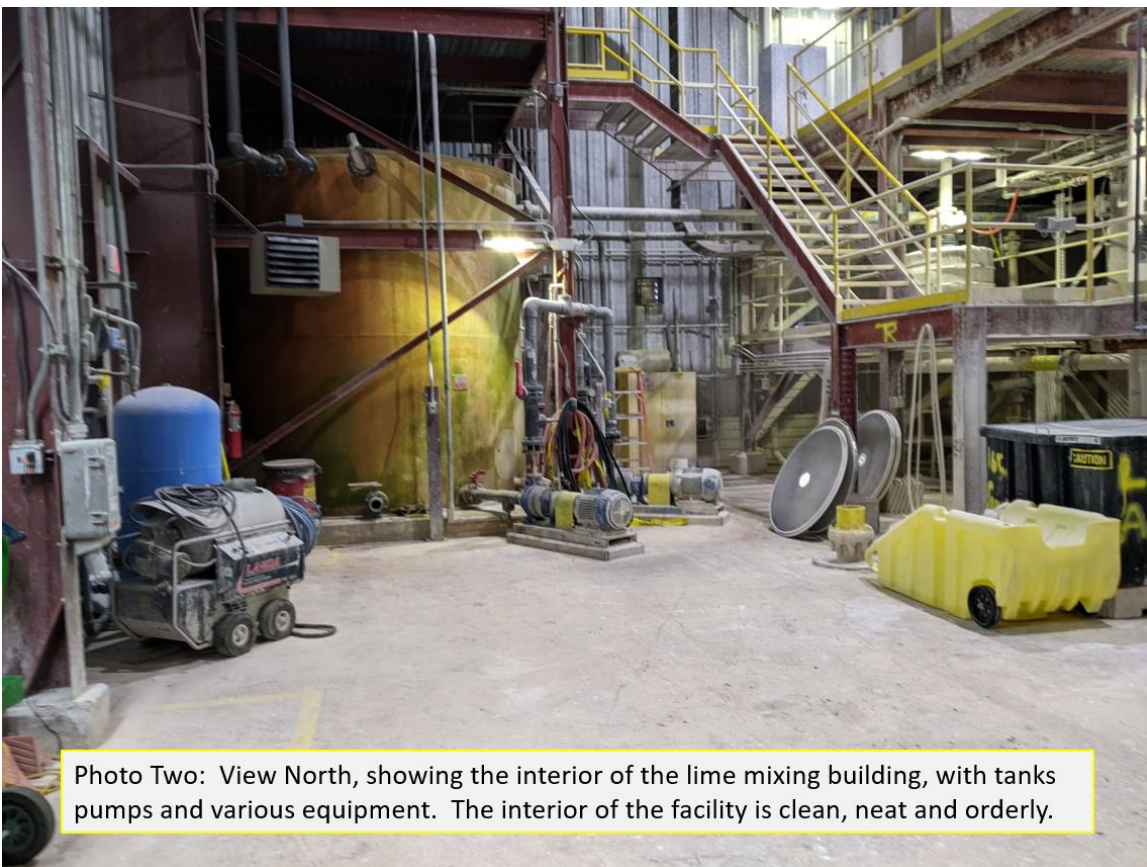
Photo Two: View North, showing the interior of the lime mixing building, with tanks pumps and various equipment. The interior of the facility is clean, neat and orderly.

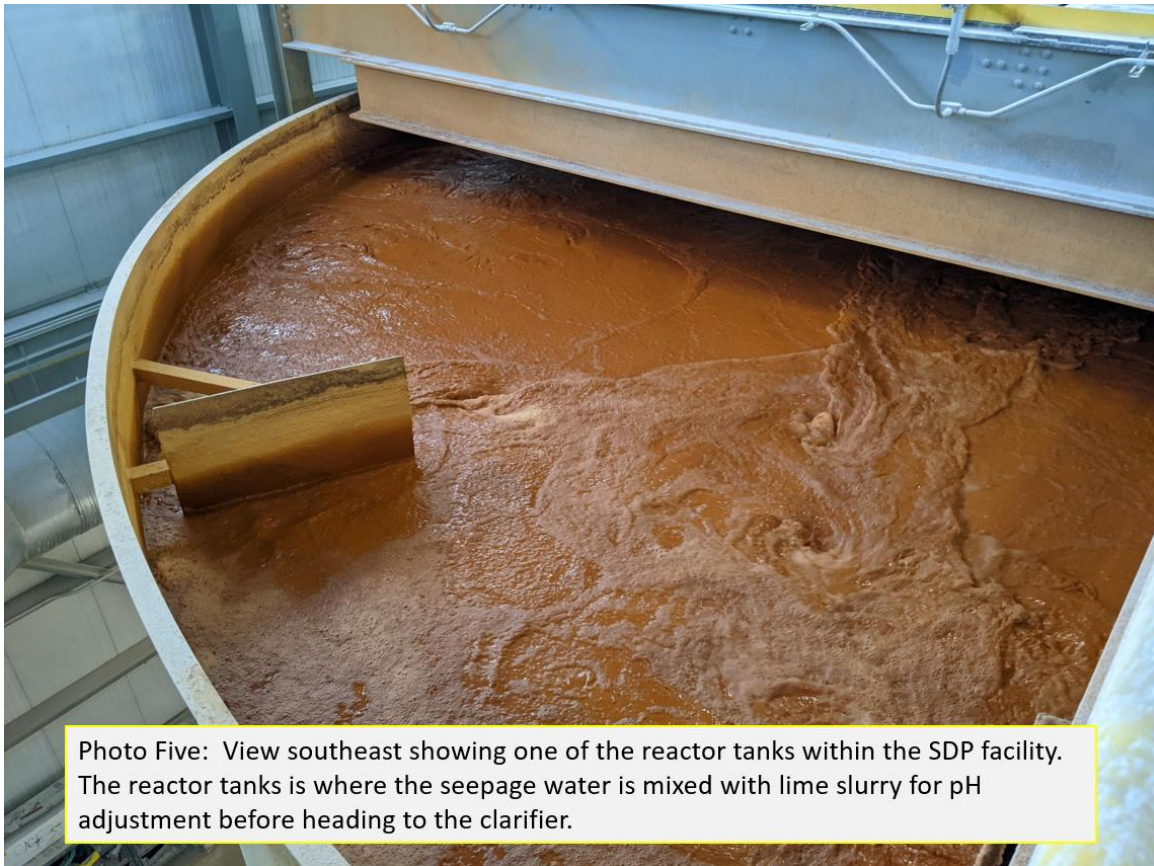
Photo Five: View southeast showing one of the reactor tanks within the SDP facility. The reactor tanks is where the seepage water is mixed with lime slurry for pH adjustment before heading to the clarifier.

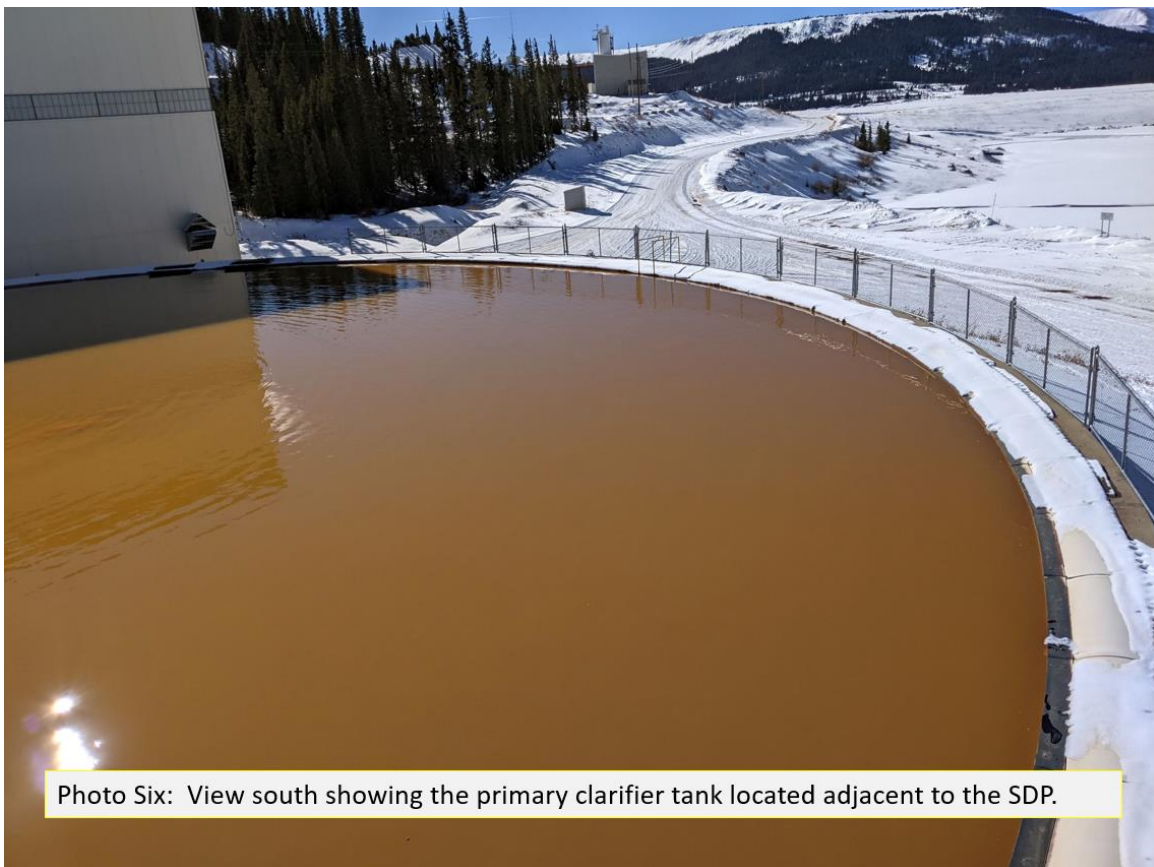
Photo Six: View south showing the primary clarifier tank located adjacent to the SDP.

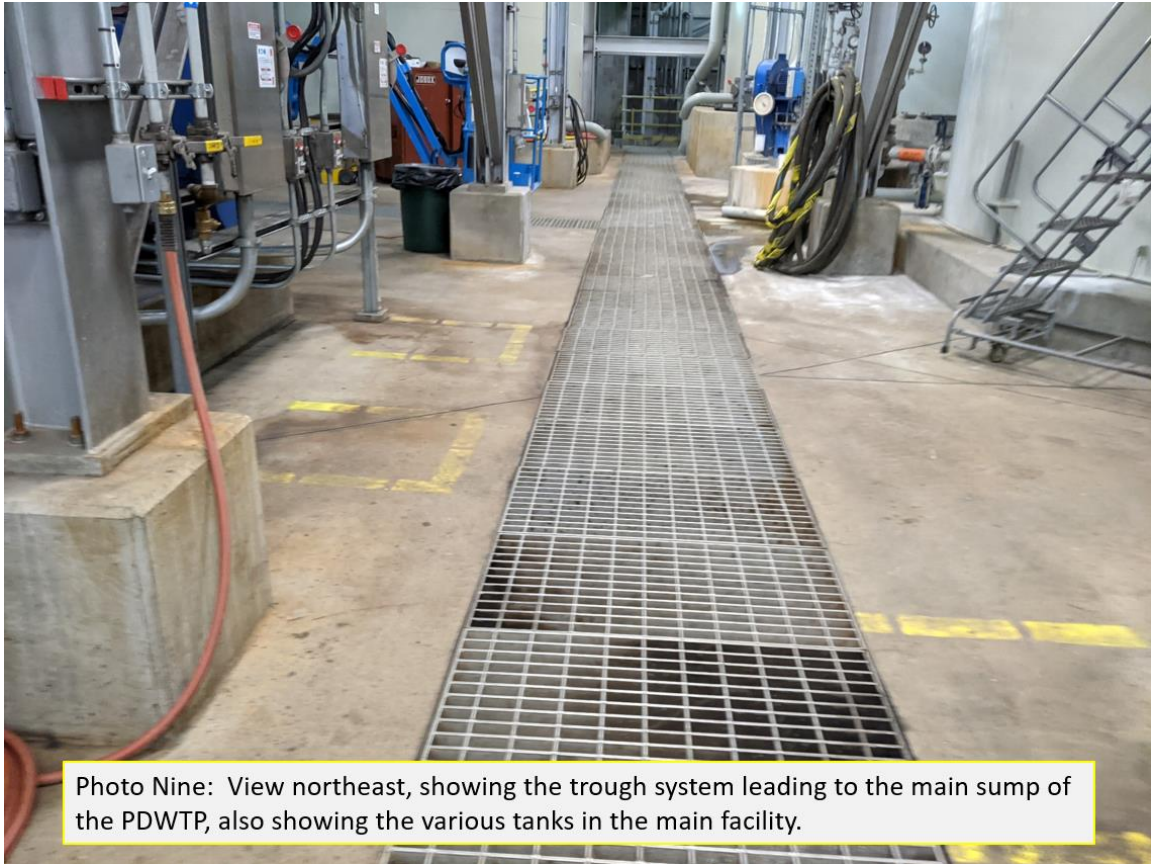
Photo Nine: View northeast, showing the trough system leading to the main sump of the PDWTP, also showing the various tanks in the main facility.

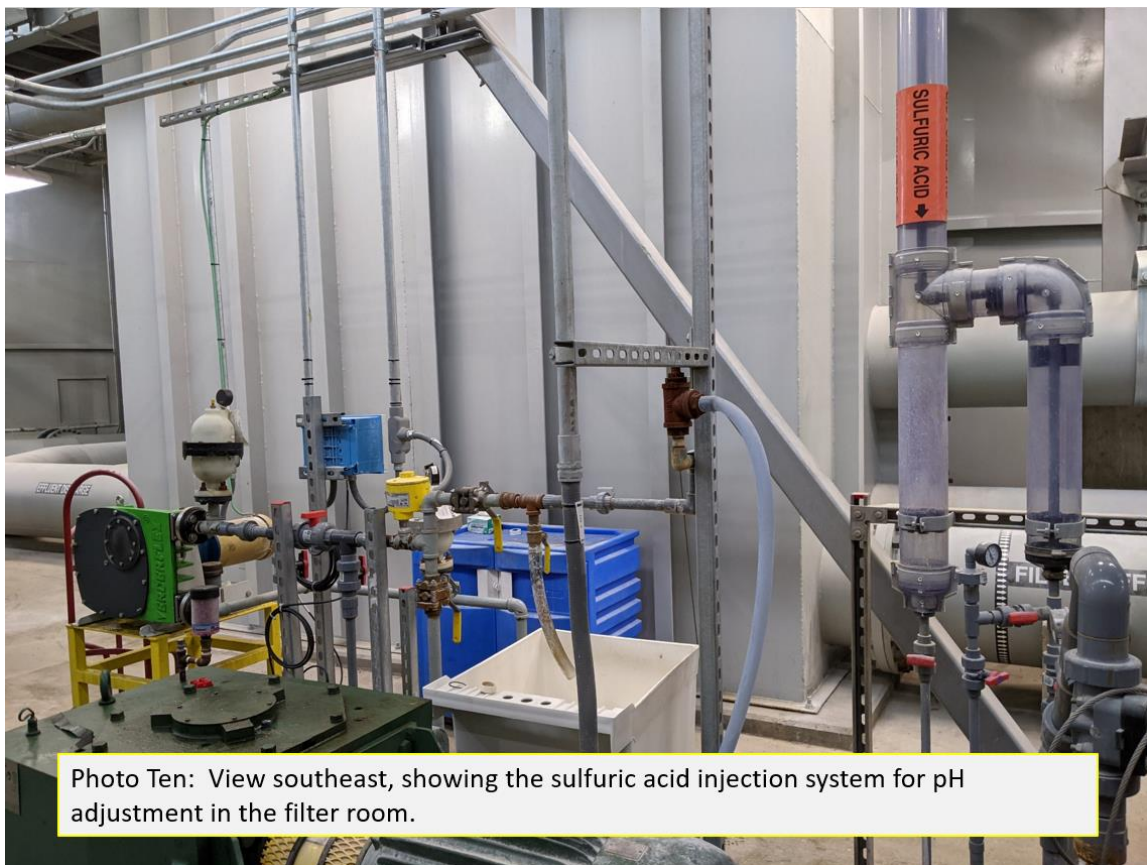
Photo Ten: View southeast, showing the sulfuric acid injection system for pH adjustment in the filter room.

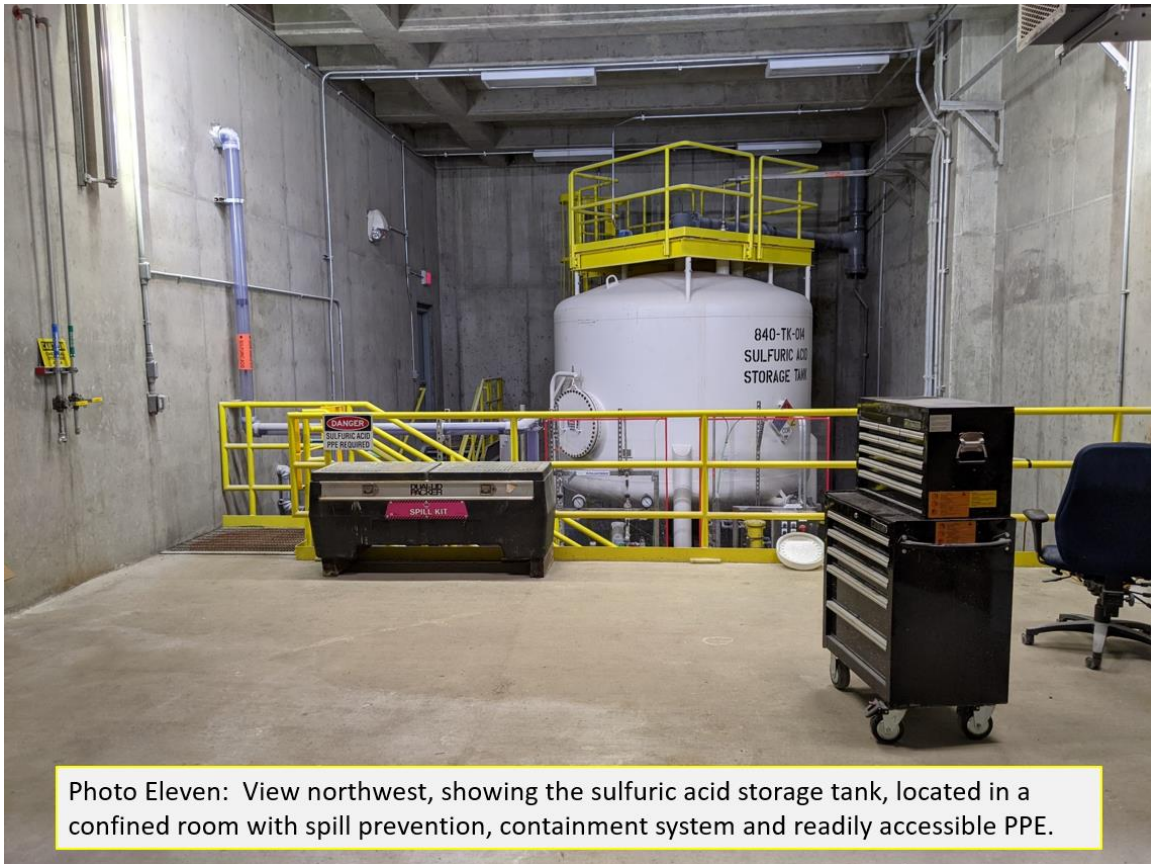
Photo Eleven: View northwest, showing the sulfuric acid storage tank, located in a confined room with spill prevention, containment system and readily accessible PPE.

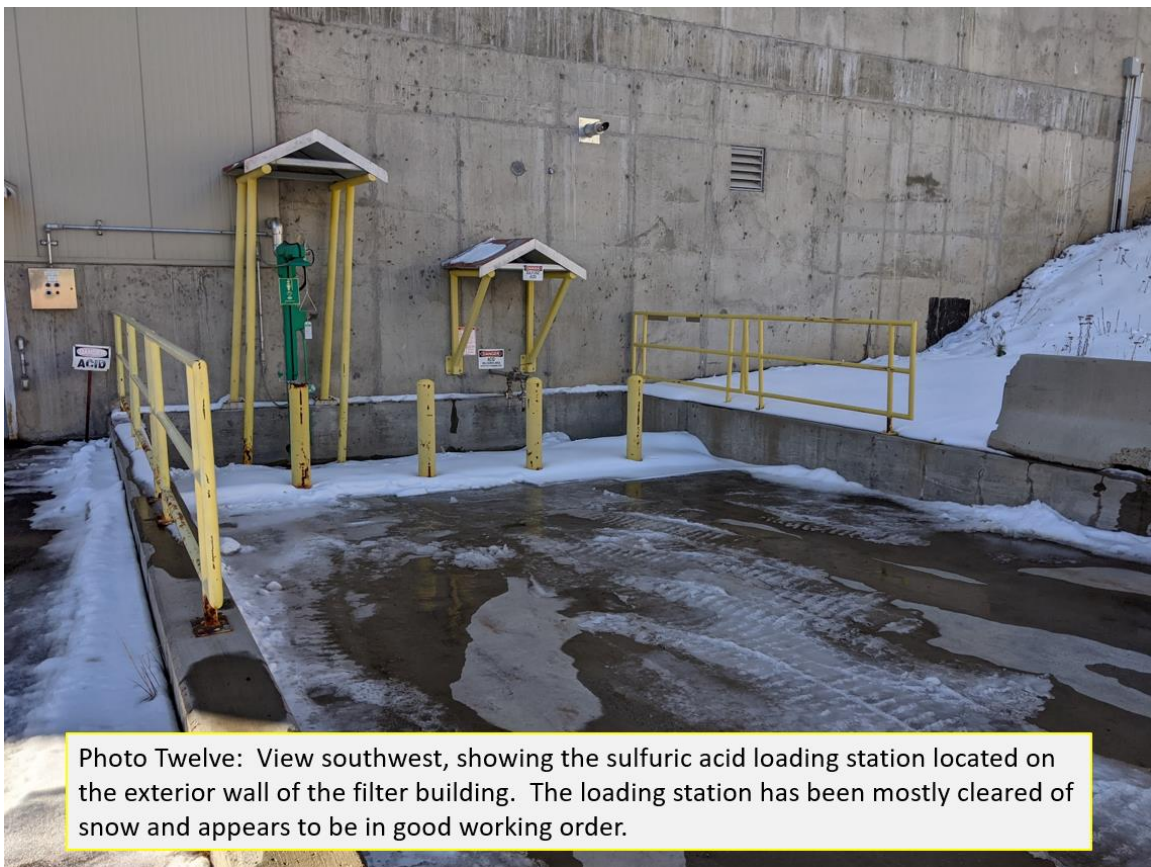
Connected by an underground man-way, the filter building is located adjacent to the clarifier tanks. The filter building is in good condition and contains various chemicals used during the water treatment process. Most notable is sulfuric acid, used for pH adjustment. The sulfuric acid injection station can be seen in Photo Ten. Photo Eleven shows the sulfuric acid storage area which is its own separate room equipped with sump, spill kits and readily accessible PPE. The tank and sump are in excellent condition. Located just outside the filter building is the sulfuric acid loading station. The loading station is equipped with secondary containment for possible spills that may happen during the unloading process. The station has been cleared of snow and is good operating condition. It can be seen in Photo Twelve.

Photo Twelve: View southwest, showing the sulfuric acid loading station located on the exterior wall of the filter building. The loading station has been mostly cleared of snow and appears to be in good working order.
