**RE: Permit No. M-1980-244; Cripple Creek & Victor Gold Mining Company; Cresson Project;  
Schist Island Backfill Weekly Report**

Newmont Mining Corporation  
 Cripple Creek & Victor Gold Mine  
 VLF2 Phase 3 Site Support 2021  
 NewFields Job No. 475.0106.053  
 Week Ending Friday, November 5, 2021

## FIELD WEEKLY PROGRESS REPORT

**PROJECT:** VALLEY LEACH FACILITY (VLF2) PHASE 3 CQA HIGH COMPACTION BACKFILL  
**SITE:** CRIPPLE CREEK & VICTOR GOLD MINE (COLORADO)  
**CONTRACTOR:** NEWMONT CC&V MINING OPERATIONS  
**WEEK ENDING:** FRIDAY, NOVEMBER 5, 2021

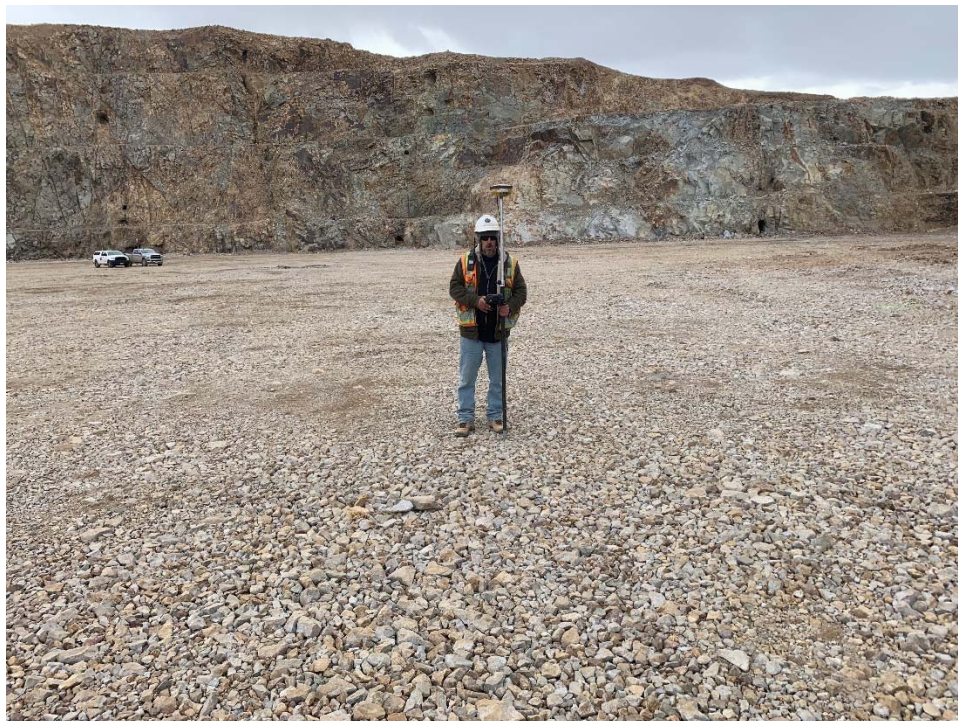
**October 30, 2021 – High Compaction Backfill controlled survey grid (TW)**

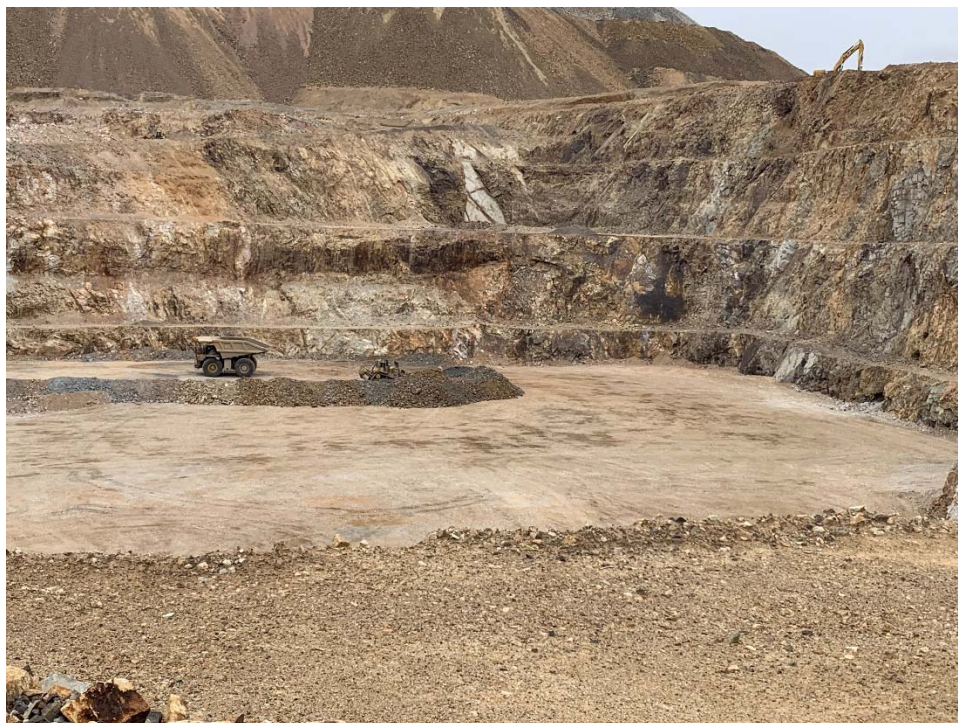
**October 30, 2021 – High Compaction Backfill progress (TW)**

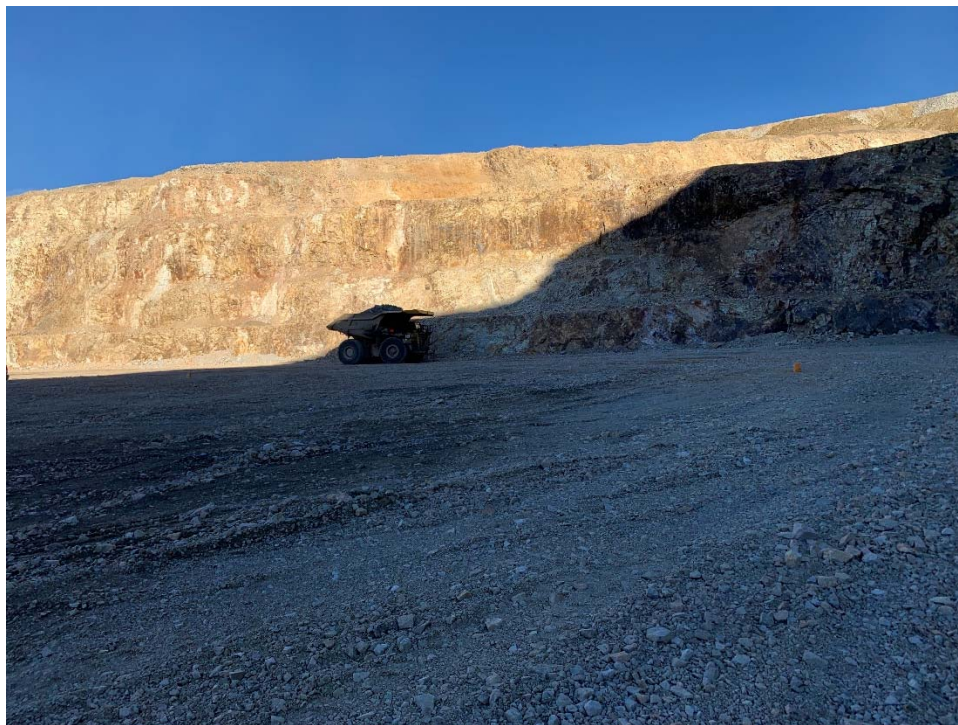
**November 5, 2021 – High Compaction Backfill wheel rolling (TW)**

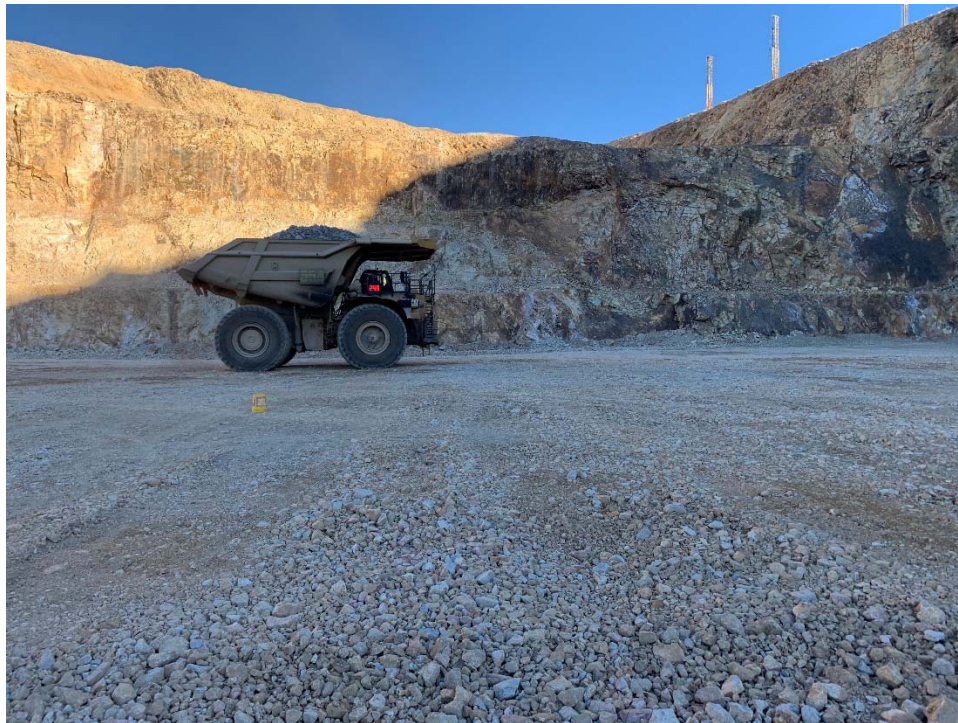
**November 5, 2021 – High Compaction Backfill wheel rolling controlled survey grid (TW)**

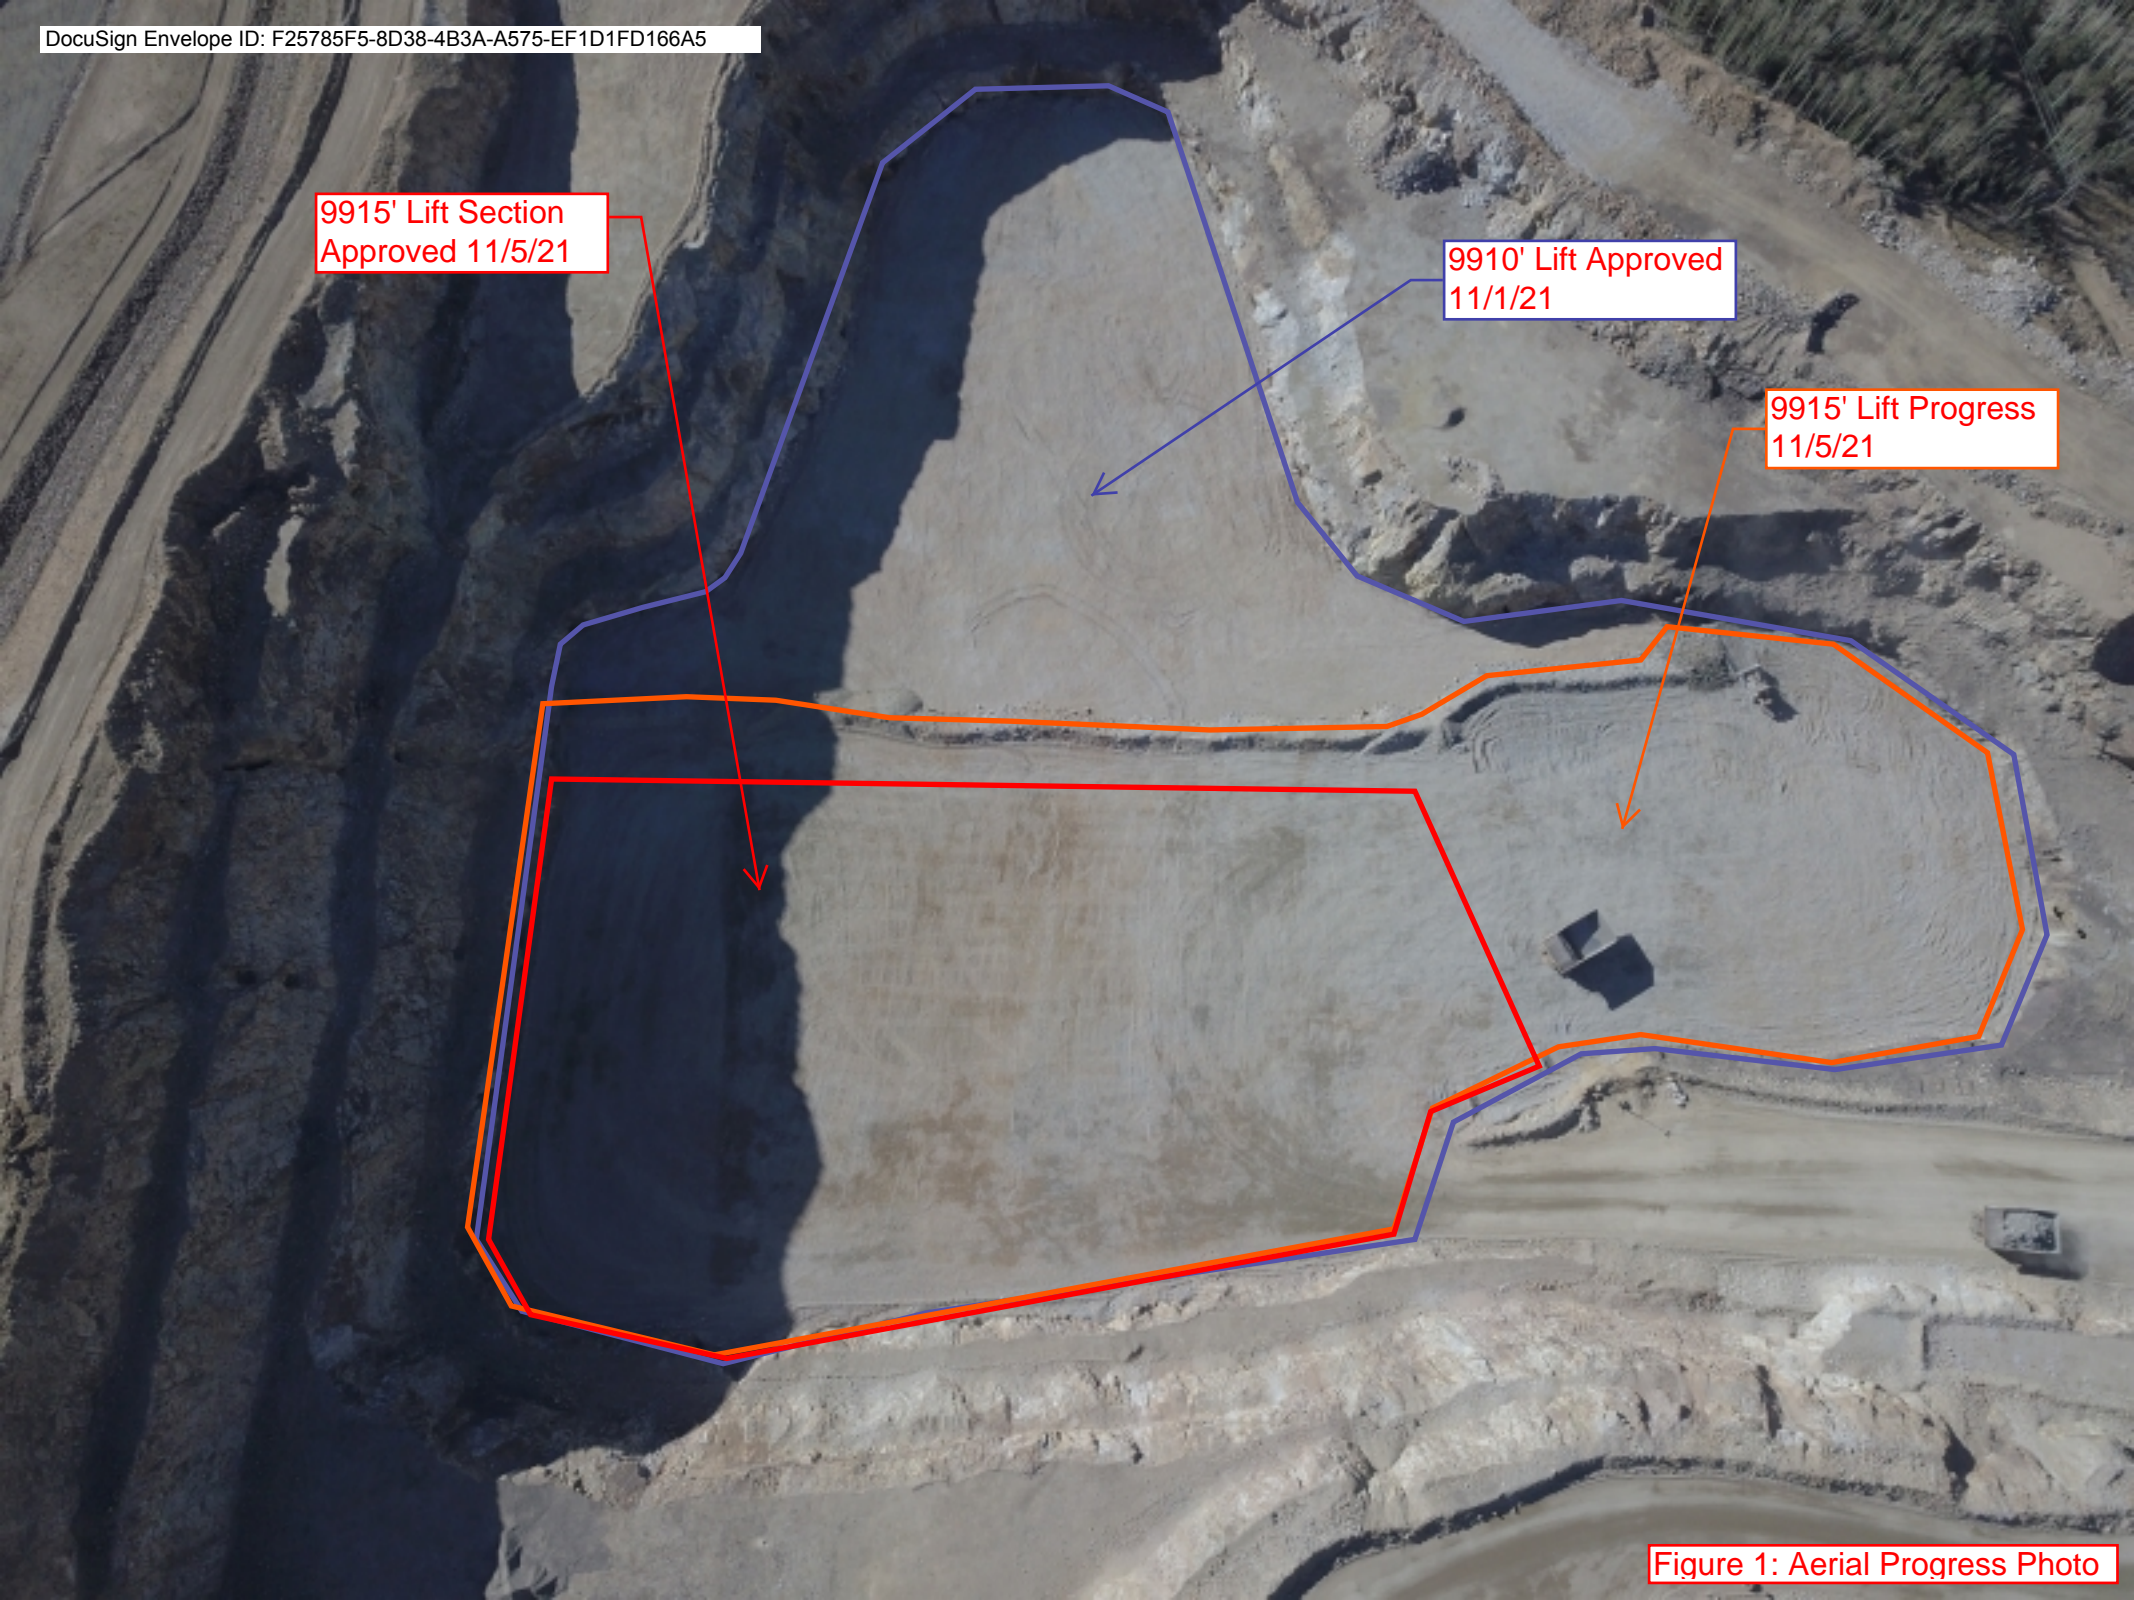
Figure 1: Aerial Progress Photo

9915' Lift Section  
Approved 11/5/21

9910' Lift Approved  
11/1/21

9915' Lift Progress  
11/5/21
