MINERALS PROGRAM INSPECTION REPORT
PHONE: (303) 866-3567

MINE NAME: Henderson Mine	MINE/PROSPECTING ID#: M-1977-342	MINERAL: Molybdenum	COUNTY: Clear Creek, Grand
INSPECTION TYPE: Monitoring	INSPECTOR(S): Peter Hays	INSP. DATE: October 22, 2021	INSP. TIME: 09:00
OPERATOR: Climax Molybdenum Company	OPERATOR REPRESENTATIVE: Geoff Niggeler	TYPE OF OPERATION: 112d-3 - Designated Mining Operation	
REASON FOR INSPECTION: Normal I&E Program	BOND CALCULATION TYPE: None	BOND AMOUNT: \$134,155,028.00	
DATE OF COMPLAINT: NA	POST INSP. CONTACTS: None	JOINT INSP. AGENCY: None	
WEATHER: Clear	INSPECTOR'S SIGNATURE:

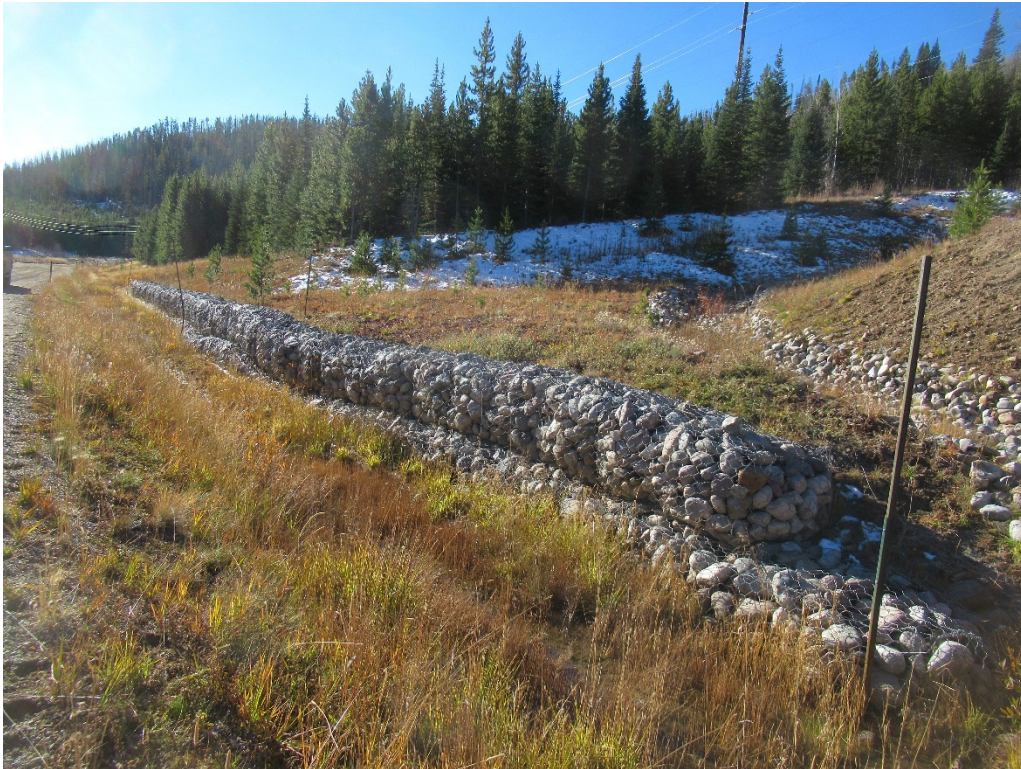
The Ultimate Canal is included in Mill EPF 3.1 - Storm Water Diversion System. The canal diverts un-impacted stormwater from the west and north ends of the tailings storage facility (TSF) around the north end of the property to the Williams Fork River. The canal was inspected from south to north during the inspection. The canal surface was partially ice covered at the time of the inspection, however sections of the canal were ice free and water was flowing freely. The gabion structures, culverts and inlet structures were observed and appeared to be working as designed. The Operator reported water from the canal was discharged to wetland areas in August.

View of gabion structures along the ultimate canal

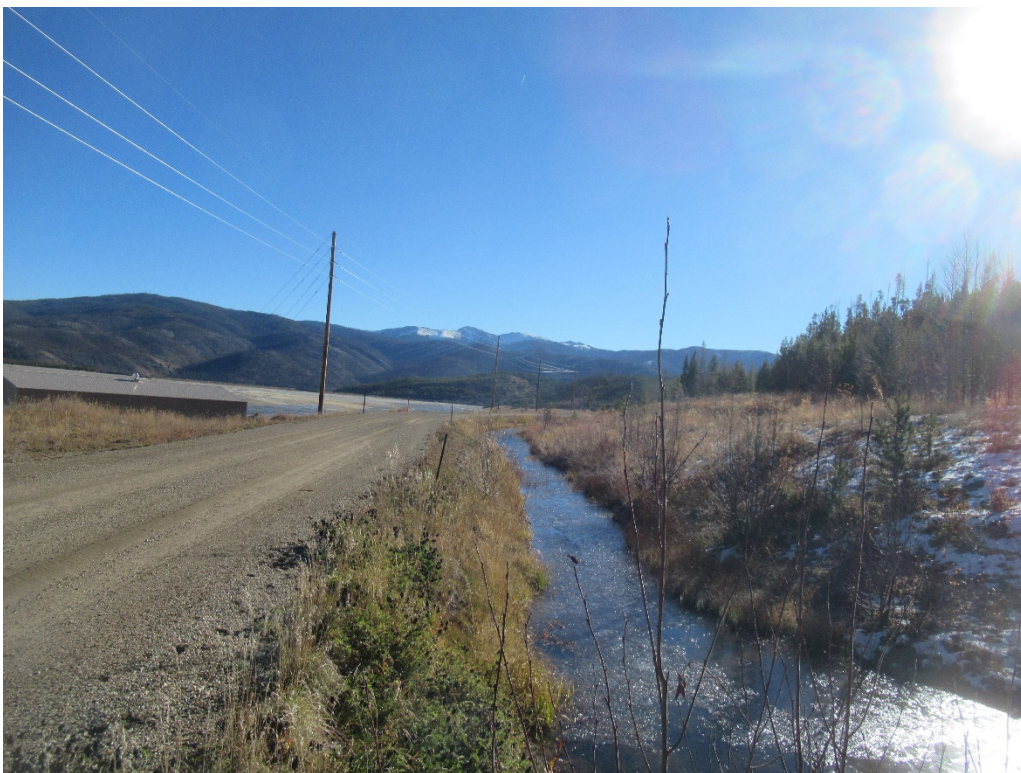
View of a section of the ultimate canal looking south

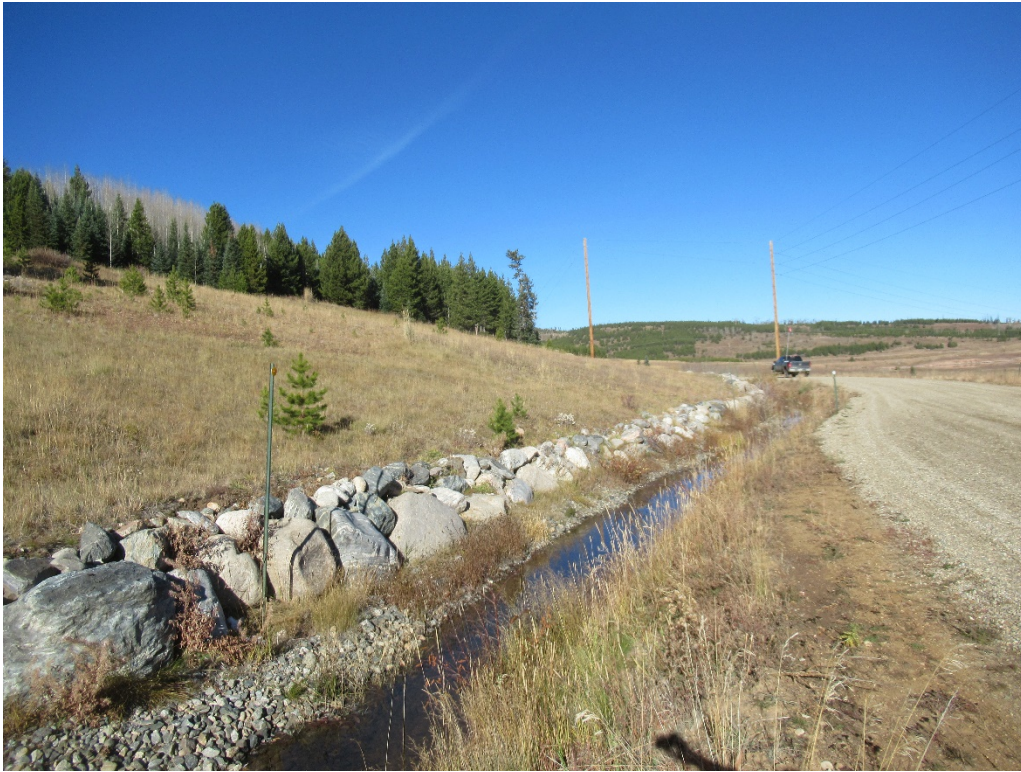
View of a section of the ultimate canal

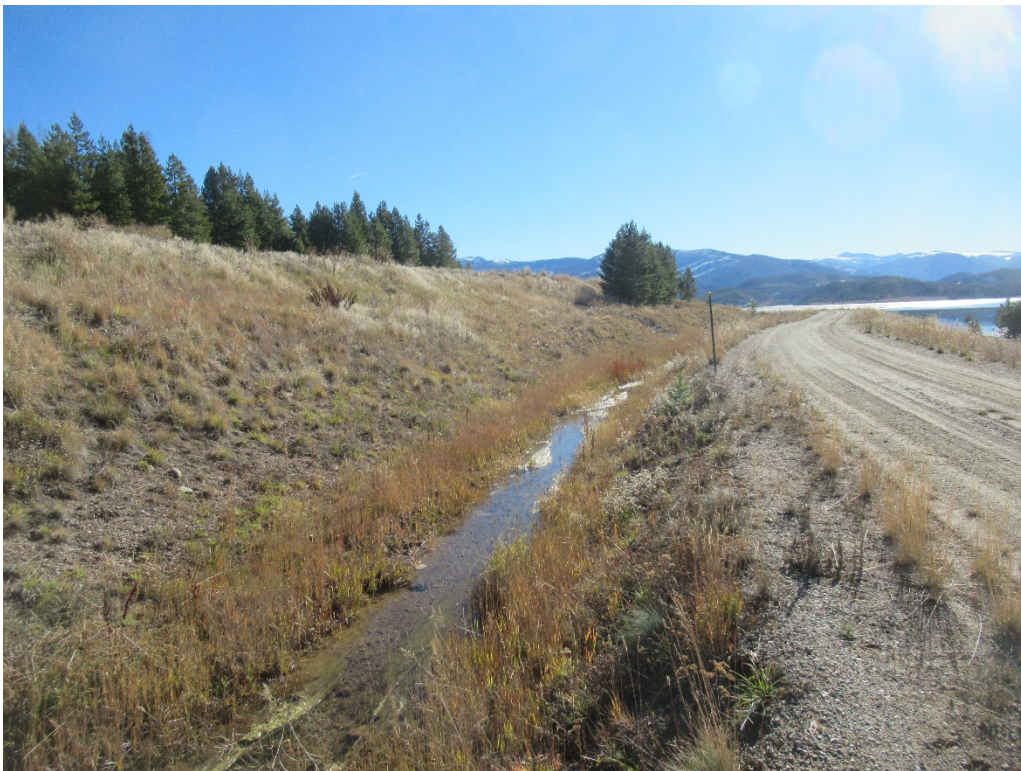
View of a section of the ultimate canal

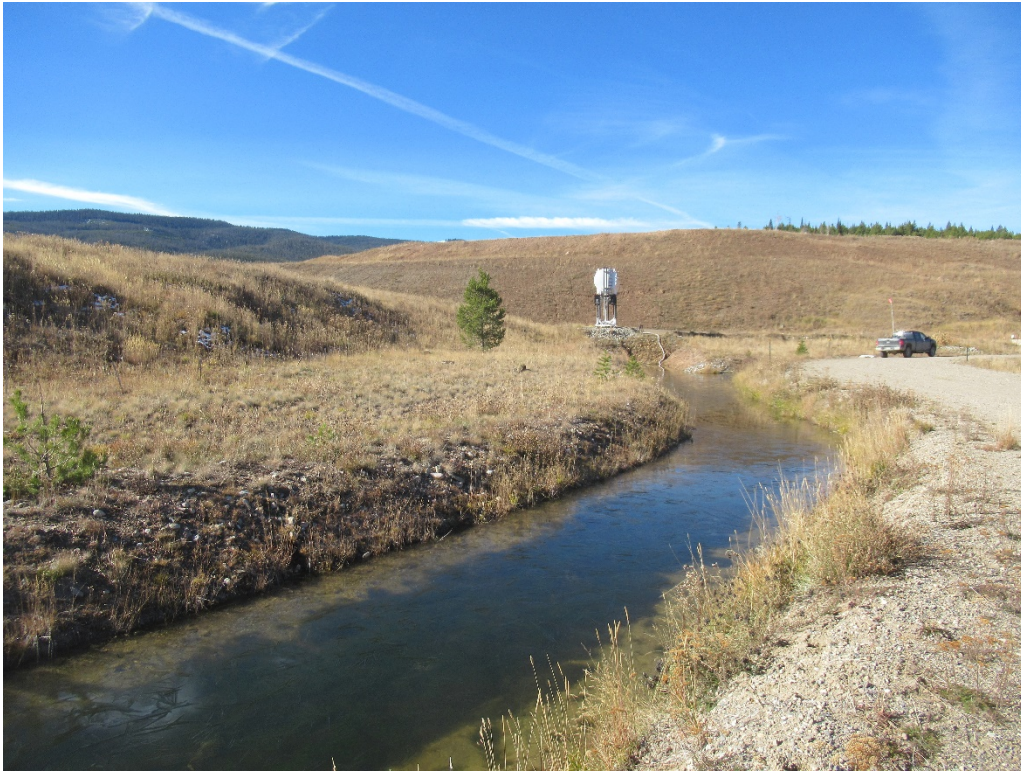
View of a section of the ultimate canal

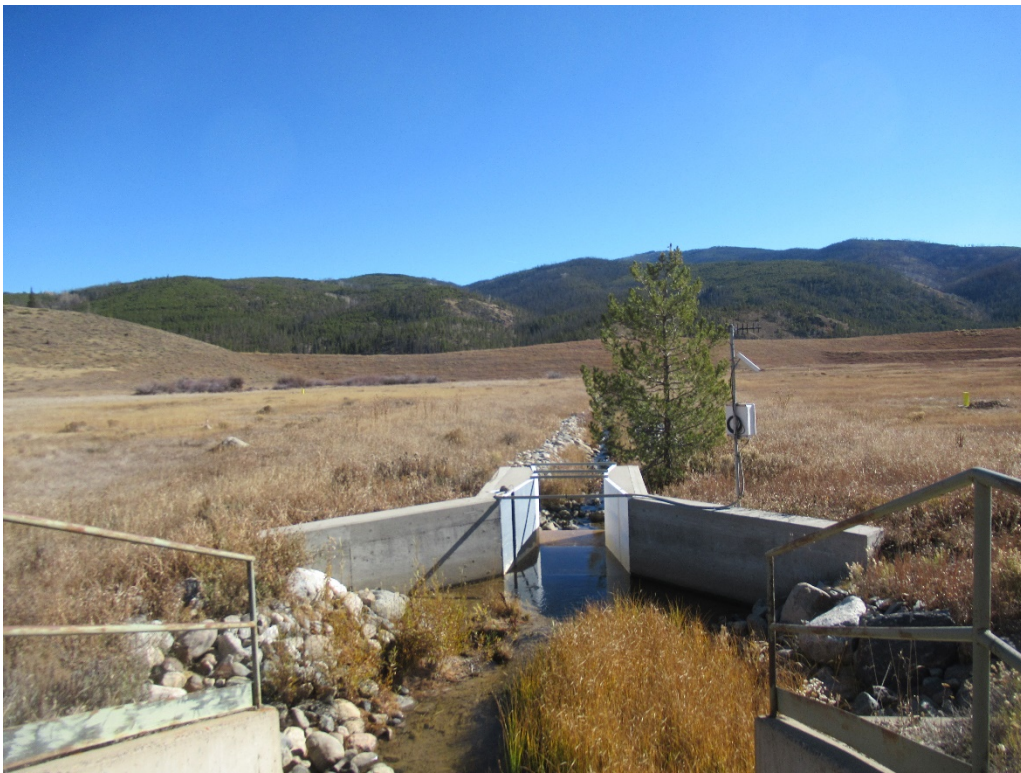
View of the end of the piped section of the ultimate canal

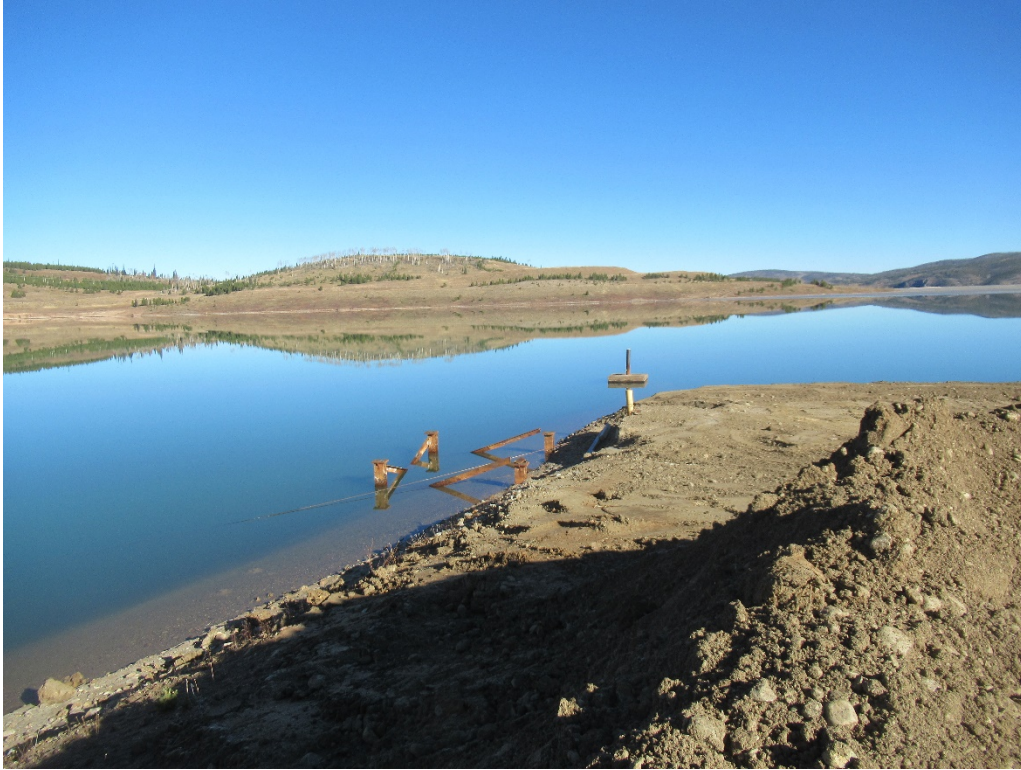
The barge pumphouse is included in Mill EPF 1.4 - Tailings Storage Facility. The barge removes process water from the Tailing Storage Facility (TSF) for reuse in the Mill by transporting the water to the East Branch Reservoir (EBR) via the barge return pipeline. Two (2) sets of foundation pylons were installed above the former location of the barge. The barge was moved to the lower set of pylons during the barge relocation. The barge might be moved to the higher set of pylons in the future. Three (3) new anchor blocks were also constructed for the barge relocation.

View of the former foundation location for the barge

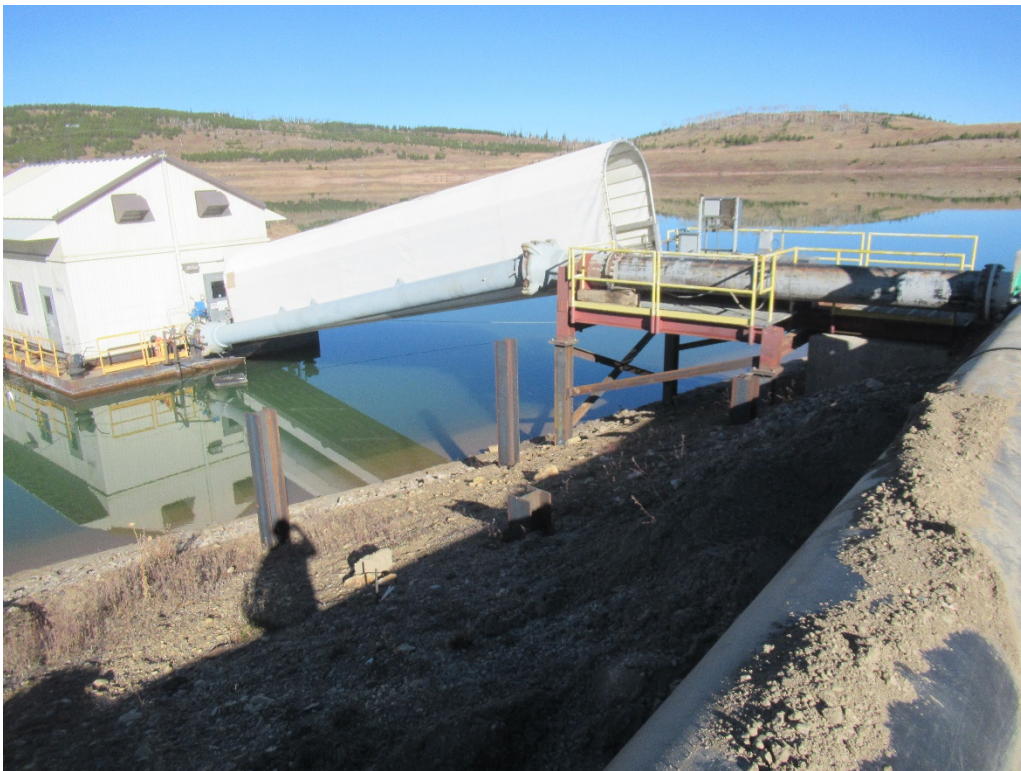
View of the two new foundations for the barge

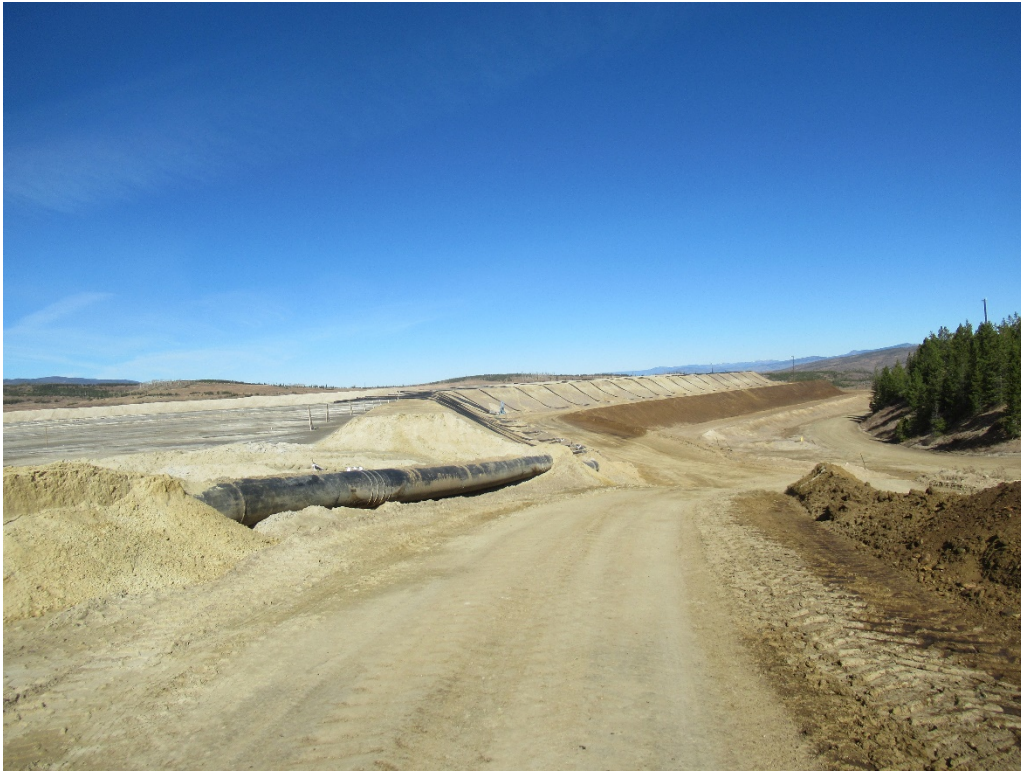
The 3-Dam crest raise construction was observed during the inspection. The crest raise was estimated at a ninety (90) foot offset from the previous face and six (6) feet in height. The 3-Dam crest raise will be completed to allow leadoff deposition on 3-Dam through the winter. The 1-Dam crest raise is schedule to occur over next summer. The connection to the TDL under the access road and to 1-Dam were complete. The north leadoff pipeline and the return pipelines from the Ute Park pumphouse were install and partially covered with tailings.

View of the north end of the 3-Dam raise

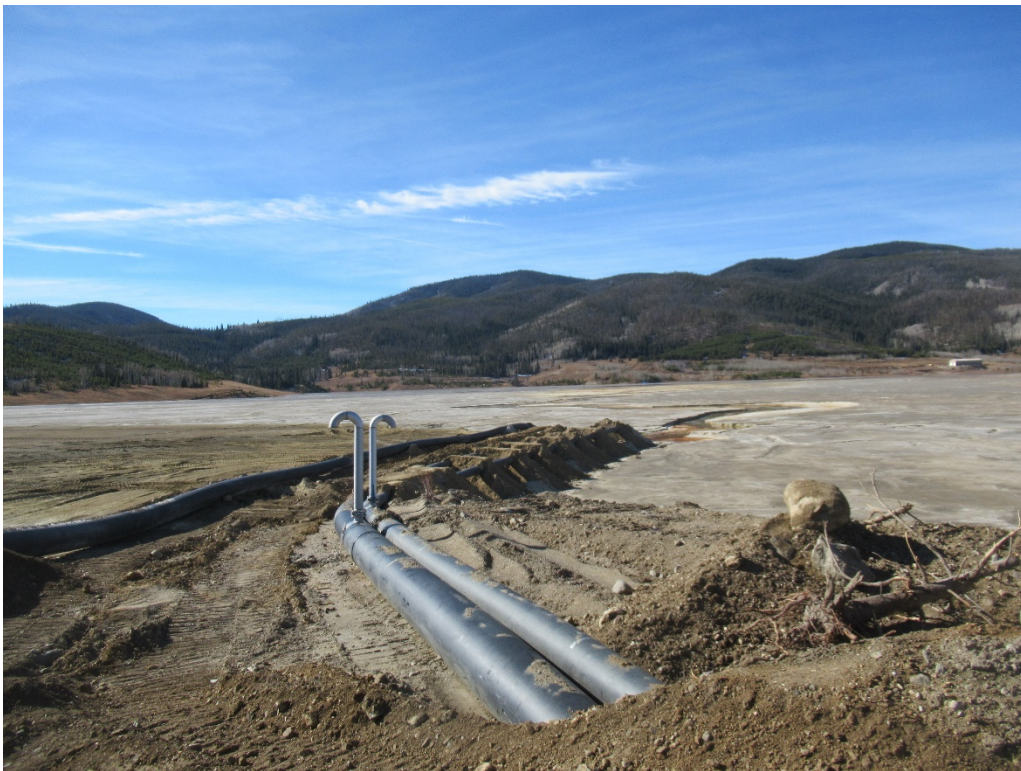
View of the Ute Park return pipelines and 3-Dam leadoff pipe

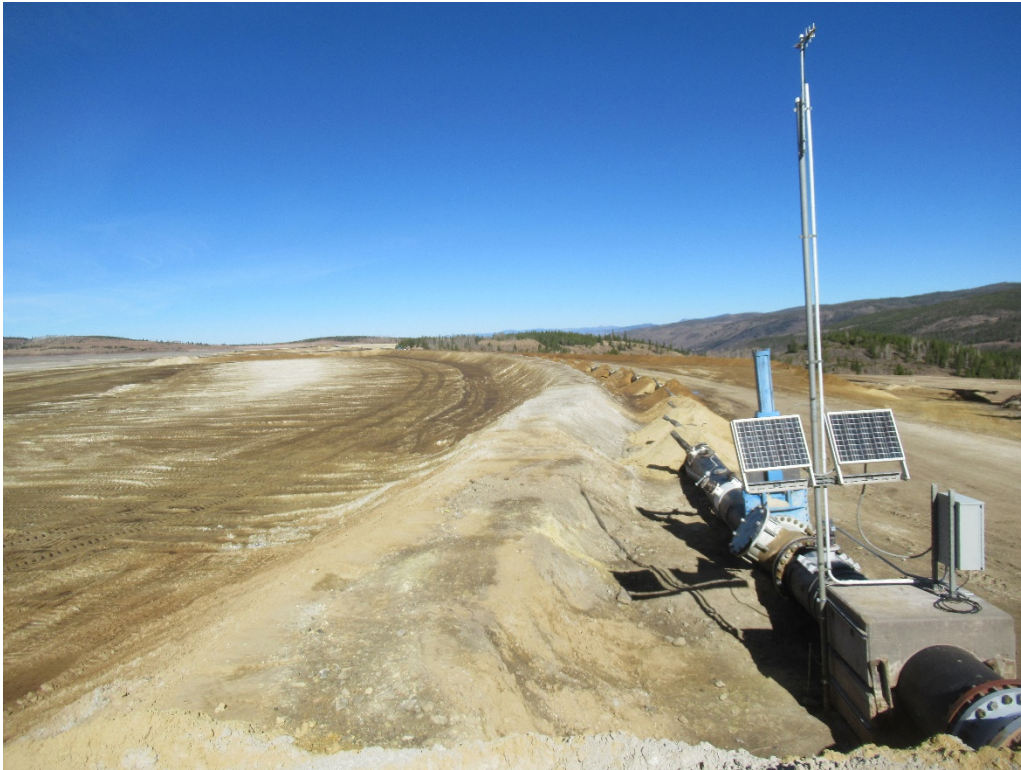
View of the 3-Dam raise from the south end looking north

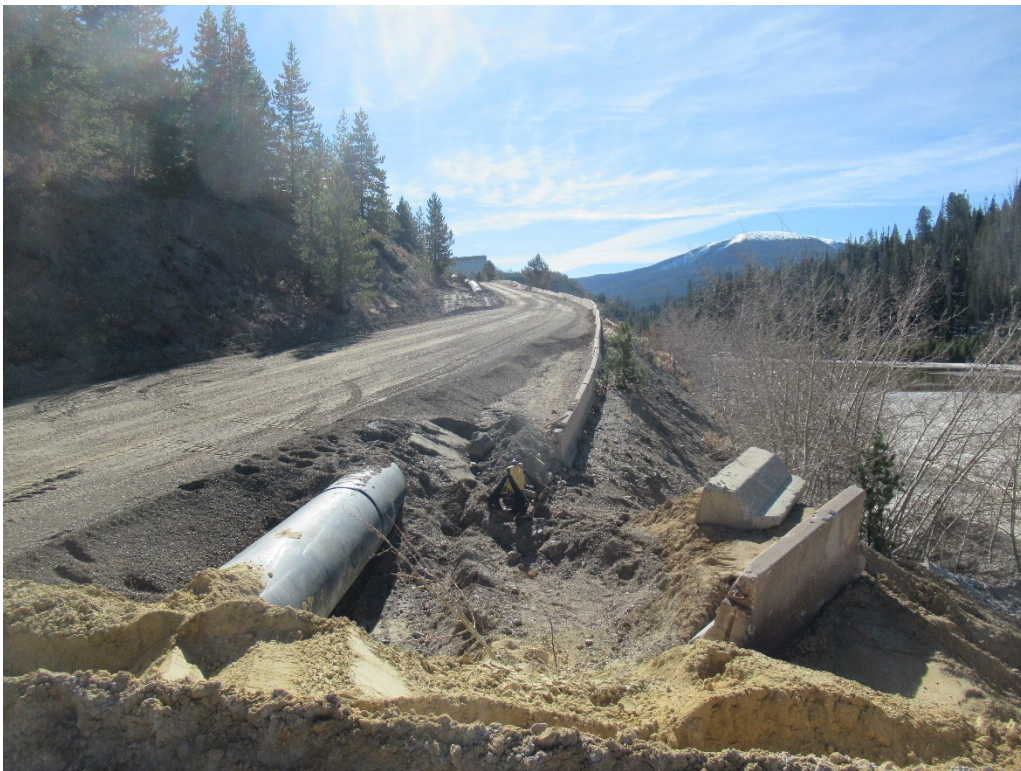
View of the 3-Dam raise from the south end looking south at the TDL connection
