MINERALS PROGRAM INSPECTION REPORT
PHONE: (303) 866-3567

MINE NAME: Henderson Mine	MINE/PROSPECTING ID#: M-1977-342	MINERAL: Molybdenum	COUNTY: Clear Creek, Grand
INSPECTION TYPE: Monitoring	INSPECTOR(S): Peter Hays	INSP. DATE: November 18, 2021	INSP. TIME: 09:30
OPERATOR: Climax Molybdenum Company	OPERATOR REPRESENTATIVE: Miguel Hamarat	TYPE OF OPERATION: 112d-3 - Designated Mining Operation	
REASON FOR INSPECTION: Normal I&E Program	BOND CALCULATION TYPE: None	BOND AMOUNT: \$134,155,028.00	
DATE OF COMPLAINT: NA	POST INSP. CONTACTS: None	JOINT INSP. AGENCY: None	
WEATHER: Clear	INSPECTOR'S SIGNATURE:

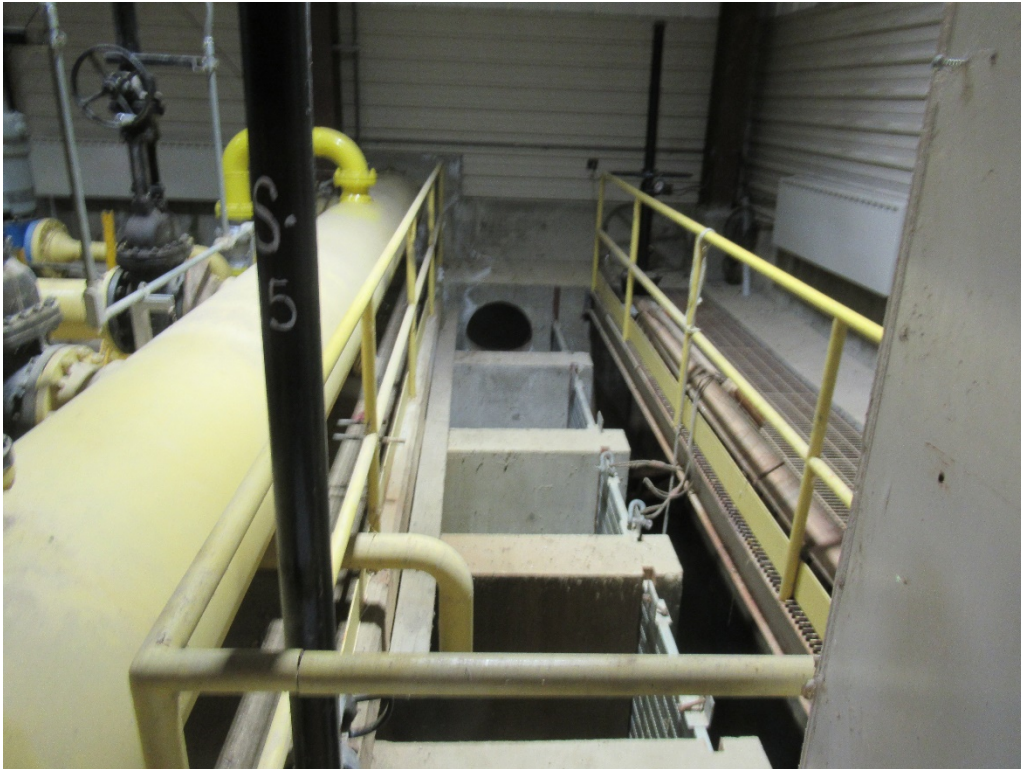
The William Fork Pumphouse pumps water from the Williams Fork River to the 2 potable water storage tanks or to the East Branch Reservoir for make-up water as needed. The pumphouse will be used in the future to discharge water from the Mill water treatment plant to the William Fork River.

View of the mixing vault inside the Williams Fork pumphouse

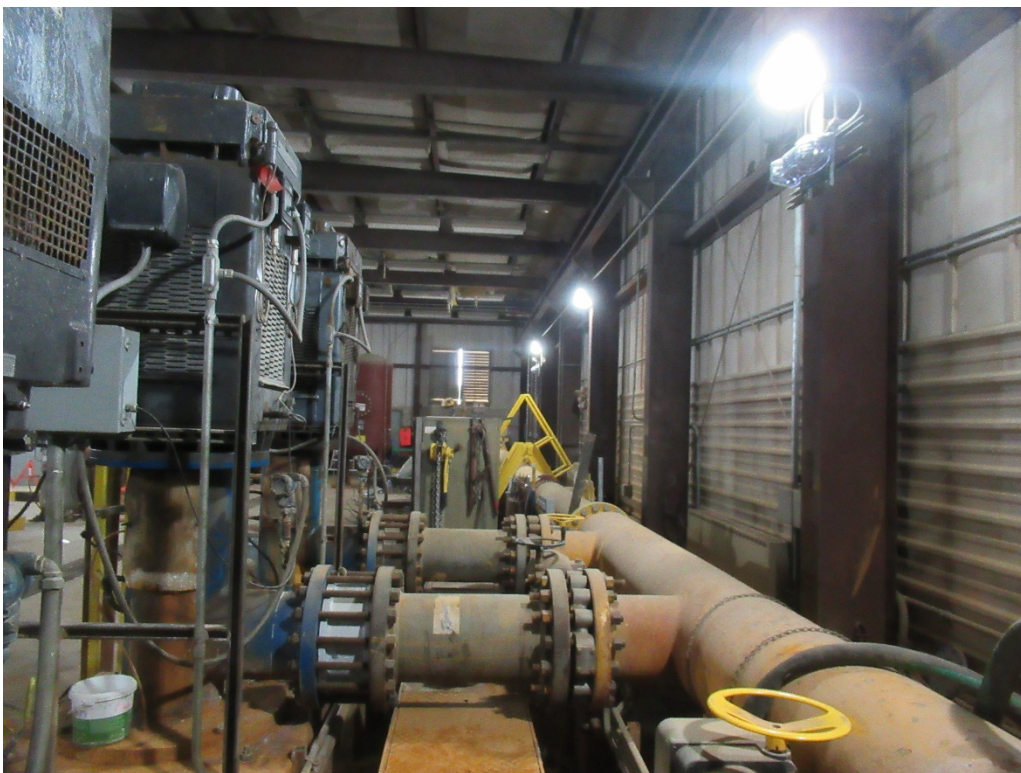
The Ute Park Pumphouse collects seep water from the tailings storage facility and water from the extraction wellfield and returns the water to the tailings storage facility. The extraction well system was improved under technical revisions TR-23, TR-25 and TR-28. The extraction wells, EPF 1.6, were not observed during this inspection.

View inside the Ute Park pumphouse

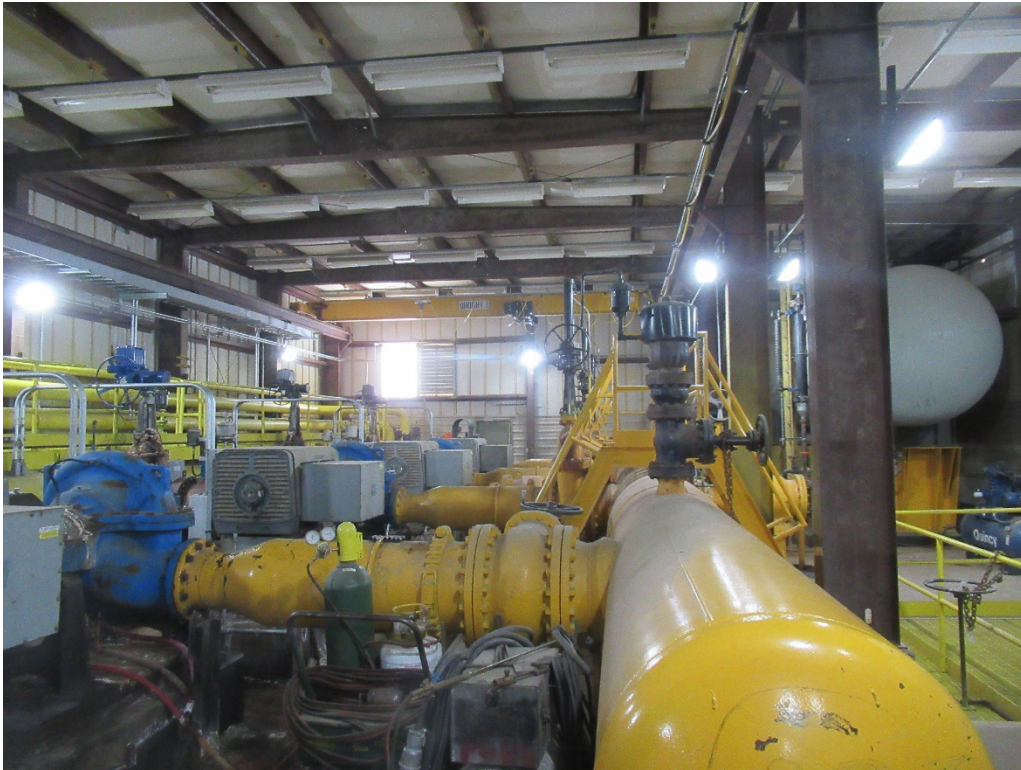
The East Branch Reservoir System includes the reservoir, dam, pump station and process water line. The reservoir is the primary storage area for mill process water. Recycled process water is delivered from the barge pump to the reservoir. An outlet pipe from the reservoir connects to the pump station. The process water is pumped from the East Branch Pumphouse to the process water storage tanks for use in the Mill.

The East Branch Pumphouse also pumps water from the Ute Creek Reservoir to the 2 potable water storage tanks. The water is treated in the plant located in the Mill building prior to use in the facility.

View inside the East Branch pumphouse

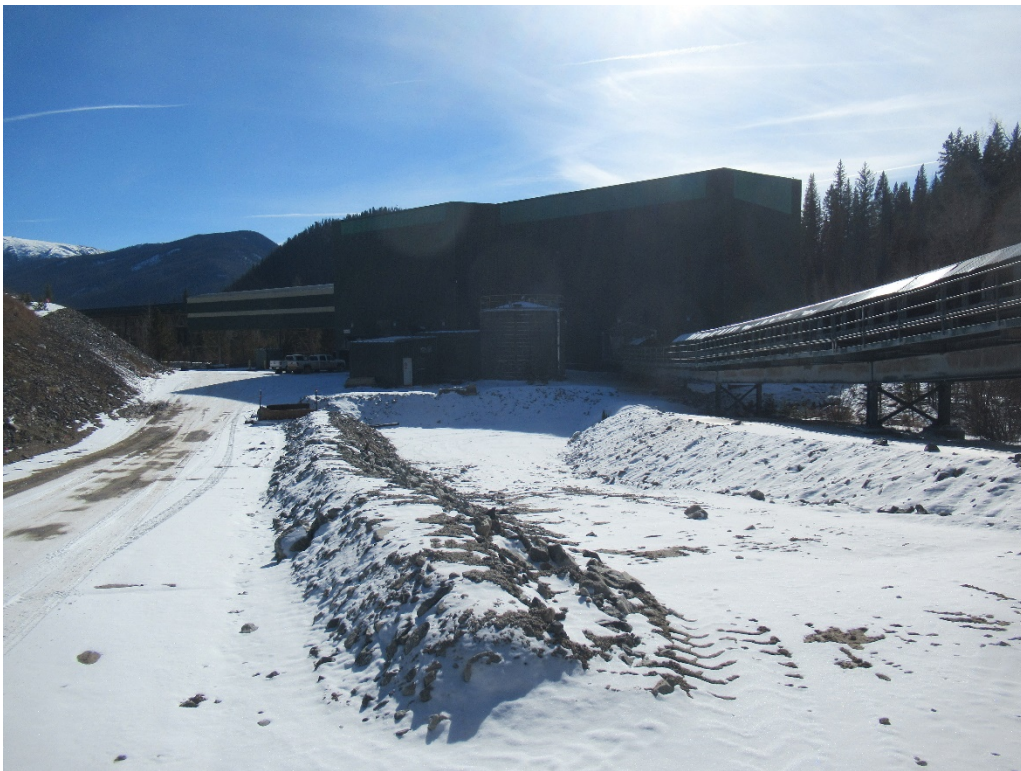
The stormwater features near the PC2/PC3 Transfer Station were recently improved by the Operator. The detention basin under the end of PC2 was regraded and the retention berm was improved to retain stormwater. A section of the stormwater ditch located southwest of the transfer station was piped to prevent dust from the transfer station collecting in the open ditch. A detention basin was constructed north of the transfer station to collect stormwater from the west and north of the transfer station prior to discharging at the stormwater outfall.

View of the detention basin located north of the PC2/PC3 transfer station

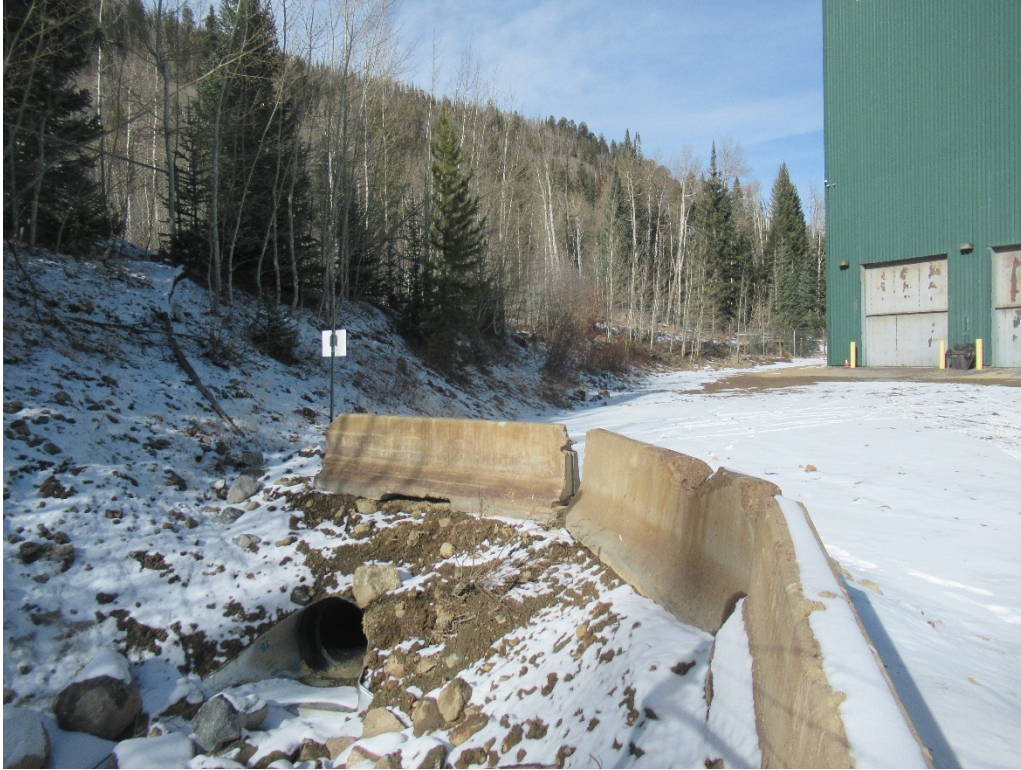
View of the piped section of the stormwater ditch located southwest of the PC2/PC3 transfer station

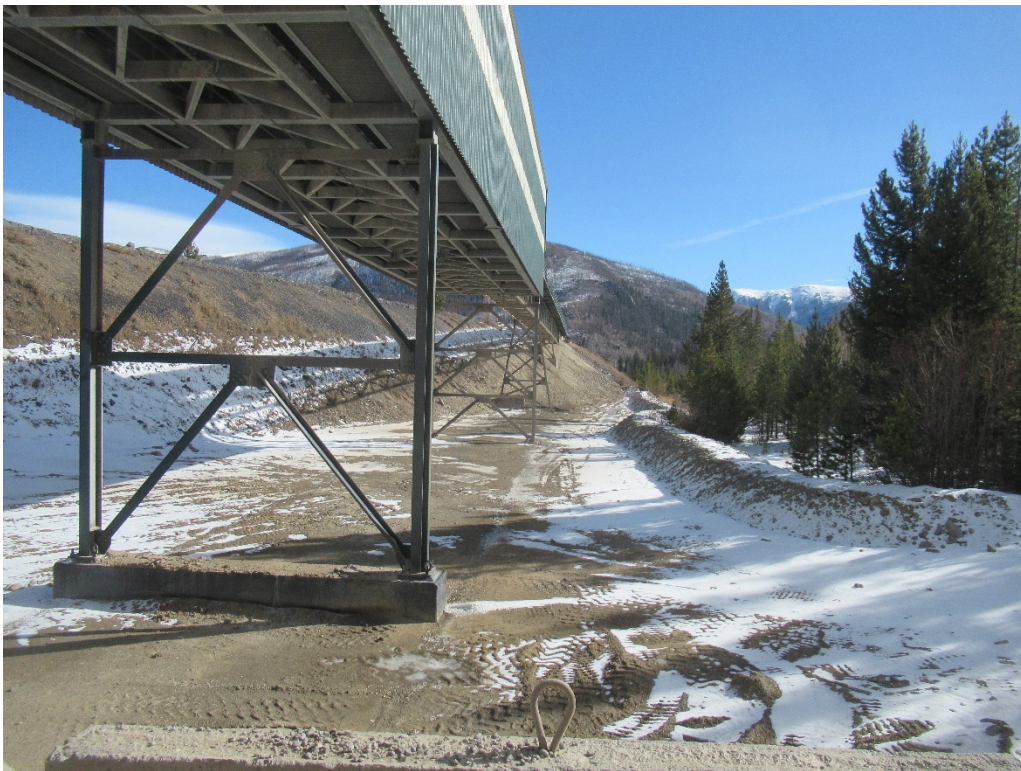
View of the improved detention basin under the end of the PC2

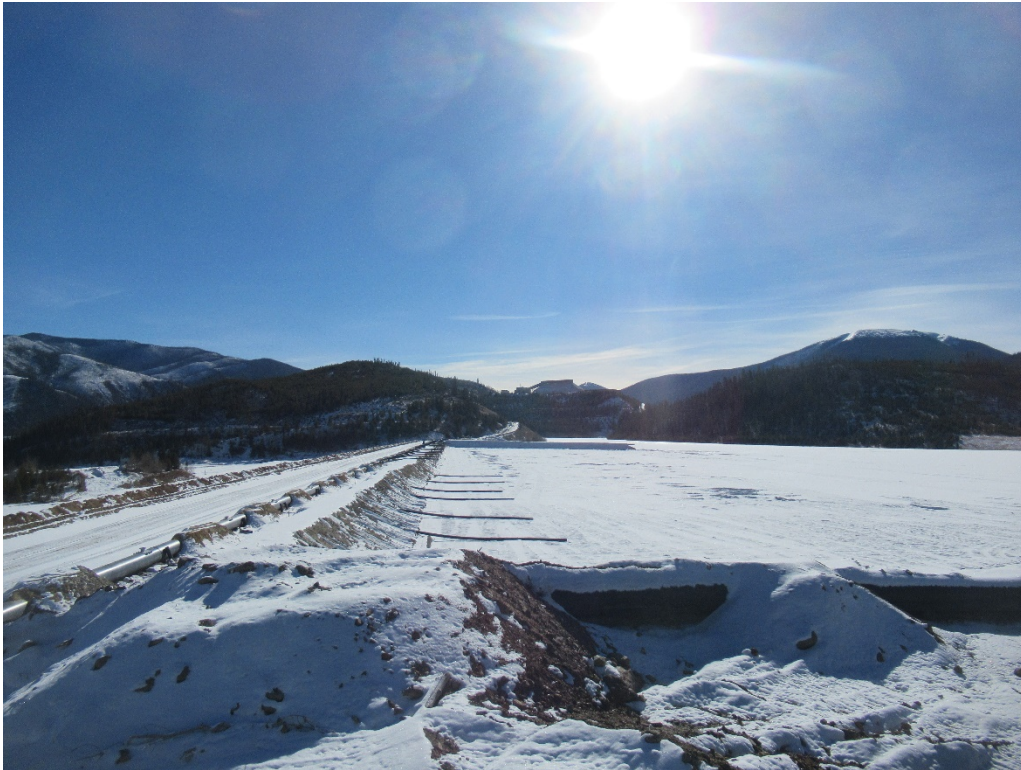
The continued 3-Dam crest raise construction was observed during the inspection. The south leadoff pipeline and spigot pipes were install since the previous inspection.

View of the 3-Dam raise looking south from the north end of the Dam

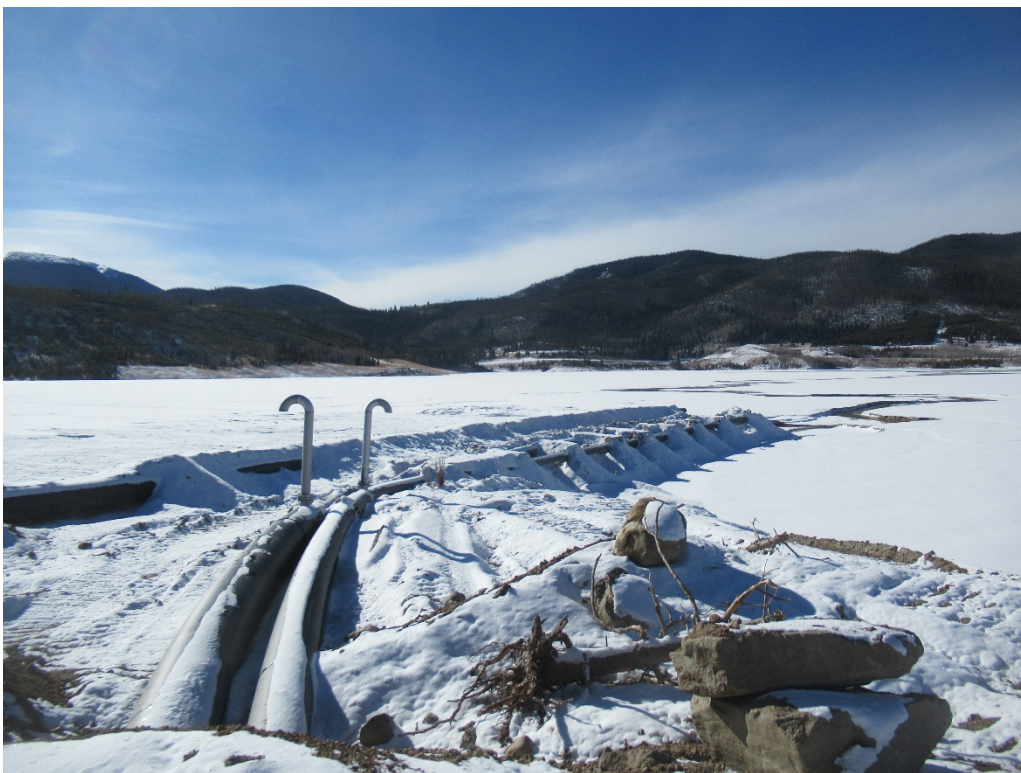
View of the Ute Park return pipelines and 3-Dam leadoff pipe
