MINERALS PROGRAM INSPECTION REPORT
PHONE: (303) 866-3567

MINE NAME: Cresson Project	MINE/PROSPECTING ID#: M-1980-244	MINERAL: Gold	COUNTY: Teller
INSPECTION TYPE: Monitoring	INSPECTOR(S): Patrick Lennberg	INSP. DATE: October 28, 2021	INSP. TIME: 08:00
OPERATOR: Cripple Creek & Victor Gold Mining Co.	OPERATOR REPRESENTATIVE: Jeana Ratcliff	TYPE OF OPERATION: 112d-3 - Designated Mining Operation	
REASON FOR INSPECTION: Normal I&E Program	BOND CALCULATION TYPE: None	BOND AMOUNT: \$209,491,188.00	
DATE OF COMPLAINT: NA	POST INSP. CONTACTS: None	JOINT INSP. AGENCY: None	
WEATHER: Clear	INSPECTOR'S SIGNATURE:

This was a normal monitoring inspection of the Cresson Project (Permit No. M-1980-244) conducted by Patrick Lennberg of the Division of Reclamation, Mining and Safety (Division). The Division was accompanied by Jeana Ratcliff and others during the inspection. This is a 112d-3 Designated Mining Operation (DMO) permitted for 6,007 acres to mine and process gold ore. The site is located between the towns of Cripple Creek and Victor in Teller County. The approved post-mining land use is a combination of rangeland and wildlife habitat. Photos 1-24 taken during the inspection are includ

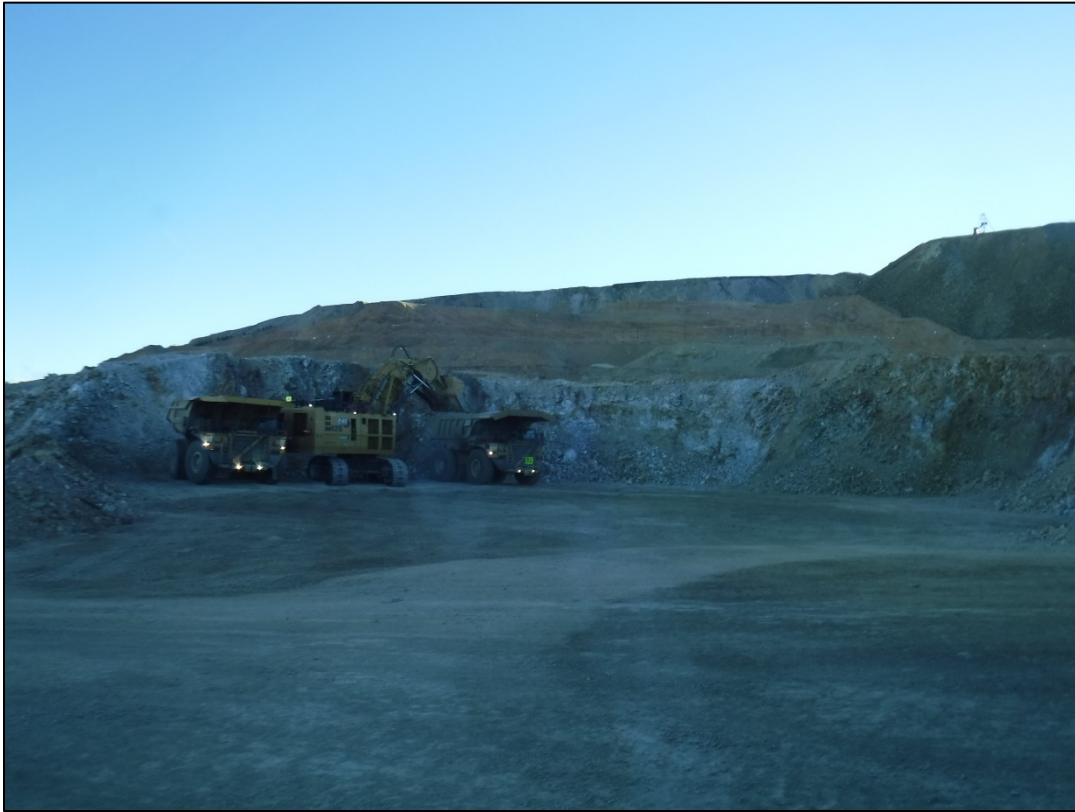
The Division received notification on October 28th that high compaction backfilling began earlier in the week. High compaction backfill consists 5 foot thick lifts comprised of -2.5 foot diameter material. The material is visually screened by the shovel operator loading trucks and again by the dozer operator that is spreading the material. If the shovel operator notes material too big has been loaded into a truck will direct the truck to dump elsewhere. If oversized material is observed by the dozer operator the operator will separate the material to be removed from the backfill area. In addition to the visual observations gradation check are done using photographs two times per shift. Finally, physical gradation samples are collected every 50,000 cubic yards (cy) and processed onsite by NewFields personnel.

Photo 1: Loading of material to be hauled to the Schist Island backfill area

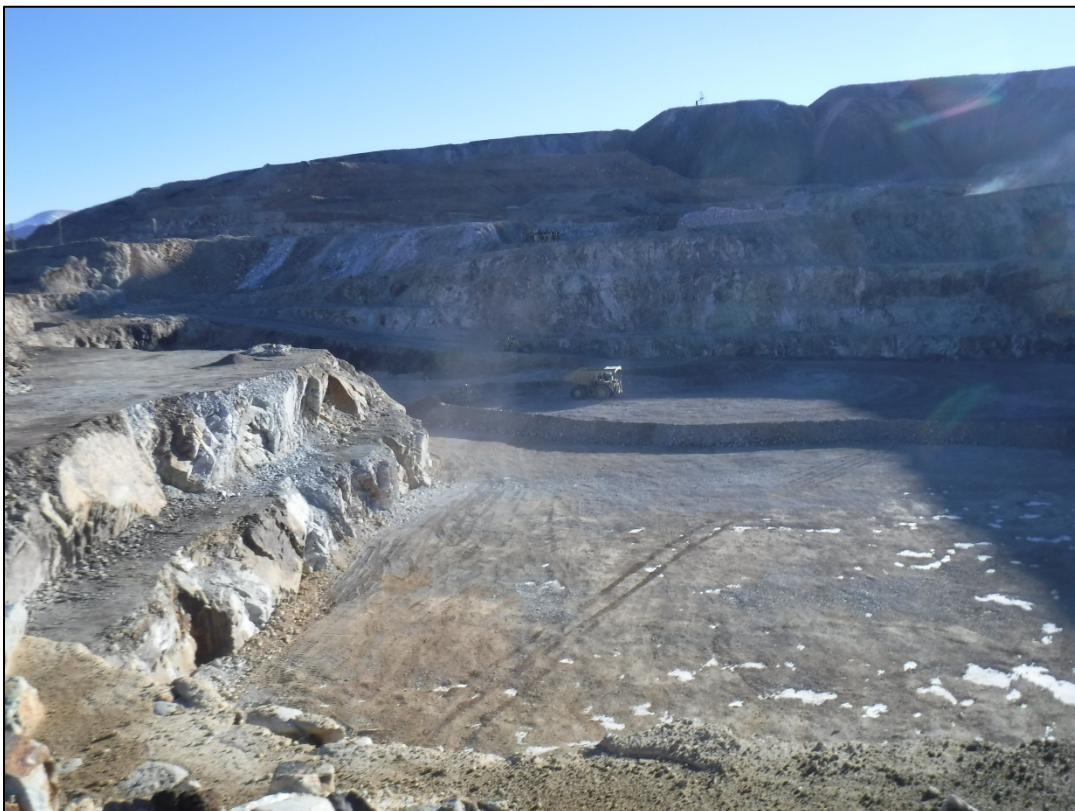
Compaction of the 5 foot lift is completed using the loaded haul trucks and heavy equipment traffic over the lift. NewFields is using a method placement specification that is checked using pre-determined survey points and visual observations. The survey points are picked at random at the beginning of the lift. After material has been placed and compacted a point is resurveyed to determine the material is no longer compressing. Visual observations will look for potential soft spots or other indications the material is not sufficiently compacted. Haul truck drivers have been directed to split-tracks and spread travel out over the lift. Each truck weighs approximately 850,000 pounds loaded. During the inspection it was noted the haul trucks were splitting tracks and varying travel patterns over the lift.

Photo 2: Schist Island high compaction area first 5 foot lift

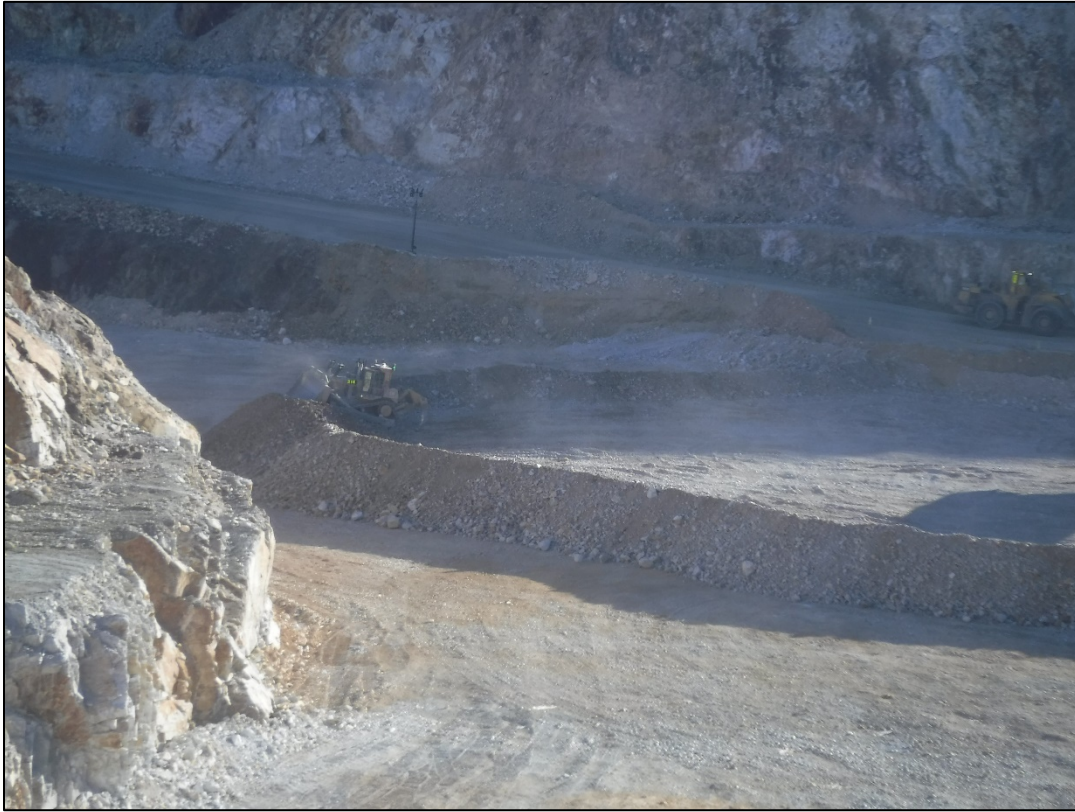
Photo 3: Dozer grading out material

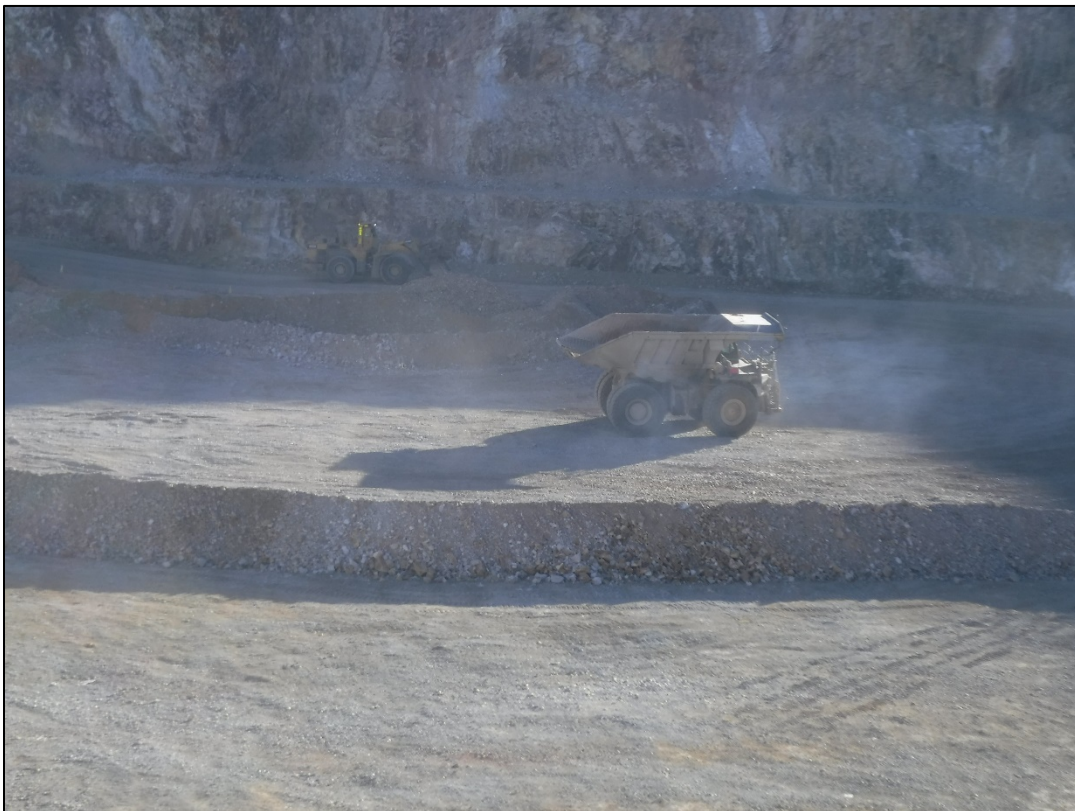
Photo 4: Haul truck leaving dump area, note even spread of tire tracks across lift area

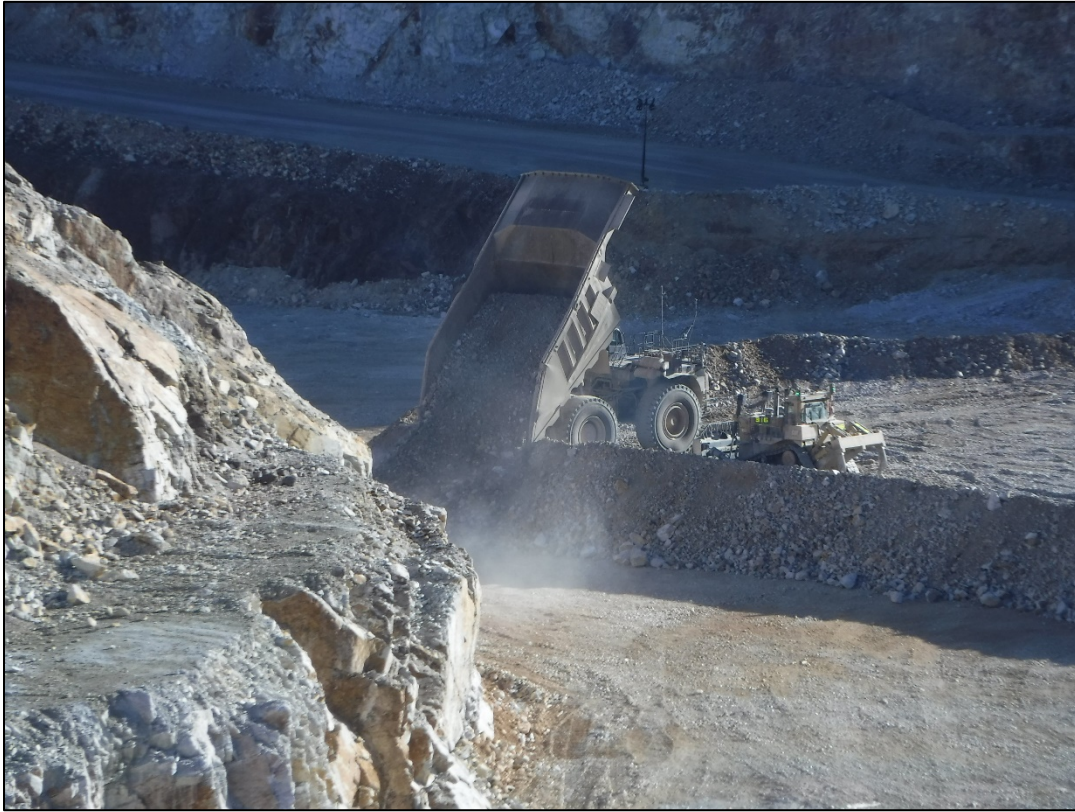
Photo 5: End dumping of material

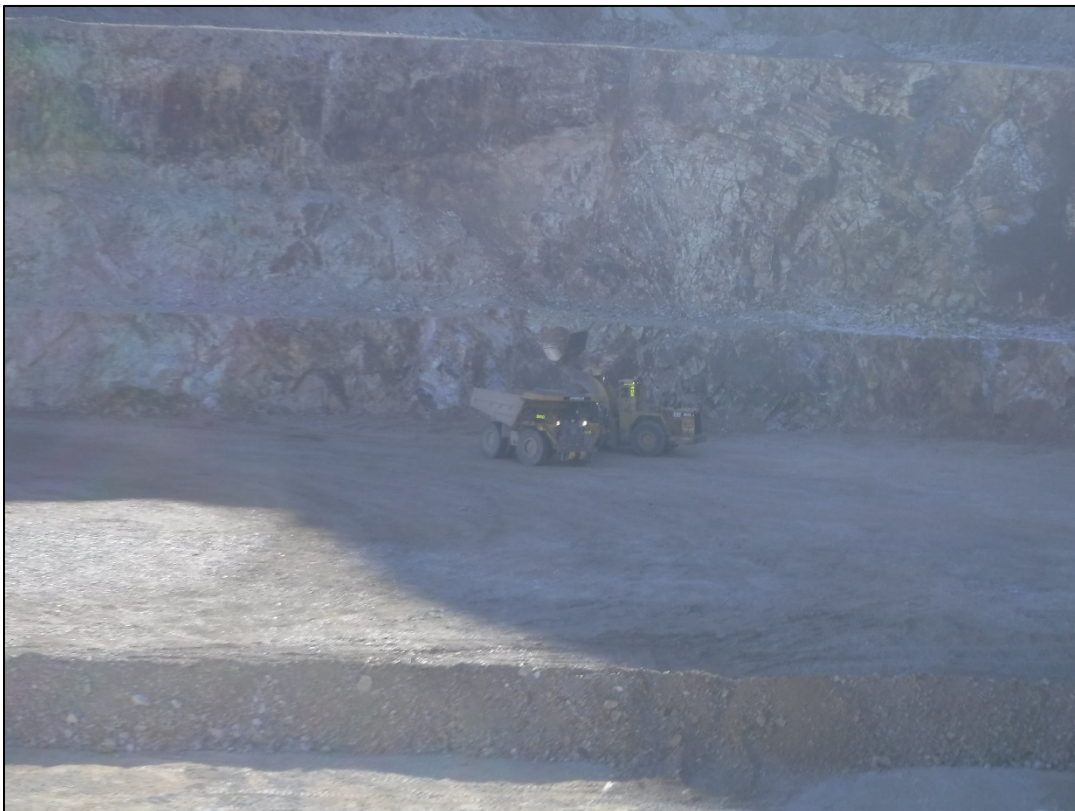
Also noted was a pile of oversized material was being loaded into a haul truck for transport and disposal outside of the backfill area.

Photo 6: Removal of oversized material from lift

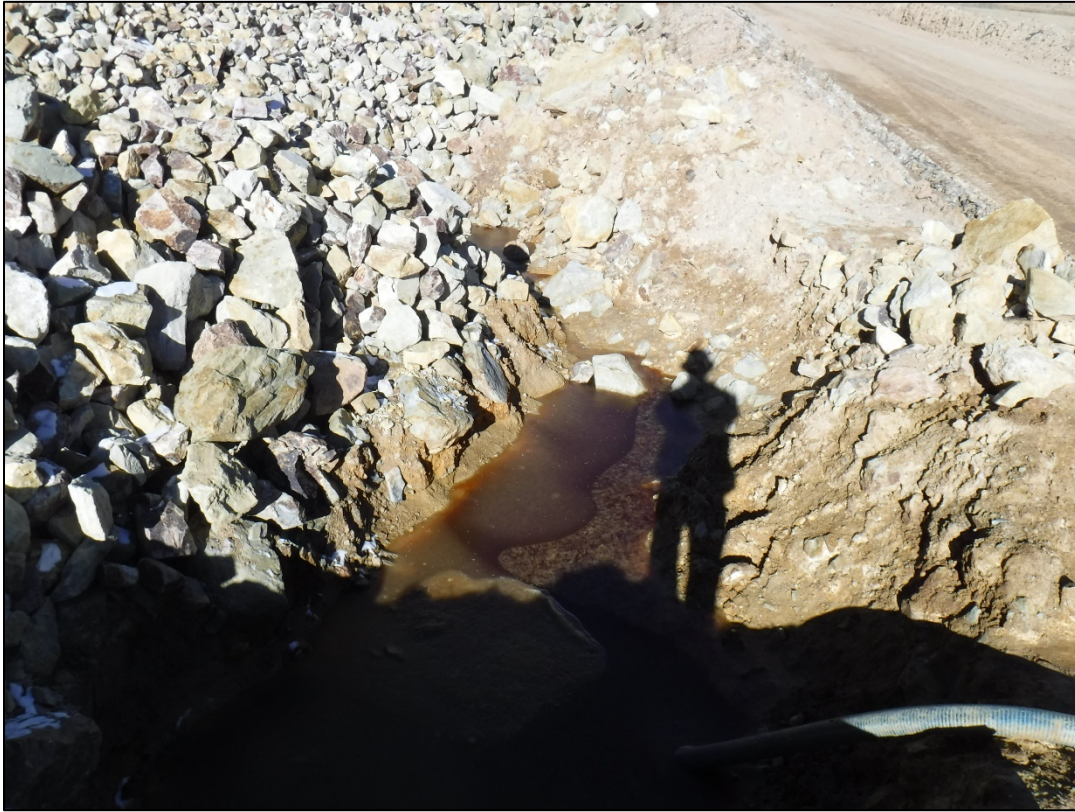
In August 2021 the Operator notified the Division a new seep had developed at the ECOSA due to the amount of precipitation that fell in region during that time. The Operator stated during this inspection, a contract had recently been signed with a consultant to begin developing a management plan for both seeps.

Photo 7: Upper ponding area of seep 2 at the ECOSA

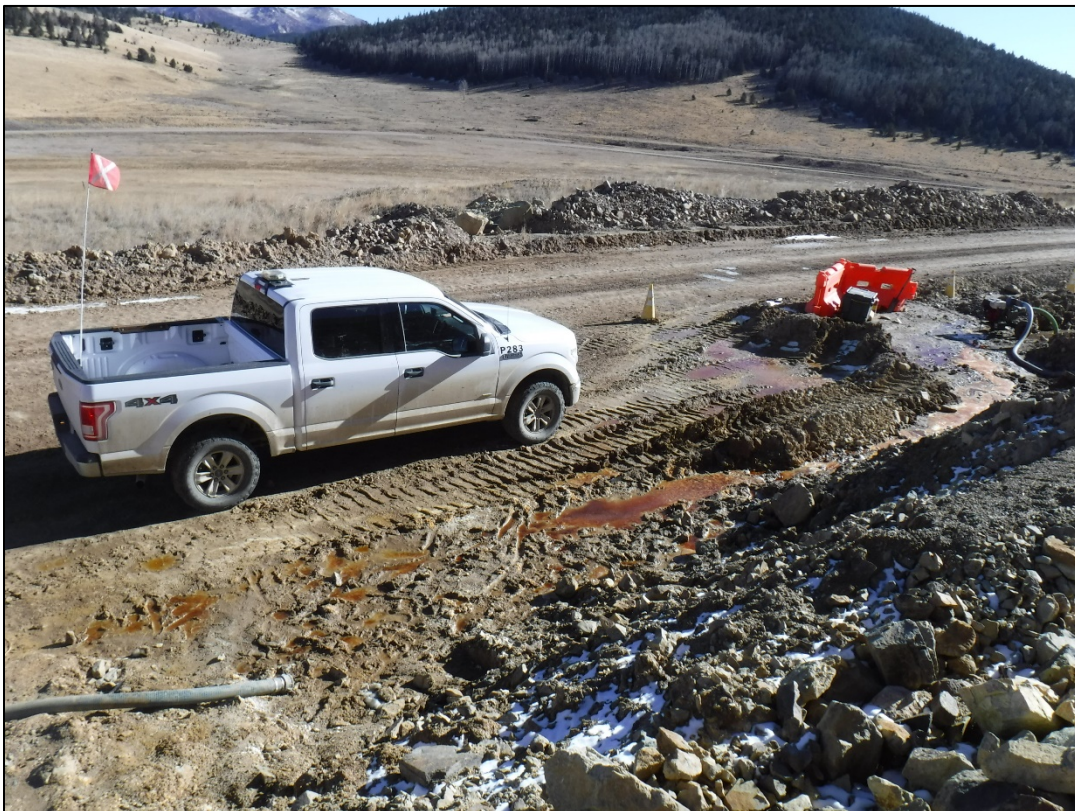
Currently, the new seep is emptied every shift and the other is emptied based on observations made in the field. The waste is pumped into a water truck which then takes and sprays the water onto a VLF.

Photo 8: Pumping set up to remove seep water from the seep 2 area

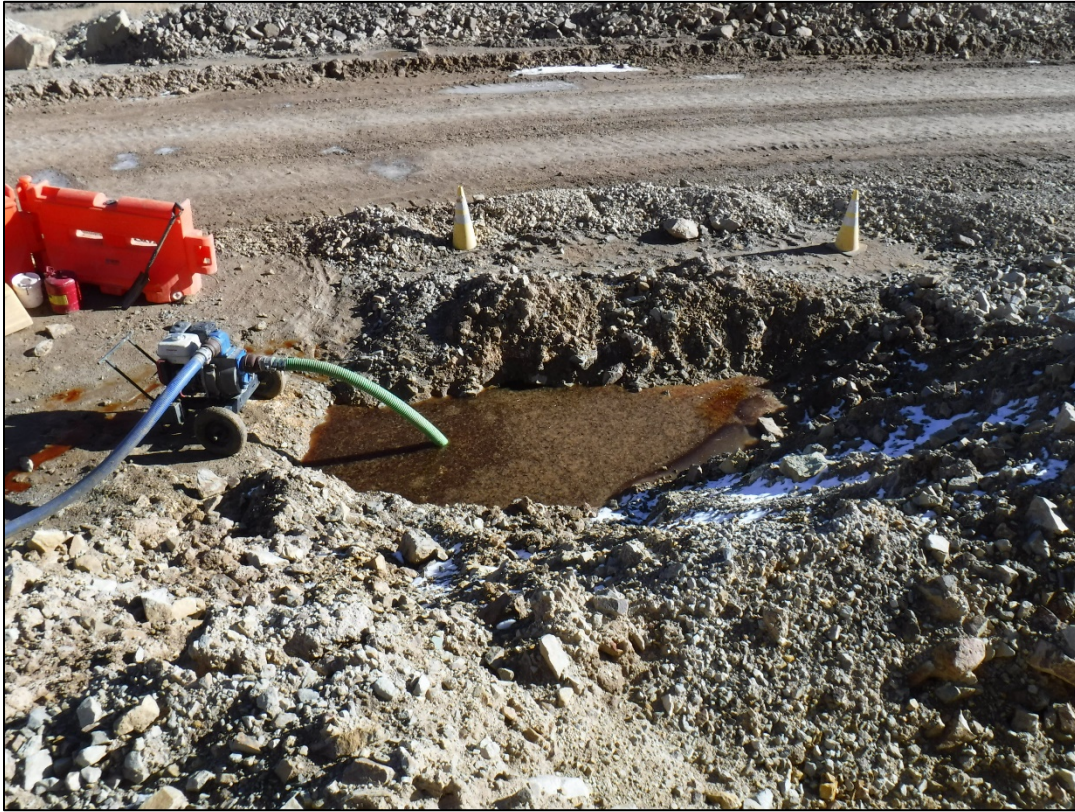
Photo 9: Lower ponding area of the seep 2 area

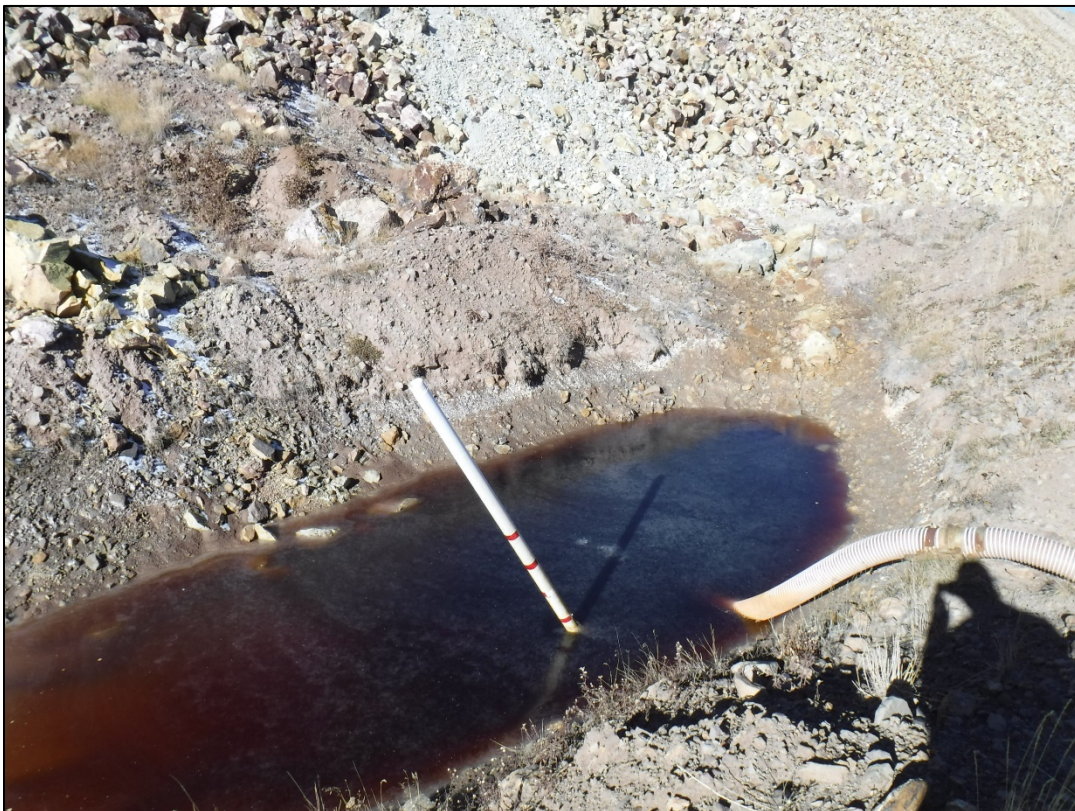
Photo 10: Seep 1 area of the ECOSA, soon after this picture was taken a truck arrived to pump out sump

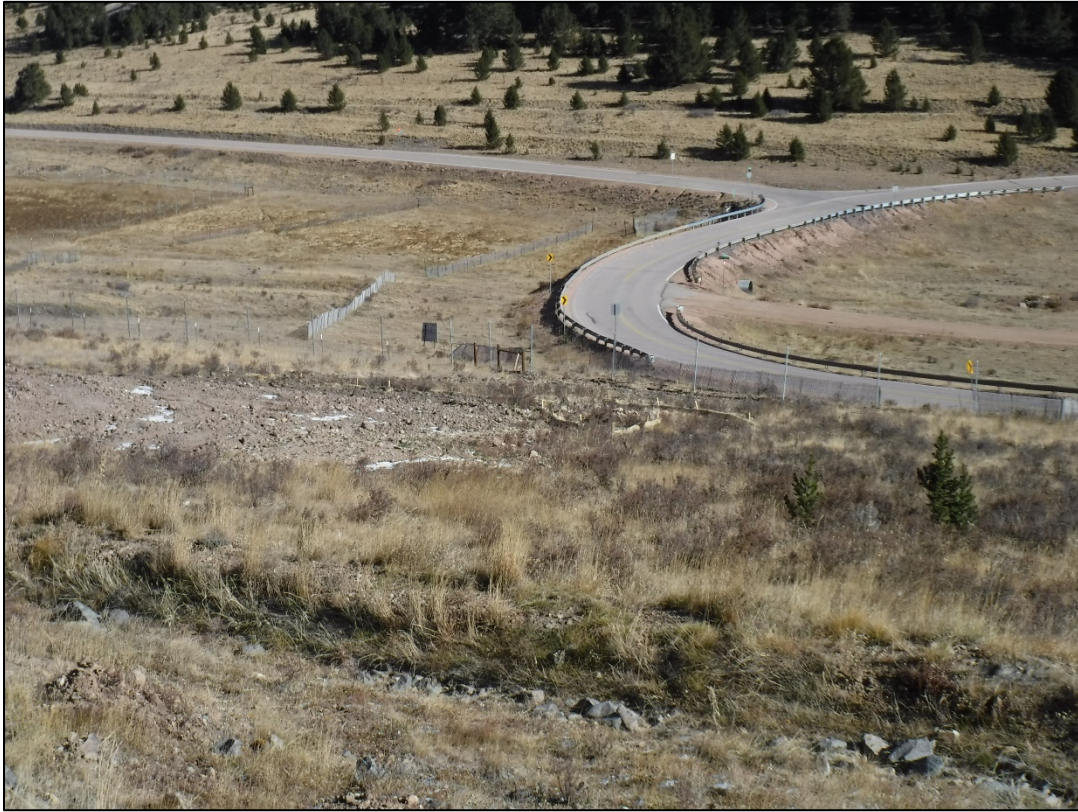
Also noted was the drill pad was in the process of being reclaimed and were waiting to broadcast seed the area. Straw wattles had been placed downgradient of the disturbed area for erosion control. The material that was up against the wildlife fence, observed in August 10th inspection, had been removed.

Photo 11: Reclaimed drill pad area with stormwater controls in place downgradient of pad and sediment has been removed from wildlife fence

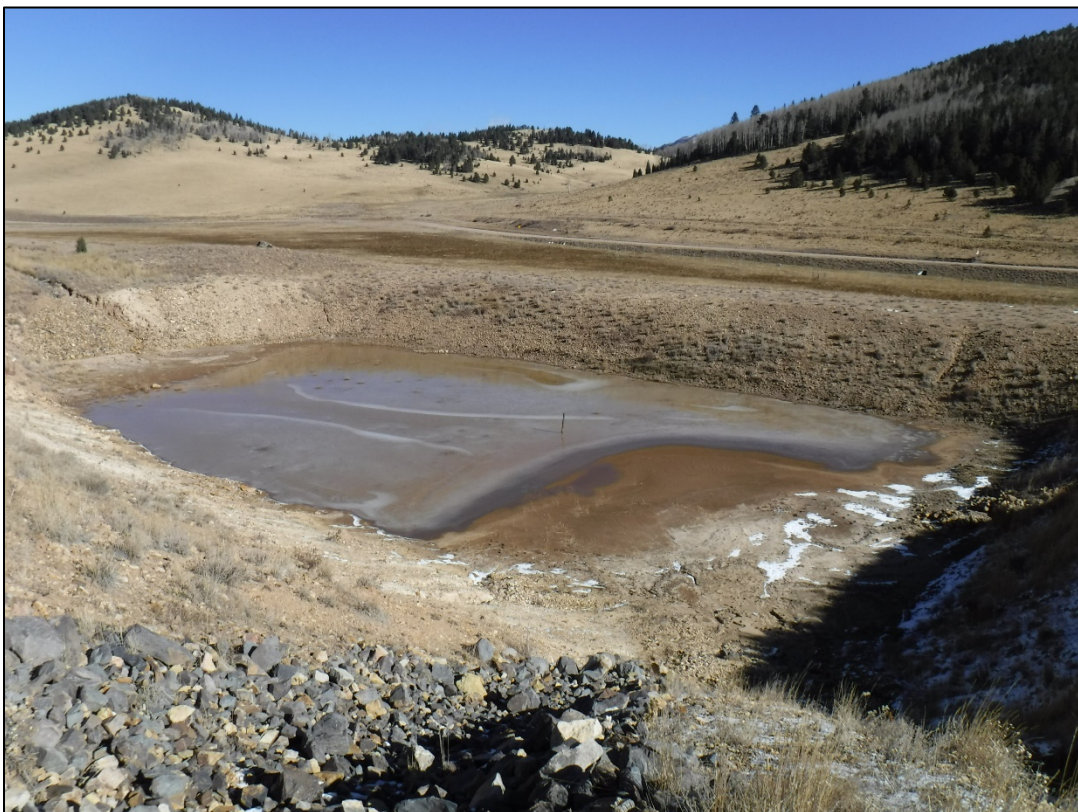
Basin EMP-20 was noted to have some water in it but the water had receded since August through infiltration.

Photo 12: Detention pond EMP-20

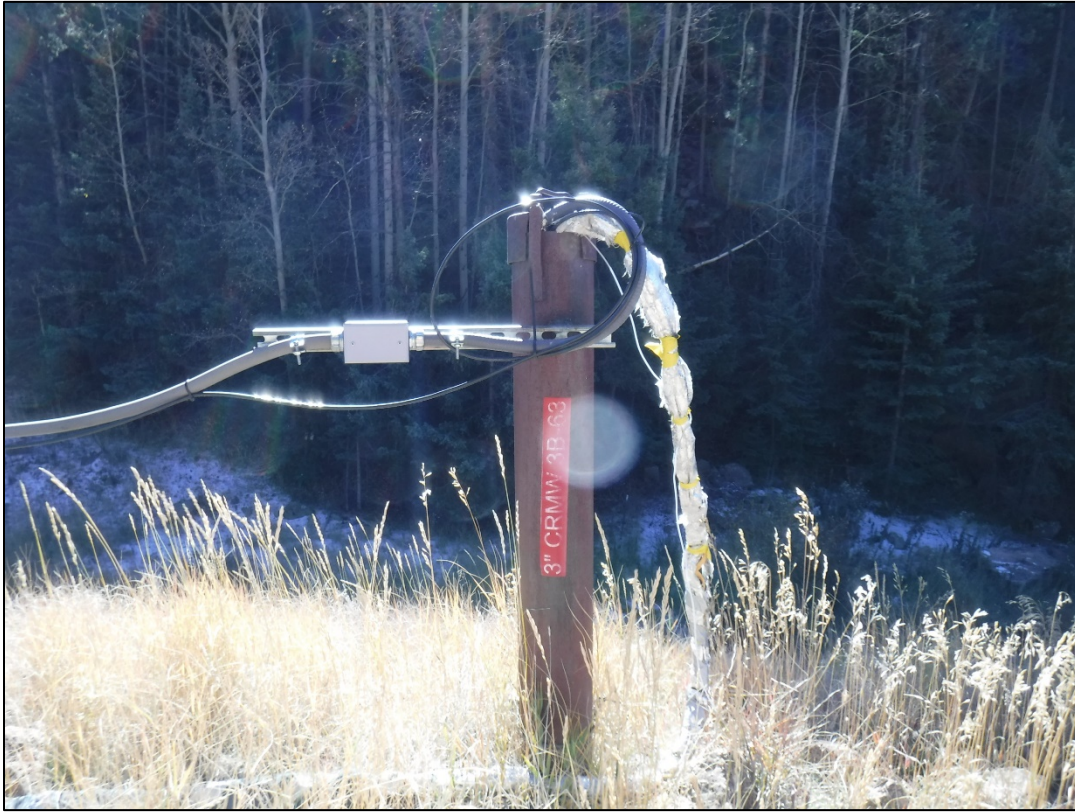
Photo 19: CRMW-3B with a pump currently working

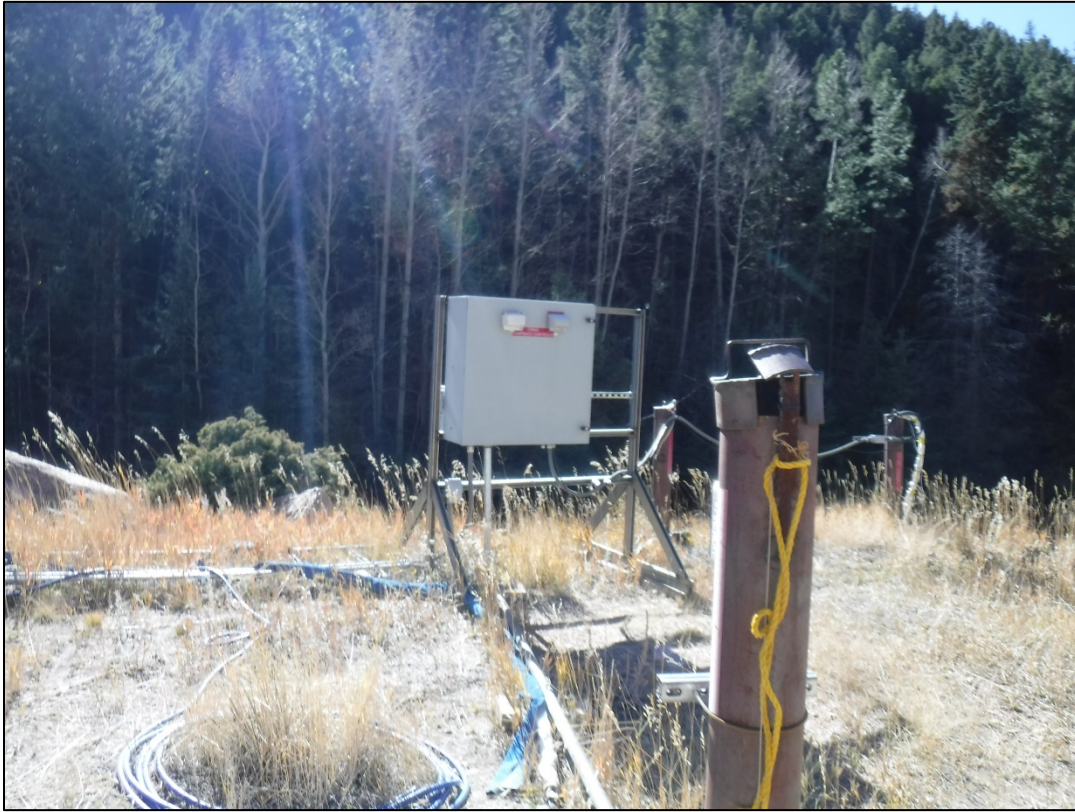
Upon arrival at the site the Division was informed the pump in CRMW-3C had stopped functioning earlier in the month. It was stated that a new pump and control unit would be installed the following week. The Operator explained supply chain issues were part of the problem that led to a delay in installing a new pump and control unit. The Operator is reminded that the pumpback system was installed to protect the environment from groundwater impacted from mining activities, an environmental protection facility. The Operator is required to notify the Division of a failure of an environmental protection facility. In 2019-2020 the Operator and Division had discussions of this manner when CRMW-3B ceased to function when it became biofouled and the Division found out through review of an exceedance notification for 3B.

Photo 21: CRMW-3 series wells with pump control panel

At the time of writing this inspection report CRMW-3C had resumed operation on November 17, 2021.
