To: Jerald Schnabel From: Paul Kos  
Continental Materials Corp. Denver, CO 80222  
File: October 2021 Monitoring Summary Date: November 30, 2021

**Reference: October 2021 Geotechnical Monitoring Summary Pikeview Quarry**

Title OBSERVATIONS FROM OCTOBER INSPECTION	
Revision #	Date 2021.11.30
Drawn By PK	Figure No. 2

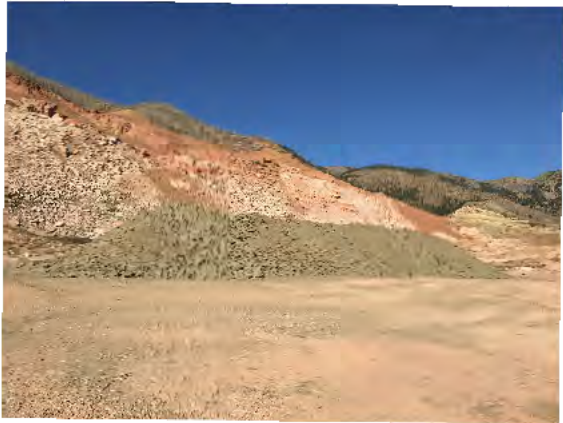
- Imported fill material and topsoil are being stockpiled in several areas on the production floor. (Photos 3-6)
- The culvert remains cleared but mostly blocked inside. CMC has partially cleared the debris, but access limitations and supports within the culvert inhibit clearing all the debris. CMC has procured a pump and will begin pumping operations if any water collects behind the culvert. CMC inspects the culvert for ponded water following rain events, and should any water be observed, it will be removed using pumps. To date, no ponding has been observed.

6. MATERIAL STOCKPILE

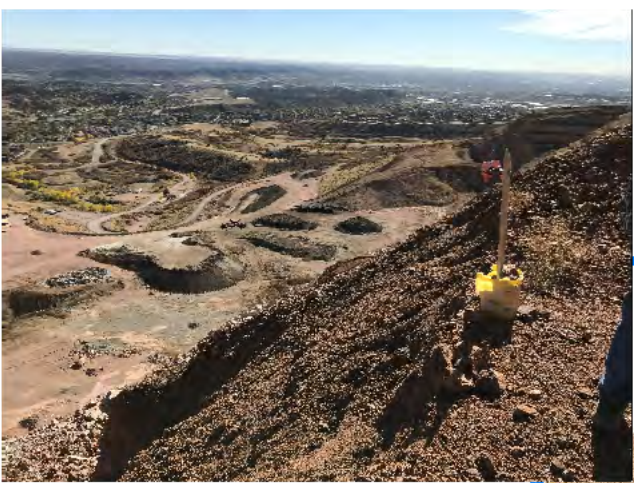
- Prisms: Several prisms were passed along the walking route and appeared to be in their original position and operating normally. Control points and most of the monitoring points are permanently cemented into the ground while some of the monitoring points are cemented into 5-gal buckets to be portable as needed. (Photo 5)

5. QUARRY SLOPES FROM THE NORTH

NOTE 1:  
NO CRACKS

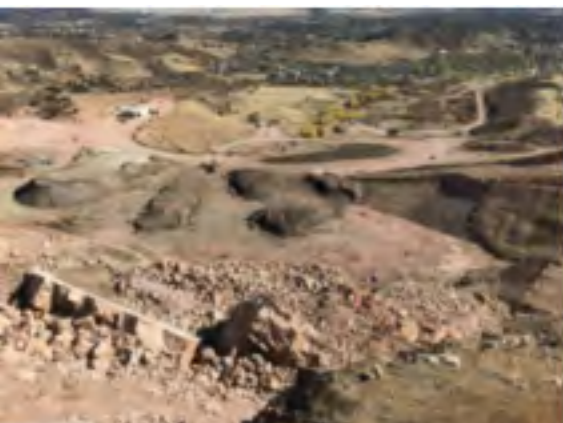
- Growth Medium: Mulch and soil are being processed on the production floor to produce growth medium. (Photo 4)
- Healed Cracks: Older cracks and recent cracks are being monitored for changes. Currently the cracks are not growing in any of the areas on the slopes of the site.

4. STOCKPILES ON PRODUCTION FLOOR

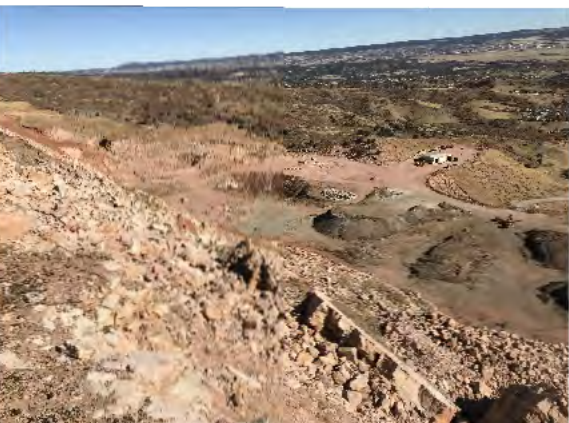
3. QUARRY SLOPES FROM THE SOUTH

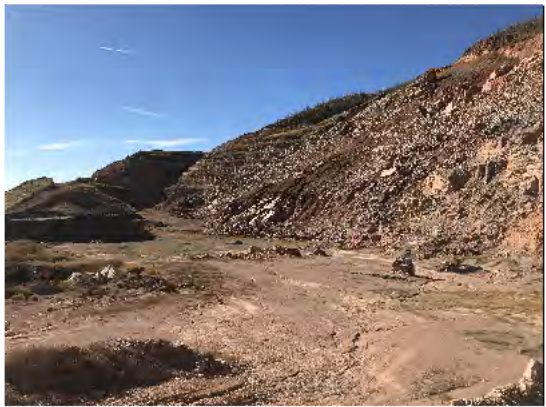
7. TOE OF SLOPE - UNCHANGED

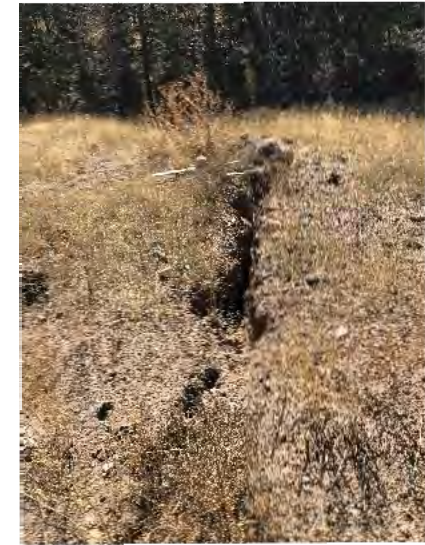
- Crack Free: No cracking was observed on the native granite slopes above the extents of the disturbed area. The hummocky field in the area immediately above the southern extent of the slide shows evidence of cracking but they are not fresh or active. No new or open cracks were found immediately inside or next to the slide area. (Photo 8)

8. CRACKS ON THE SOUTH END - UNCHANGED

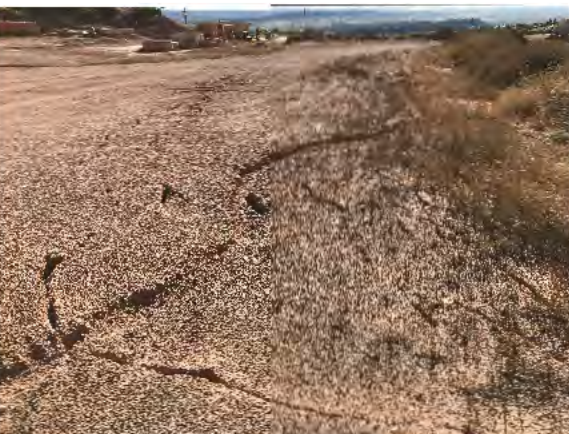
- Previously Observed Cracks: Previously observed tension cracks remain on the production floor and at the crest of fill slopes. These cracks were observed following the period of heavy rain and are likely due to the recent heavy rain allowing consolidation of the material in this area. (Photo 2)

2. CRACKING NEAR PRODUCTION FLOOR

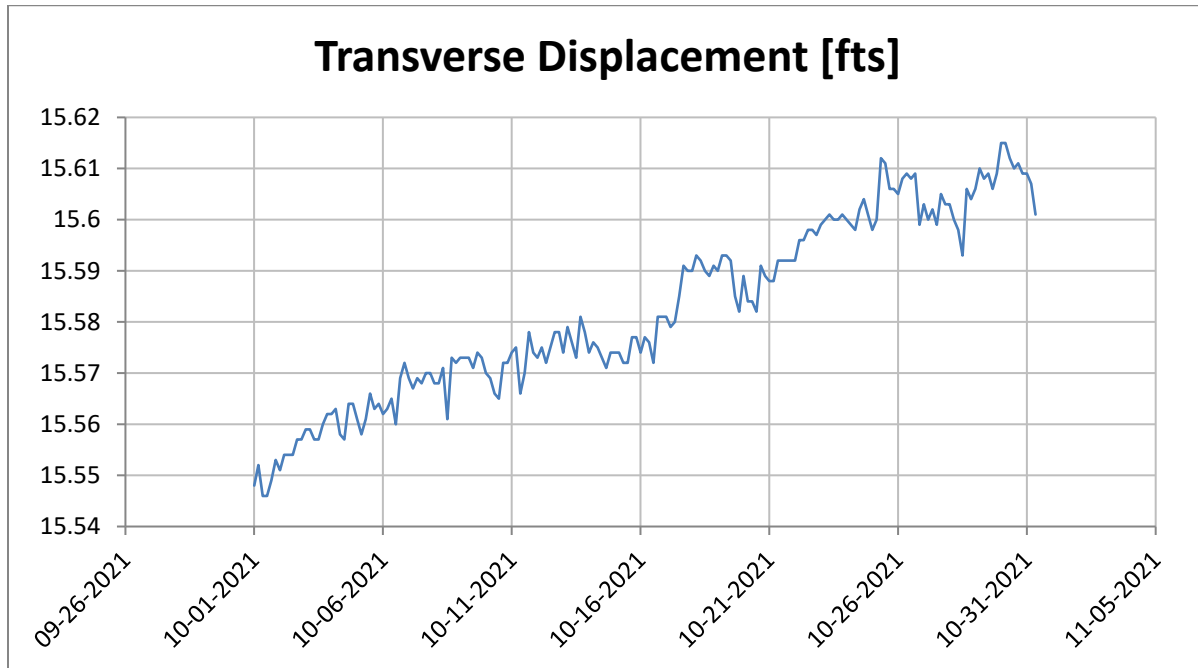
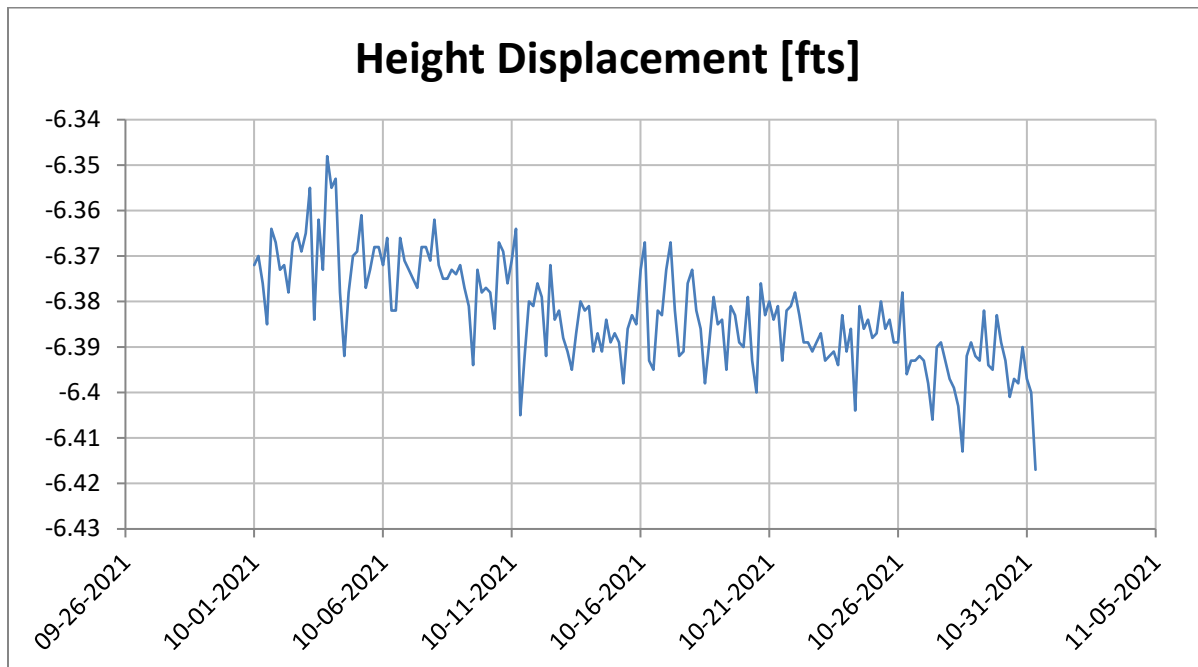
## Prism P63

The data show stable conditions with no movement for 17 of 20 prisms with recorded displacements limited to data scatter and not actual movements. Prisms P63 and TOE3 are located at the toe of the landslide, and these locations showed slope creep movements at slow velocities (approximately 0.001 feet per day or less). Prism NP66 is located above the landslide, and this prism also recorded slope creep movements at slow

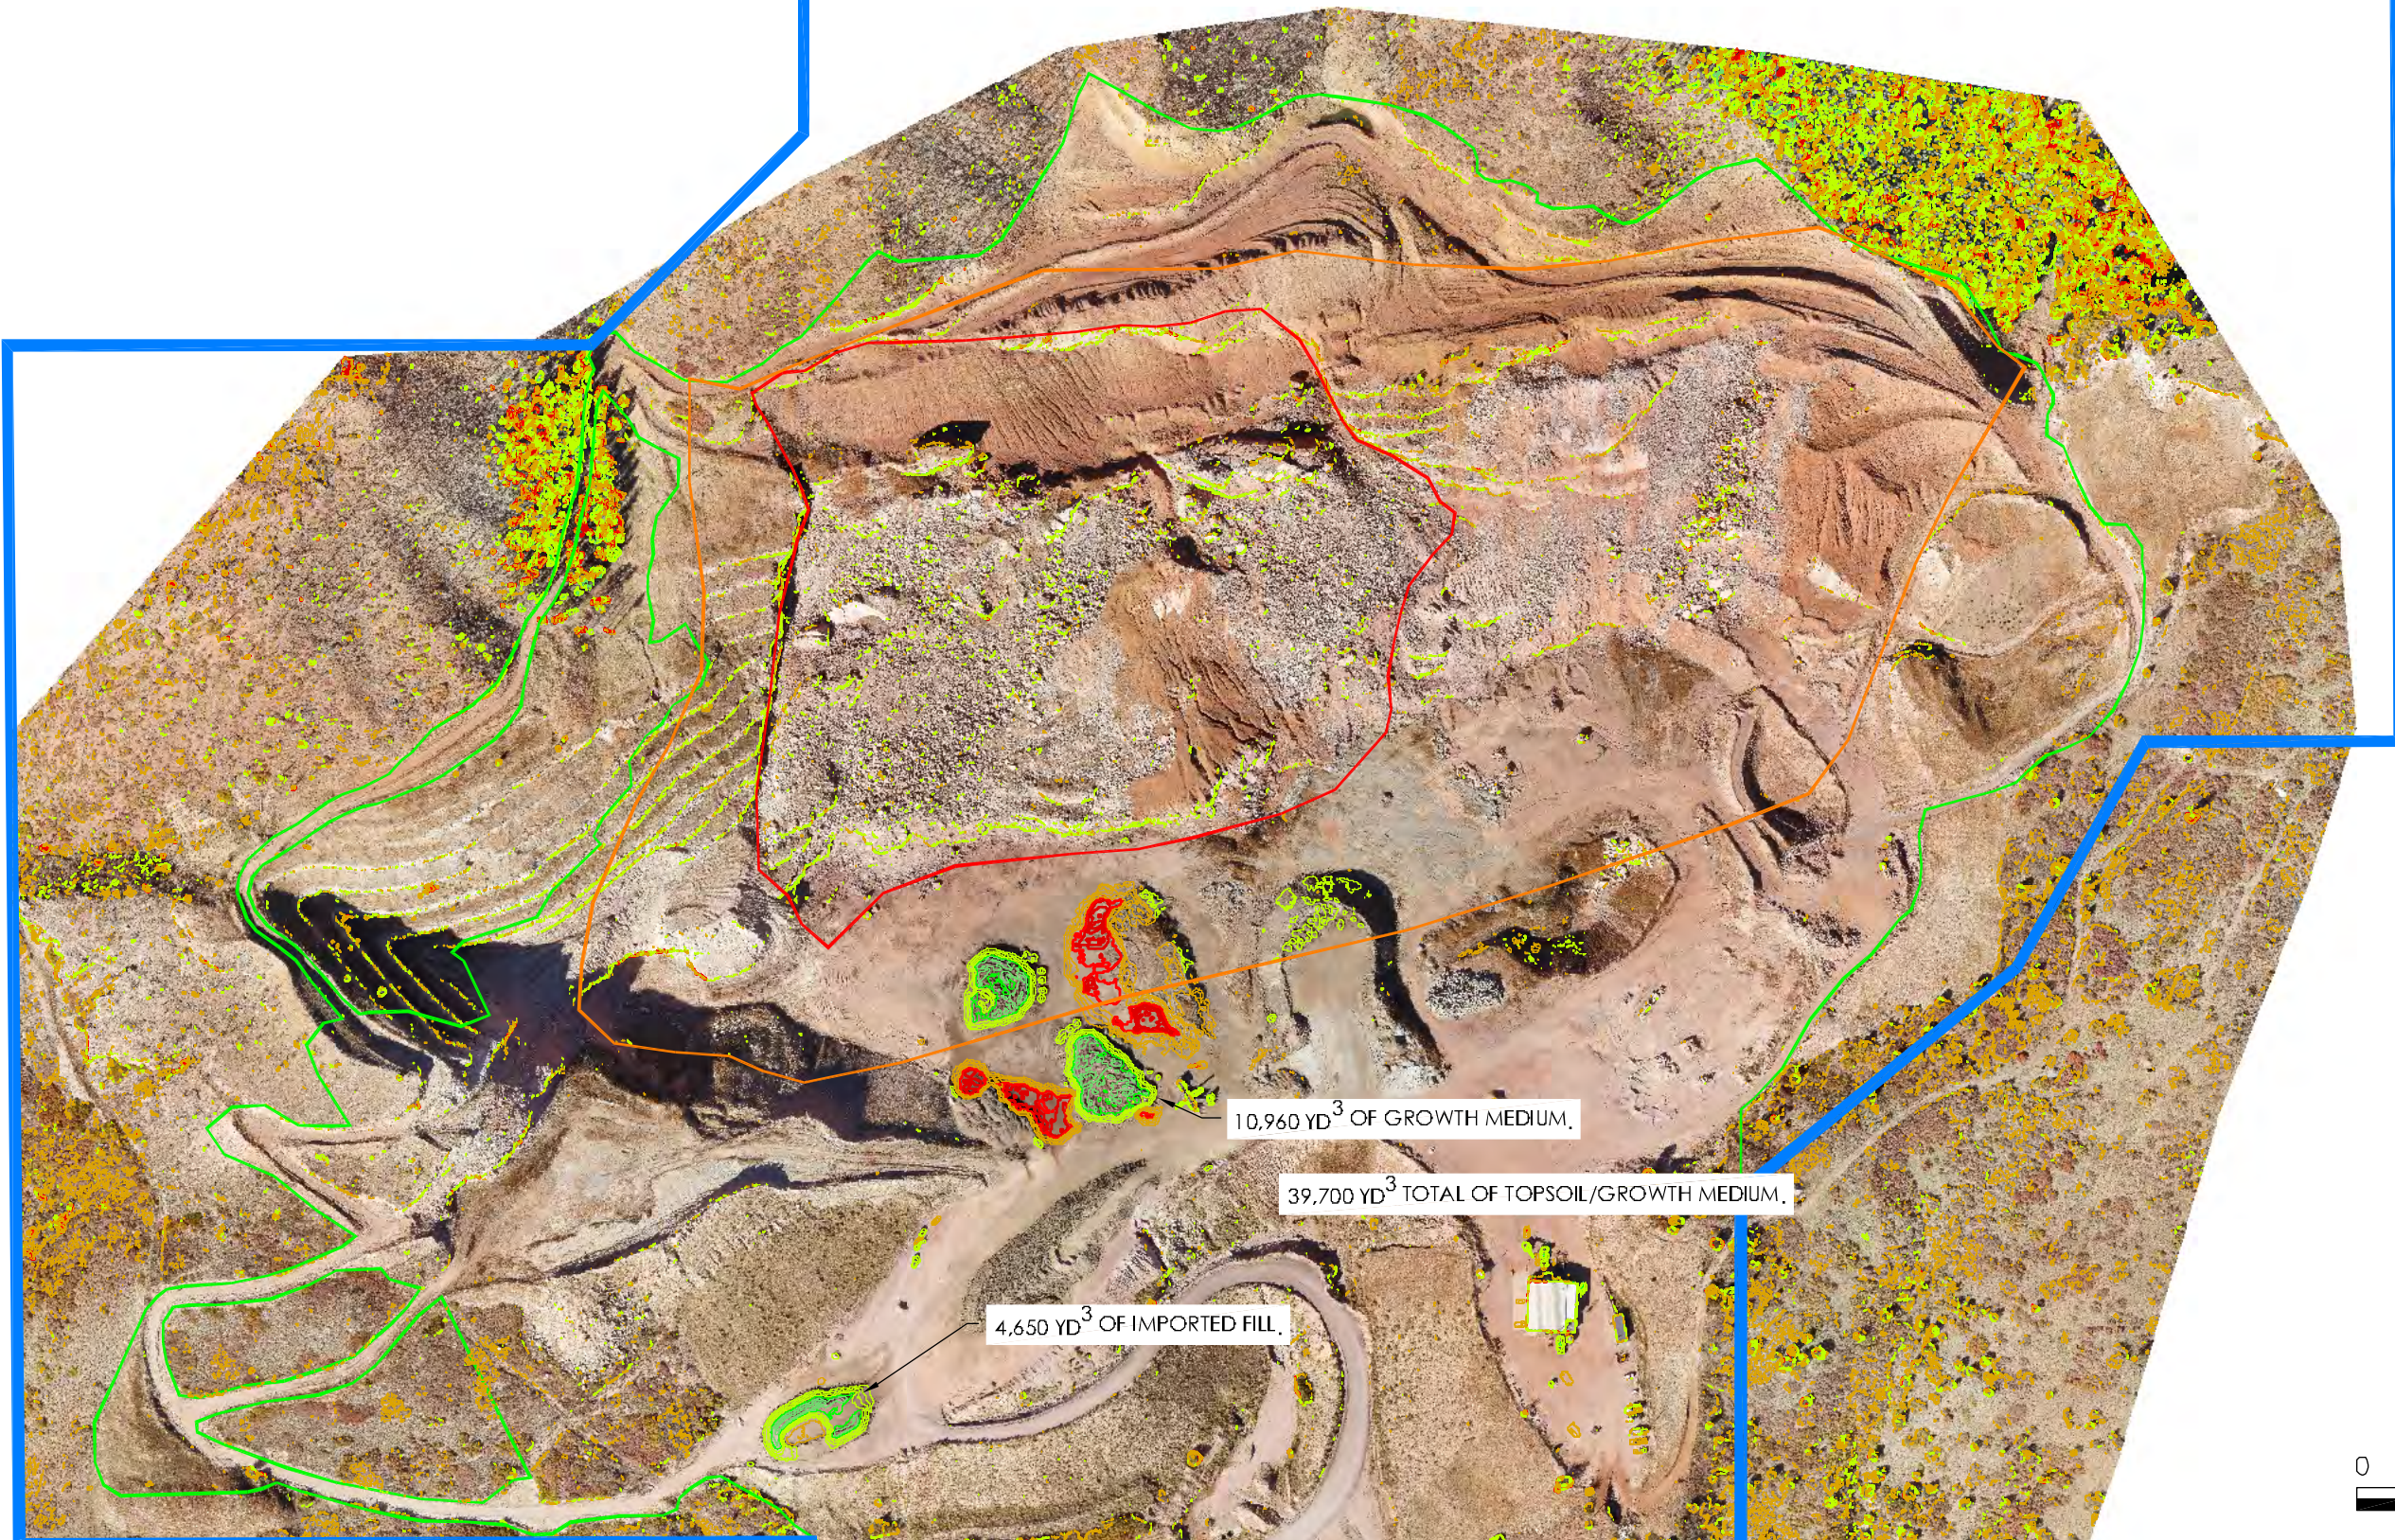
The September topography was also compared to the October topography to identify changes in the site topography. Comparison of the two surveys showed that approximately 4,560 yd<sup>3</sup> of fill had been imported and temporarily placed on the stockpile near the top of the ramp. Additionally, 10,960 yd<sup>3</sup> of growth medium were prepared as a balanced cut/fill near the Aztec screen plant. Much of the imported fill was topsoil, and it was added to the growth media pile. Approximately 39,700 yd<sup>3</sup> topsoil/growth medium has been imported or prepared. No slope movements or other changes in topography were identified. The current imagery and

topography are included in Figures 1 and 3, and the comparison surface is included as Figure 5 in Appendix C.
