**MINERALS PROGRAM INSPECTION REPORT**  
**PHONE: (303) 866-3567**

<b>MINE NAME:</b> Pueblo East Pit	<b>MINE/PROSPECTING ID#:</b> M-2000-041	<b>MINERAL:</b> Sand and gravel	<b>COUNTY:</b> Pueblo
<b>INSPECTION TYPE:</b> Surety-Related Inspection	<b>INSPECTOR(S):</b> Patrick Lennberg	<b>INSP. DATE:</b> November 2, 2021	<b>INSP. TIME:</b> 09:00
<b>OPERATOR:</b> Fremont Paving & Redi-Mix, Inc.	<b>OPERATOR REPRESENTATIVE:</b> James Higgs	<b>TYPE OF OPERATION:</b> 112c - Construction Regular Operation	
<b>REASON FOR INSPECTION:</b> Surety Release Requested	<b>BOND CALCULATION TYPE:</b> Complete Bond	<b>BOND AMOUNT:</b> \$2,186,592.00	
<b>DATE OF COMPLAINT:</b> NA	<b>POST INSP. CONTACTS:</b> None	<b>JOINT INSP. AGENCY:</b> None	
<b>WEATHER:</b> Cloudy	<b>INSPECTOR'S SIGNATURE:</b>

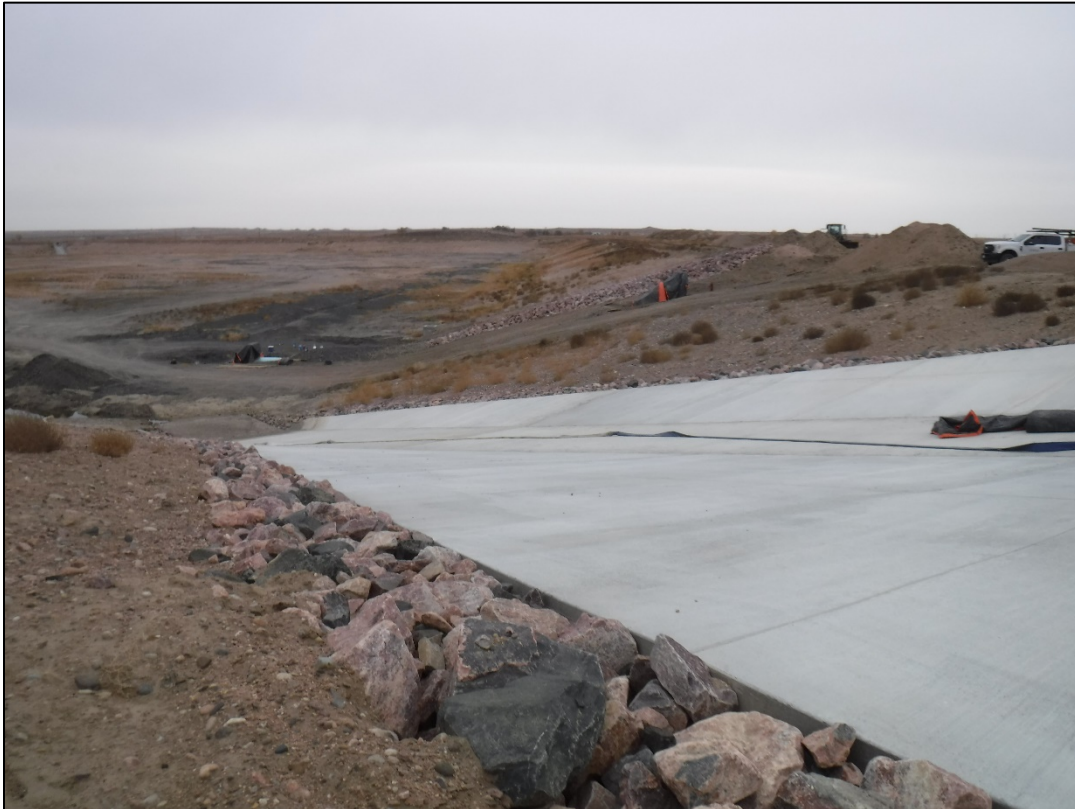
During the September 2019 inspection the Division determined the spillway approved under TR-04 is a critical component of the slurry wall infrastructure, which was designed to safely pass flood waters from a 100-year flood event. Until the spillway is constructed, the slurry wall remains at risk from damage during a flood event. Therefore, the Division was willing to reduce the financial warranty to \$1,318,581, which is 50% of the cost to install the slurry wall. The Operator needed to submit a new TR for approval of the redesigned spillway. Approval of TR-7 was for the redesigned spillway. During the inspection the spillway construction was viewed and determined to be consistent with TR-7. Since the last inspection, infrastructure for filling the reservoir has also been completed and it is ready to begin operation.

**Photo 1:** Looking at the recently constructed outfall of the reservoir in the southeast corner

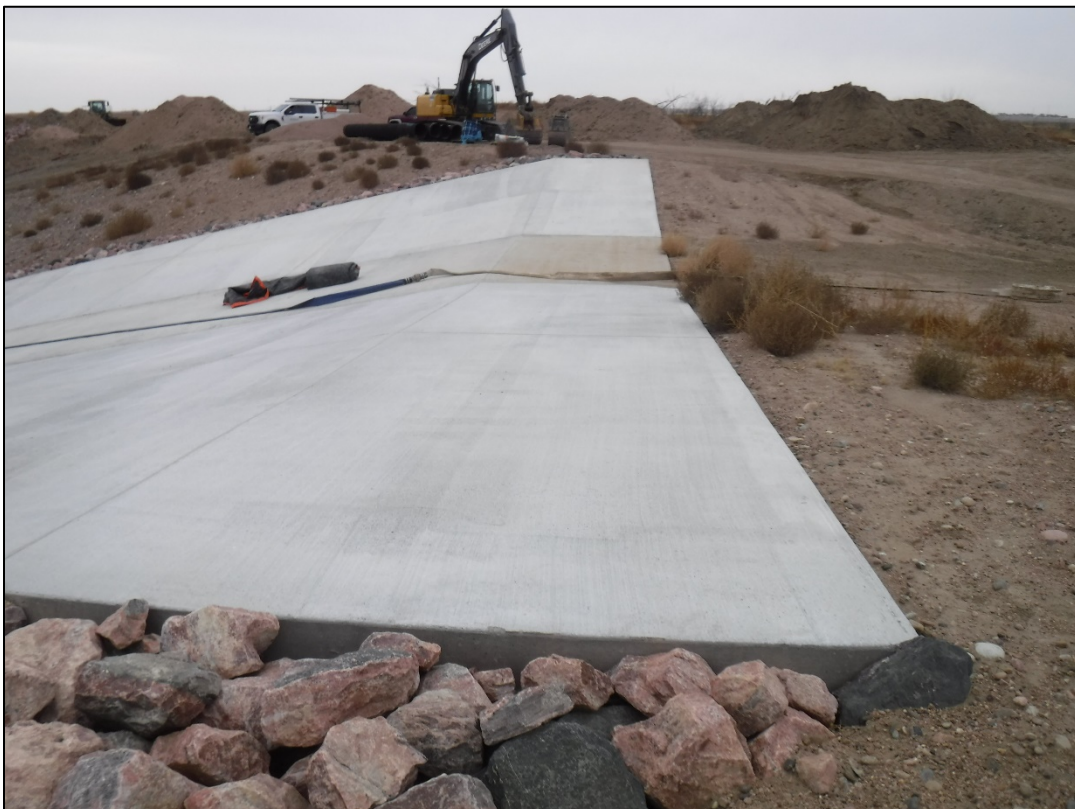
**Photo 2:** Crest of outfall

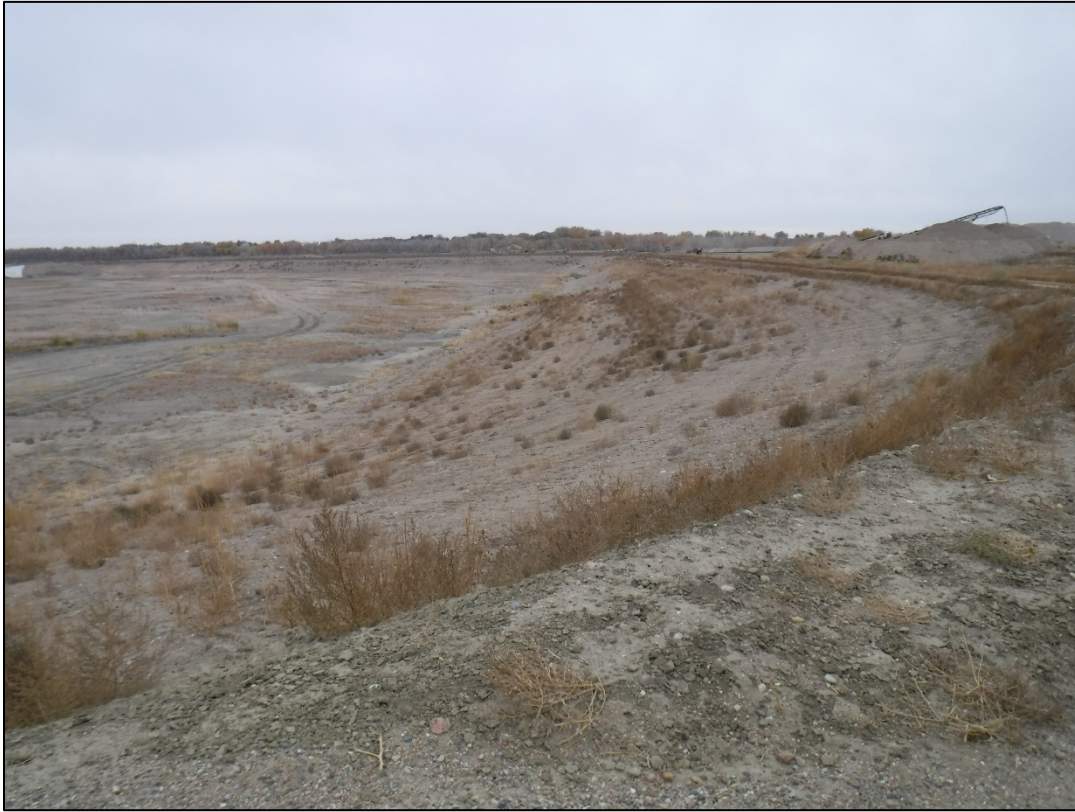
**Photo 3:** Looking south from northwest corner of reservoir

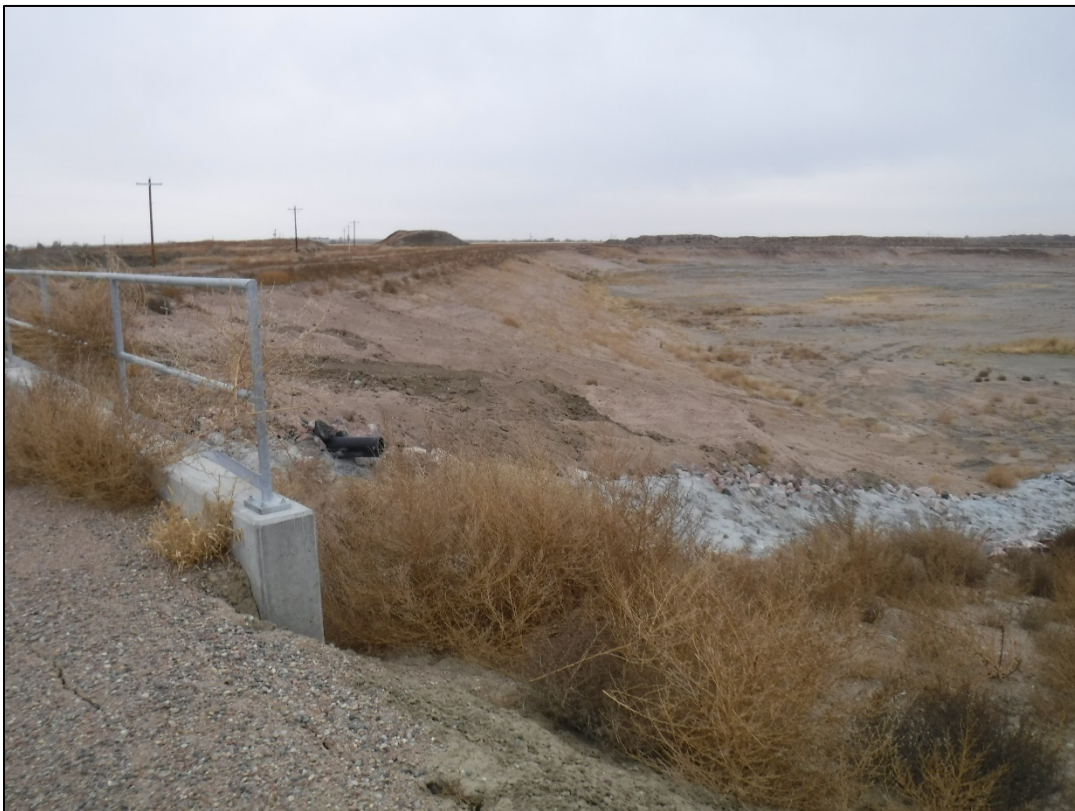
**Photo 4:** Looking east from northwest corner, the rundown structure in center of picture is used for filling

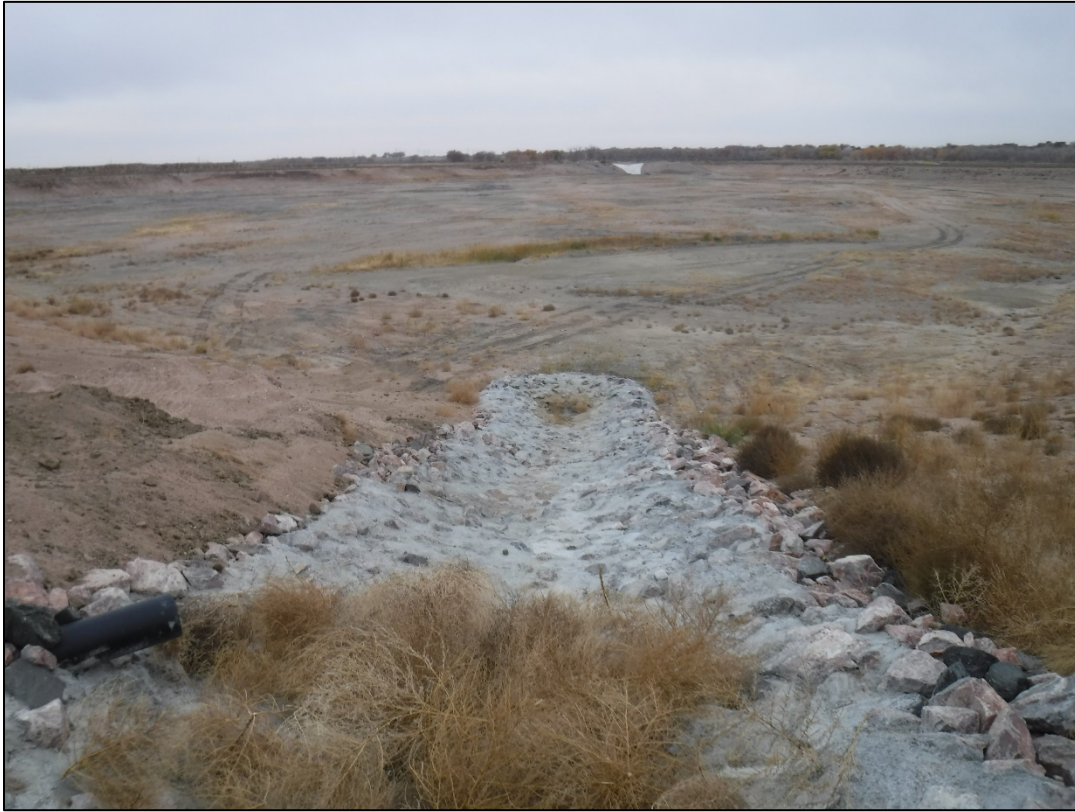
**Photo 5:** Rundown structure used for filling reservoir

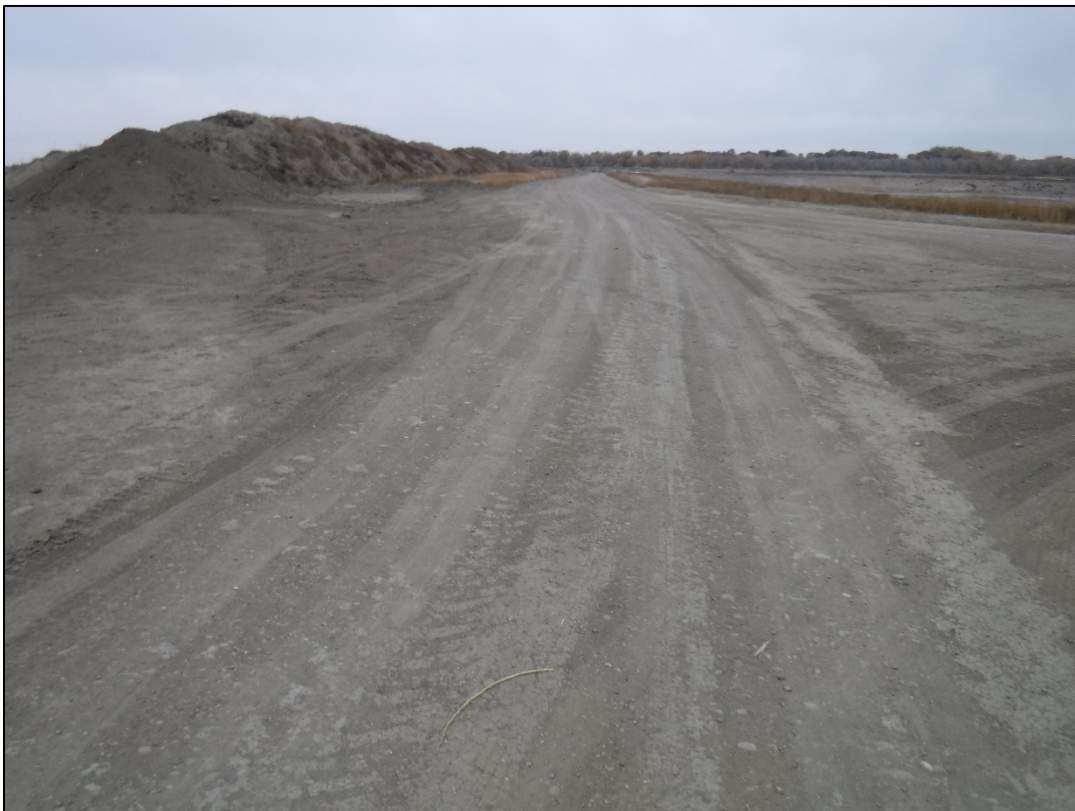
**Photo 6:** Typical conditions of maintenance road around reservoir

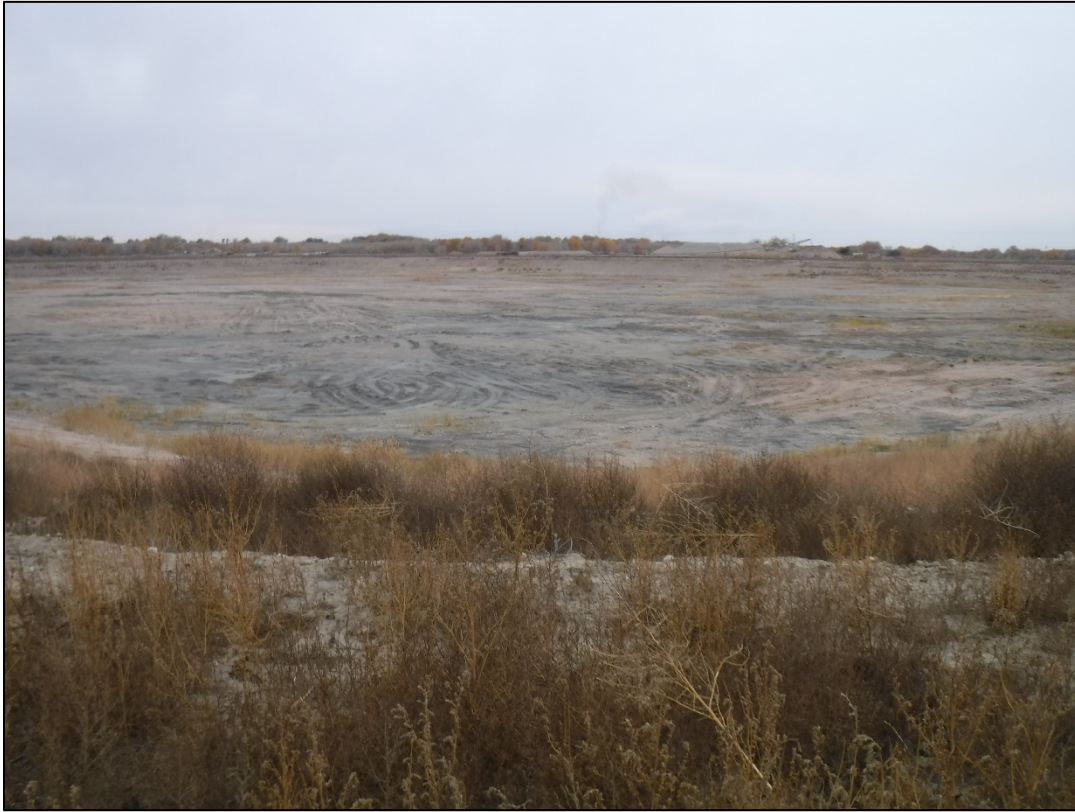
**Photo 7:** Looking west across reservoir

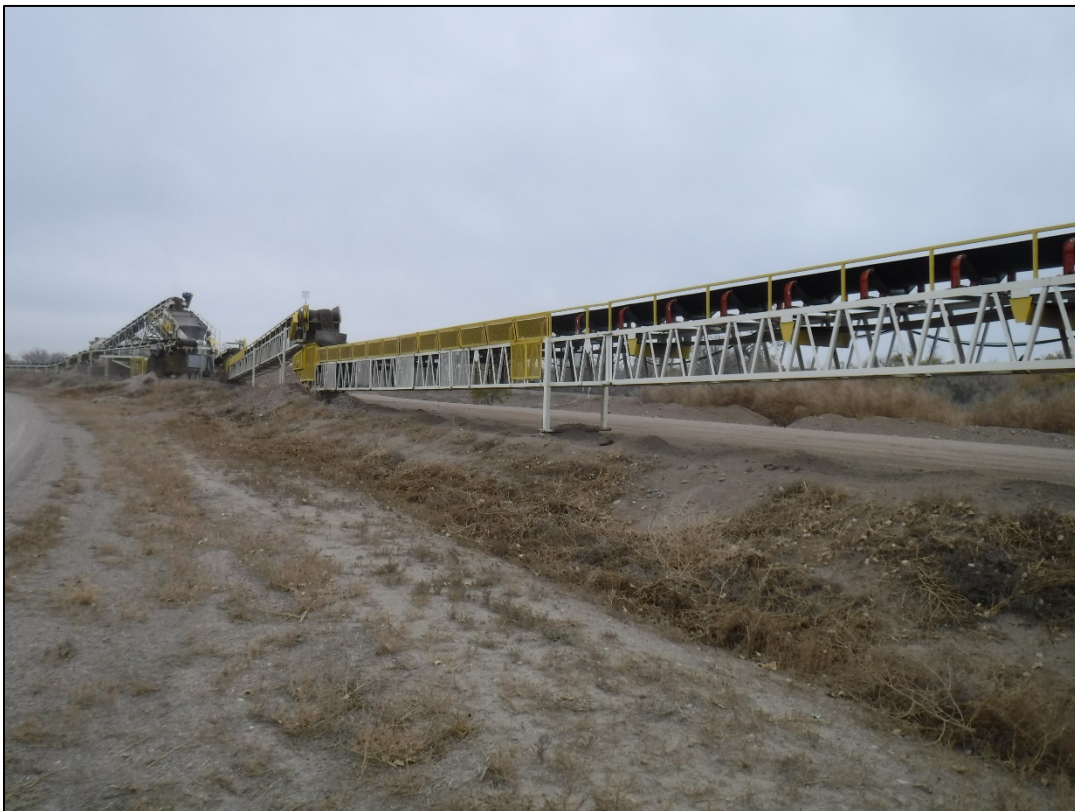
The Operator is also seeking release of the 96.82 acres that are associated with the completed reservoir while allowing for a 1.4 acre conveyor easement. The conveyor easement will allow for continued mining south and east of the reservoir. The Division is concerned that equipment may use the reservoir area for equipment travel and temporary storage which could be considered affecting land outside the permit boundary. The Division reminded the Operator any disturbances outside the new permit boundary could be subject to a possible violation. It was discussed in the field that clear visual barriers be installed to prevent accidental passage outside of the proposed permit area.

**Photo 8:** Conveyor belt corridor along south reservoir boundary

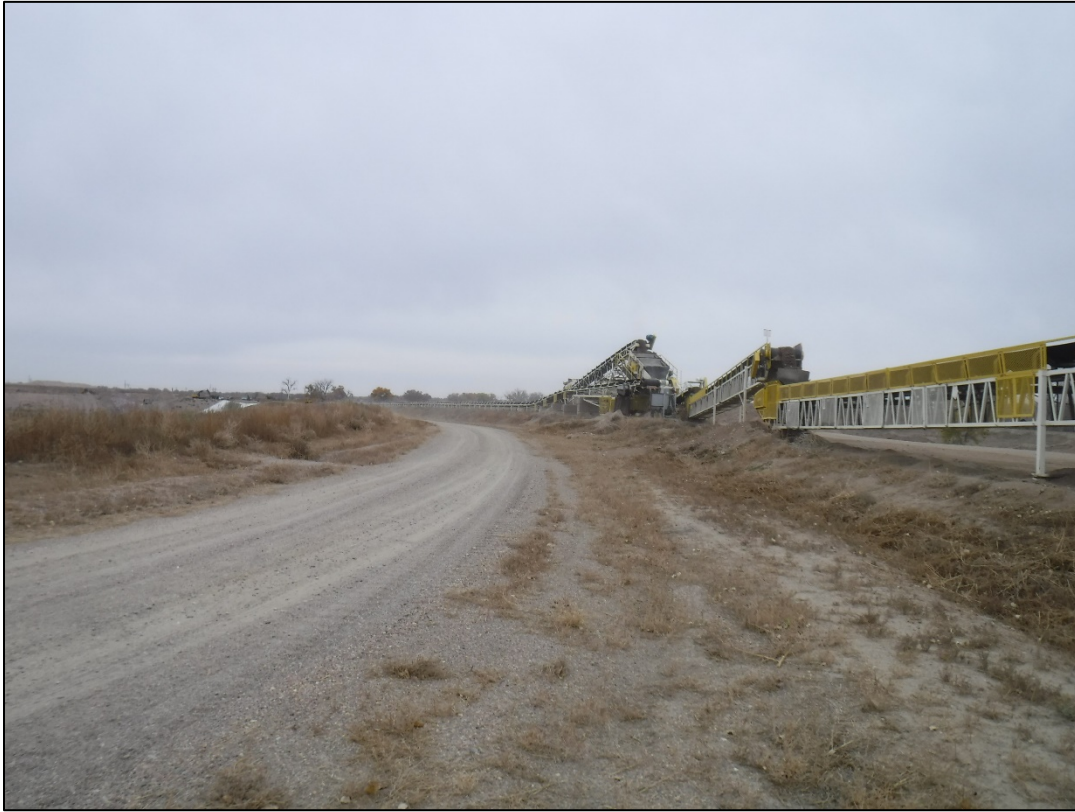
**Photo 9:** Conveyor belt corridor along south reservoir boundary

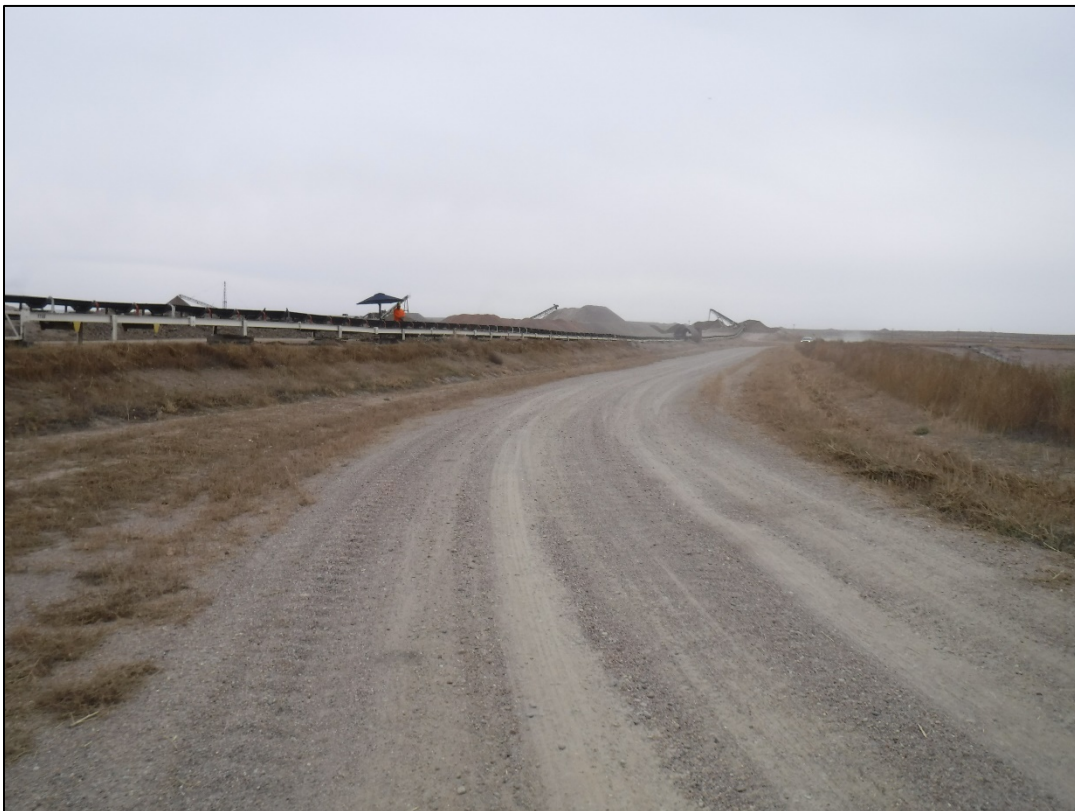
**Photo 10:** Conveyor belt corridor along southwestern reservoir boundary

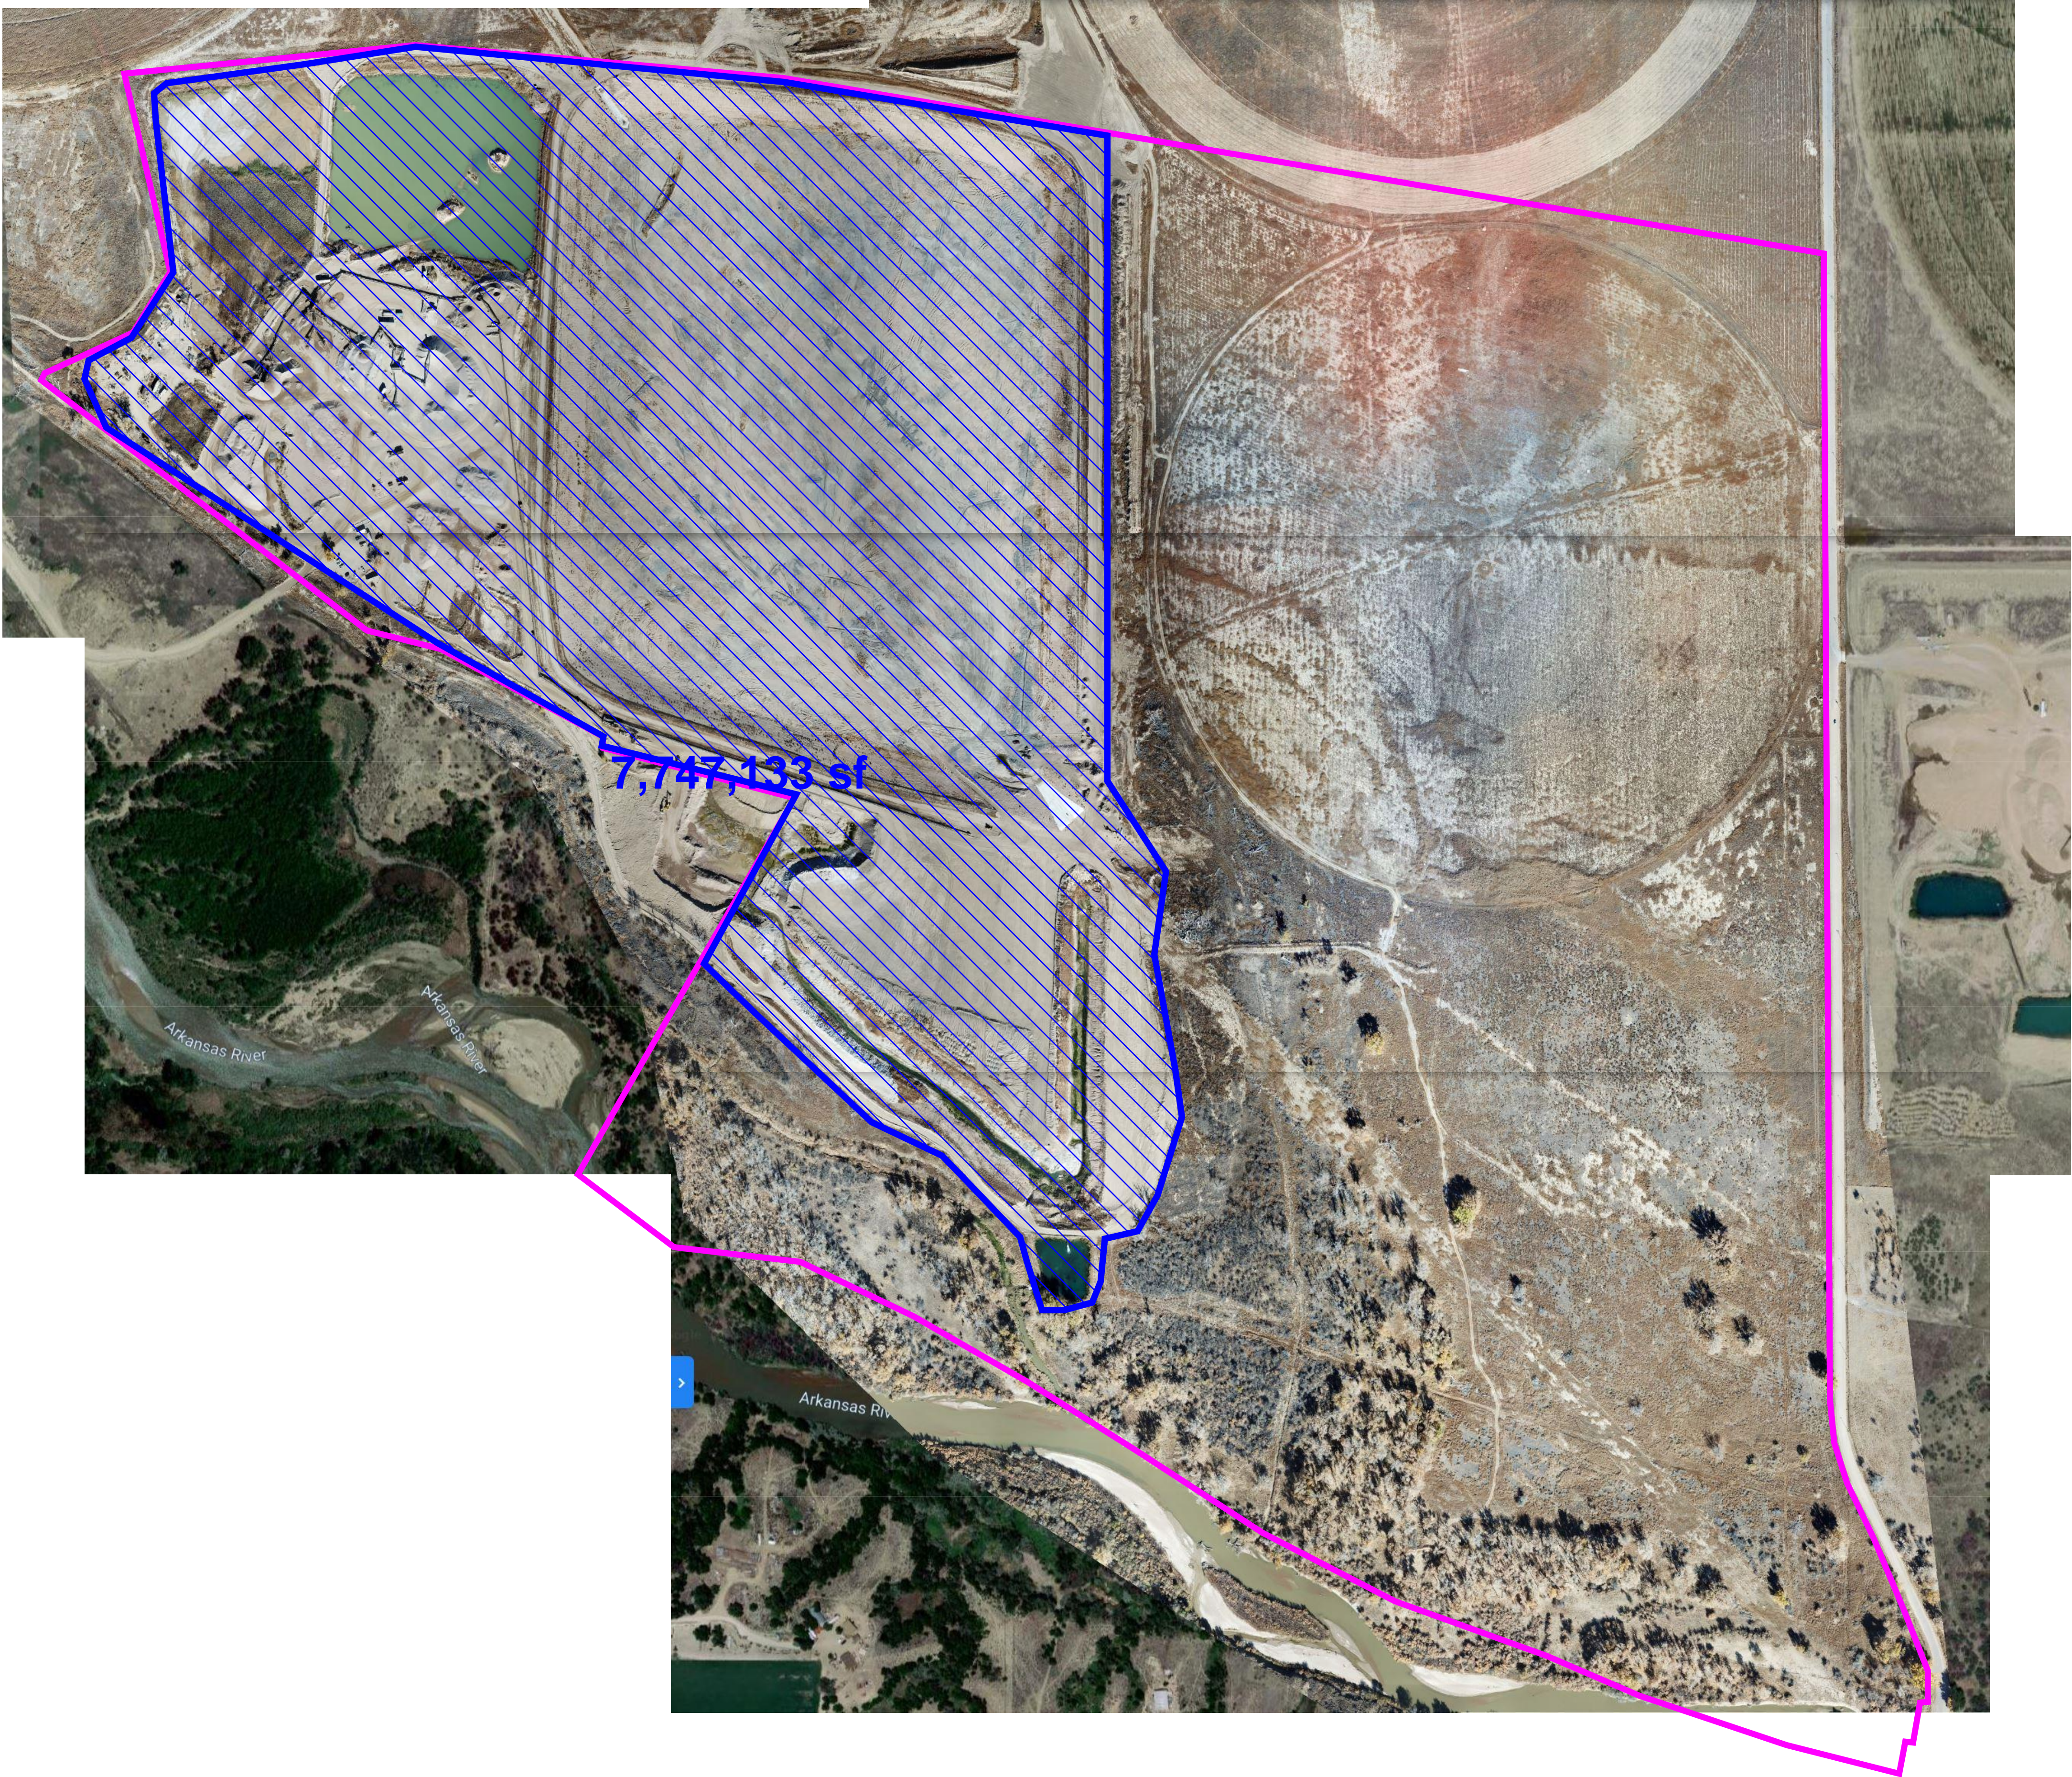
East Plt  
Map by James Higgs  
Droned on 11/4/21

7,747,133 sf = 177.85 acres Total Disturbance  
- 98.24 acres Triview  
+ 1.42 acres Belt easement

81.03 acres Reduced Disturbance
