**COLORADO**  
Division of Reclamation,  
Mining and Safety  
Department of Natural Resources

Permit Number: C1981010 Mine Name: Trapper Mine Operator: Trapper Mining, Inc. Operator Address:  Mr. Graham Roberts P.O. Box 187 Craig, CO 81626	County: Moffat Operation Type: Surface Permit Status: Active Ownership: Federal Operator Representative Present:  No, as this was an aerial inspection.
This report was issued electronically from the Divisions' Denver Office.

Inspection Start Date: <b>8 Sept 2021</b> Inspection Start Time: 10:01 a.m. Inspection End Date: <b>8 Sept 2021</b> Inspection End Time: 10:07 a.m.	Inspection Type: <b>Coal Aerial Inspection</b> Inspection Reason: Normal I&E Program Weather: Clear
Joint Inspection Agency:  None	Joint Inspection Contacts:
Post Inspection Agency:  None	Post Inspection Contacts:
Inspector(s):  Robin A. Reilley, M.S. GISP  Brock Bowles	Inspector's Signature:

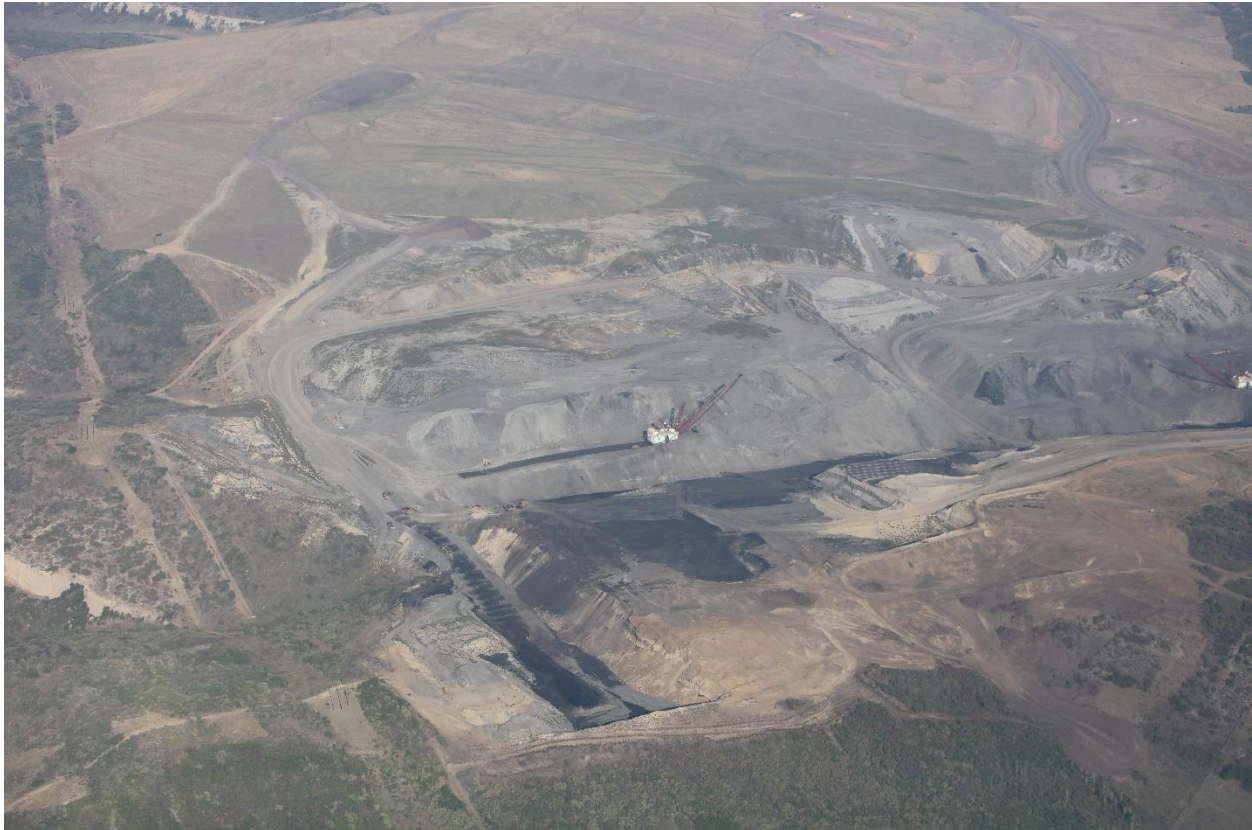
*Photo 1: Overview of L pit activities.*Number of Partial Inspection this Fiscal Year: 4Number of Complete Inspections this Fiscal Year: 1

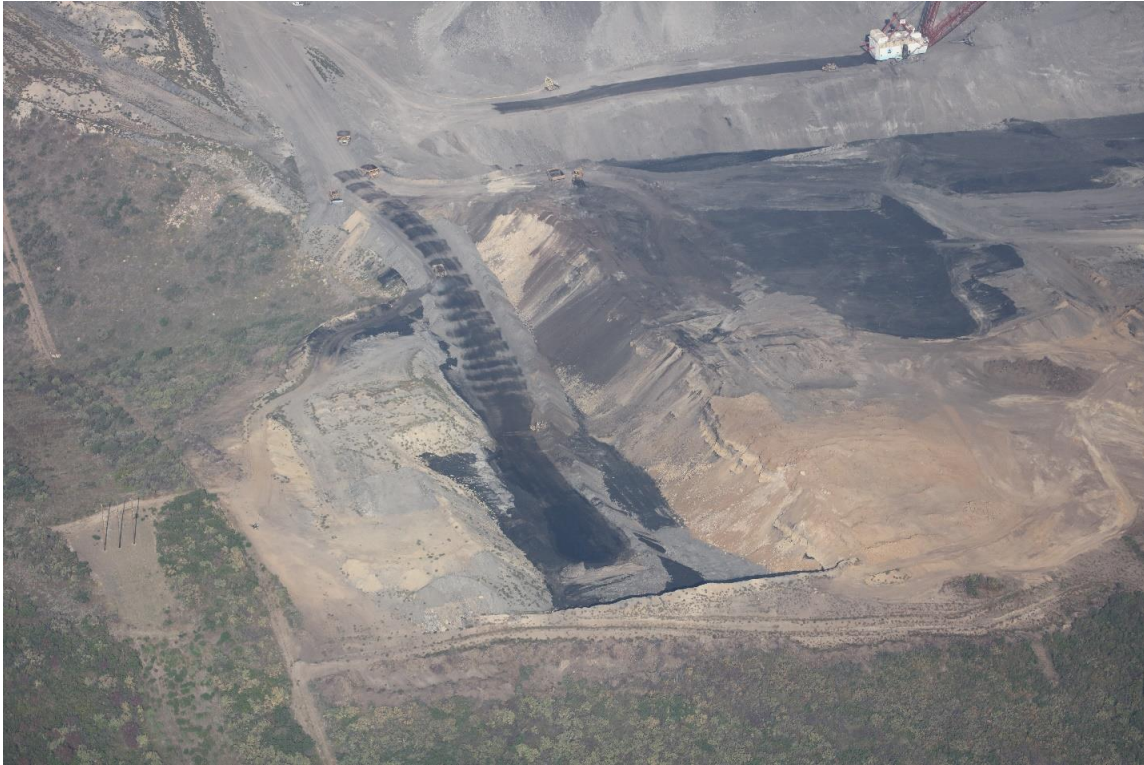
- No flow or discharge was apparent in the imagery.
- Constructed drainages appeared dry and stable in the imagery.
- Impoundment H held a small amount of water
- Industrial waste pond was full. This pond does not discharge.
- Horse Pond appeared dry, awaiting dredging.
- The Johnson Pond system held water.
- Middle Pyeatt system appeared dry in the imagery.
- East Pyeatt #3 Pond held water and #2 and #3# appeared dry at the time of inspection.
- Middle Pyeatt #1 holding water. Middle Pyeatt Ponds #2 and #3 appeared dry in the imagery.

***Photo 2: Dry Middle Pyeatt Pond system.***

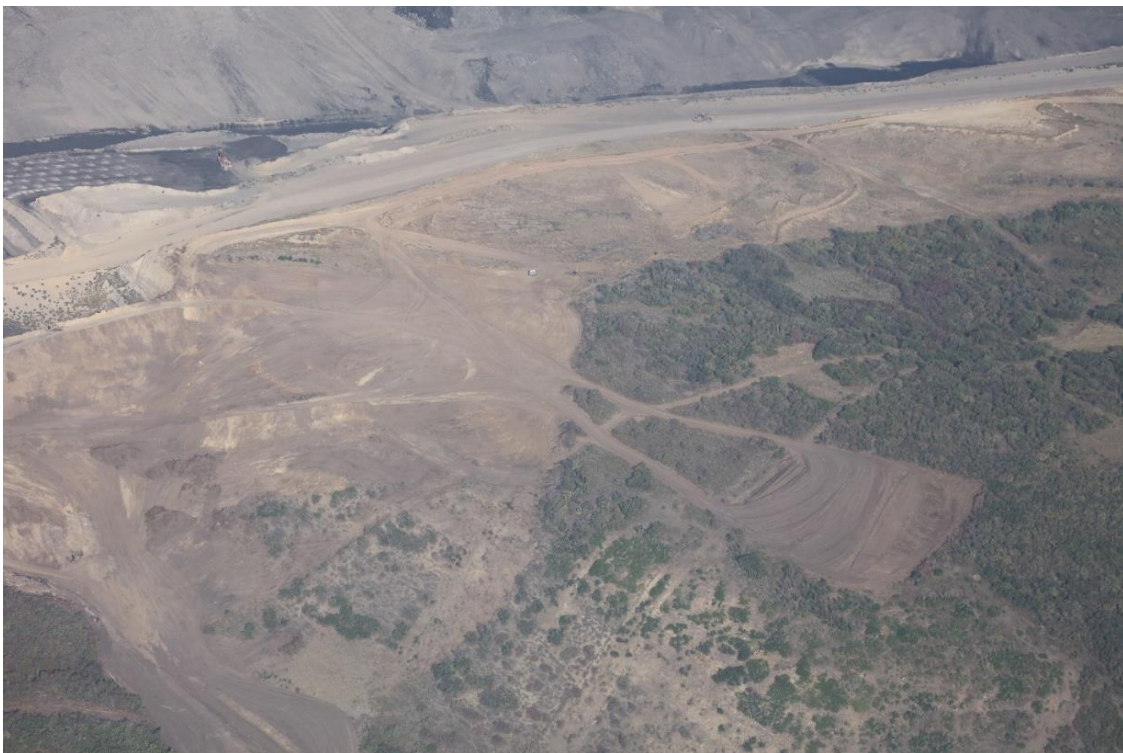
***Photo 3: L Pit stripping at east end of the pit, with a blast set up in upper left of photo.***

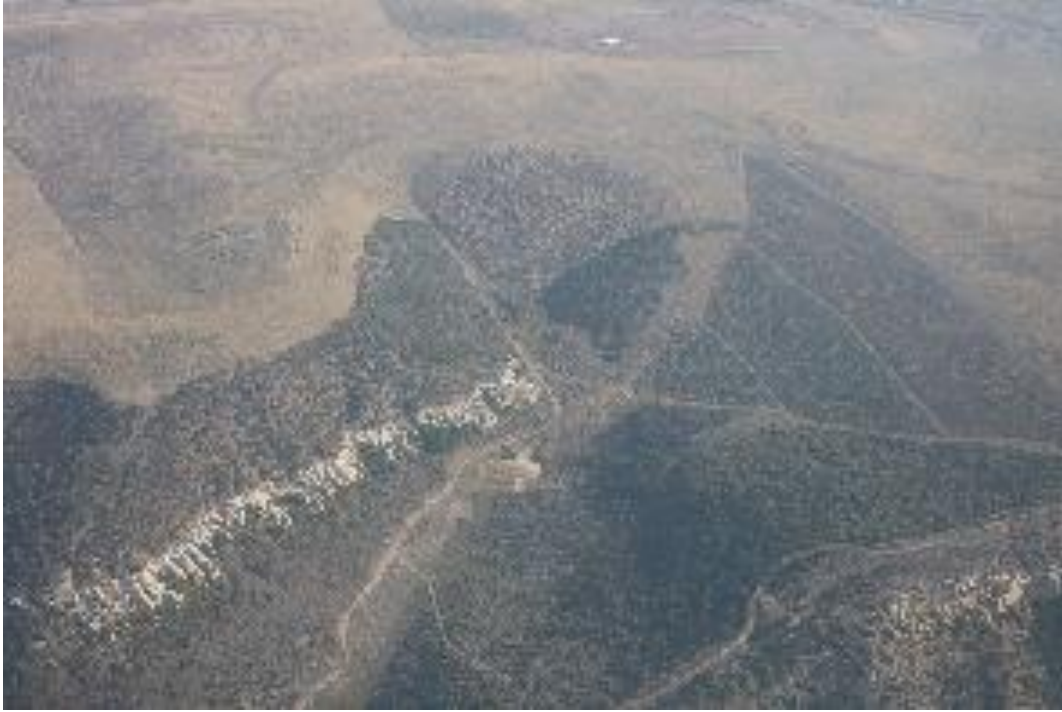
*Photo 4: Horse Gulch Fill and surrounding reclamation.*

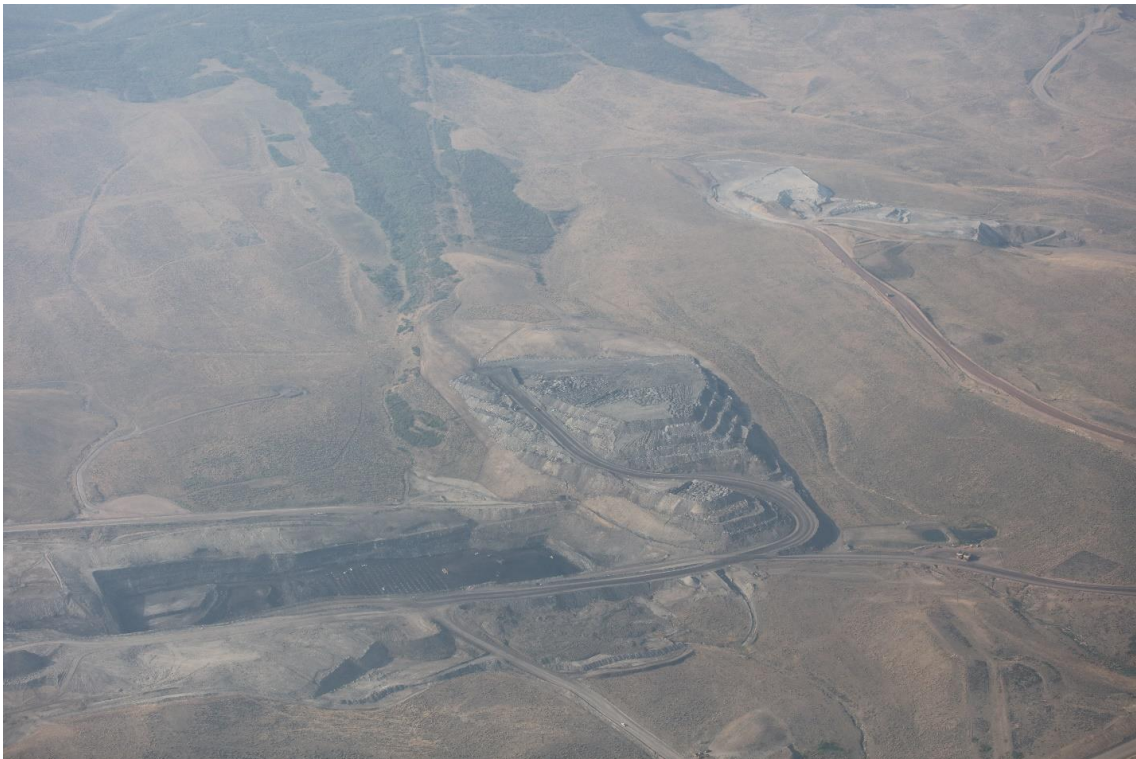
*Photo 5: Overview of N Pit with blast set up.*

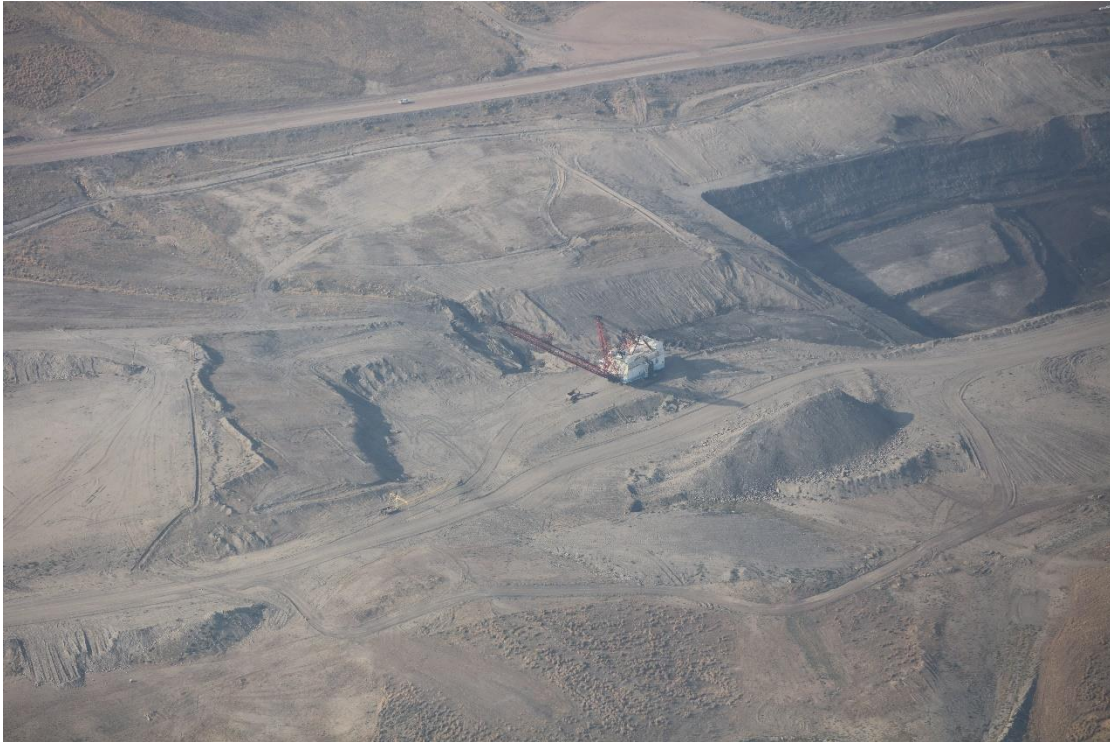
***Photo 6: N Pit activities.***

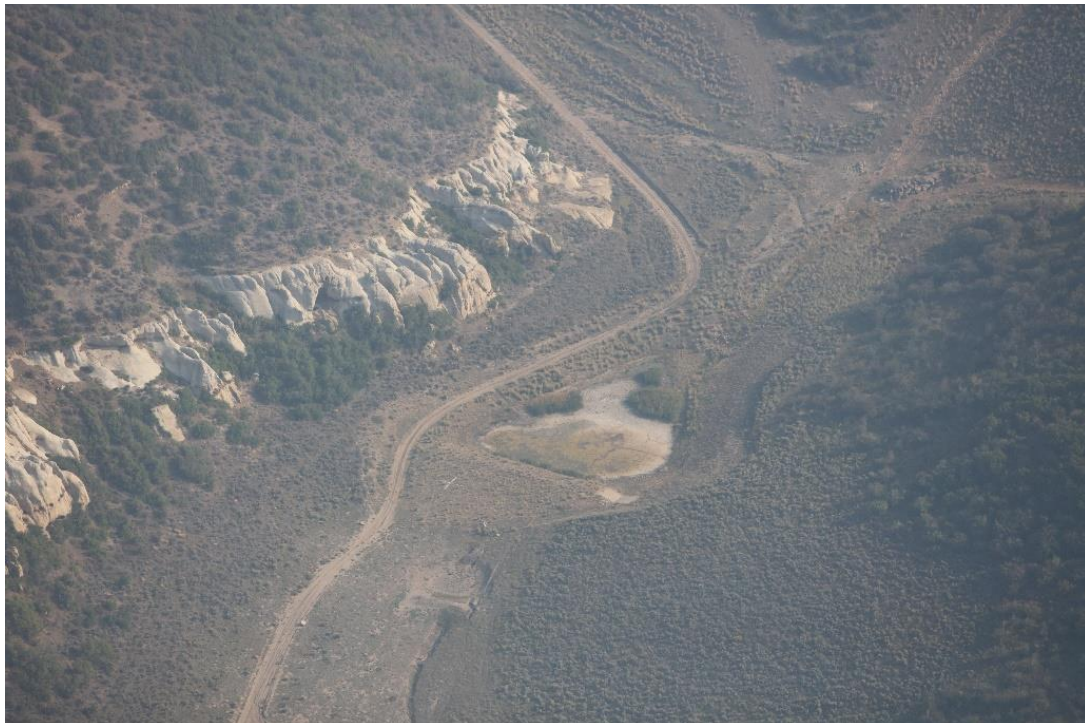
***Photo 7: Horse Pond, dry and awaiting dredging***

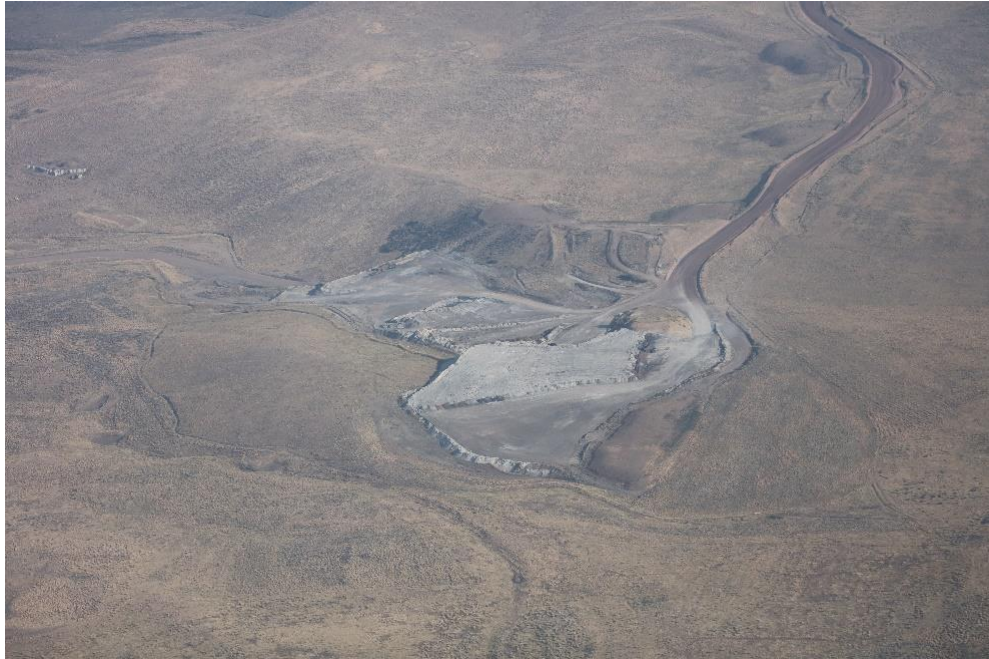
*Photo 8: Ash disposal area and topsoil stockpiled along the access road.*

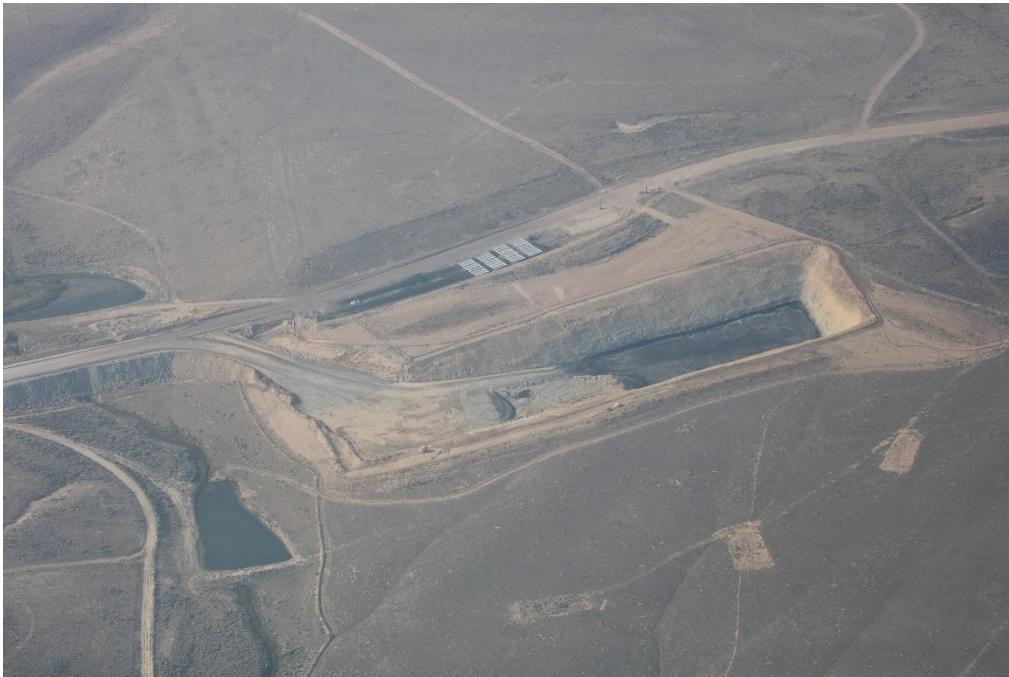
*Photo 9: West end of the mine site where highwall miner cars are staged at I Pit with Johnson Pond system at left in photo.*

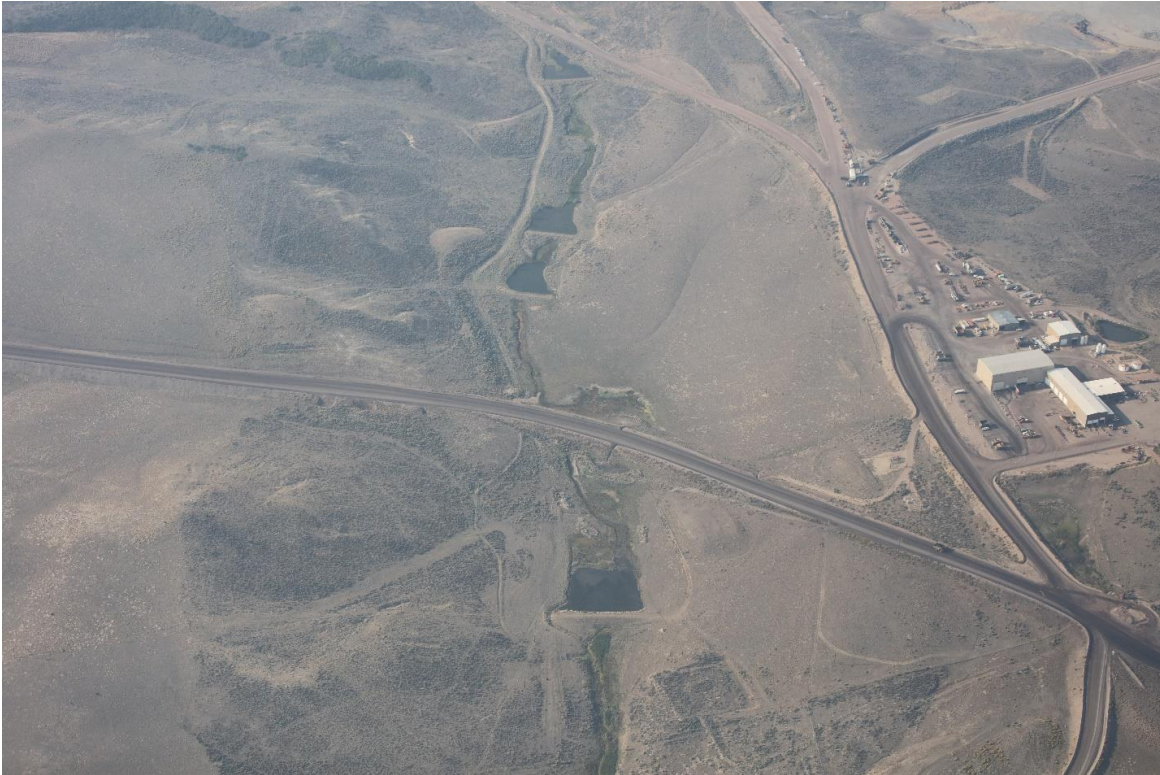
**Photo 10:** Facilities area with Industrial Waste Pond holding water (right), and Impoundment H (lower right part of photo), holding a small amount of water. The Johnson System of ponds is also holding water.

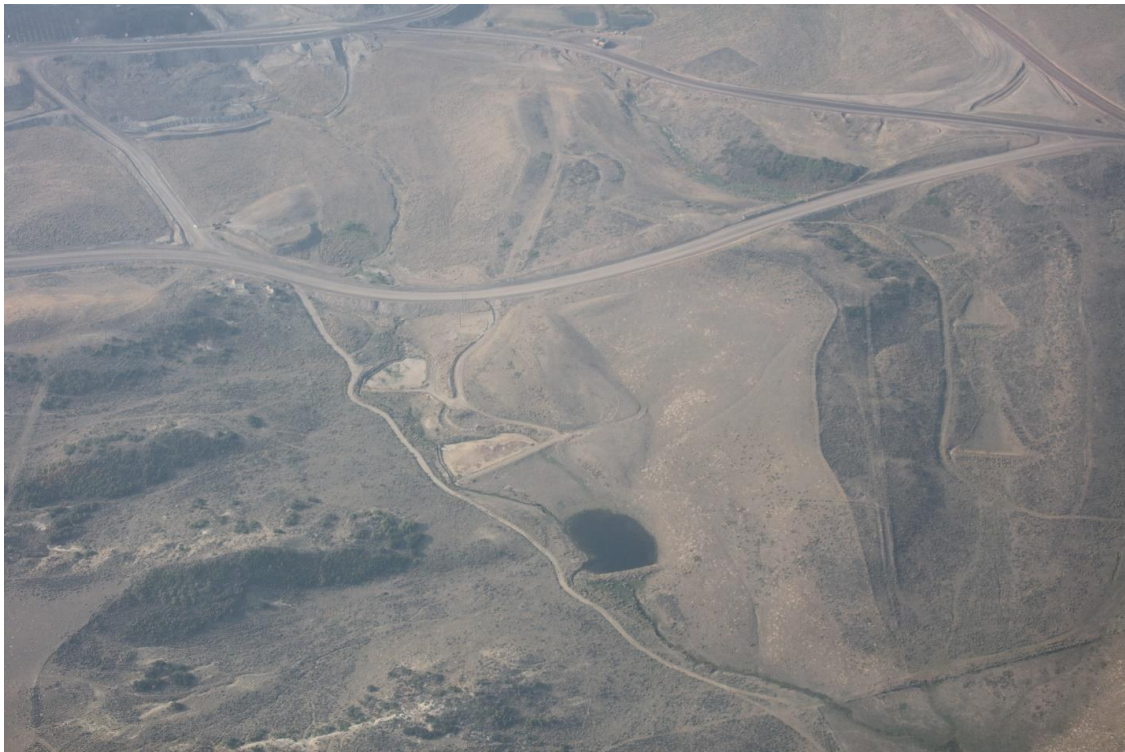
**Photo 11:** East Pyeatt system (photo left), with East Pyeatt #3 holding water. Middle Pyeatt system (photo right), Middle Pyeatt #1 holding water and the other two appear dry.
