**MINERALS PROGRAM INSPECTION REPORT**  
**PHONE: (303) 866-3567**

<b>MINE NAME:</b> NCCI Pit #1	<b>MINE/PROSPECTING ID#:</b> M-2001-107	<b>MINERAL:</b> Sand and gravel	<b>COUNTY:</b> Weld
<b>INSPECTION TYPE:</b> Monitoring	<b>INSPECTOR(S):</b> Peter Hays	<b>INSP. DATE:</b> November 30, 2021	<b>INSP. TIME:</b> 12:00
<b>OPERATOR:</b> Northern Colorado Constructors, Inc. Aggreg	<b>OPERATOR REPRESENTATIVE:</b> Chris Zadel	<b>TYPE OF OPERATION:</b> 112c - Construction Regular Operation	
<b>REASON FOR INSPECTION:</b> Normal I&E Program		<b>BOND CALCULATION TYPE:</b>	<b>BOND AMOUNT:</b> \$486,745.00
<b>DATE OF COMPLAINT:</b> NA		<b>POST INSP. CONTACTS:</b> None	<b>JOINT INSP. AGENCY:</b> None
<b>WEATHER:</b> Clear	<b>INSPECTOR'S SIGNATURE:</b>

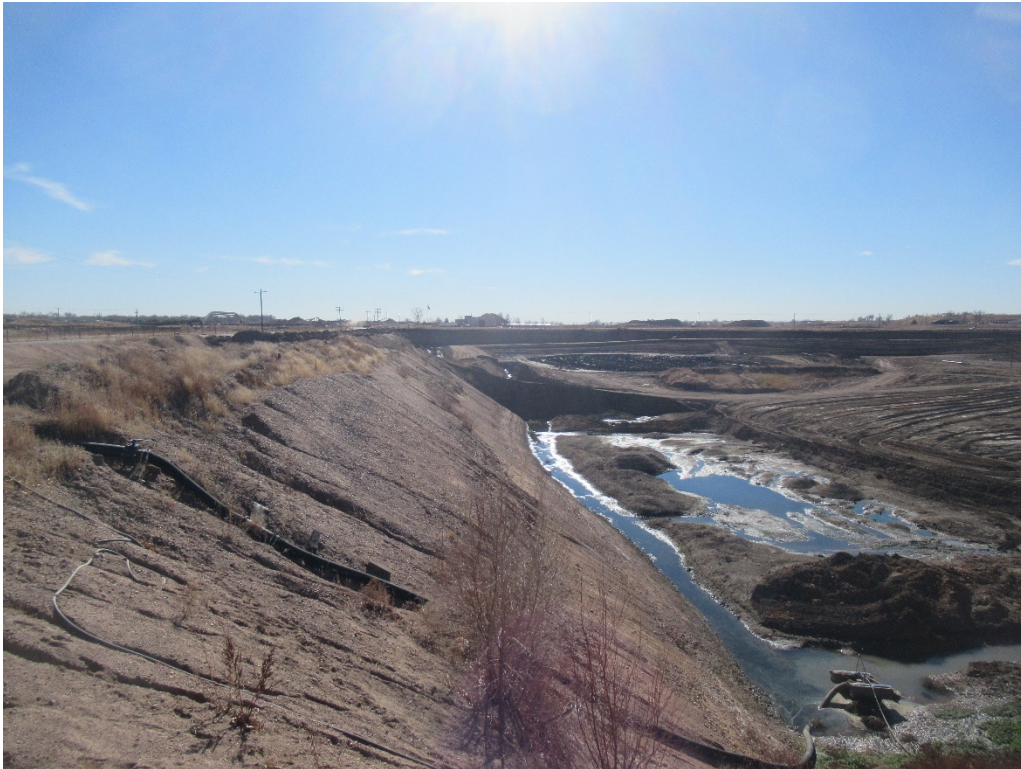
View of the southeast corner of the southern reservoir from the entrance looking south

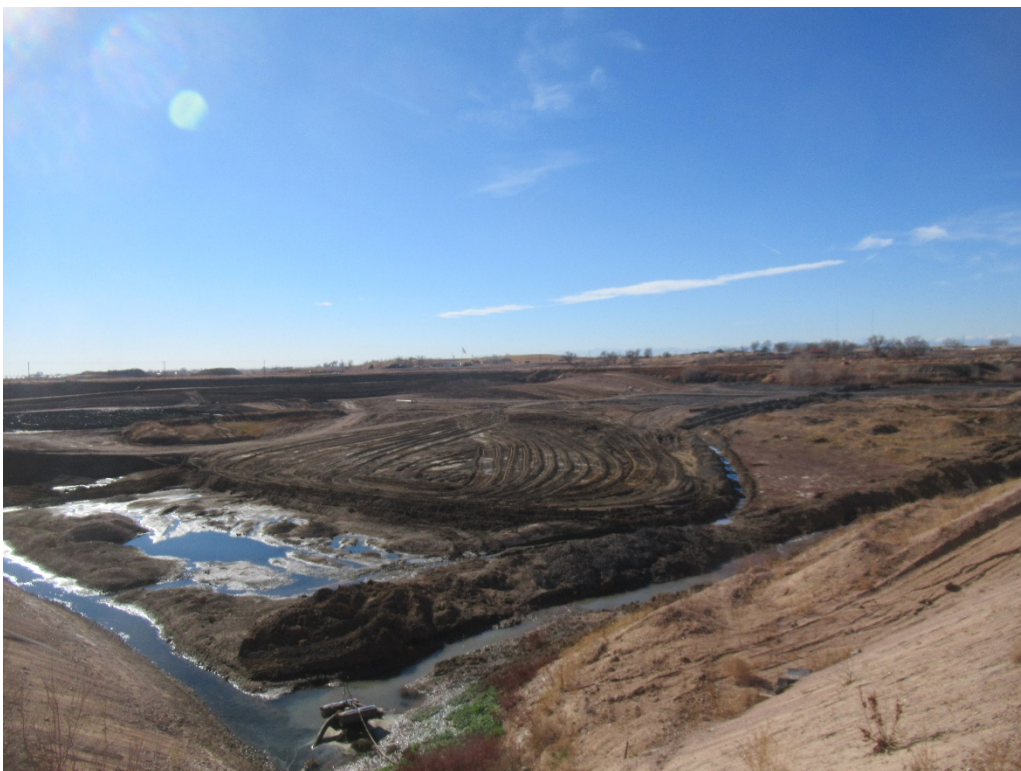
View of the southern portion of the southern reservoir from the entrance looking southwest

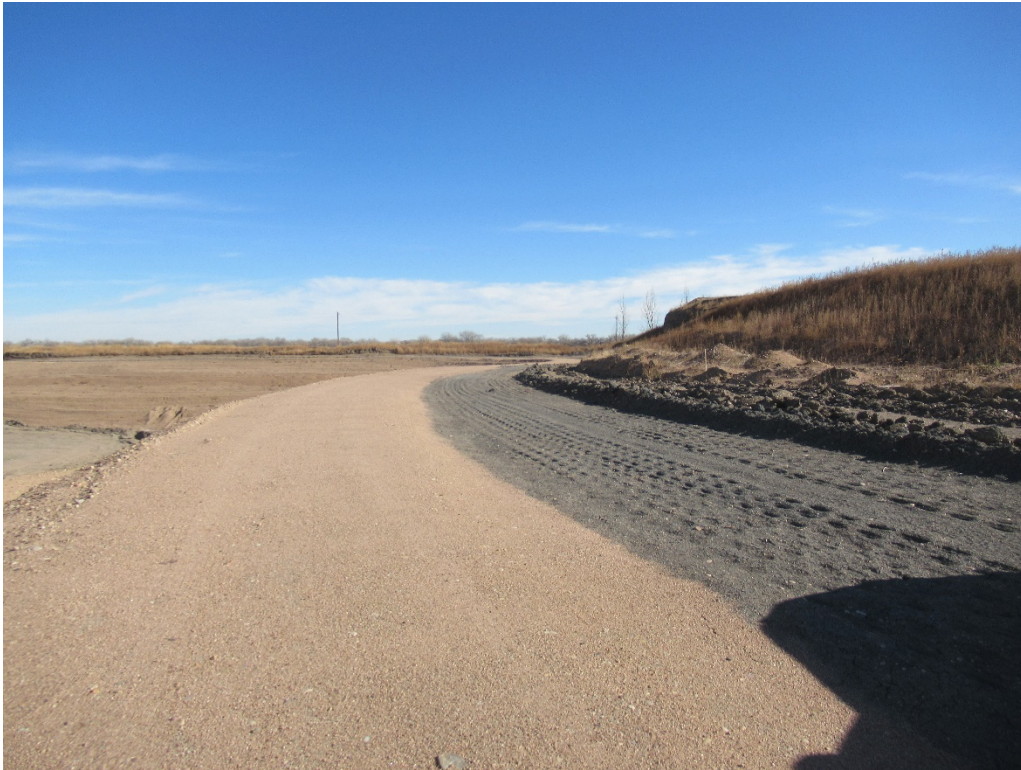
The site is an 112c operation permitted for 175.63 acres. Mining activities have concluded at the site. The approved post-mining land use for the site is developed water resources. The construction of the clay liner in the southern reservoir is underway and was observed during the inspection. The liner in the southeast and northwest sections of the southern reservoir are installed. The liner construction will continue from the southwest corner of the southern reservoir in a clockwise direction. The middle section of liner along the eastern boundary of the southern reservoir will be the final section to be installed. The Operator expects the liner will be completed by May or June next year.

Typical view of the top of the completed clay liner in the southern reservoir

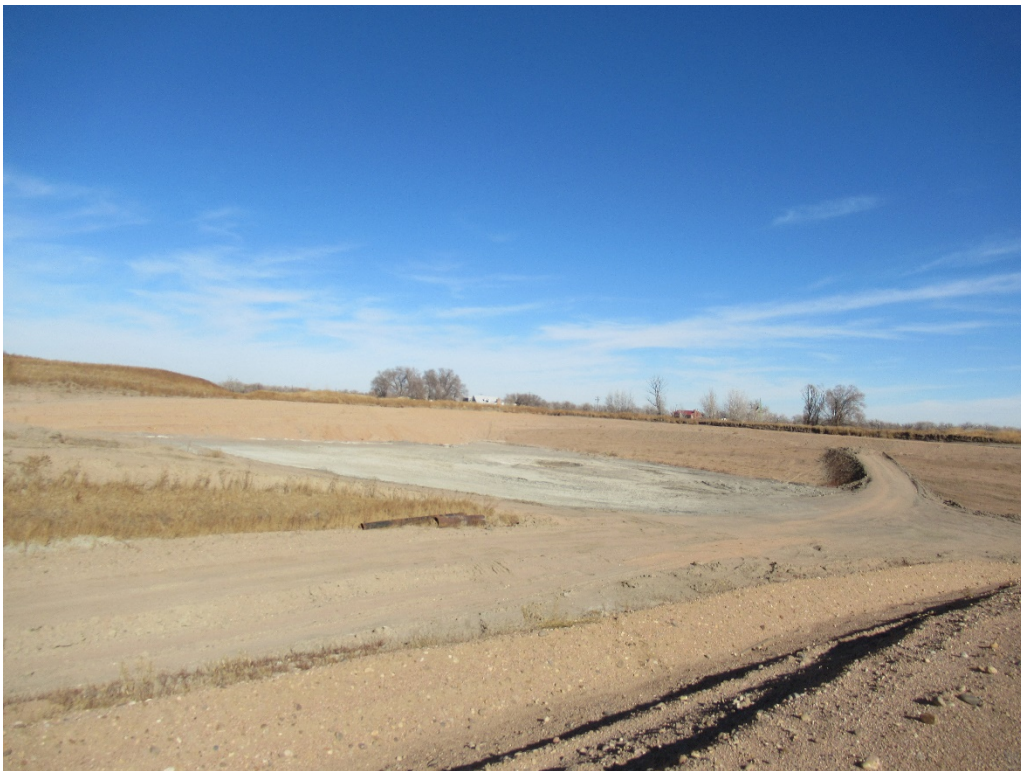
View of the completed clay liner in the northeast corner of the southern reservoir

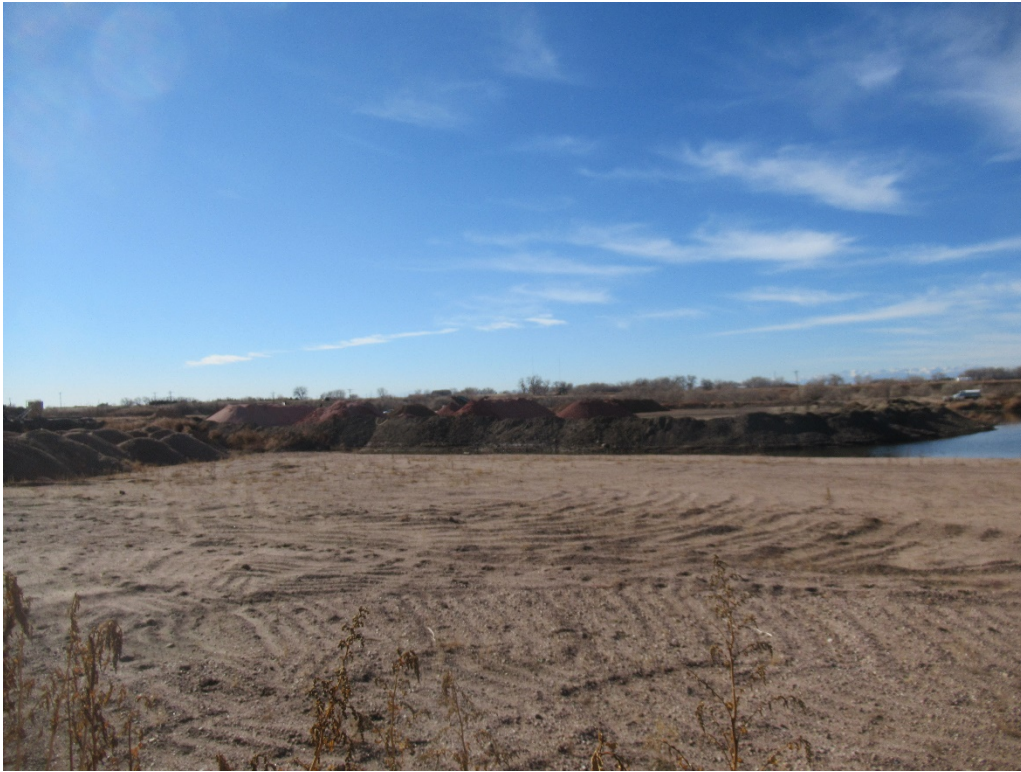
The approved post-mining land use for the northwest mining cells is developed water resource as approved under AM-01 in 2007. The northwest mining cells are being backfilled with inert fill by the Operator. As cited as a problem on the first page, the Division will require the Operator to submit a technical revision, with the required \$216 revision fee, to update and clarify the currently approved Reclamation Plan to reflect the existing and proposed activities by the corrective action date. A copy of the approved Reclamation Plan map is attached for reference. The technical revision must include the requirements of Rule 3.1.5(9) discussing the use of fill material generated outside of the approved permit area.

View of the backfilling and landscape operation located in the southern portion of the northern mining cells

**CORRECTIVE ACTIONS:** The Operator shall submit a Technical Revision, with the required \$216 revision fee, to update and clarify the currently approved Reclamation Plan to reflect the existing and proposed activities by the corrective action date.

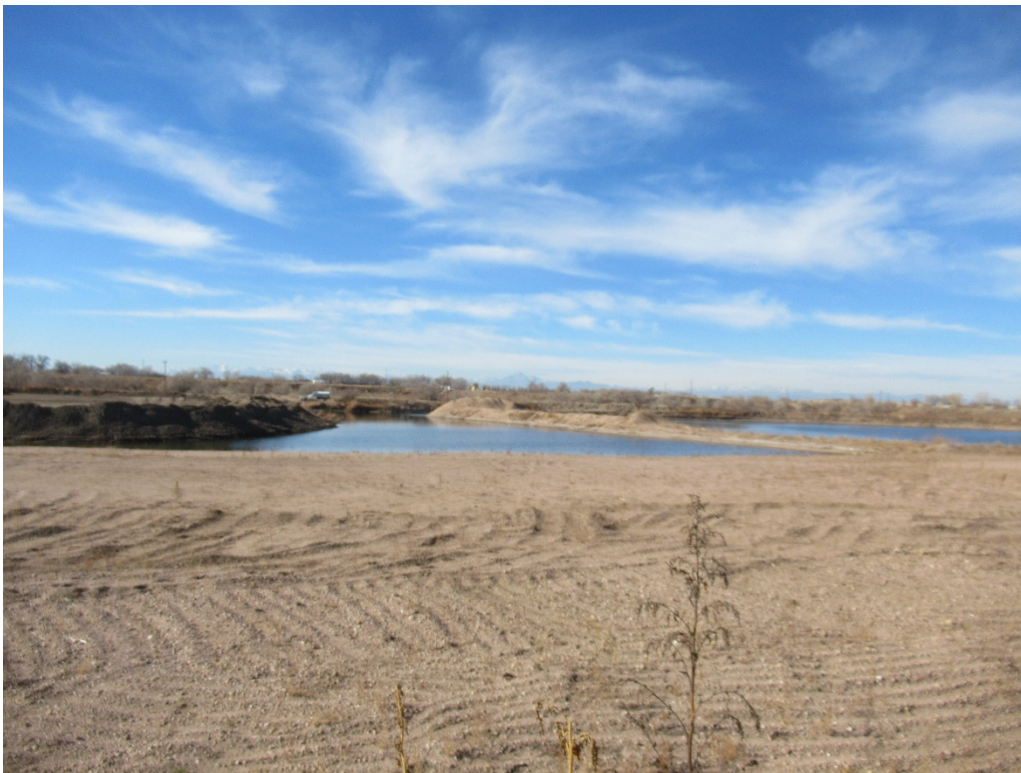
The southeast portion of the northwest mining cells are stripped, but were not mined. The material may be required for the clay liner shell construction. A landscaping business was located in the southern portion of the northwest mining cells. The business is screening on-site and imported materials for specialized landscape uses.

View of the unmined area in the northern mining cells
