MINERALS PROGRAM INSPECTION REPORT PHONE: (303) 866-3567

MINE NAME:		MINE/PROSPECTING ID#:	MINERAL:	COUNTY:
Perry Pit		M-1990-098	Sand and gravel	Weld
INSPECTION TYPE:		INSPECTOR(S):	INSP. DATE:	INSP. TIME:
Monitoring		Peter Hays	November 30, 2021	13:00
OPERATOR:		OPERATOR REPRESENTATIVE:	TYPE OF OPERATION:	
Northern Colorado Constructors		Chris Zadel	112c - Construction Regular Operation	
			T	
REASON FOR INSPECTION:		BOND CALCULATION TYPE:	BOND AMOUNT:	
Normal I&E Program			\$313,987.00	
DATE OF COMPLAINT:		POST INSP. CONTACTS:	JOINT INSP. AGENCY:	
NA		None	None	
WEATHER:	INSPECTOR'S SIGNATURE:		SIGNATURE DATE:	
Clear	fthe.		December 3, 2021

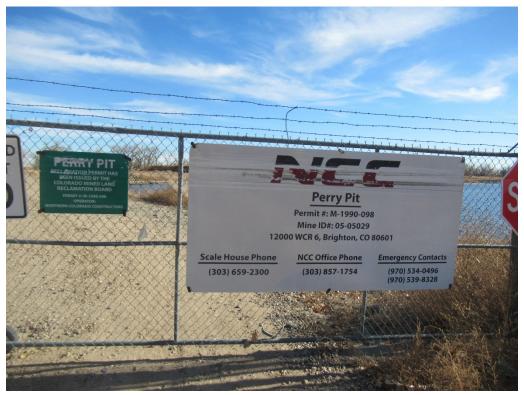
The site vegetation consisted mainly of annual and noxious weeds, including cheat grass and kochia. Equipment and debris was observed south of the topsoil stockpile. The Operator is aware of the requirement to control the noxious weeds and remove the equipment and debris from the site. The mine sign and boundary markers were observed as required by Rule 3.1.12.

Perry Pit mine sign

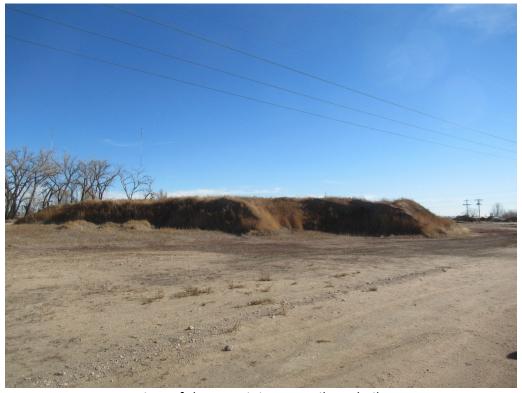
Mining activities are complete at the site. The Operator has been selling the remaining topsoil stockpiles at the site over the last few years. The Operator intends to spread the remaining topsoil stockpile around the reservoir shoreline and potentially on the eastern upland portion of the site. The Operator is checking to see if the additional material on the eastern portion would affect the floodplain elevation.

View of the remaining topsoil stockpile

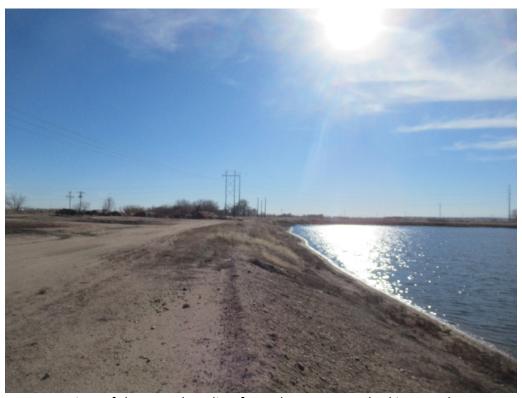
The reservoir is owned by Consolidated Mutual Water Company and operated by the City of Fort Lupton. The reservoir was partially full of water and evidence of water removal based on horizontal shoreline erosion features were observed during the inspection. The shoreline of the reservoir appeared to be rough graded at approximately a 3H:1V slope. The Division will require the Operator to submit a topographic survey verifying the final 3H:1V slope prior to consideration for any future final release requests. The Operator intends to complete the topsoiling and seeding of the site by next spring. The three (3) inlet/outlet structures approved under technical revision no. 3 are installed and appeared to be properly constructed by the Operator.

View of the east shoreline from the NE corner looking south

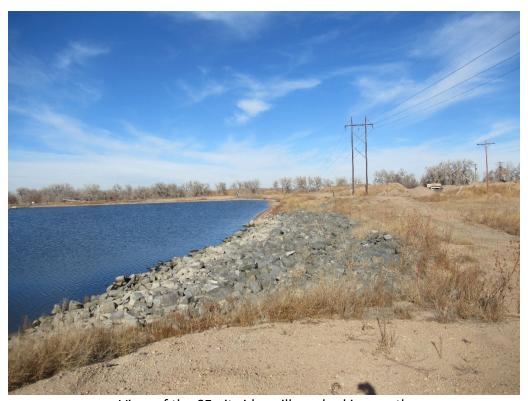
View of the SE pit side spillway looking north

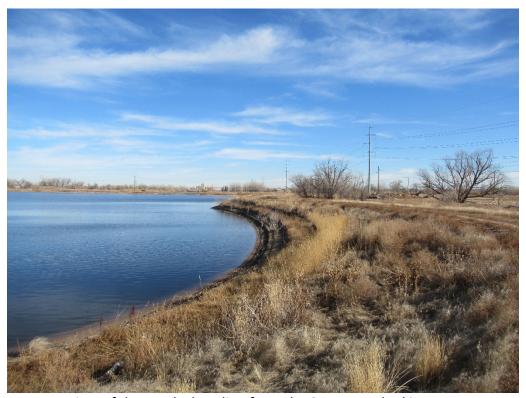
View of the south shoreline from the SW corner looking east

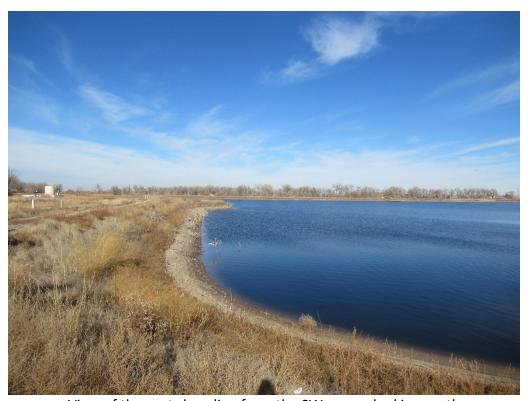
View of the east shoreline from the SW corner looking north

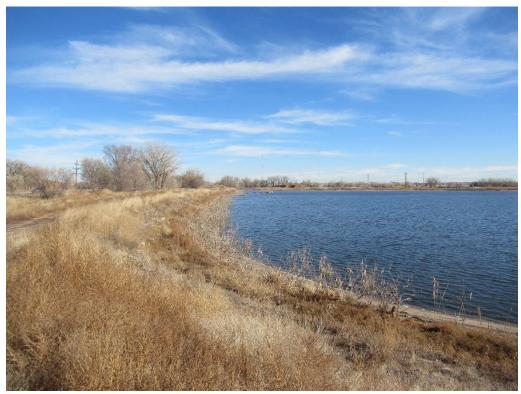
View of the north shoreline from the NW corner looking east
