MINERALS PROGRAM INSPECTION REPORT

MINE NAME: Marrs Memorials	MINE/PROSPECTING ID#: M-1977-168	MINERAL: Aggregate	COUNTY: Fremont
INSPECTION TYPE: Surety-Related Inspection	INSPECTOR(S): Timothy Cazier, P.E.	INSP. DATE: December 2, 2021	INSP. TIME: 11:10
OPERATOR: Colorado Quarries Inc	OPERATOR REPRESENTATIVE: Aaron Tezak	TYPE OF OPERATION: 110c - Construction Limited Impact	
REASON FOR INSPECTION: Surety Related	BOND CALCULATION TYPE: Complete Bond	BOND AMOUNT: \$3,040.00	
DATE OF COMPLAINT: NA	POST INSP. CONTACTS: U.S.BLM	JOINT INSP. AGENCY: None	
WEATHER: Clear	INSPECTOR'S SIGNATURE:

OBSERVATIONS

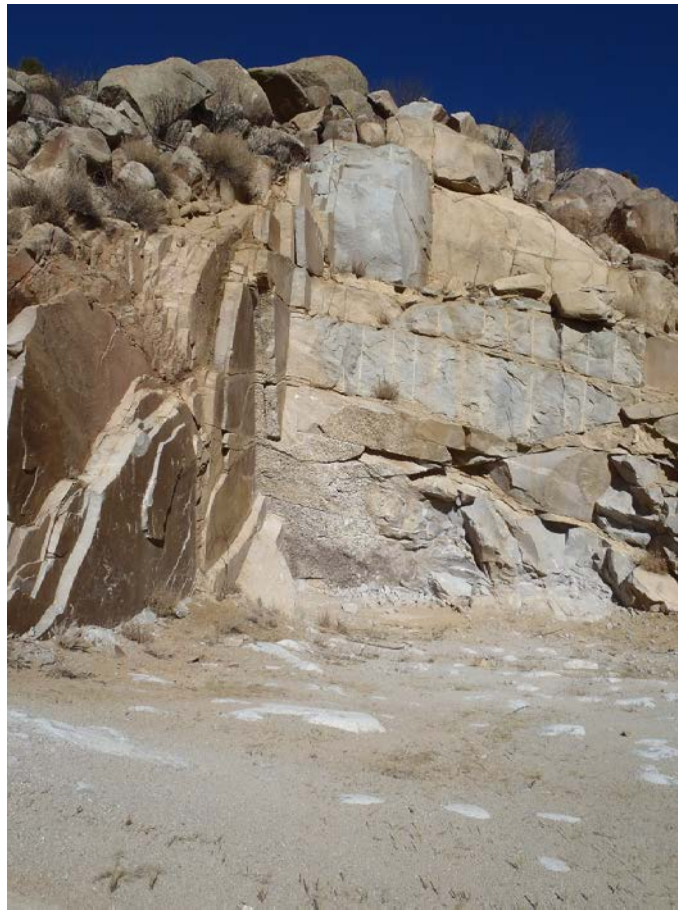
Gen. Compliance with Mine Plan: The operation appeared to be in compliance with the approved mine plan. The maximum allowed disturbed area is 2 acres. Google Earth was used to measure the disturbed pit floor area, which was estimated to be approximately 0.25 acres, based on 2019 imagery. Highwalls were estimated to vary between 30 and 40 feet in height and appeared stable (see **Photo 1**).

Photo 1. Most recently active highwall (Blasting drill holes visible midway, lower portion suggestive of jackhammer activity).

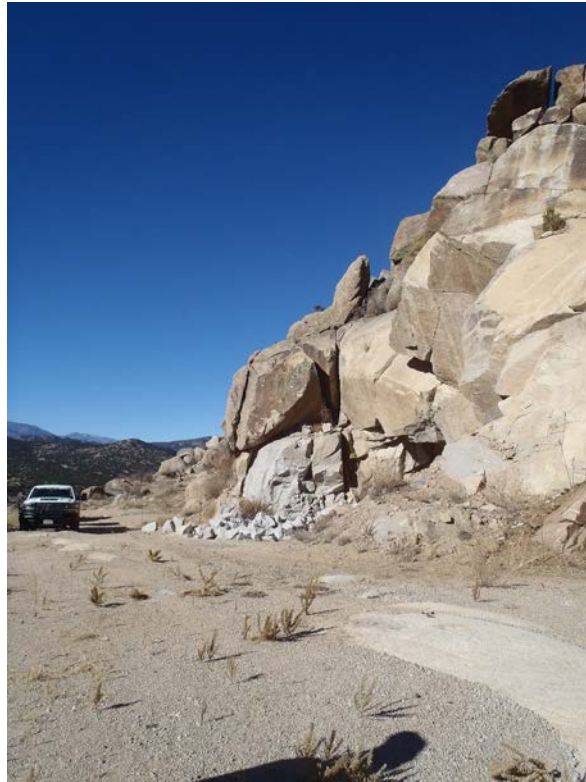
Roads: The only road in the permit area is the pit floor (see **Photo 2**). No maintenance was needed at the time of the inspection.

Photo 2. Pit floor/access road (looking west).

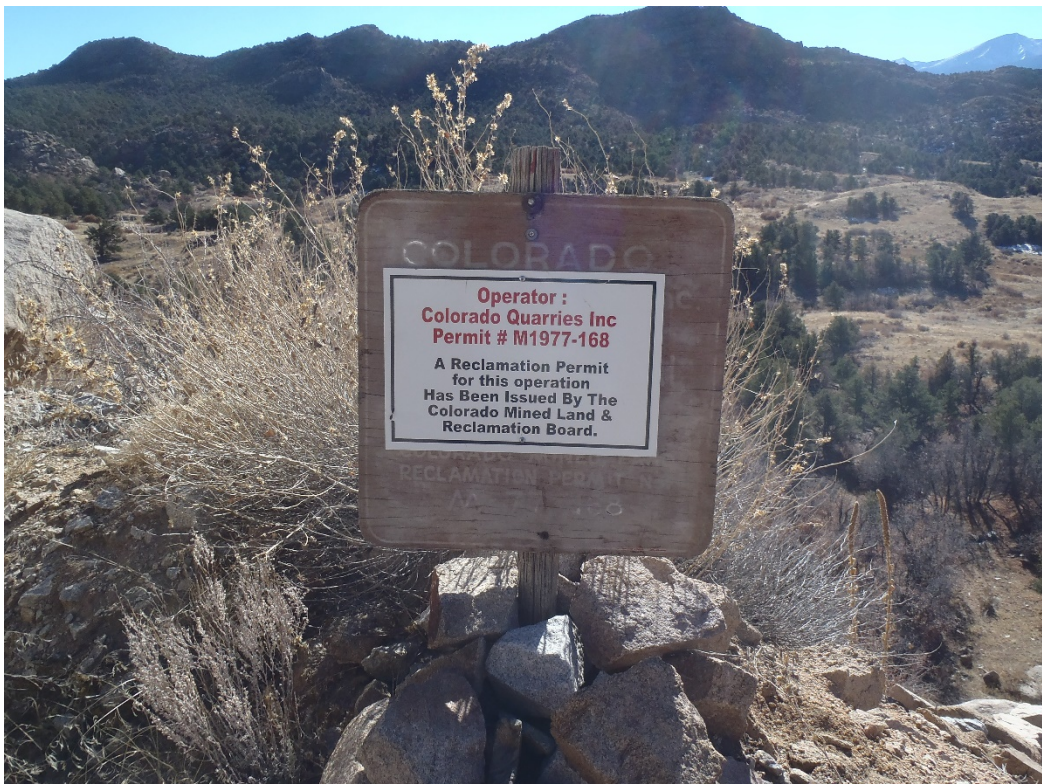
Signs and Markers: The permit sign was properly posted (see **Photo 3**) and all four boundary marker corners were observed to delineate the permit boundary (see **Photo 4** and **5**).

Photo 3. Permit boundary sign (at entrance).

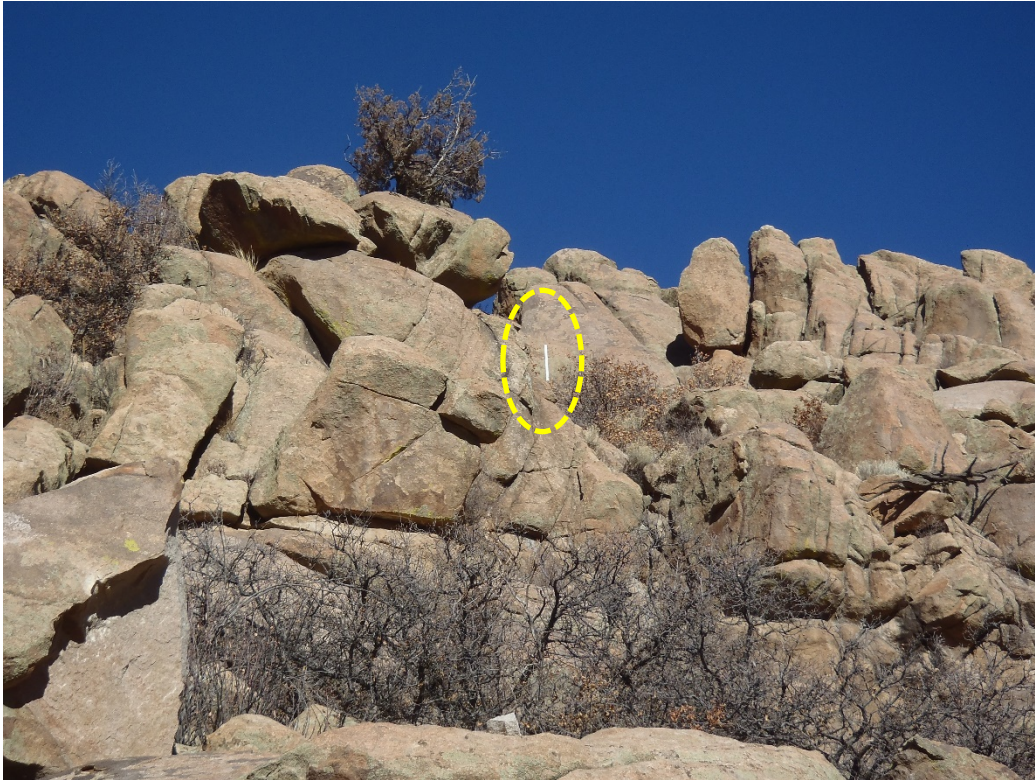
Photo 4. NE corner permit boundary marker (observed from pit floor).

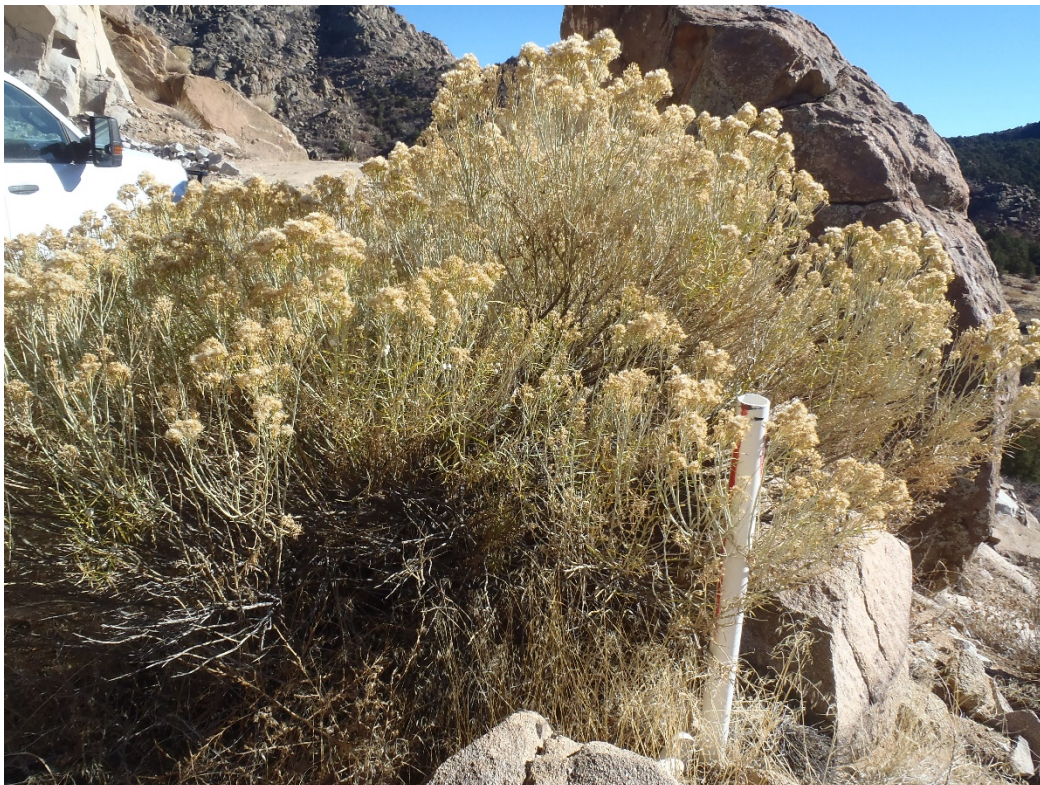
Photo 5. SW corner permit boundary marker (next to pit floor, looking east).
