MINERALS PROGRAM INSPECTION REPORT
PHONE: (303) 866-3567

MINE NAME: Golden Wonder Mine	MINE/PROSPECTING ID#: M-1978-091-UG	MINERAL: Gold	COUNTY: Hinsdale
INSPECTION TYPE: Monitoring	INSPECTOR(S): Stephanie Mitchell	INSP. DATE: August 13, 2020	INSP. TIME: 11:00
OPERATOR: LKA International Inc.	OPERATOR REPRESENTATIVE: Kye Abraham	TYPE OF OPERATION: 110d - Designated Limited Impact	
REASON FOR INSPECTION: Normal I&E Program	BOND CALCULATION TYPE: None	BOND AMOUNT: \$136,046.10	
DATE OF COMPLAINT: NA	POST INSP. CONTACTS: None	JOINT INSP. AGENCY: None	
WEATHER: Clear	INSPECTOR'S SIGNATURE:

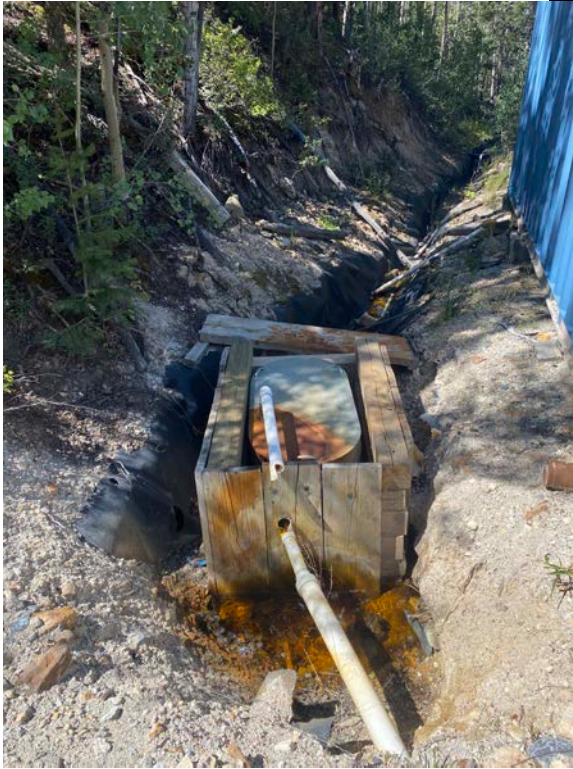
No active mining was observed during the inspection. An orange colored mine water discharge was observed exiting the portal which was observed during prior inspections. The discharge was NOT collecting into the grate that then goes into piping that directed the water into the passive metal slag treatment system. The flow is still estimated to be 0.1 gpm.

Water treatment- not repaired- waiting on new treatment system to be installed from TR4

The main focus of the inspection was to observe the current configuration of the proposed water treatment system that was approved under technical revision no. 4. At this time the proposed water treatment system was NOT installed. The Operator stated that they are waiting for equipment to be shipped. DRMS will do a follow up inspection in the Spring of 2021 to observe new treatment measures.

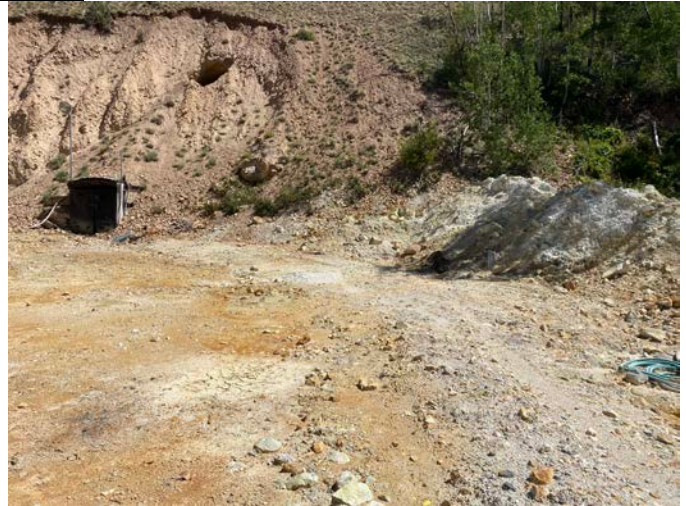
Level 6 Portal with Subsidence/Collapse above

Above the portal at the level 6, there appears to be some subsidence or collapsing. The Operator is encouraged to repair the feature to reduce future collapsing.

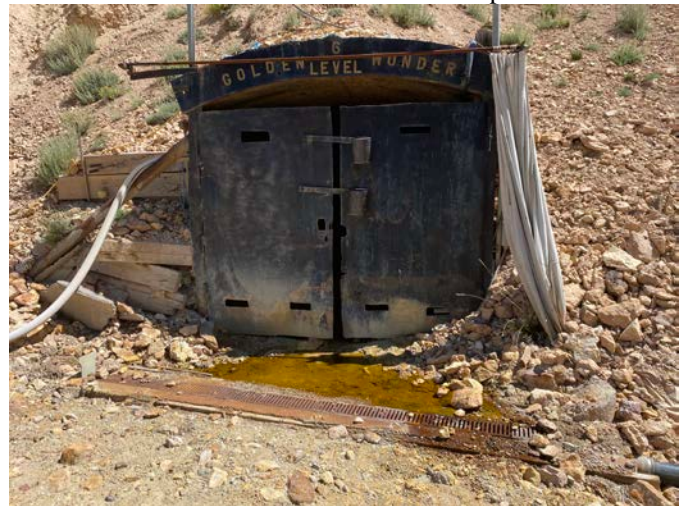
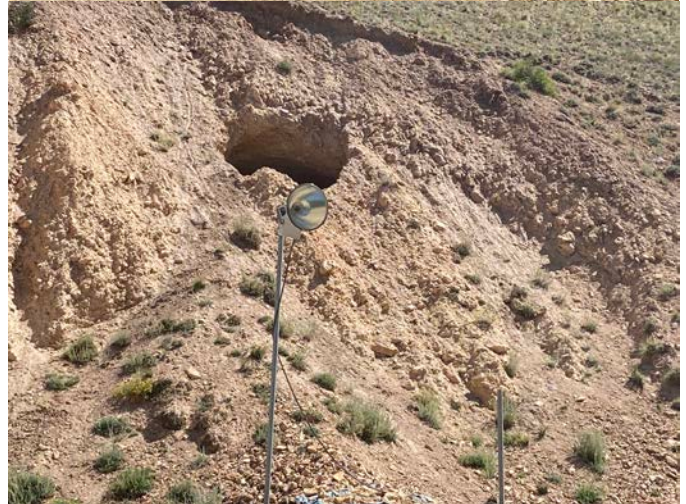
Subsidence/collapse to be repaired

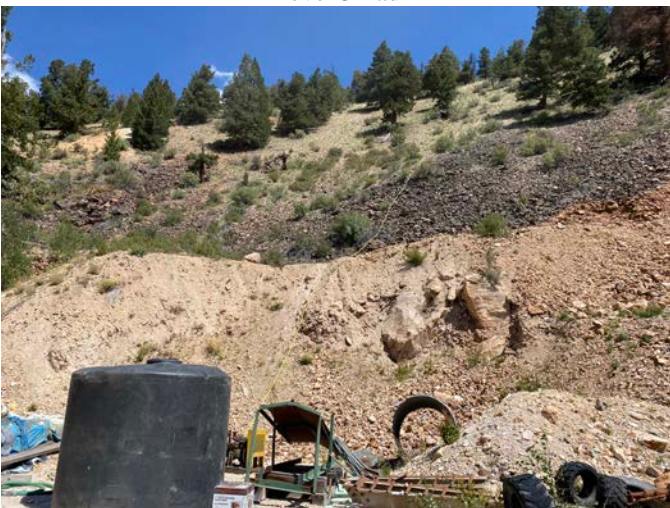
Miscellaneous mining debris / trash was observed along the eastern portion of the mine bench. The materials appeared disorganized and out of place. The conditions observed are not considered problem but poor housekeeping and is noted in this inspection report to be used as a tool to monitor future site conditions.

Debris on site- level 3
