MINERALS PROGRAM INSPECTION REPORT
PHONE: (303) 866-3567

MINE NAME: Green Bros Pit No 2	MINE/PROSPECTING ID#: M-1995-030	MINERAL: Sand and gravel	COUNTY: Morgan
INSPECTION TYPE: Monitoring	INSPECTOR(S): Brock Bowles	INSP. DATE: October 20, 2021	INSP. TIME: 12:30
OPERATOR: McAtee Construction Company	OPERATOR REPRESENTATIVE: Victor Anido	TYPE OF OPERATION: 112c - Construction Regular Operation	
REASON FOR INSPECTION: Normal I&E Program	BOND CALCULATION TYPE:	BOND AMOUNT: \$45,124.07	
DATE OF COMPLAINT: NA	POST INSP. CONTACTS: None	JOINT INSP. AGENCY: None	
WEATHER: Clear	INSPECTOR'S SIGNATURE:

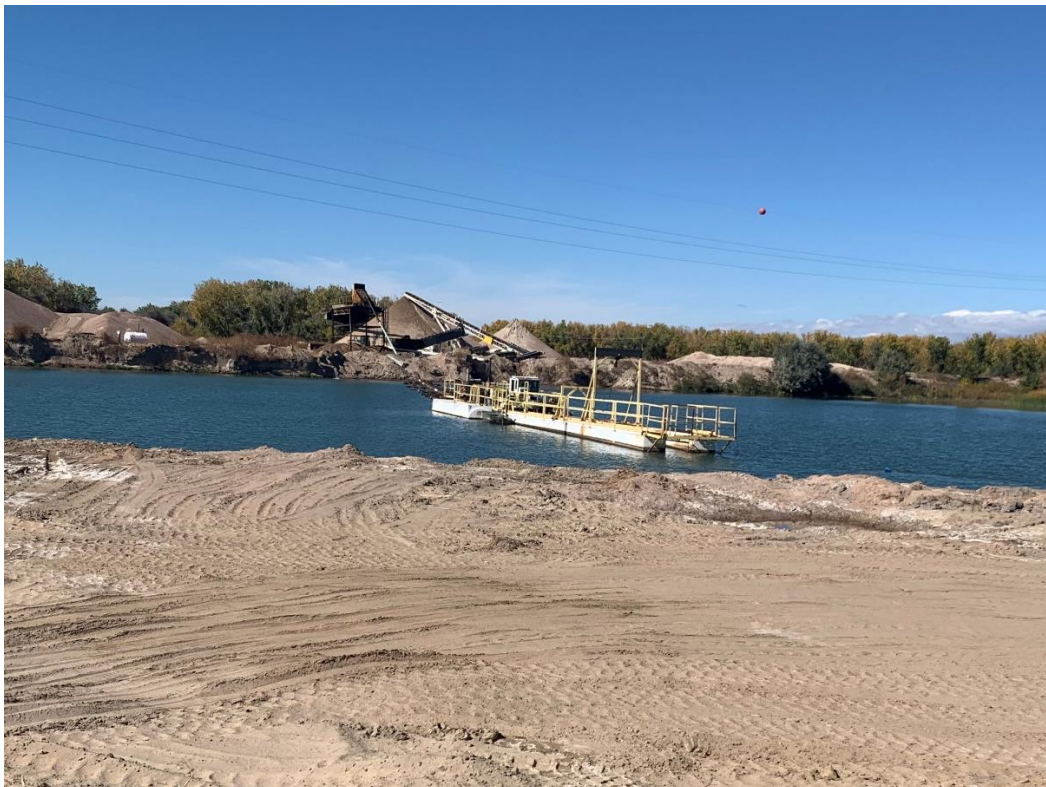
The dredge was in operation during the inspection (photo 1). The dredge was removing material from the southern bank of the pond. Material was being pumped to the screening equipment on the northwestern bank of the pond where it was sorted and stacked. The reject sand was being pumped back into the pond from the western bank.

Photo 1 – Dredge and screening equipment in background

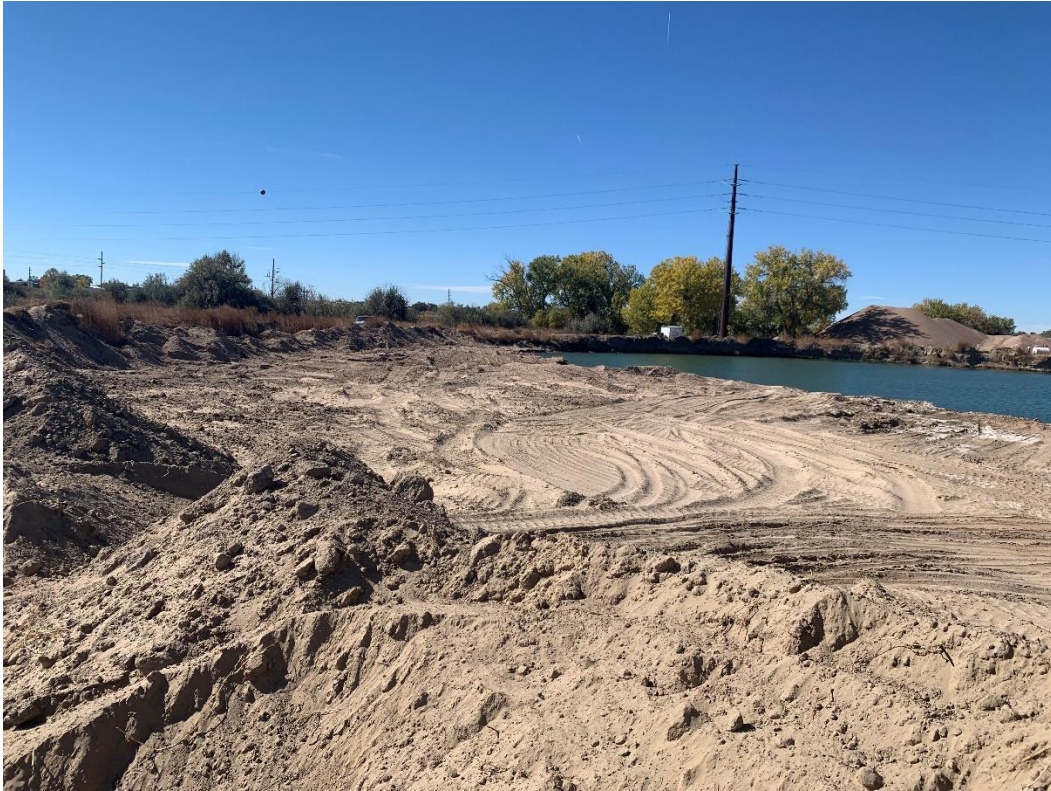
The topsoil was stripped from in front of the mining area and was stored in a long stockpile (photo 2).

Photo 2 – Topsoil stripped from in front of mined area

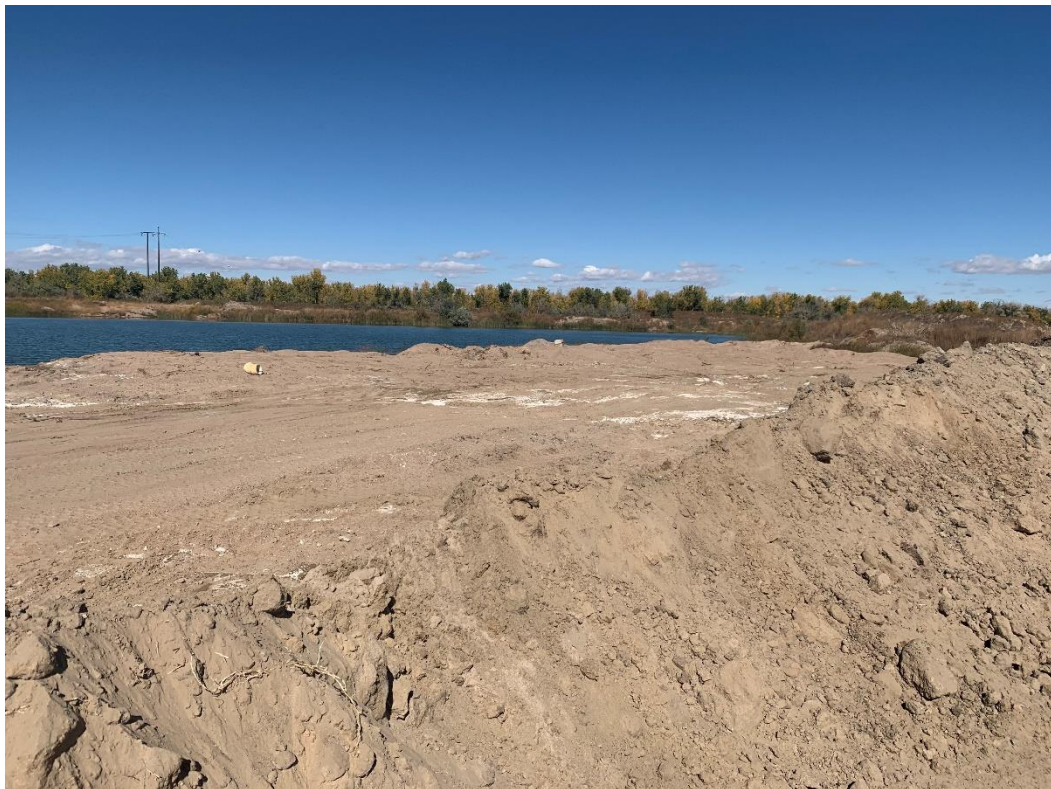
Photo 3 – Eastern part of mined pond, facing north east
