New Elk Mine, C-1981-012, December 8, 2021 Inspection Report

COLORADO
Division of Reclamation,
Mining and Safety
Department of Natural Resources

PERMIT INFORMATION

INSPECTION INFORMATION

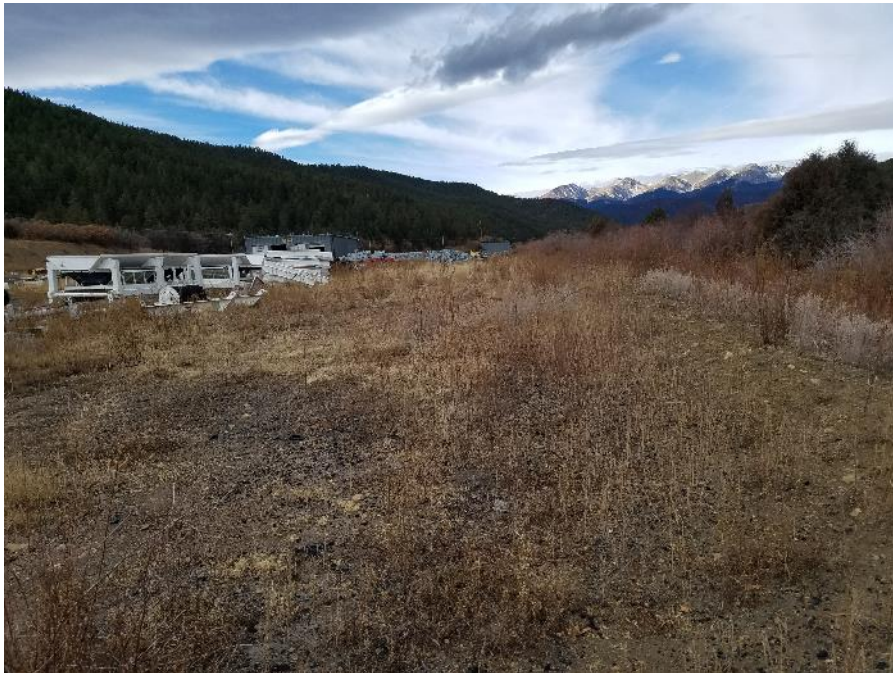
On the south side of the Middle Fork of Purgatorie River west of the soil storage area, NECC is using this area to store equipment. A small quantity of trash and debris was observed in this area being blown by the wind. Vince Massarotti indicated that he would have some staff members clean up this area of excess debris. The berm on the north side of this area is in place and is vegetated. This berm is containing the excess debris observed in this area.

Figure 1. South side of the Middle Fork of the Purgatoire River, looking at the equipment storage area south of Ditch D5.

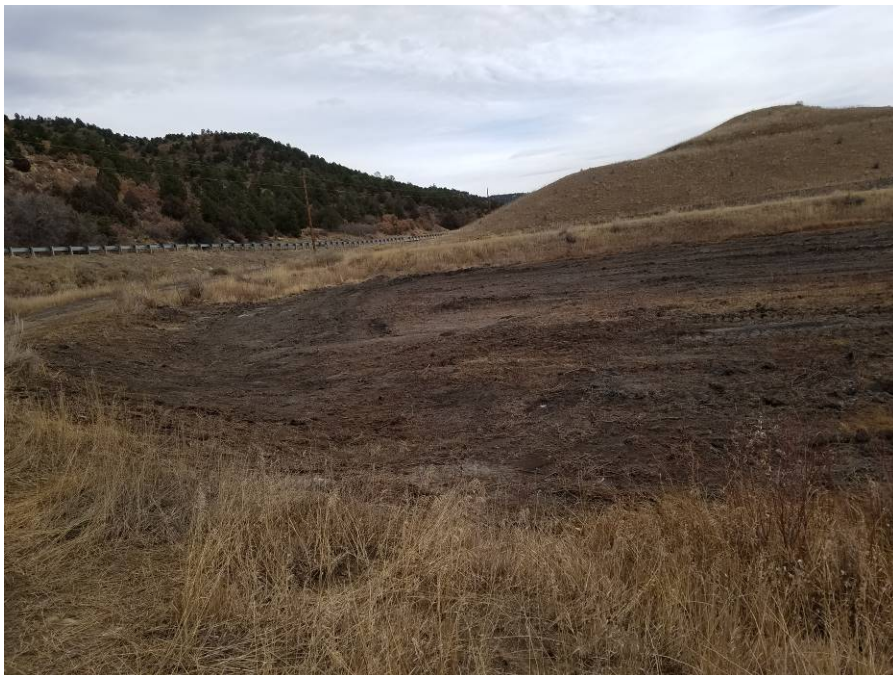
Figure 2. Pond 004

Pond 004 was dry. NECC recently cleared the shrubby vegetation/willows established in the pond area. Also while conducting this maintenance work, NECC found that the outlet concrete collar and pipe was being undercut

According to Mr. Massarotti, NECC would like to burn the shrubby/willow slash removed from Pond 004. Mr. Massarotti indicates NECC must work with the local government on the timing of this activity when sufficient snow is on the ground and when the wind conditions are optimal. In accordance with Rule 2.05.3(8), the permit must include a plan for non-coal waste removal, handling, storage, and transportation and disposal areas and structures within the permit area in accordance with Rule 4.10 and 4.11. The slash material is currently being stored in the northeast corner of the soil storage area. Currently NECC Permit Application Package (PAP) section 2.05.3(8) includes how non-coal waste will be handled. This plan does not include a provision for the burning of the Pond 004 slash materials. **DRMS requests that NECC submit a minor revision to update this plan in section 2.05.3(8) of the PAP to discuss the disposal procedures associated with the Pond 004 slash and how it will comply with Rule 4.11.4.**

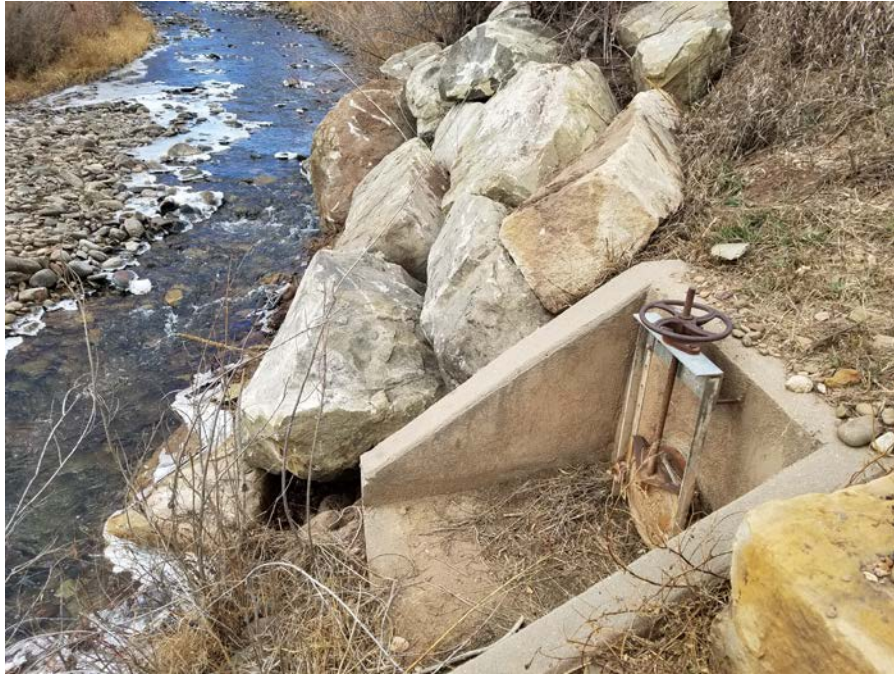
by erosion. To correct this, Mr. Massarotti placed large rocks upstream of the structure to armor the bank of the river and to protect the outlet. The primary and emergency spillway appeared clear and functional. Some of the desired vegetation on the pond embankment was disturbed as a result of the maintenance work conducted at Pond 004. Mr. Massarotti indicated that he would seed this disturbance area in the future to help establish desired vegetation at the site.

Figure 3. Rip-rap placed on river bank upstream of the outlet of Pond 004.

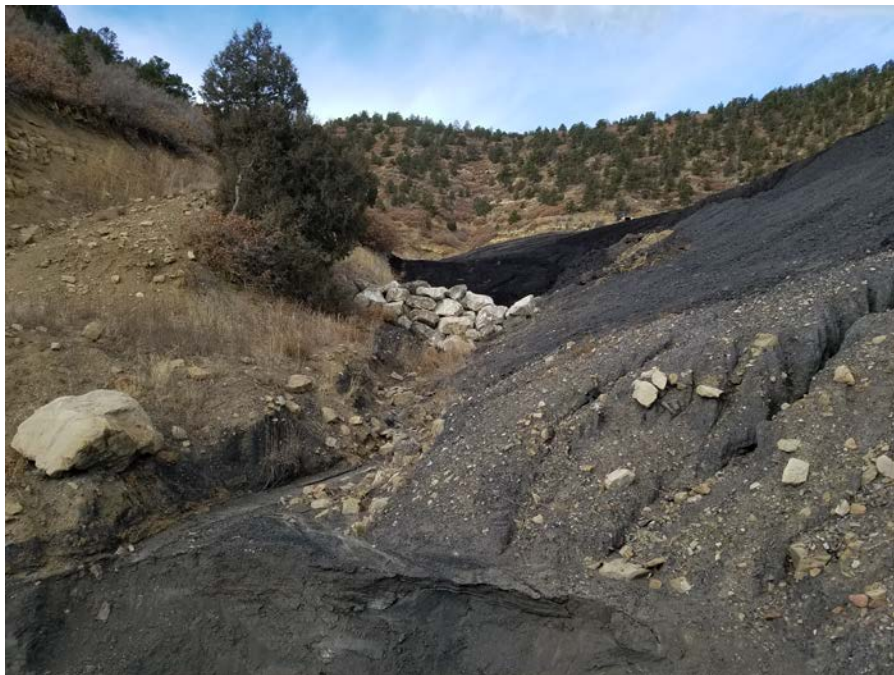
The Refuse Disposal Area (RDA) was observed. NECC was placing and compacting waste at the time of the inspection. NECC has begun to add waste to the drainage area above Culvert C81 below the clean water ditch D55. A large rock check dam structure has been constructed upstream of Culvert C81 to assist with drainage control in this area. The eastern and western rip-raped channel of the RDA was observed. Overall, these drainages were stable and functional. Some undercutting was observed near where the top of the 2nd bench intersects the eastern drainage channel. Mr. Massarotti indicated that NECC is planning to conduct some maintenance of this area in the spring of 2022.

Figure 4. The west side of the RDA, recent waste placement.

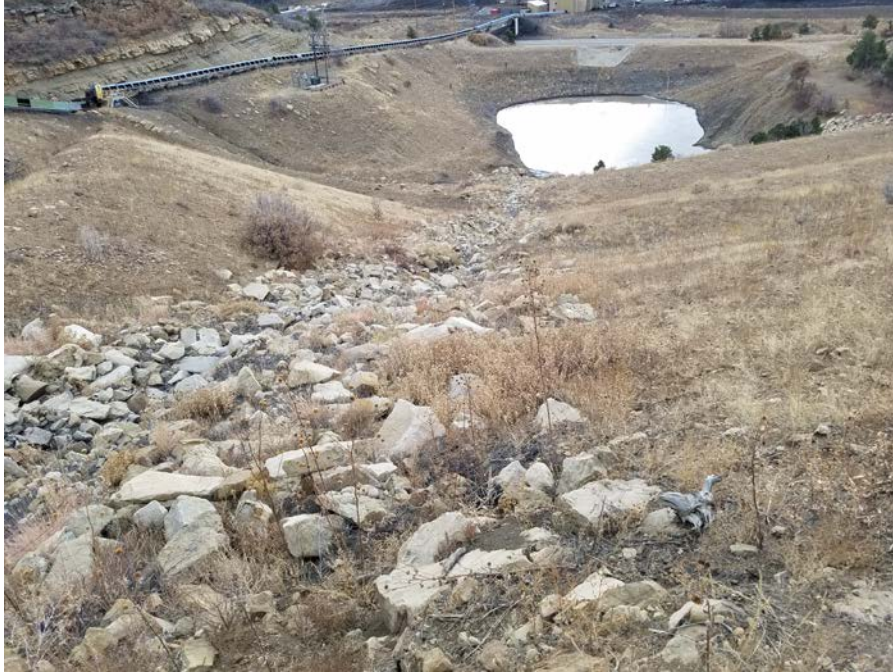
Pond 008 was holding water but not discharging. The primary and emergency spillway appeared clear and functional.

Figure 5. From the top of the eastern drainage of the RDA looking south. Pond 008.

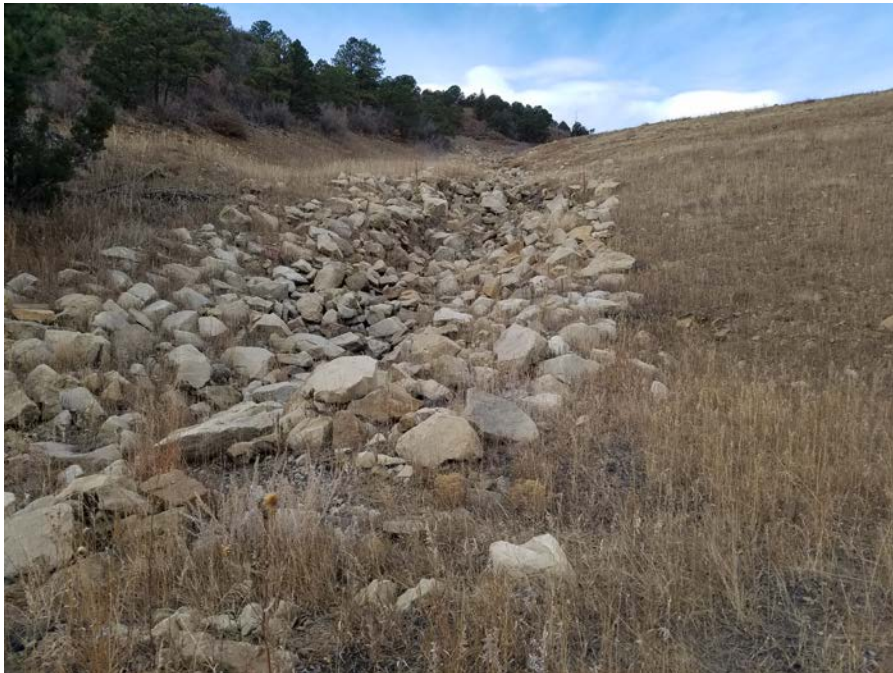
Figure 6. West drainage ditch of the RDA from the south end looking north.
